COLORADO DIVISION OF RECLAMATION, MINING AND SAFETY
MINERALS PROGRAM INSPECTION REPORT
PHONE: (303) 866-3567

MINE NAME: Cresson Project	MINE/PROSPECTING ID#: M-1980-244	MINERAL: Gold	COUNTY: Teller
INSPECTION TYPE: Monitoring	INSPECTOR(S): Amy Eschberger	INSP. DATE: April 14, 2015	INSP. TIME: 11:30
OPERATOR: Cripple Creek & Victor Gold Mining Company	OPERATOR REPRESENTATIVE: Chris Hanks	TYPE OF OPERATION: 112d-3 - Designated Mining Operation

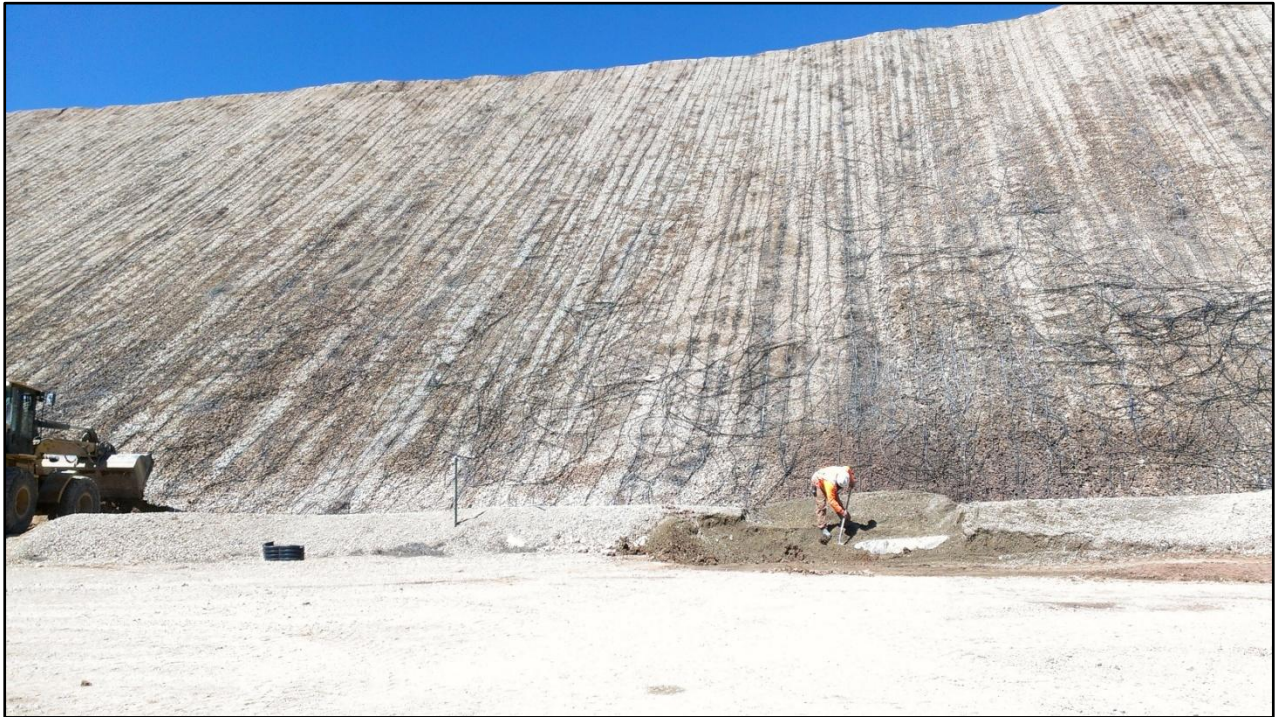
At the time of inspection, the weather was clear, cool and sunny, and the ground was dry with some snow cover remaining in shaded areas. Upon arrival at the operator's main office in the city of Victor, CO, Mr. Hanks informed the Division of a small spill of sodium cyanide leach solution (solution) that was discovered earlier that morning around 8:00-8:30 am. This spill occurred in the northeastern portion of Phase 5 of the Arequa Gulch Valley Leach Facility (AGVLF), where the old AMES shop was previously located (just southwest of the Main Cresson Mine). This area was inspected first. Mr. Hanks estimated that approximately 30-50 gallons of solution had leaked from the faulty dripline(s). This amount is based on the driplines running at a rate of approximately 2 gallons per hour, and the fact that the spill must have occurred after the area was last inspected by mine staff the previous morning around the same time (8:00-8:30 am). Mr. Hanks stated that the solution flow was shut off in this portion of the AGVLF immediately after the spill was discovered. He estimated it would take approximately 3 days to replace the faulty dripline(s). At the time of the inspection, a mine staff member was hand shoveling out the solution-saturated material in order to keep from damaging the liner underneath (**Photo 1**). The spill area appeared to cover approximately 225-300 square feet (approximately 15 feet wide by approximately 15-20 feet out from the liner berm; **Photo 2**). The solution appeared to stop flowing outward and began spreading out laterally once it left the liner berm and hit the compacted ground outside of the berm. A small wheeled loader was hauling off the shoveled solution-saturated material and dumping it back onto the AGVLF (inside the liner berm) at a nearby (dry) location. After all solution-saturated material is removed from the spill area, fresh material will be brought in from a nearby stockpile to replace any removed material and repair the berm. According to Mr. Hanks, the spill would be tracked in the mine's incident response system. Mr. Will Adams, the leach pad supervisor, would continue overseeing the project. The Division believes that mine staff responded appropriately to the spill incident and effectively minimized environmental impact.

Photo 1. View of northeastern side of AGVLF Phase 5, showing small cyanide solution spill from busted dripline(s). Note mine staff hand-shoveling saturated material off of liner, and small loader (at left) depositing this material back onto AGVLF inside the liner berm at a nearby (dry) location.

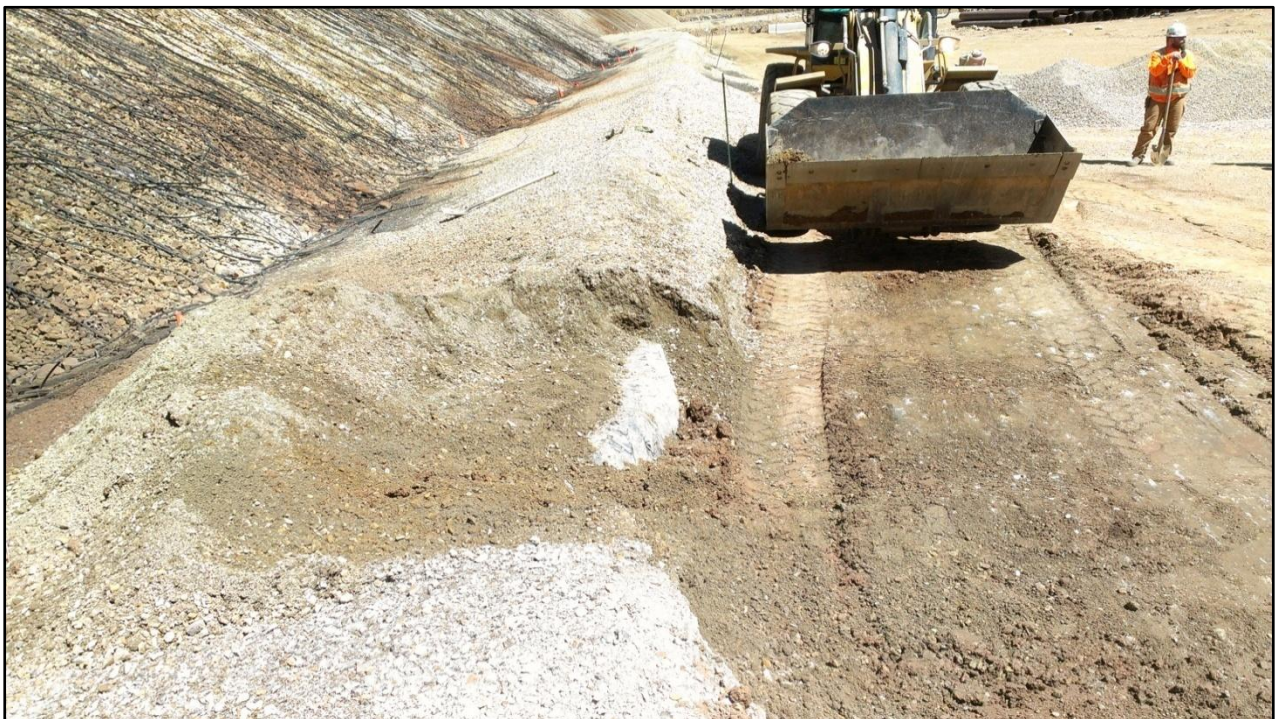
Photo 2. View of northeastern side of AGVLF Phase 5, showing small cyanide solution spill from busted dripline(s). Note area affected by spilled solution is approximately 15 feet wide by 15-20 feet out from the liner berm. Liner is exposed at center where saturated material was shoveled out.

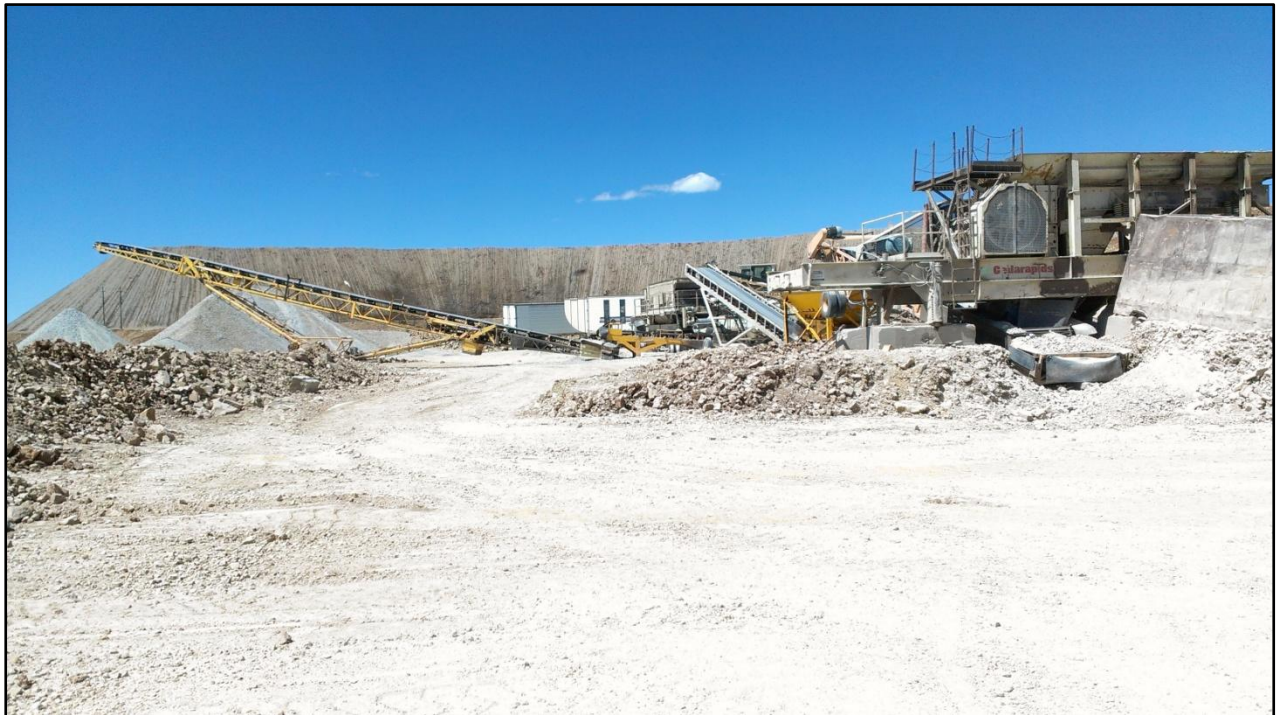
Next, the Division inspected the new location for crushing stemming material for packing blast holes in the South Cresson Pit (**Photo 3**). The operation was active at the time of the inspection. Initially, this mobile crushing operation was to occur in the West Blue Overburden Storage Area located between the Wild Horse Extension Pit (WHEX) and the old Wild Horse Pit. However, the operation encountered a topographic constraint in the previous location and decided to move the operation to its current location. The previous location will still be utilized for storage of stemming material. This small crushing operation operates 12 hours per day at a rate of approximately 1,000 tons per hour. The mine operation requires a total of approximately 250,000 tons of crushed stemming material annually for blasting activities. The operator anticipates completion of this crushing operation by mid-June 2015. No problems were observed in this area.

Photo 3. View of new mobile stemming material crushing operation located in the South Cresson Pit.

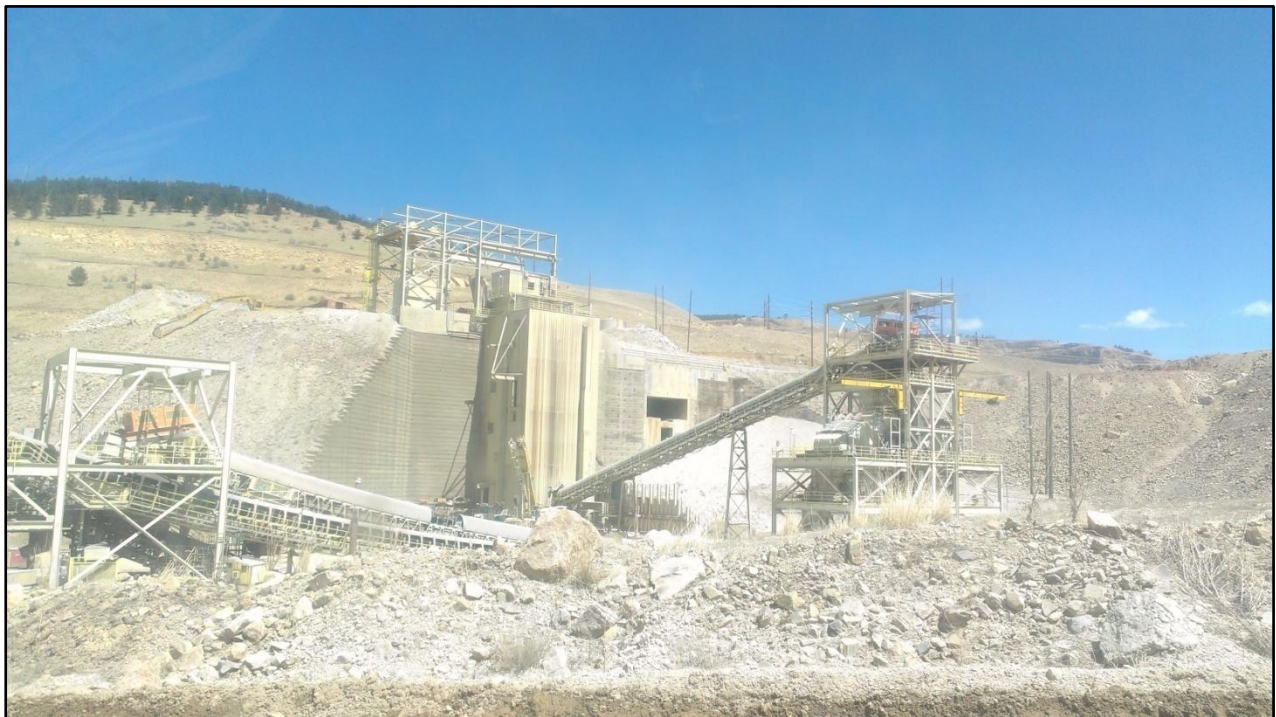
The Division also inspected the main crusher area located between the AGVLF and the Main Cresson Mine (**Photos 4 and 5**). This facility includes a primary crusher, secondary crushers, and a lime silo. The crushed ore is conveyed up to a load-out bin (LOB) located northwest of the crusher area, where trucks haul the material to the AGVLF leach pad. The facility did not appear to be in operation at the time of the inspection. No mine staff were present. Before conducting this inspection, the Division was curious about what appeared to be a stockpile located adjacent to the old Hilfiger Wall just east of the old crusher (**Photo 6**; visible in Google Earth). Upon further inquiry, the operator informed the Division that the material was not a stockpile but a structural fill of 6-8 inch minus crush placed and

Photo 4. View of eastern portion of main crusher area located between AGVLF and Main Cresson Mine. Primary crusher at center.

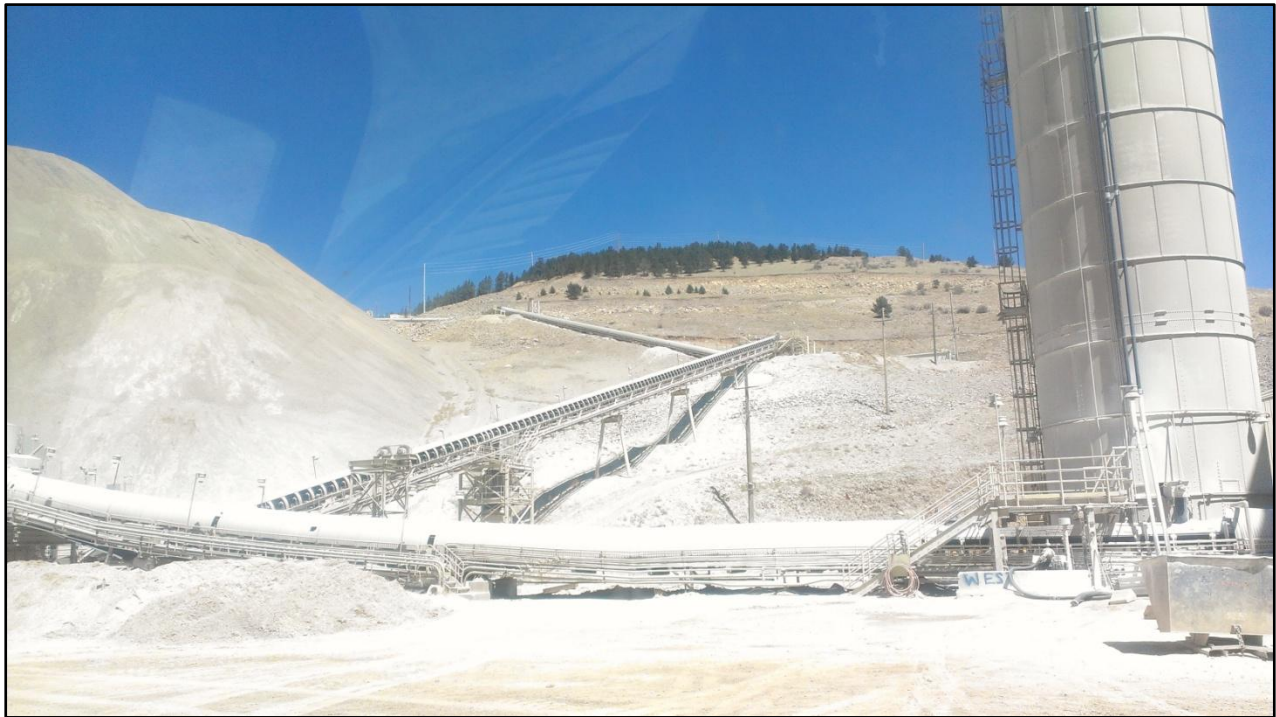
Photo 5. View of western portion of main crusher area located between AGVLF and Main Cresson Mine. Lime silo at right and conveyor at center (which leads to load-out bin where trucks haul crushed ore to AGVLF leach pad).

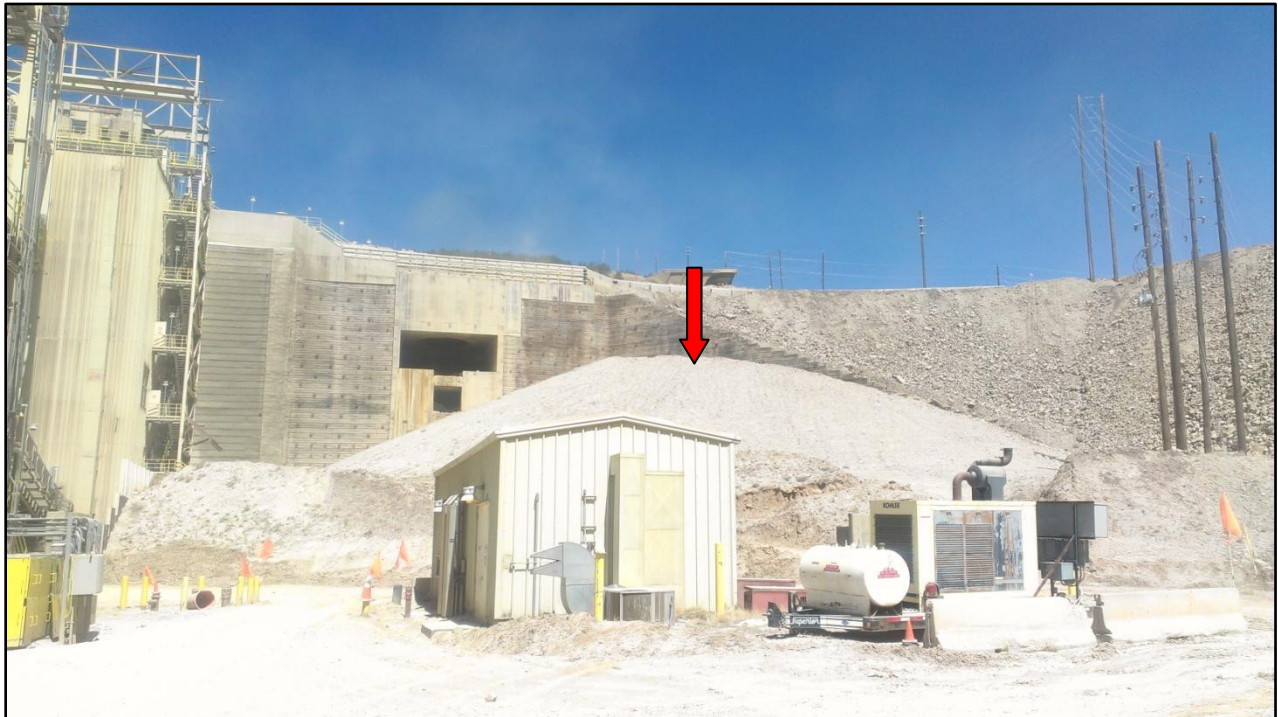
compacted against the old Hilfiger Wall for stability. Apparently, a slight bulge was found at the base of the wall, and a geotechnical evaluation was completed in 2013/2014. The fill against the Hilfiger wall was designed to pick up the slope angle above the wall and stabilize the structure for life of mine. Currently, the rest of the structure is stable and no further work is anticipated at this time. The primary crusher is located immediately west of the old crusher area, and therefore, maintaining the integrity of this area is critical. The area located uphill north and northeast of the main crusher area is undergoing construction. A portion of the haul road was removed for placement of a culvert that will help drain roads in this area to a catchment pond. No problems were observed in this area.

Photo 6. View of main crusher area, showing structural fill (indicated) that was placed and compacted against the old Hilfiger Wall to help stabilize the structure.

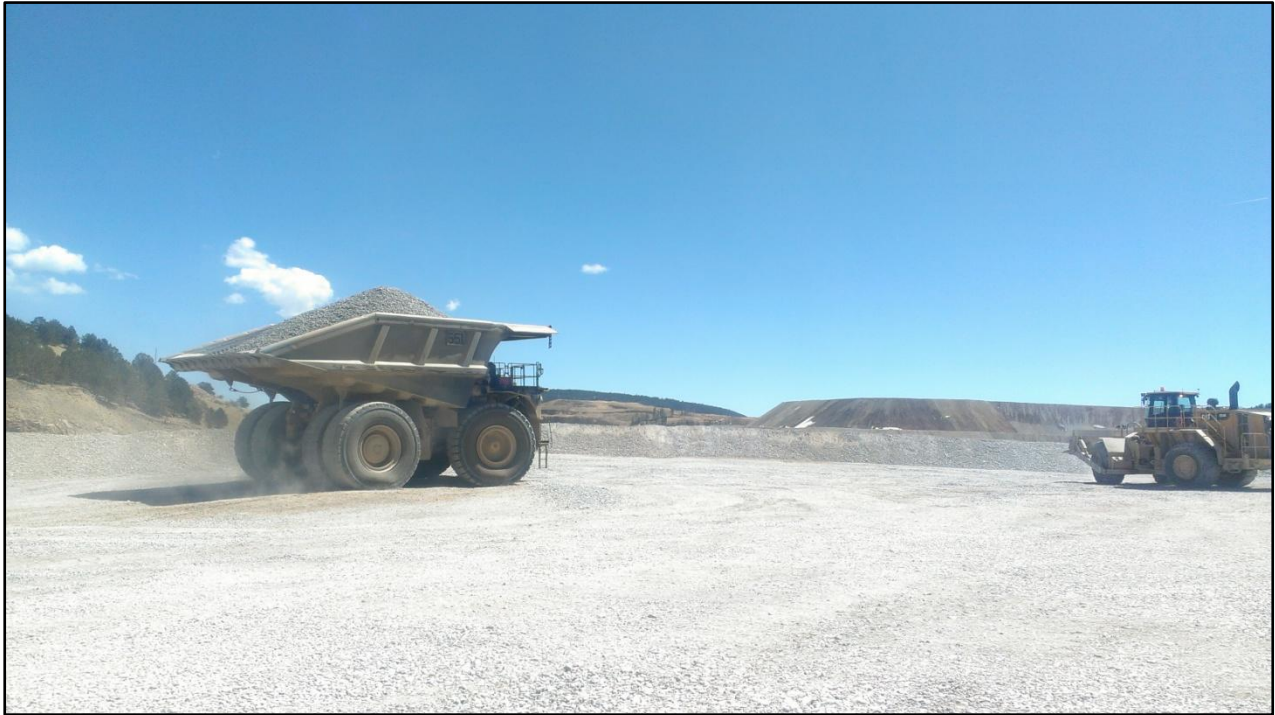
Before exiting the AGVLF area, the Division briefly inspected the Phase 4 area where spent ore (ore previously leached by sodium cyanide) was removed and hauled to the SGVLF. This material was used to stabilize the High Volume Solution Collection System (HVSCS) riser pipes in the Pregnant Solution Storage Area (PSSA) and to help build the ADR-2 platform to yard grade. This operation began in October 2014 after approval of Technical Revision No. 72 (TR-72, approved 09/18/2014). The operation was completed within a few weeks before this inspection. A total of approximately 1.75 million tons of spent ore was moved. At the time of the inspection, mine staff were re-loading Phase 4 with crushed ore (**Photo 7**). No problems were observed in this area.

Photo 7. View of AGVLF Phase 4 area where spent ore was removed and hauled to the SGVLF to help stabilize the HVSCS riser pipes. Mine staff are reloading this area with crushed ore.

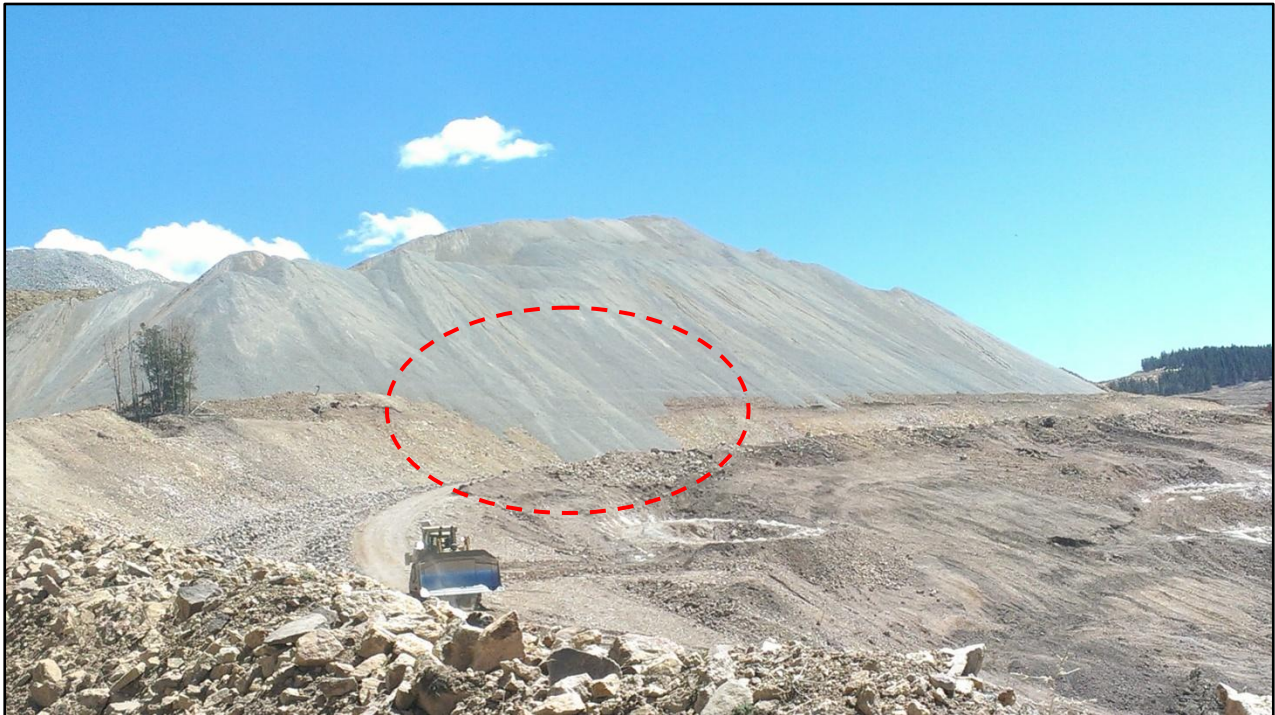
Next, the Division inspected the southwestern edge of the DCF stockpile located west of the AMES construction yard. Based on a recent aerial image of this area (shown in the aerial inspection report from 12/03/2014), the Division was concerned that there may be sloughing of the stockpile into the adjacent Phase 2 stormwater diversion ditch. If this were the case, the Division would have concerns about overall slope stability of the stockpile and potential impacts on the diversion ditch. At the time of the inspection, any excess DCF material that had spilled over into the ditch had been removed, and this portion of the stockpile appeared to be stable (**Photos 8 and 9**). After discussing the matter with Mr. Hanks and other mine staff, it appears that this was not a case of stockpile sloughing, but occurred as the stockpile was being stacked approximately 1-1/2 to 2 years ago. Apparently, the stacker built up this portion of the stockpile too quickly, causing the material to spill over the surrounding berm. The problem was resolved by moving back the stacker. At that time, the adjacent diversion ditch was unlined. Now, the ditch is lined with riprap, and does not appear to be impacted by the stockpiled material. Because the DCF material is clean (not waste rock) there should be no concerns about surface water contamination. No problems were observed in this area.

Photo 8. View of southwestern edge of DCF stockpile located west of AMES construction yard. Note area (circled) where stockpiled material appeared to be sloughing into adjacent stormwater diversion ditch.

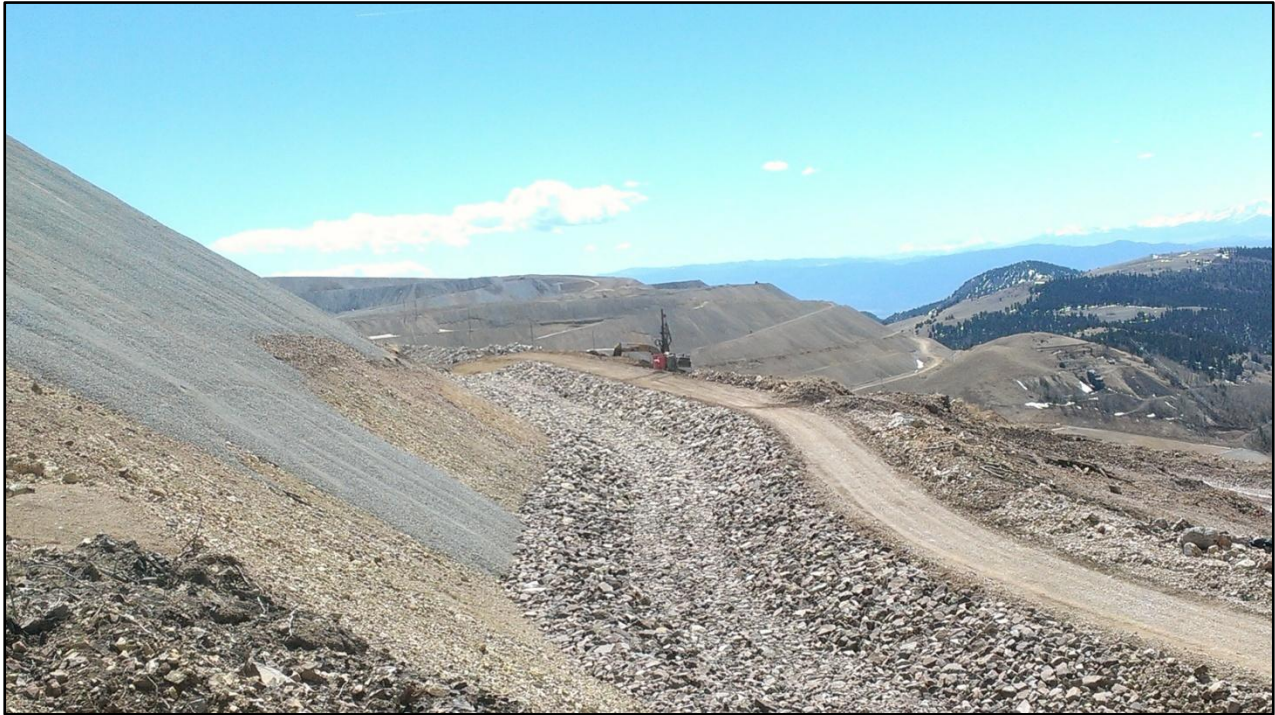
Photo 9. Closer view of southwestern edge of DCF stockpile located west of AMES construction yard where stockpiled material appeared to be sloughing into adjacent stormwater diversion ditch. Note diversion ditch is not currently impacted by DCF material.

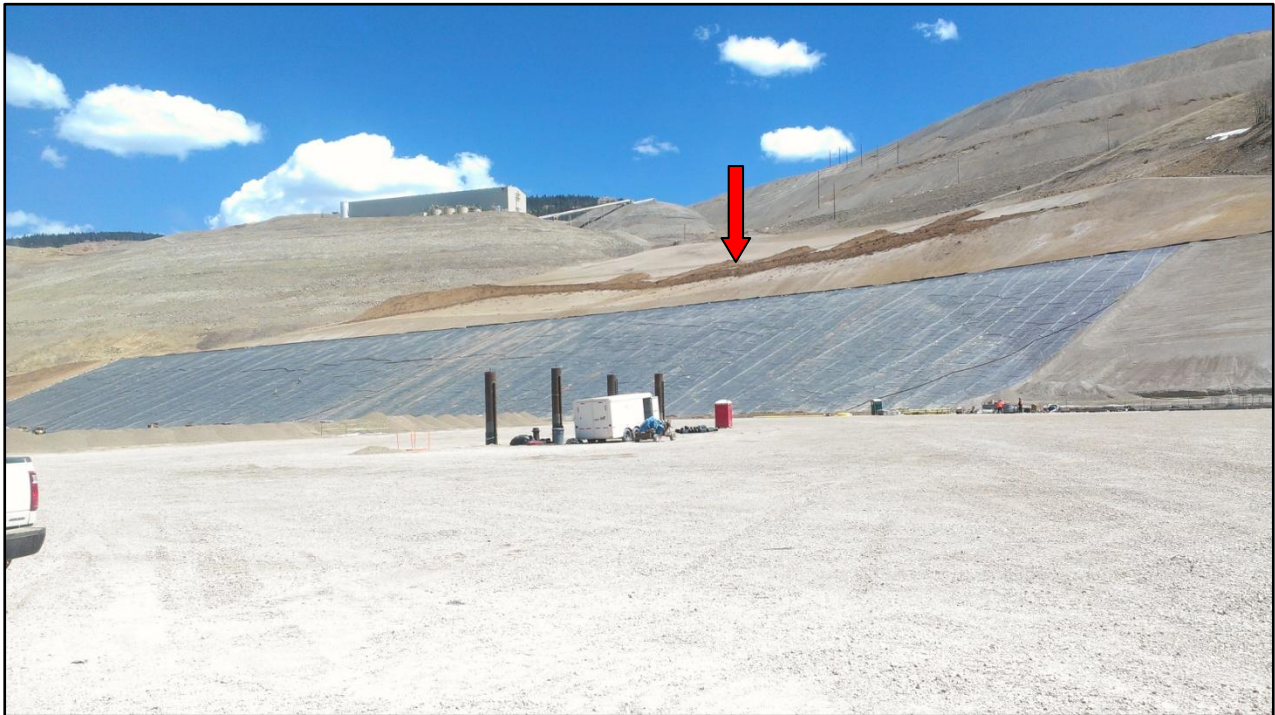
The inspection continued at the SGVLF. The four HVSCS riser pipes located in the southwestern portion of the PSSA will be cut off and leveled, and the header will be installed at an elevation of approximately 9,450 feet (current grade). The southern slope of the SGVLF where the accepted Phase I 80-mil LLDPE geomembrane liner was installed before winter was in the process of being recertified by AMEC staff (**Photos 10 and 11**). This process includes inspecting the entire liner, marking locations of any defects, beading these areas, and performing vacuum tests. As each portion of the liner in this area is recertified, DCF material is placed per the approved specifications (**Photo 12**). Prior to DCF placement, the HVSCS piping is placed on the accepted liner (**Photo 13**). During the inspection, the Division also observed mine staff placing Soil Liner Fill material (SLF) on Phase I acceptance areas located above (southeast of) the area receiving DCF placement (shown in **Photo 10**). SLF was also being placed on the northern slope of the SGVLF (**Photo 14**). Mine staff had recently completed excavating the Phase I leak detection trench along the western edge of the liner near the ADR-2 (**Photo 15**; also shown in **Photo 14**). According to the approved specifications, a 3-inch perforated polyethylene leak detection pipe is installed in this trench and transitions to solid piping. During the inspection, mine staff were in the process of constructing the SLF plug and berm adjacent to the trench (as completed on the southern portion of the SGVLF) to create the cut-off wall from perforated to solid piping.

Photo 10. View of southern slope of SGVLF, showing lined portion of Phase I being recertified by AMEC to receive DCF material. Note DCF material already placed on portion at far right. Also note SLF being placed on Phase I portion above (indicated). Four HVSCS riser pipes shown at center.

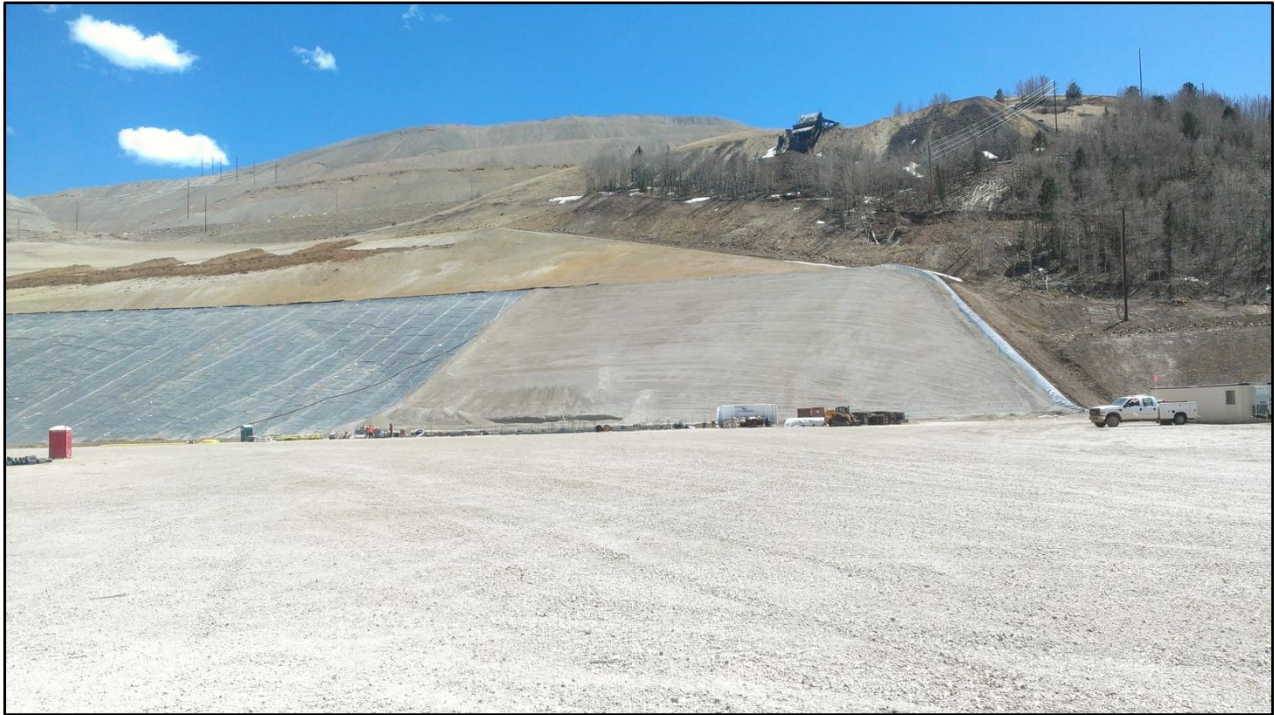
Photo 11. View of southern slope of SGVLF, showing lined portion of Phase I that has recently received DCF material placement. Note anchor trench and clay berm shown at right (southwestern edge of PSSA).

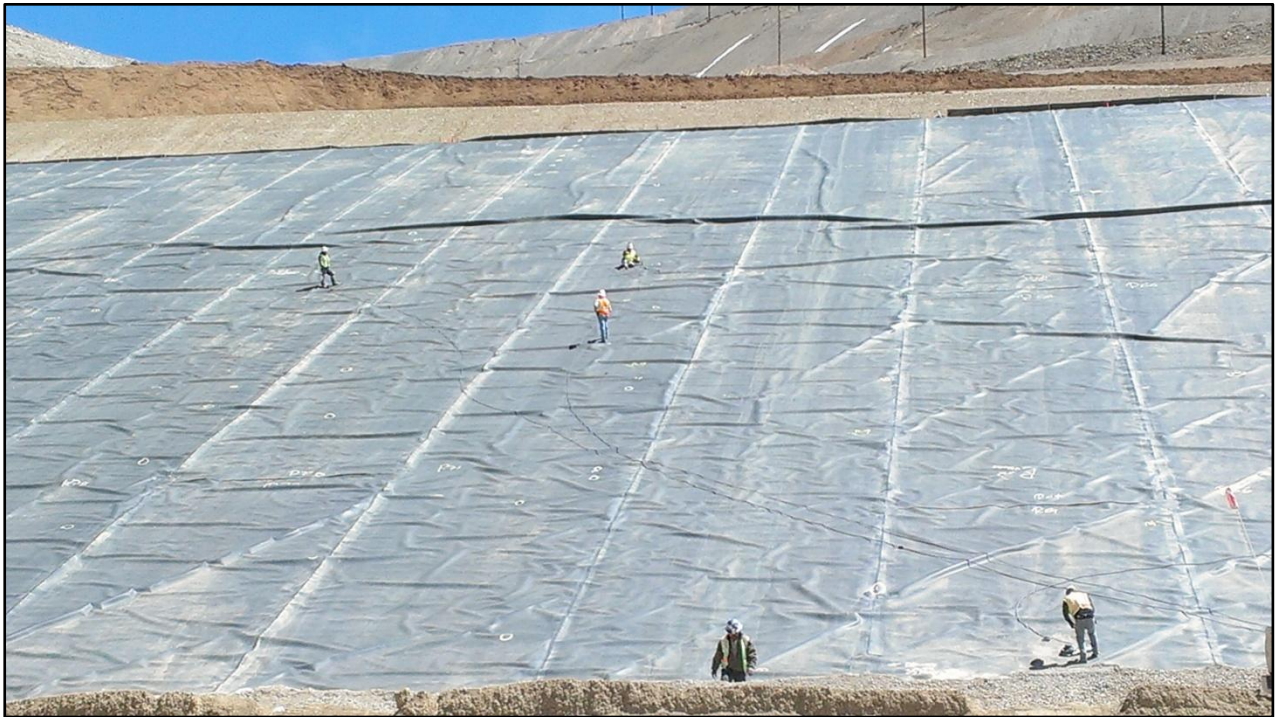
Photo 12. View of southern slope of SGVLF, showing lined portion of Phase I being recertified by AMEC personnel.

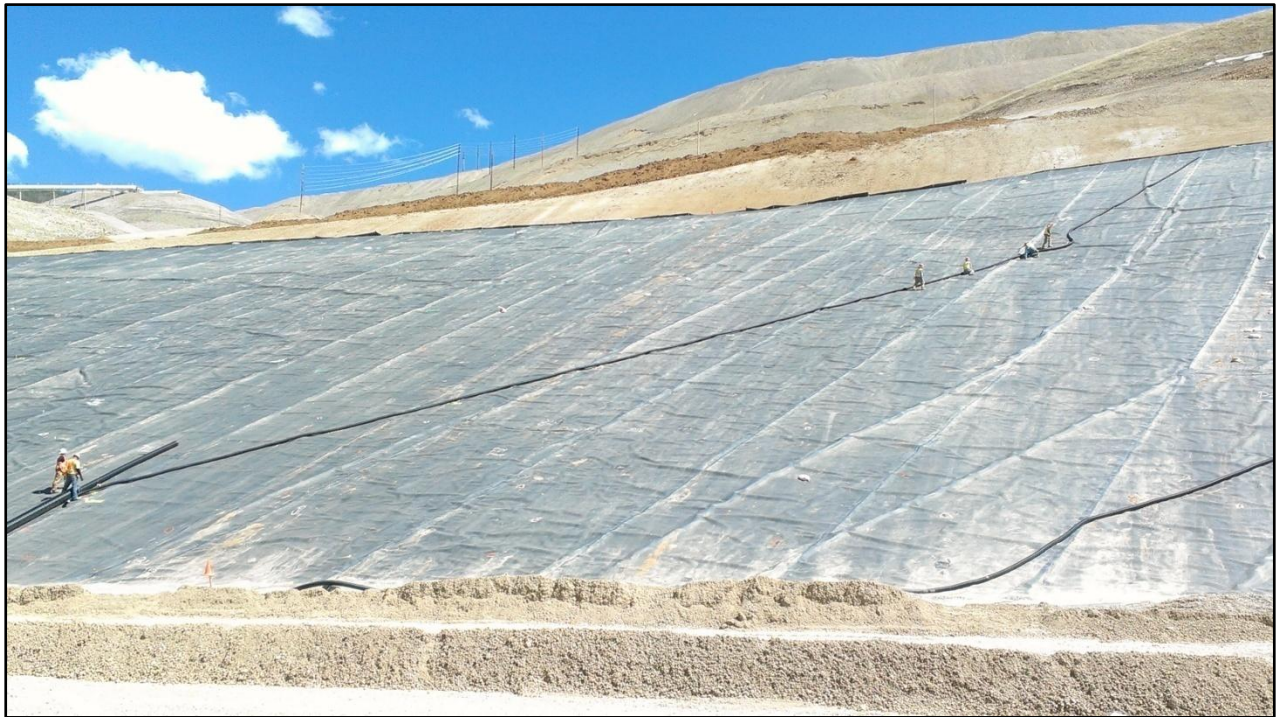
Photo 13. View of southern slope of SGVLF, showing lined portion of Phase I where HVSCS piping is being placed on accepted liner.

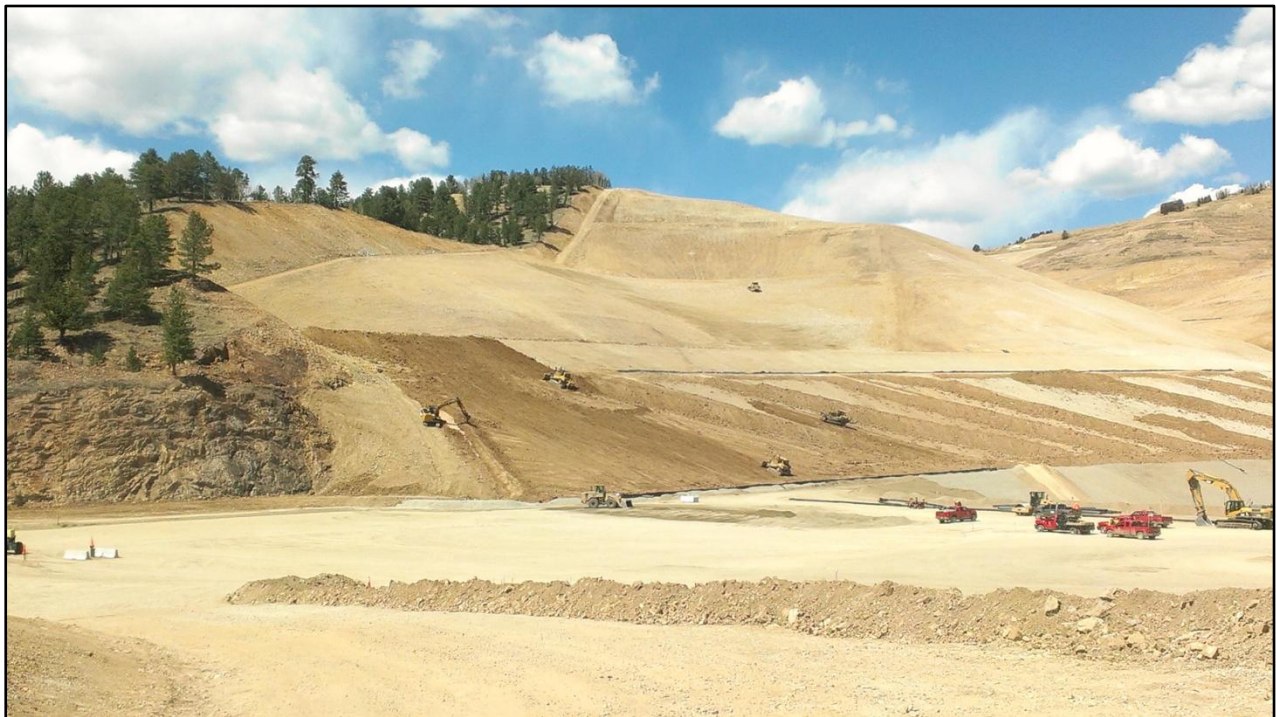
Photo 14. View of northern slope of SGVLF, showing placement of SLF material and finishing work of leak detection trench at western edge.

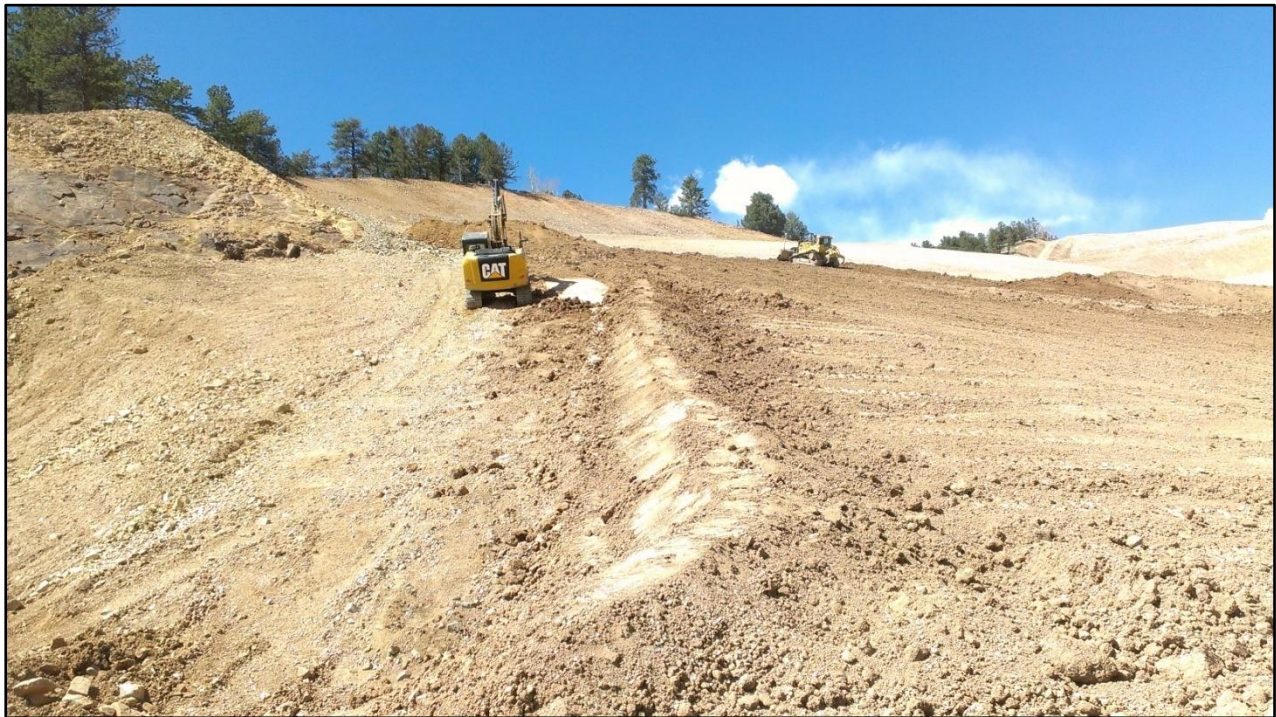
Photo 15. Closer view of western edge of SGVLF northern slope, showing finishing work of leak detection trench and SLF berm adjacent to anchor trench location.

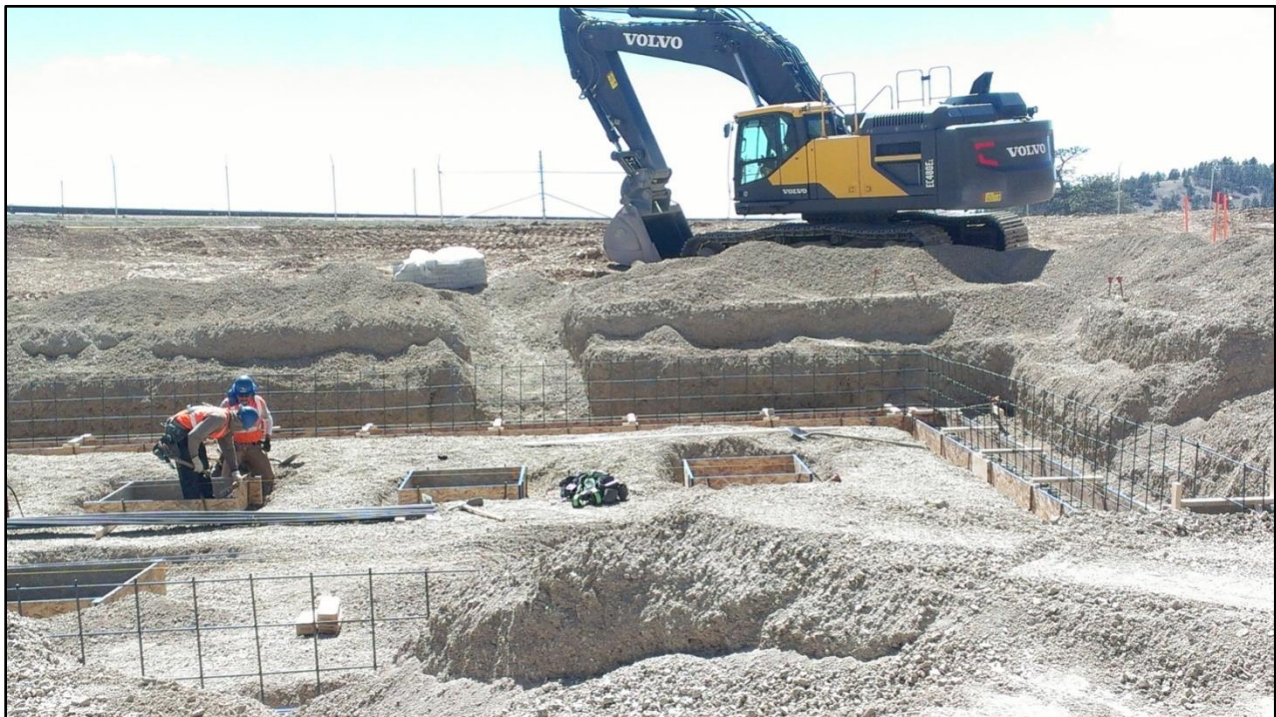
The Division observed construction activities in the ADR-2 pad area where foundation work was in progress (**Photos 16 and 17**). Mr. Hanks indicated that the concrete work would begin soon. According to the Weekly Construction Quality Assurance Report submitted by the operator for the weeks ending on 03/14/2015 and 03/21/2015, approximately 8 feet of spent ore (SO) was excavated from the ADR-2 engineered fill footprint (9,439 to 9,447-foot elevation) and replaced with a mixture of SO and Low Volume Solution Collection Fill (LVSCF) in the PSSA engineered fill area. The LVSCF material was hauled from the stockpile to the PSSA with Cat 777 haul

Photo 16. View of northern portion of ADR-2 pad area where foundation work was in progress.

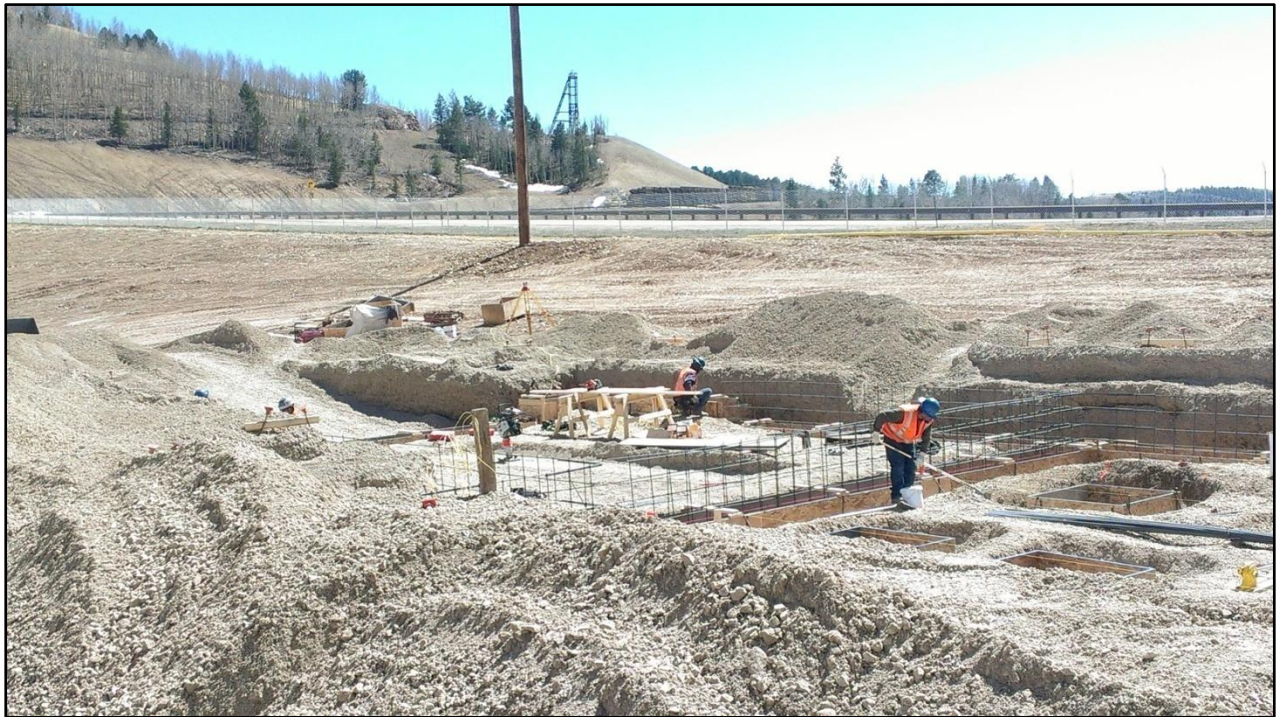
Photo 17. View of southern portion of ADR-2 pad area where foundation work was in progress. Note Hwy 67 located in background (at top of SGVLF embankment).

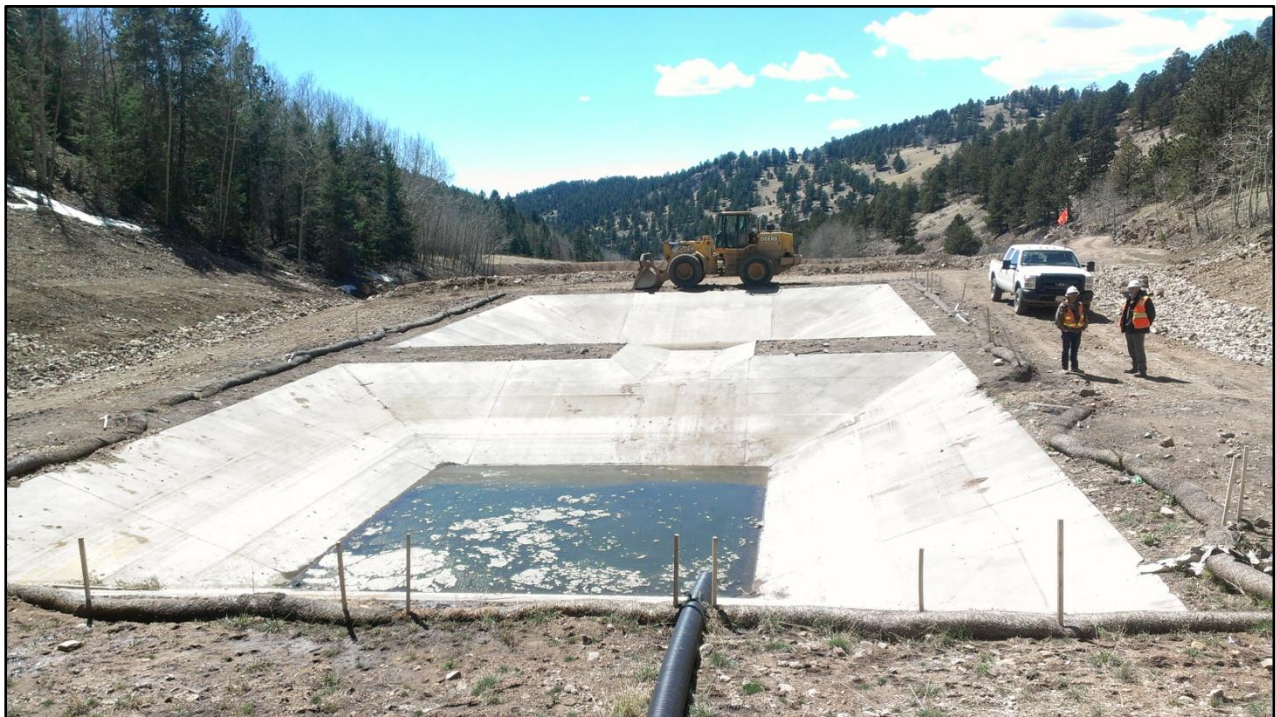
The inspection continued to the portion of the valley below the SGVLF toe berm/Hwy 67 realignment. During the inspection, there was discussion with Mr. Hanks about the operator's plans to submit a Technical Revision in the near future to modify the approved SGVLF toe berm underdrain pump-back system. Initially, the operator had proposed pumping from the downgradient of the two concrete underdrain ponds (**Photo 18**) constructed to collect water from the underdrain line and toe berm cut-off trench. However, after further engineering review, the operator determined it would be better to build a subsurface enclosure with a well to collect water from the underdrain and cut-off trench that runs along the base of the toe berm. Water from the toe berm cut-off trench will be collected in the subsurface enclosure and then pumped with the water from the underdrain line up to the ADR-2 facility. The existing underdrain ponds will be lined and used only as emergency overflow for the subsurface enclosure. A trash pump will be used to feed water from the concrete ponds back into the well of the subsurface enclosure as space becomes available following an overflow event. Currently, water from the toe berm cut-off trench (**Photo 19**) is being pumped out and hauled to the SGVLF PSSA. A power line will need to be installed on the north side of the toe berm to accommodate the new pumpback system. After this inspection, the operator submitted Technical Revision No. 74 (on 05/14/2015) to address this modification to the SGVLF toe berm underdrain pumpback system. This revision is currently being reviewed by the Division and has a decision date of 07/13/2015.

Photo 18. View of concrete underdrain ponds located in valley southwest of SGVLF toe berm/Hwy 67 realignment. TR-74 proposes to line these ponds and use them only as emergency overflow for the subsurface enclosure. Currently, water collected in these ponds is pumped out and hauled to SGVLF PSSA.

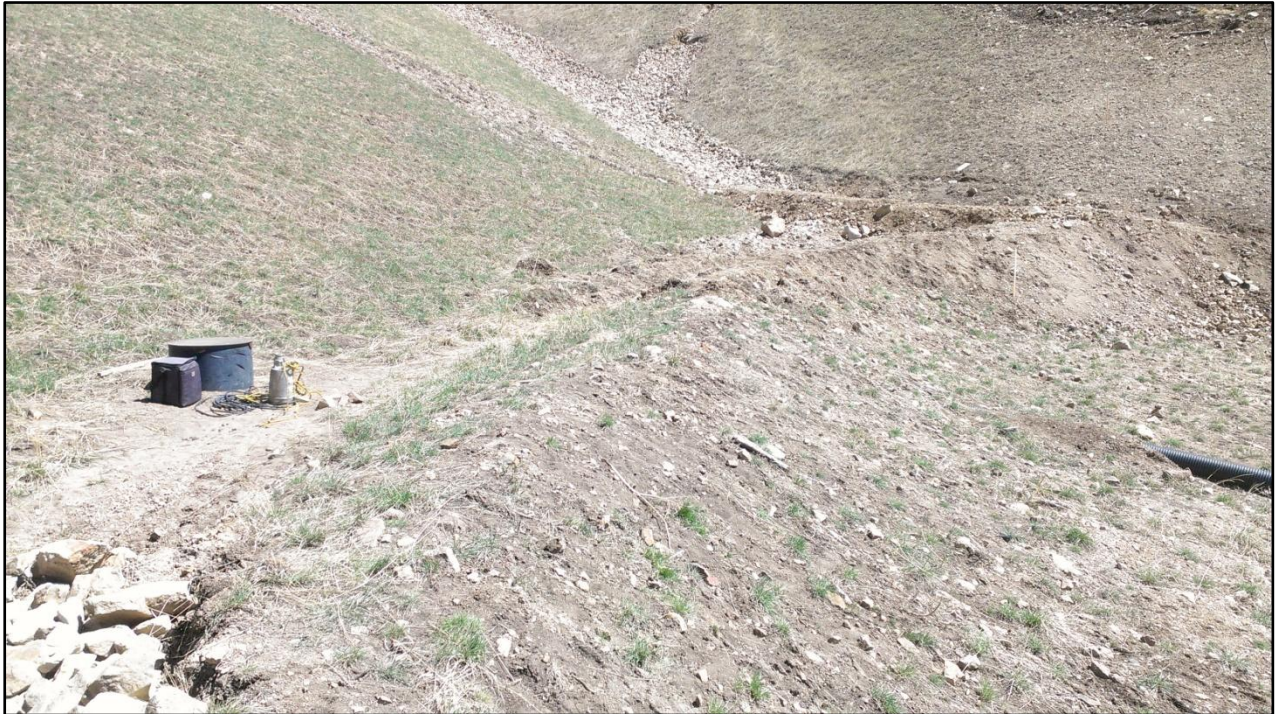
Photo 19. View of SGVLF toe berm cut-off trench where water is currently pumped out and hauled to SGVLF PSSA.

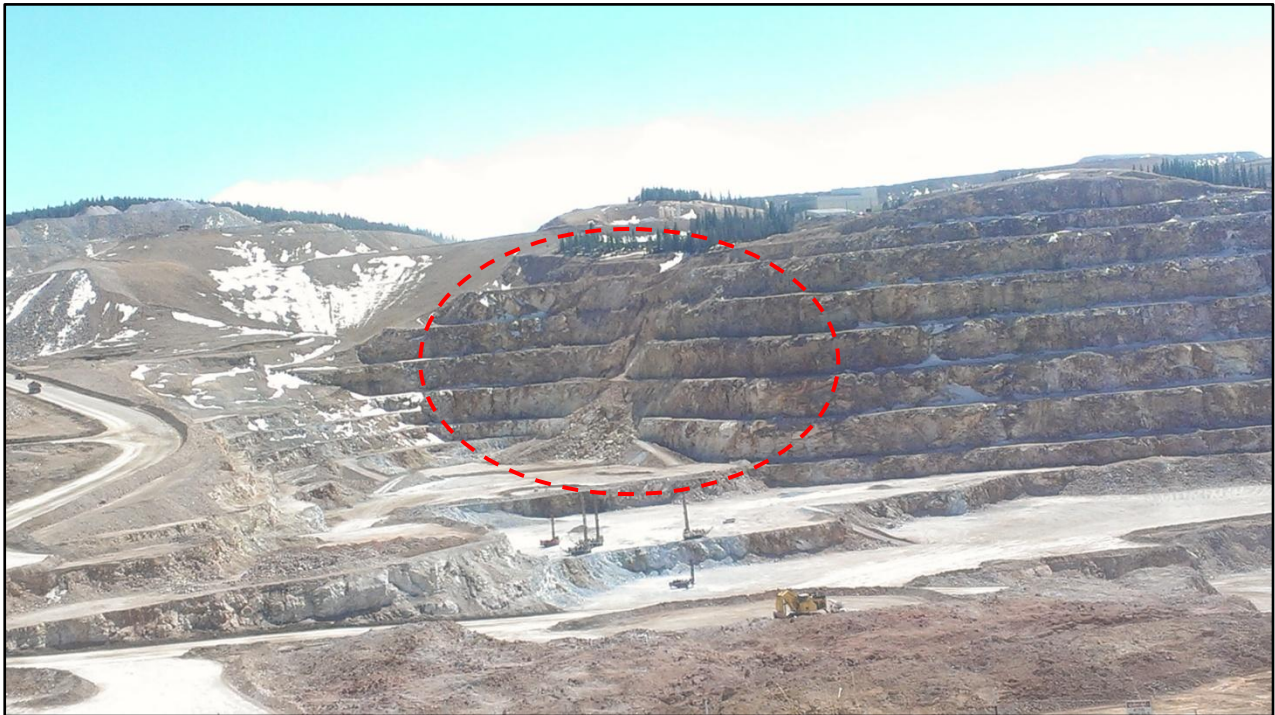
Upon leaving the site, the Division observed the East Cresson Mine Wildhorse Extension (WHEX) pit where active mining and production drilling is occurring. A slope failure occurred in November/December 2014 on an east/northeast-facing wall in the southernmost portion of the WHEX (near the Ironclad Facility), affecting 6-7 mined benches (**Photo 20**). After the operator informed the Division of the slope failure, the Division met with mine staff in January 2015 to discuss the matter. The Division determined at that time that the incident is not a compliance issue. During the inspection, Mr. Hanks indicated that mine geologists and engineers are monitoring the area with LiDAR to help characterize the slope failure and detect any additional movements. Mining activities have been restricted from this portion of the WHEX until a plan of action is developed. The operator has committed to notifying the Division of any additional slope stability issues that develop on site.

Photo 20. View of southernmost portion of WHEX pit where slope failure (circled) occurred on an east/northeast-facing wall in late 2014. This area is currently being monitored with LiDAR. Note production drilling in foreground; however, mining activities are restricted from area of the slope failure.
