**COLORADO DIVISION OF RECLAMATION, MINING AND SAFETY**  
**MINERALS PROGRAM INSPECTION REPORT**  
**PHONE: (303) 866-3567**

<b>MINE NAME:</b> Lusk Pit #36	<b>MINE/PROSPECTING ID#:</b> M-2009-002	<b>MINERAL:</b> Sand and gravel	<b>COUNTY:</b> Baca
<b>INSPECTION TYPE:</b> Monitoring	<b>INSPECTOR(S):</b> Amy Eschberger	<b>INSP. DATE:</b> November 19, 2014	<b>INSP. TIME:</b> 08:00
<b>OPERATOR:</b> Baca County	<b>OPERATOR REPRESENTATIVE:</b> Norm Shaw and Waylon Hoeffner	<b>TYPE OF OPERATION:</b> 112c - Construction Regular Operation

# M-2009-002 / Lusk Pit #36 / Baca County

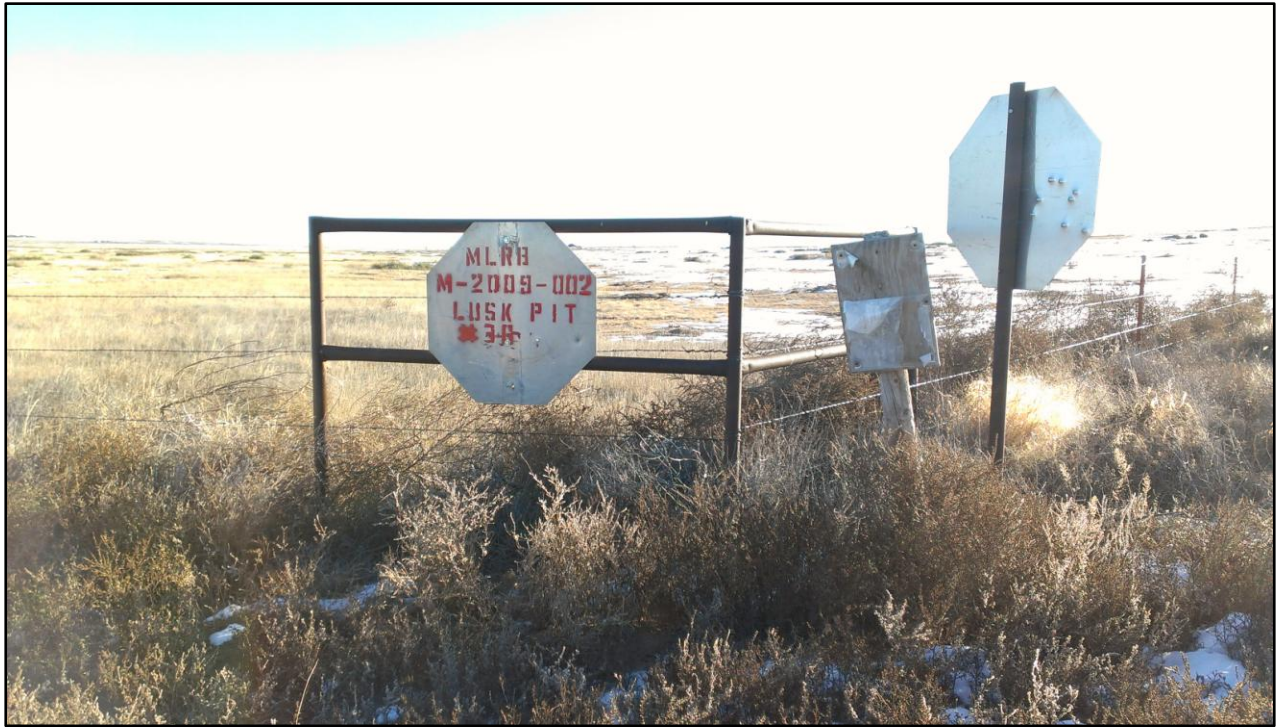
At the time of the inspection, the weather was clear, cold and sunny, and the ground had some snow cover. A permit identification sign was posted at the main site entrance off of Co Rd 21 (**Photo 1**). The permit boundary was delineated by 4-strand barbed wire fencing (**Photo 2**). The mine was not active during the inspection, and no equipment was present on site. Mr. Shaw and Mr. Hoeffner stated that no extraction has occurred at this pit since the later part of 2012. However, the county hauls product off site from the caliche stockpile every year, which is in compliance with its intermittent status.

**Photo 1.** View of permit sign posted at main entrance to site off of Co Rd 21.

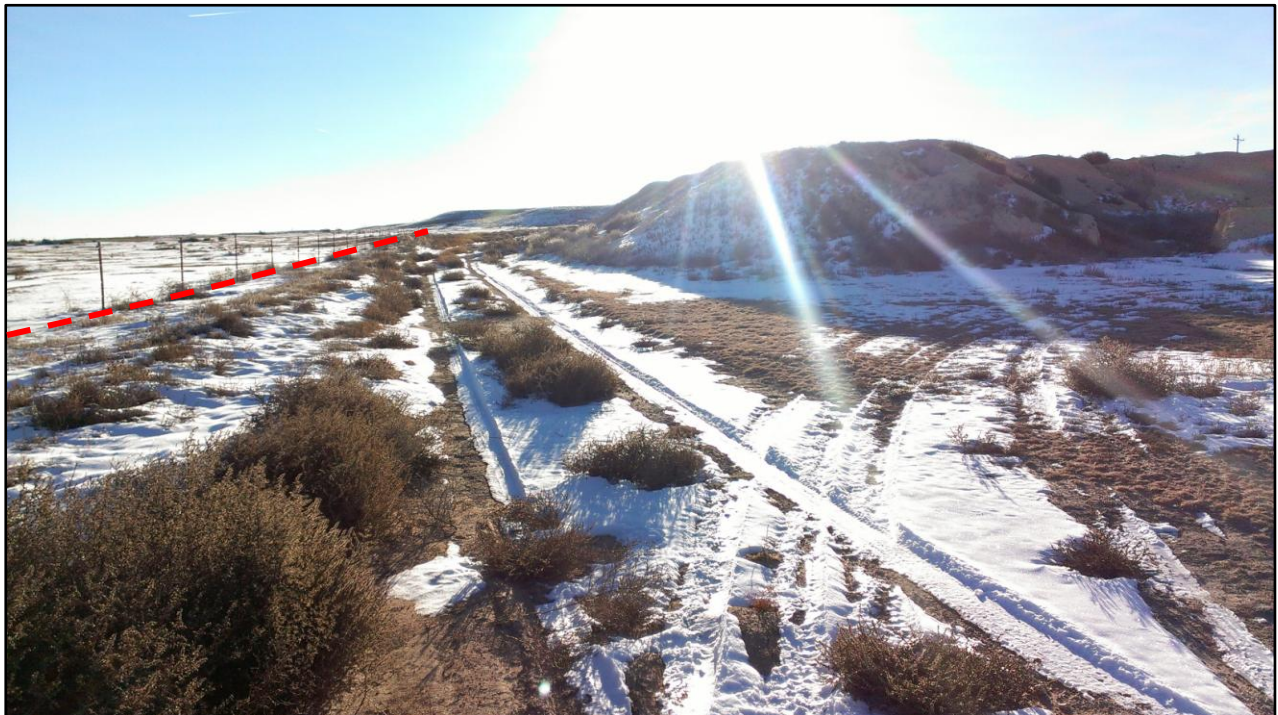
**Photo 2.** View looking east from mine entrance, showing northern permit boundary delineated by 4-strand barbed wire fence (indicated with red dashed line). Note caliche stockpile at right.

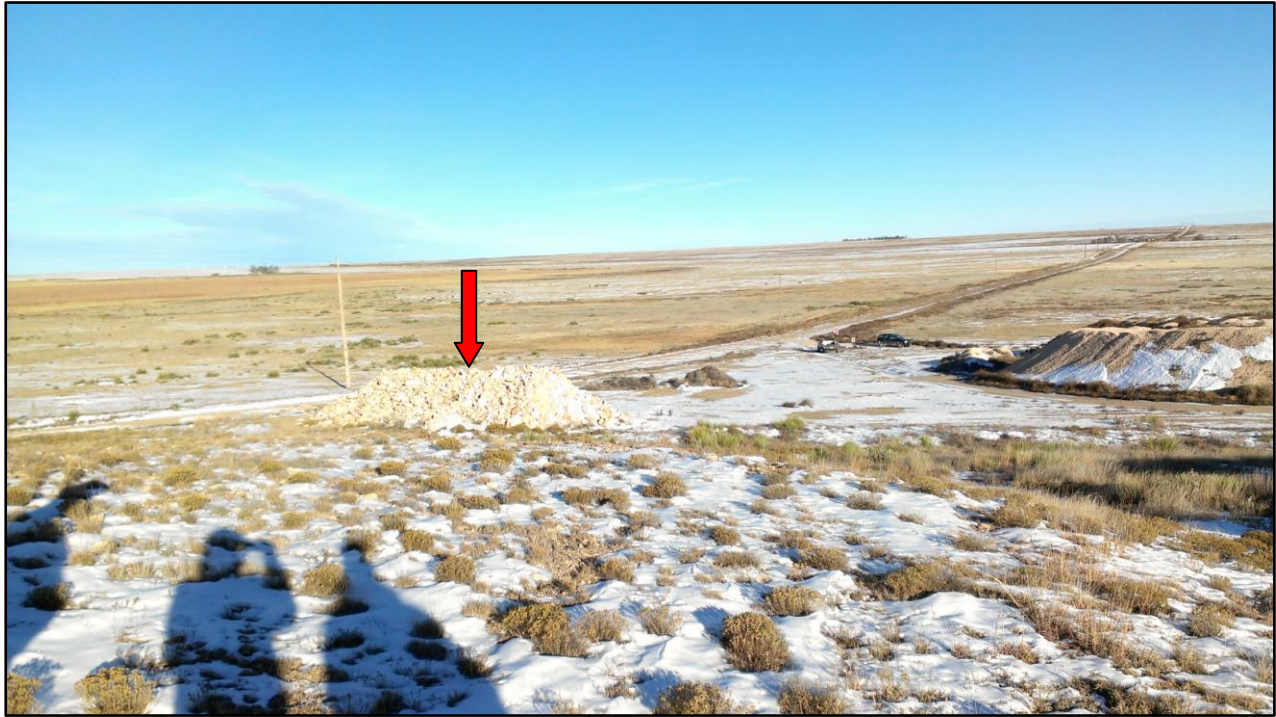
**Photo 3.** View looking northwest from southwestern portion of permit area, showing small waste rock stockpile (indicated) stored at western edge of site.

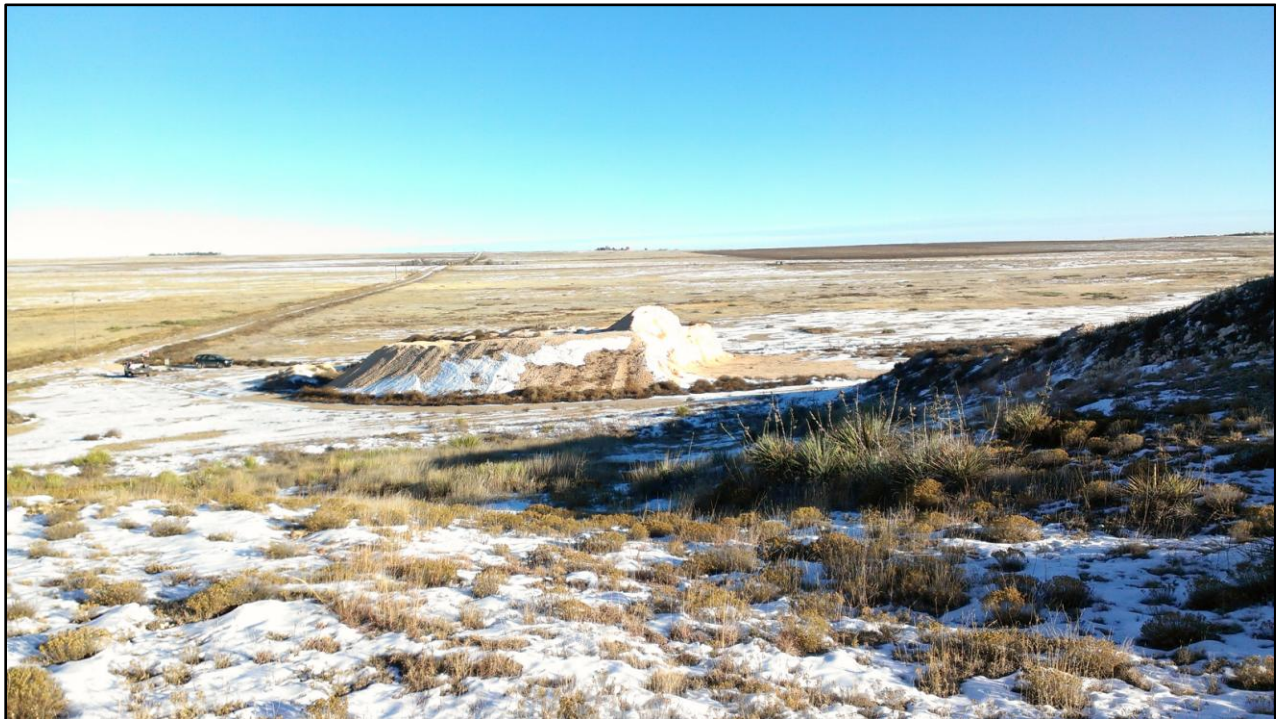
**Photo 4.** View looking north from southwestern portion of permit area, showing caliche stockpile stored in northwestern portion of permit area, near mine entrance.

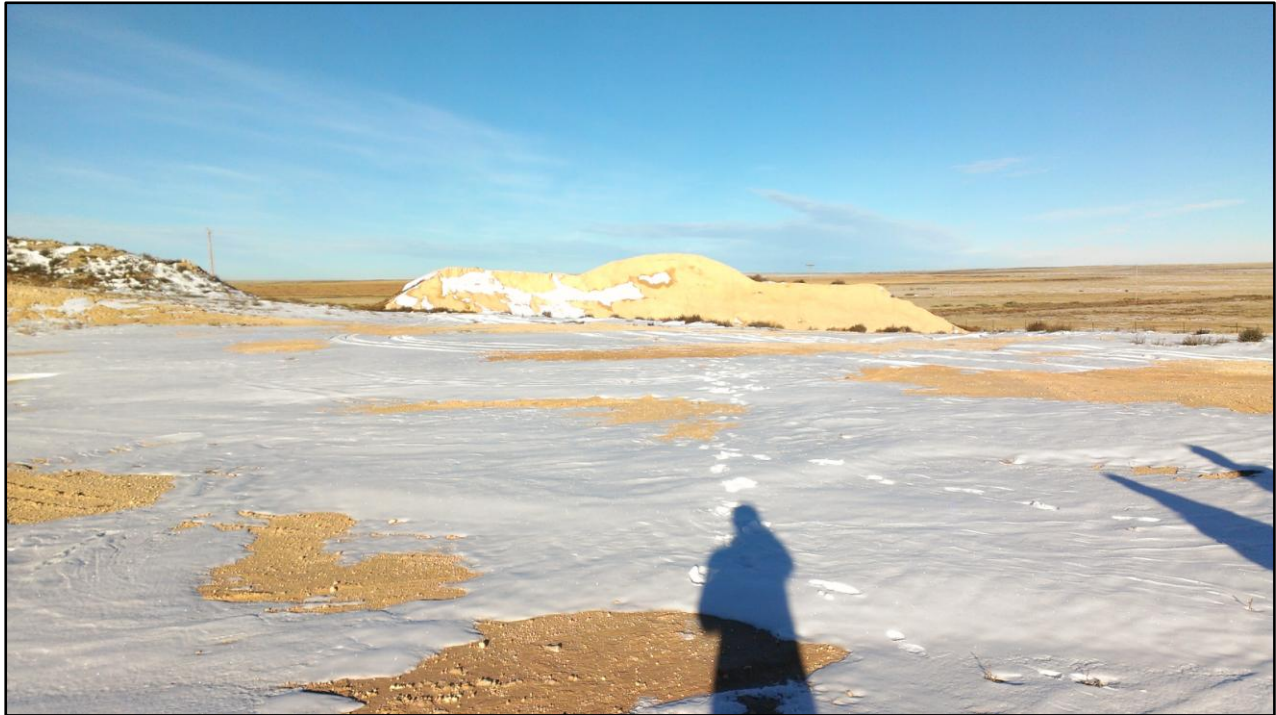
**Photo 5.** View looking west from pit floor, showing eastern side of caliche stockpile stored in northwestern portion of permit area, near mine entrance.

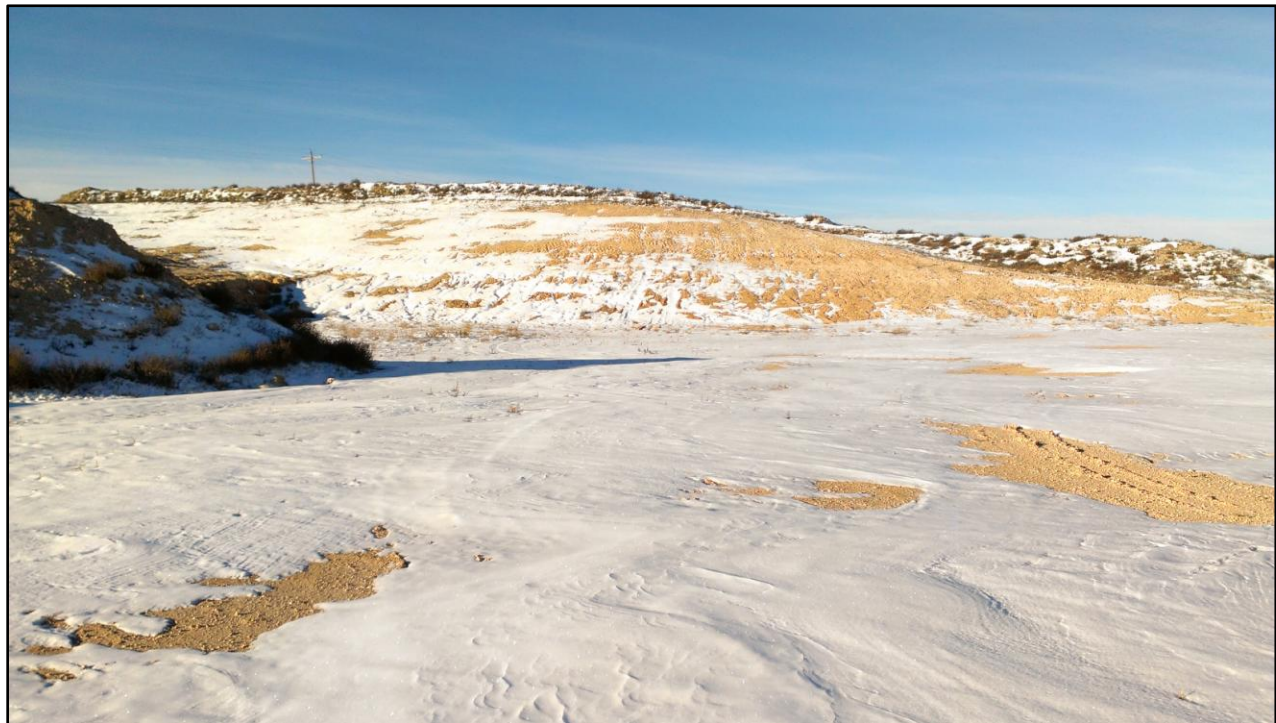
**Photo 6.** View looking west from pit floor, showing mined slope with approximate 3H:1V gradient.

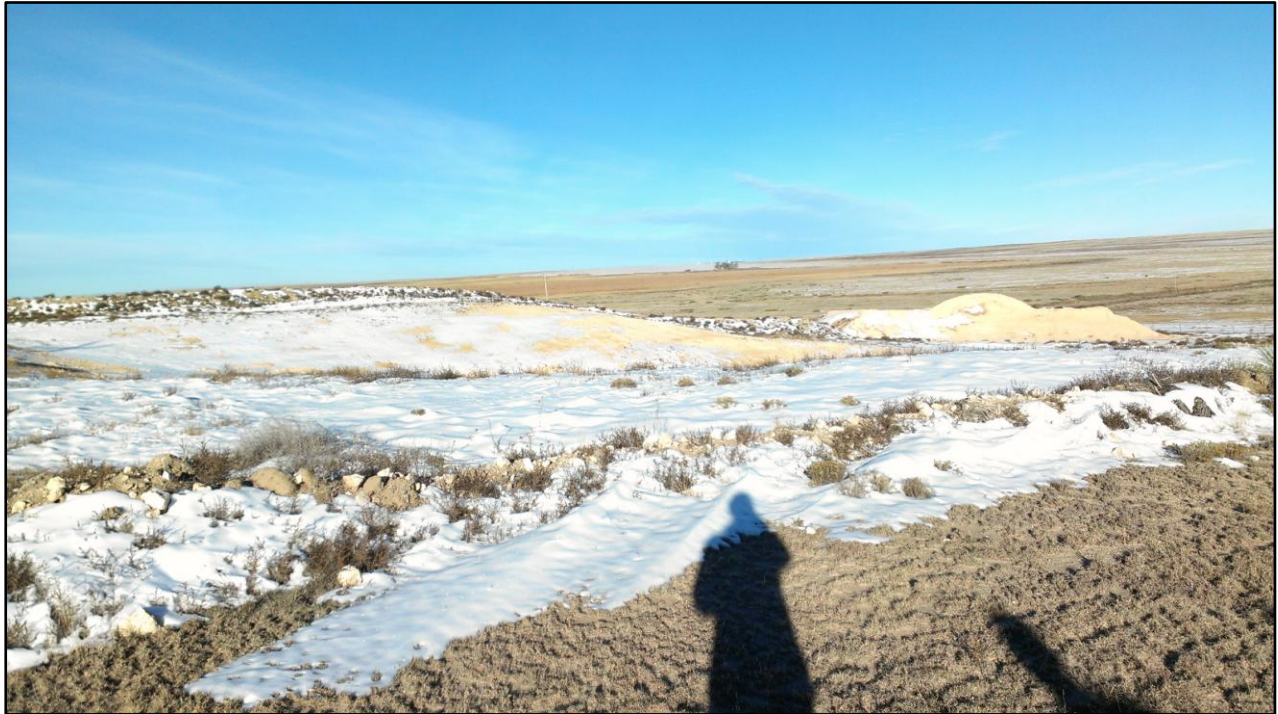
**Photo 7.** View looking northwest from southeastern edge of pit, showing mined slopes with 3H:1V or flatter gradients.

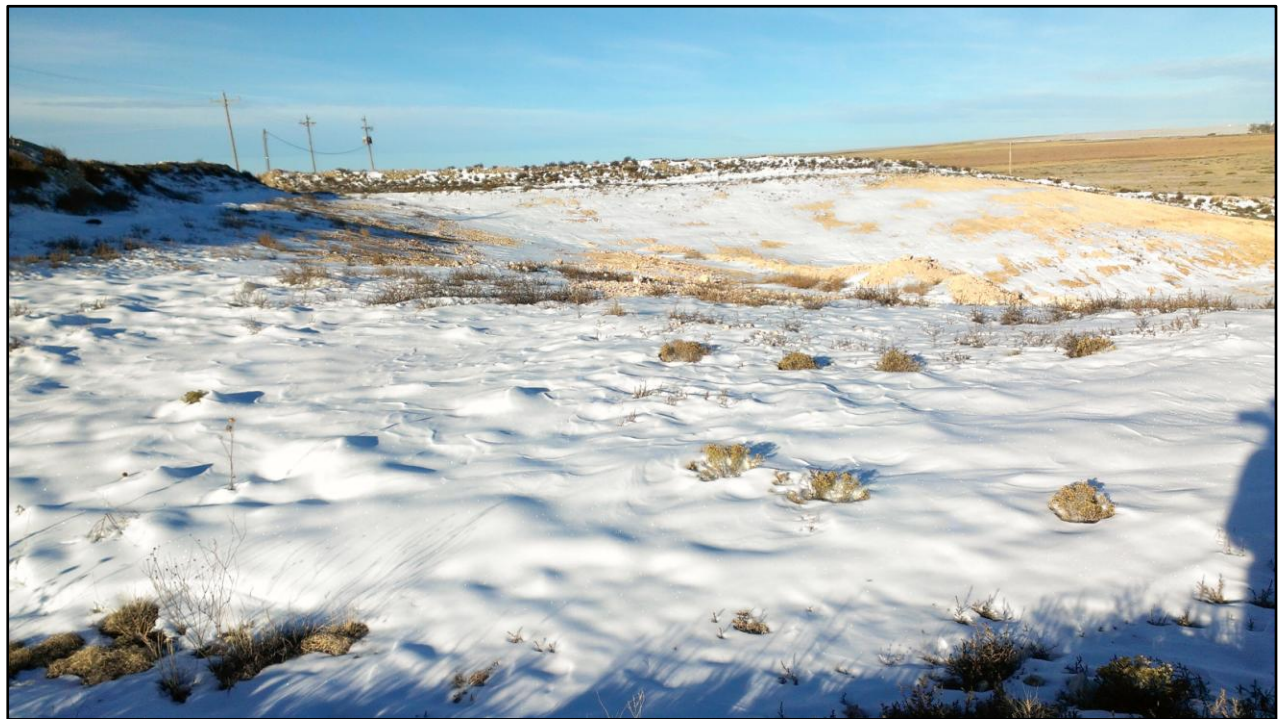
**Photo 8.** View looking west from southeastern edge of pit, showing mined slopes with 3H:1V or flatter gradients.

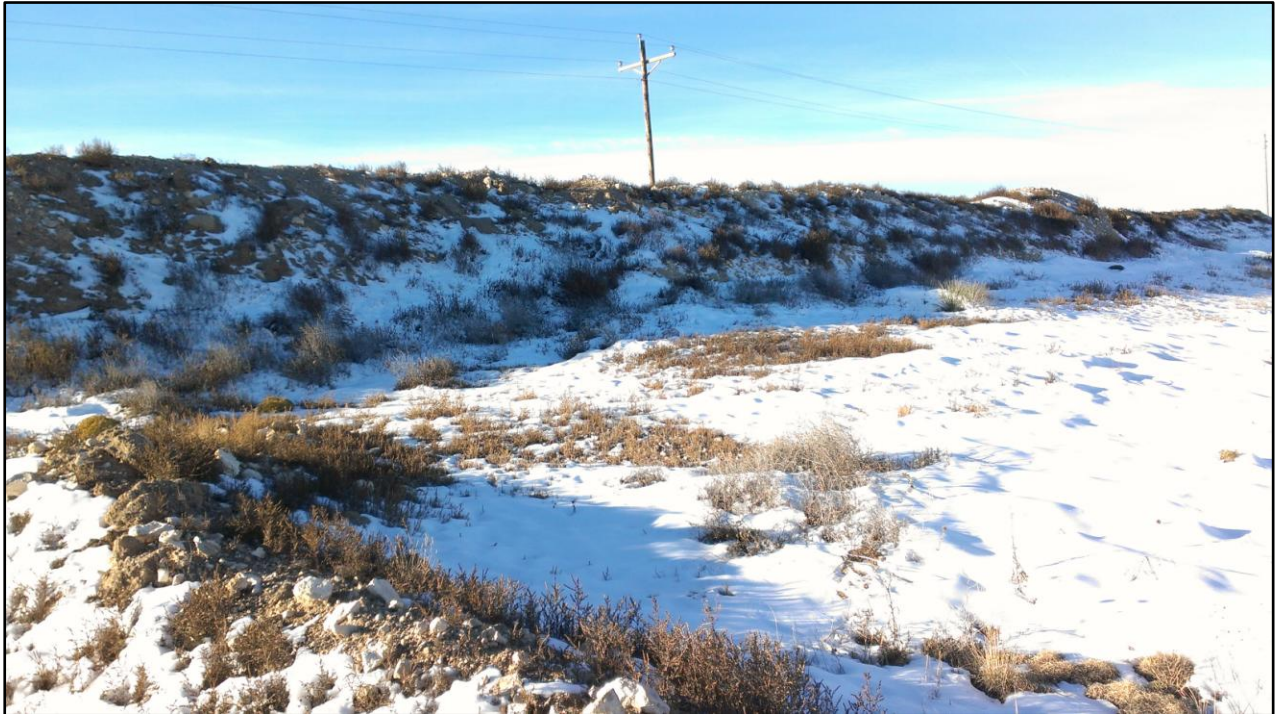
**Photo 9.** View looking southwest, showing topsoil berm stored along top (southern) edge of pit.

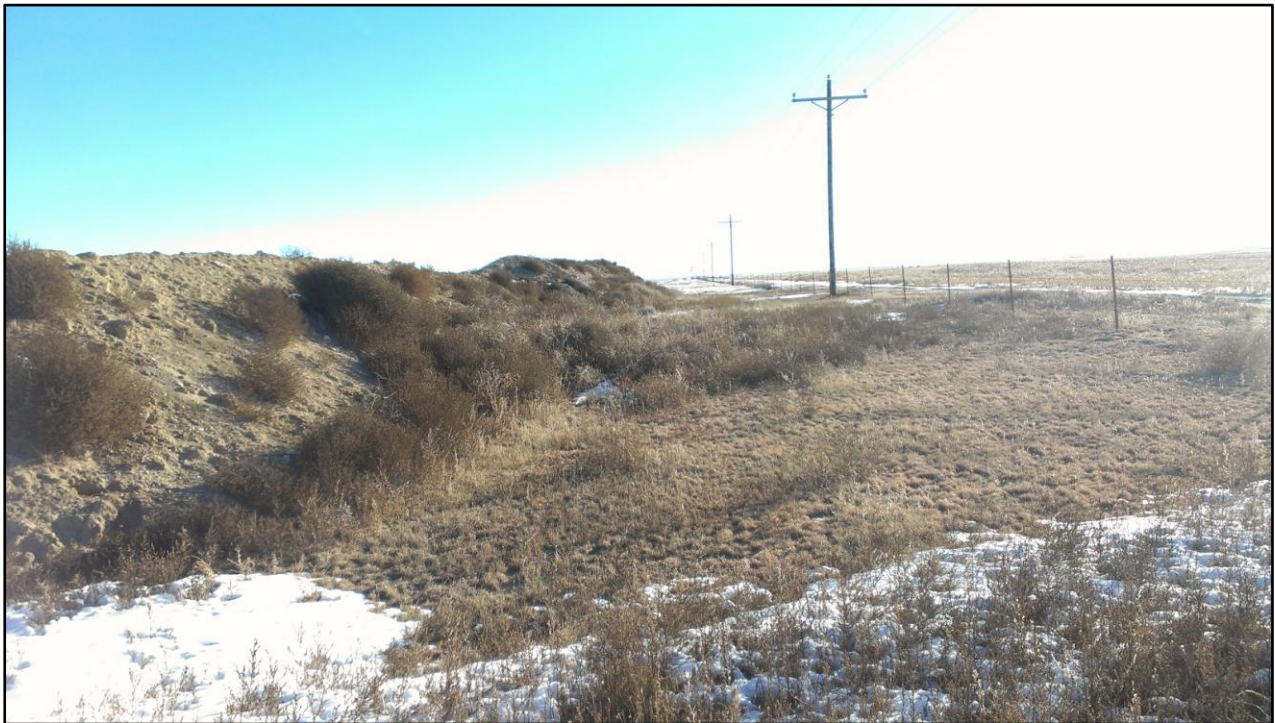
**Photo 10.** View looking east from southern edge of site, showing topsoil berm maintained at more than 10 feet from property fence line that delineates southern permit boundary.

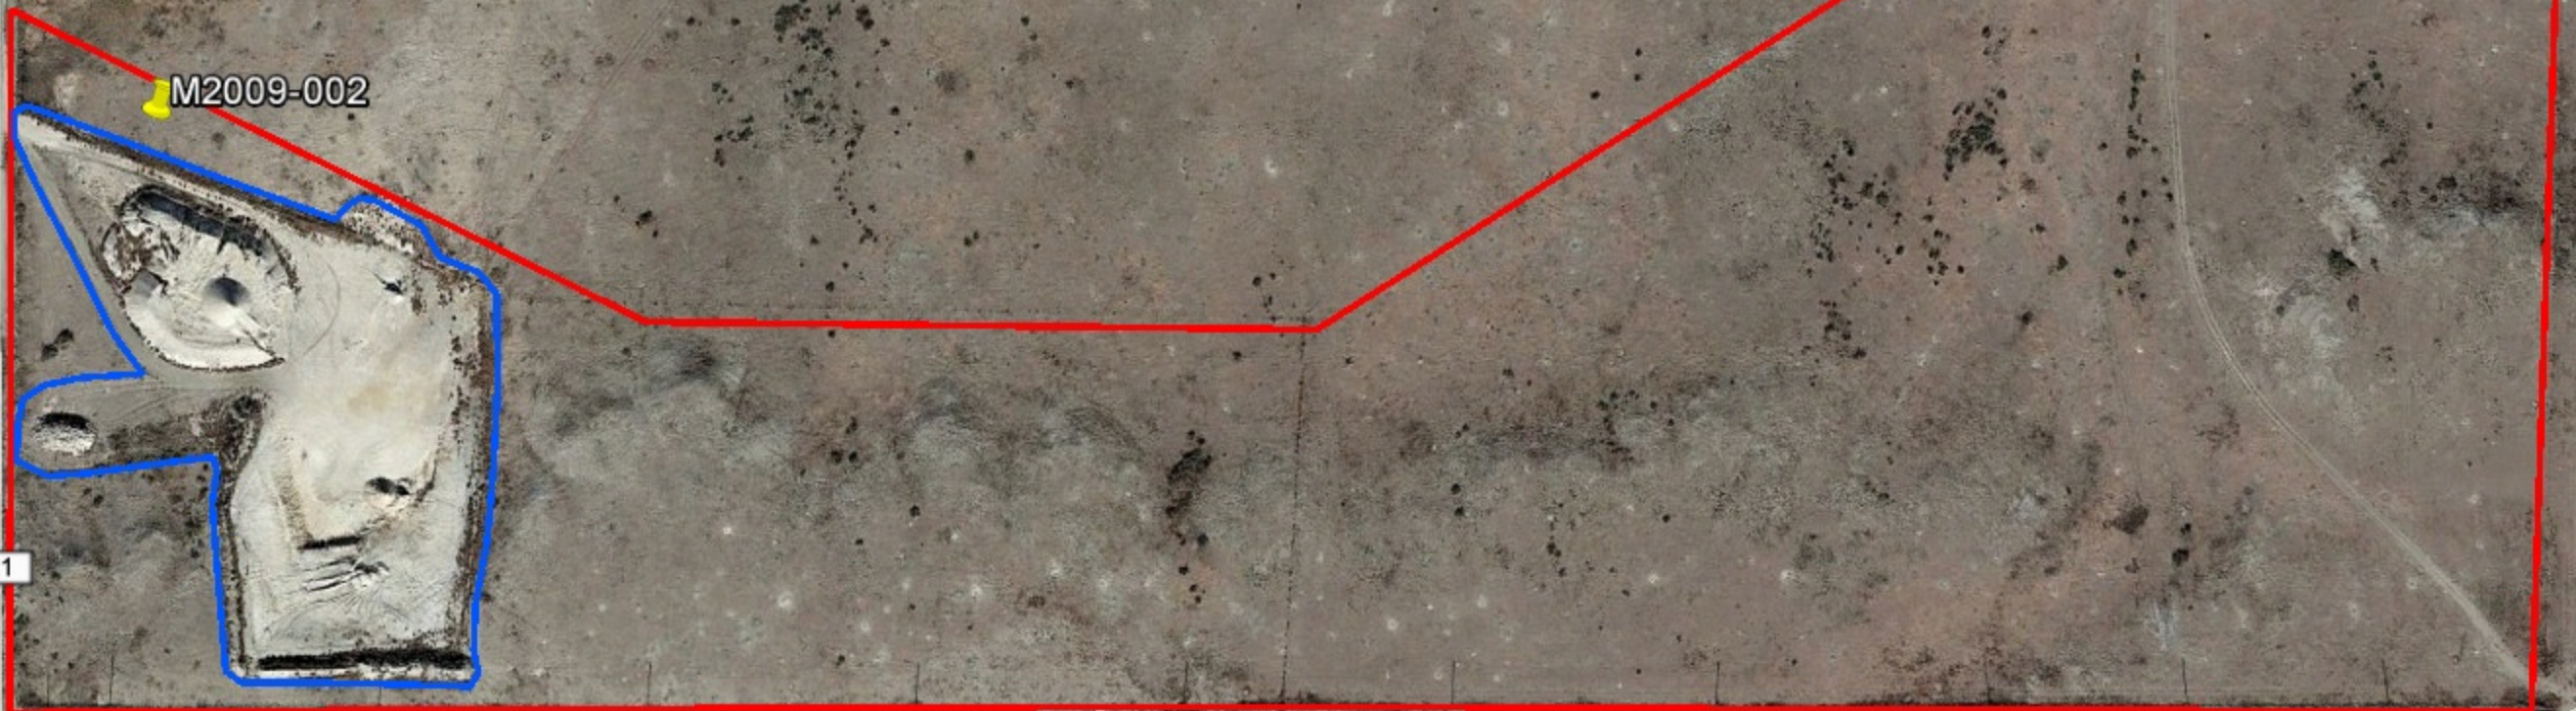
Overall, mining will proceed eastward through the permit area until the caliche ridge has been mined out. The Division estimates that approximately 4.30 acres have been disturbed by this operation thus far (see enclosed Google Earth image of site), which is well within the maximum allowed disturbance. The disturbed area includes a small waste rock stockpile on the far western portion (near Co Rd 21; **Photo 3**), a caliche stockpile on the northwestern portion (near the main entrance; **Photos 4 and 5**), a dirt haul road that circles through the pit, a half-box shaped extraction area with 3H:1V or flatter slopes on the southeastern portion (**Photos 6-8**), and a topsoil berm that runs along the top (southern) edge of the pit (**Photo 9**). The operator is keeping the topsoil berm a minimum of 10 feet from the southern property fenceline (**Photo 10**) as committed to in the approved mining plan. This stockpile was 20-25 feet from the fenceline at the time of the inspection, and it appeared to be stable with some vegetative cover. All stockpiles and mined surfaces appeared to be stable at the time of the inspection. Some native grasses, annual weeds (mainly Russian thistle), and yucca have volunteered into the pit area.

Red Line = Approved Permit Area = 34.33 acres

Blue Line = Disturbed Area = 4.30 acres (as of 11/19/2014 inspection)
