COLORADO DIVISION OF RECLAMATION, MINING AND SAFETY
MINERALS PROGRAM INSPECTION REPORT
PHONE: (303) 866-3567

| MINE NAME: Gravel Pit No 8 | MINE/PROSPECTING ID#: M-1977-485 | MINERAL: Sand and gravel | COUNTY: Baca |
| INSPECTION TYPE: Monitoring | INSPECTOR(S): Amy Eschberger | INSP. DATE: November 19, 2014 | INSP. TIME: 09:30 |

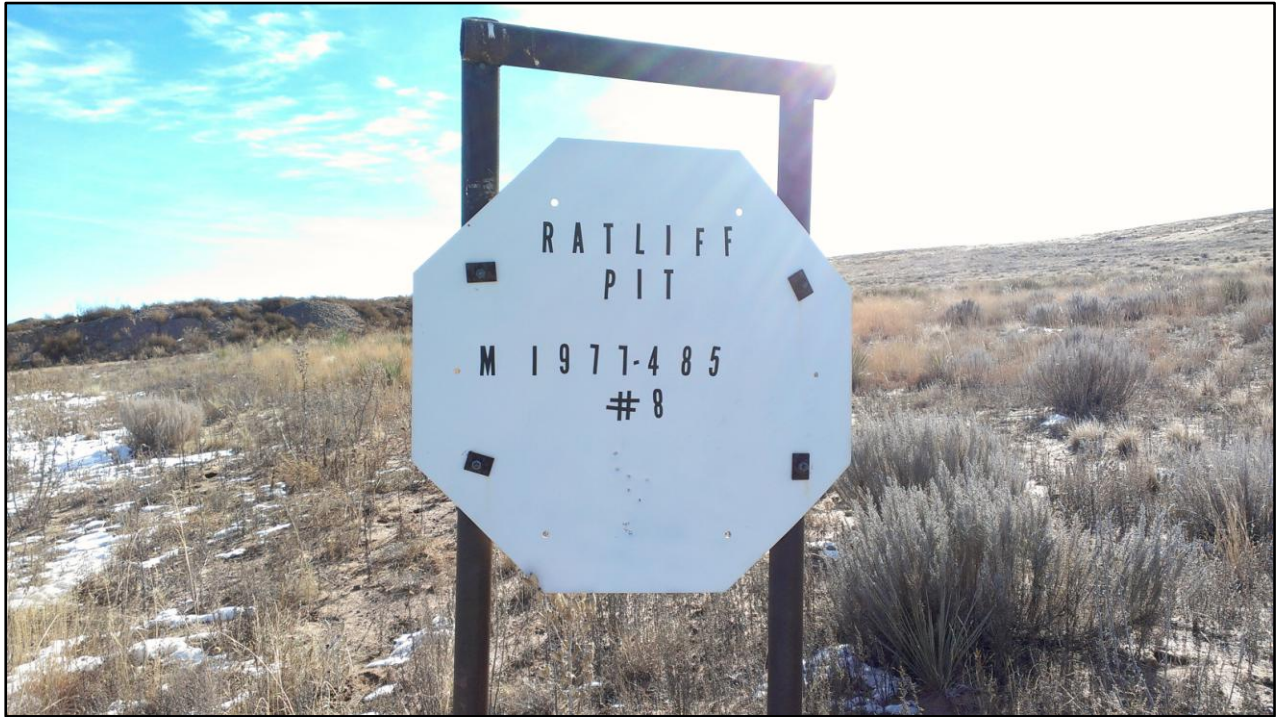
At the time of the inspection, the weather was clear, cool and sunny, and the ground had some snow cover. A permit identification sign was posted at the main site entrance off of Co Rd 13 (**Photo 1**). This sign includes the permit number as required; however, pursuant to Rule 3.1.12(1), it should also include the operator's name and a statement that the permit was issued by the Colorado Mined Land Reclamation Board (MLRB). Although the site name is not required to be on the permit sign, the sign currently displays "Ratliff Pit" as the site name. To be consistent, the operator might consider correcting this to the site name listed with the Division, which is "Gravel Pit No 8". The permit boundary was delineated by metal posts and rock piles. The mine was not active during the inspection. However, a few trucks were parked near the entrance. Mr. Adams and Mr. Eskew stated that material is processed and/or hauled off from this site every year, which is in compliance with its intermittent status.

Photo 1. View of permit sign posted at main site entrance off of Co Rd 13. A permit sign should include the permit number (already included here), a statement that the permit was issued by the CO MLRB, and the operator's name.

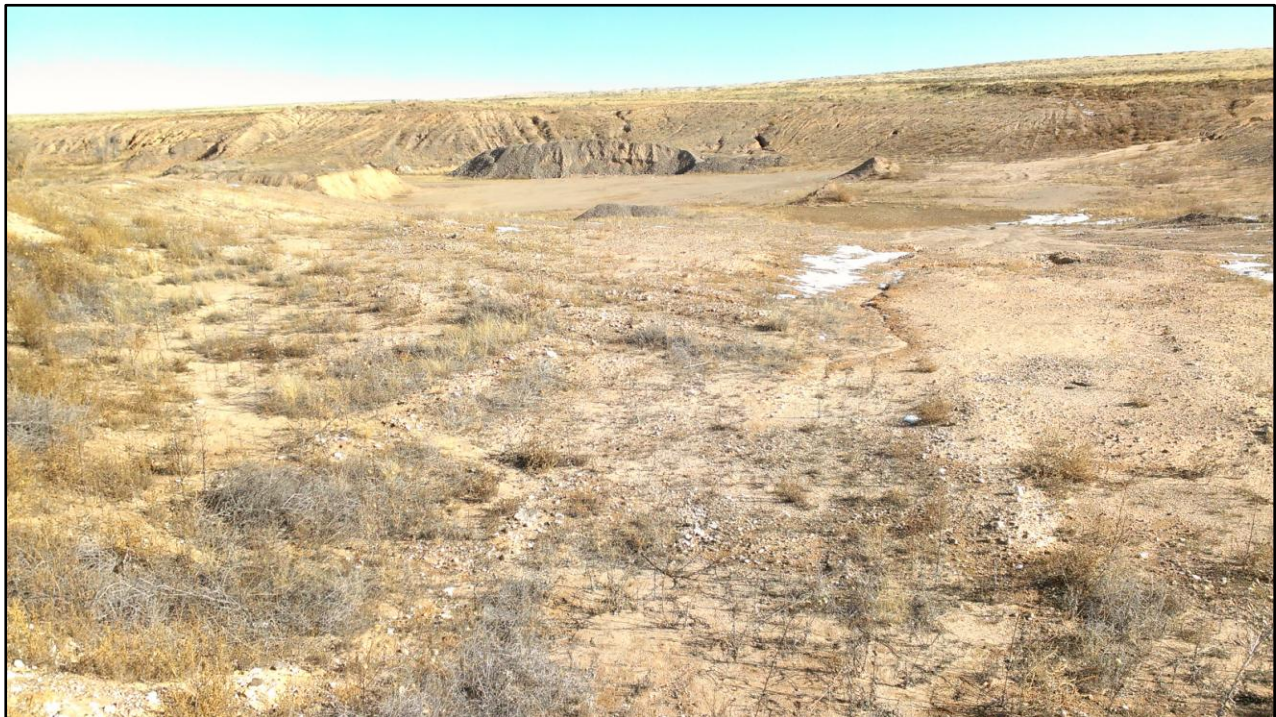
Photo 2. View looking northeast into pit from top of southwestern pit wall. Note mined material stockpiled at center. Also note some erosional damage present on eastern slopes.

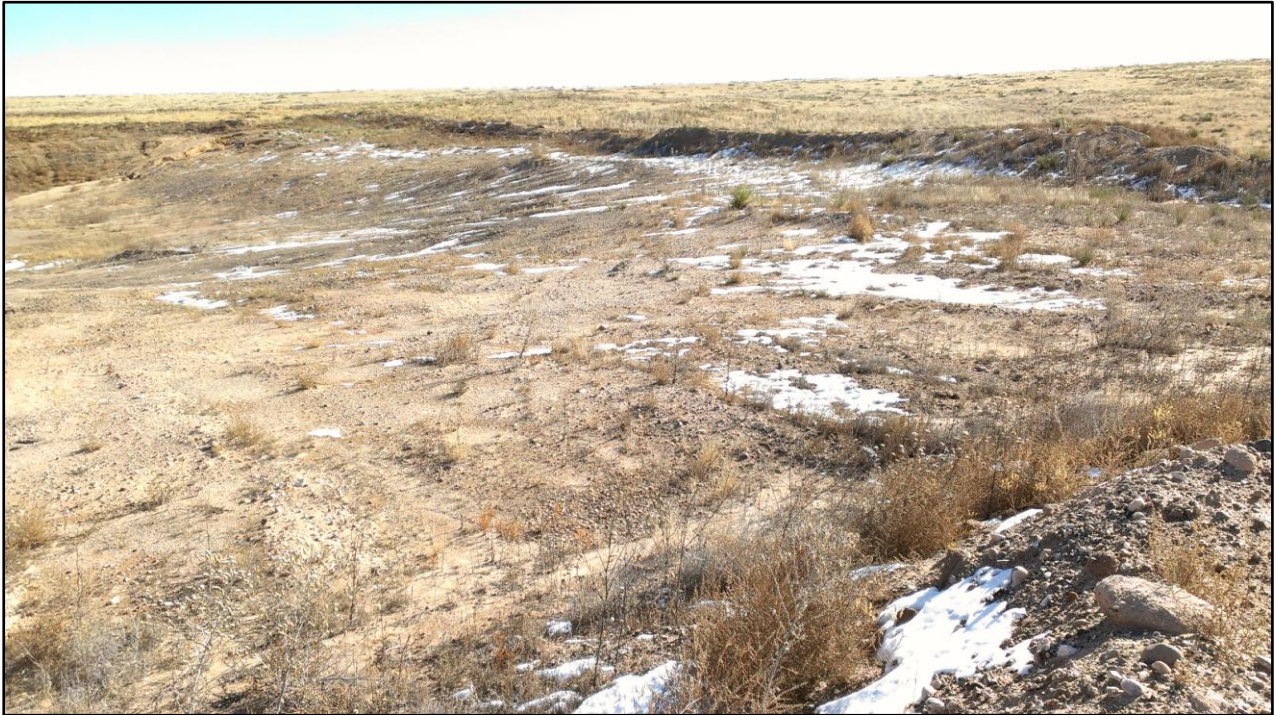
Photo 3. View looking south at southern pit wall, showing slopes graded flatter than 3H:1V.

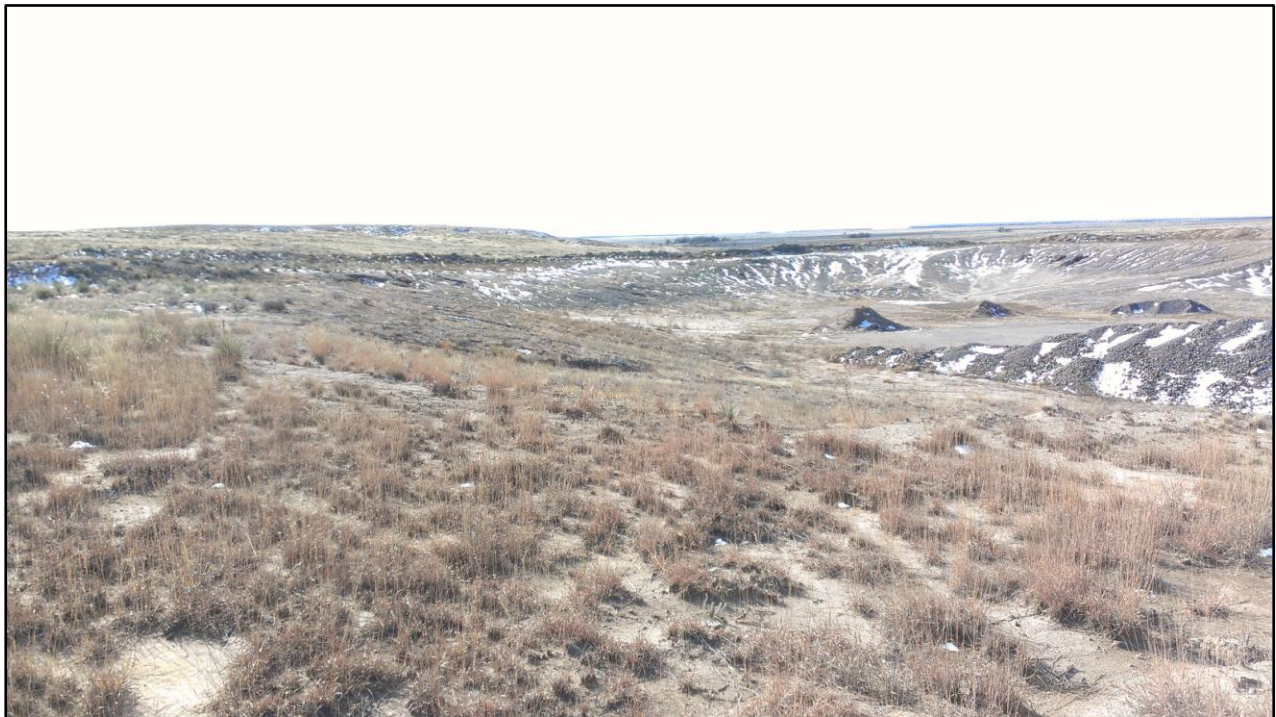
Photo 4. View looking southwest into pit from top of eastern pit wall, showing slopes graded flatter than 3H:1V. Note native grasses and shrubs establishing across pit slopes.

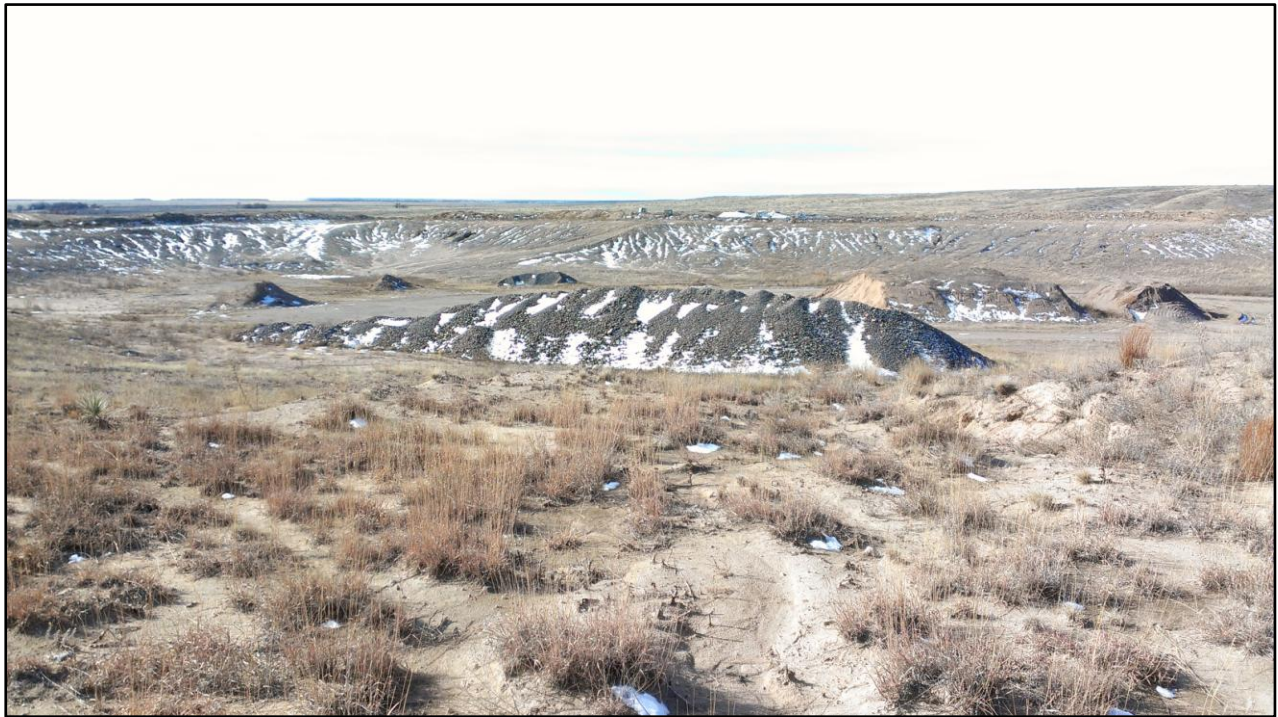
Photo 5. View looking west into pit from top of eastern pit wall, showing slopes graded flatter than 3H:1V. Note native grasses and shrubs establishing across pit slopes. Also note mined material stockpiled at center.

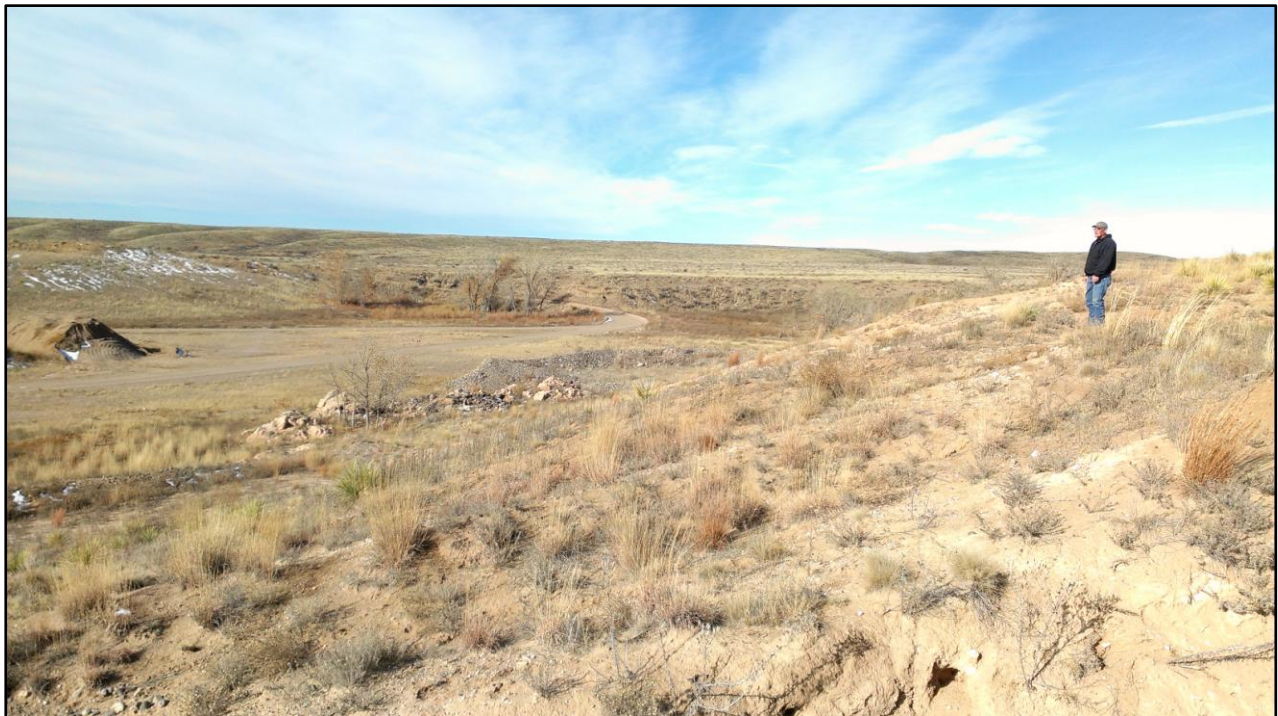
Photo 6. View looking northwest into pit from top of eastern pit wall, showing slopes graded to 3H:1V. Note native grasses and shrubs establishing across pit slopes.

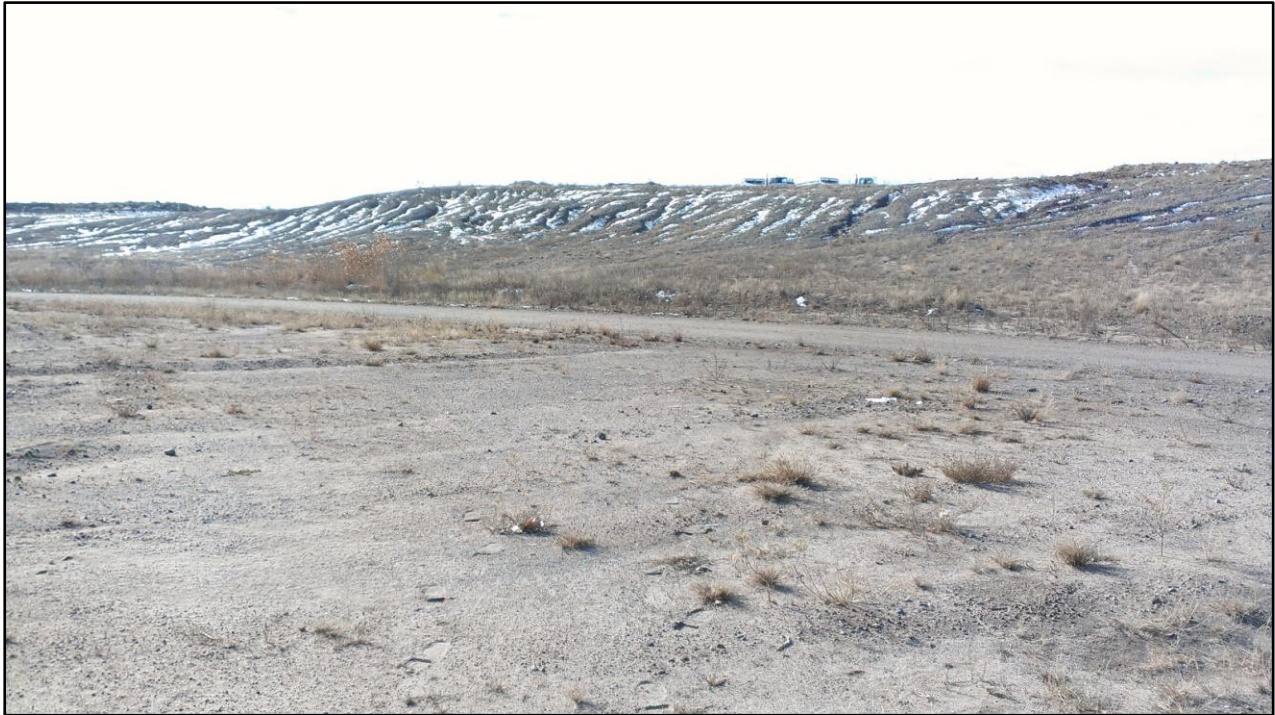
Photo 7. View looking southwest from northern portion of pit floor, showing western pit wall graded to near 3H:1V. Note some native grasses establishing across the slope. Also note some minor erosional damage present along some portions of the slope.

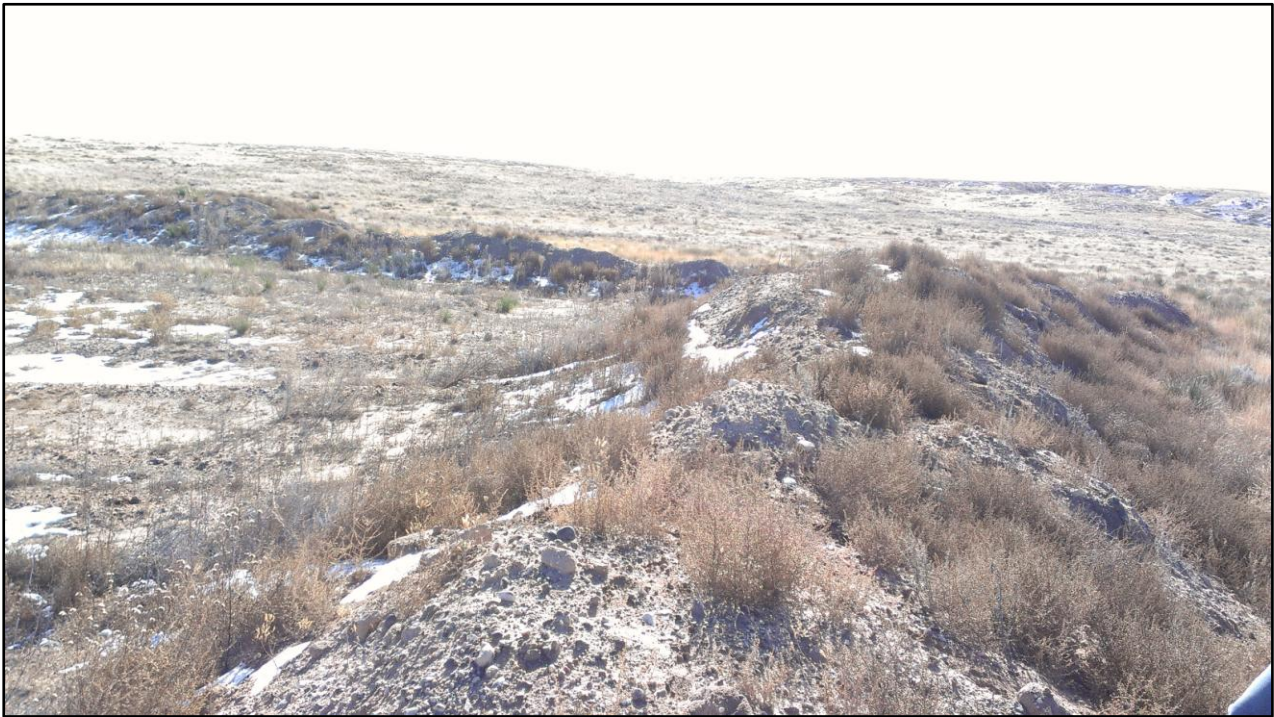
Photo 8. View of portion of topsoil berm stored along top of southern pit wall. Note berm appears to be stable with some vegetative cover (mainly Russian thistle).

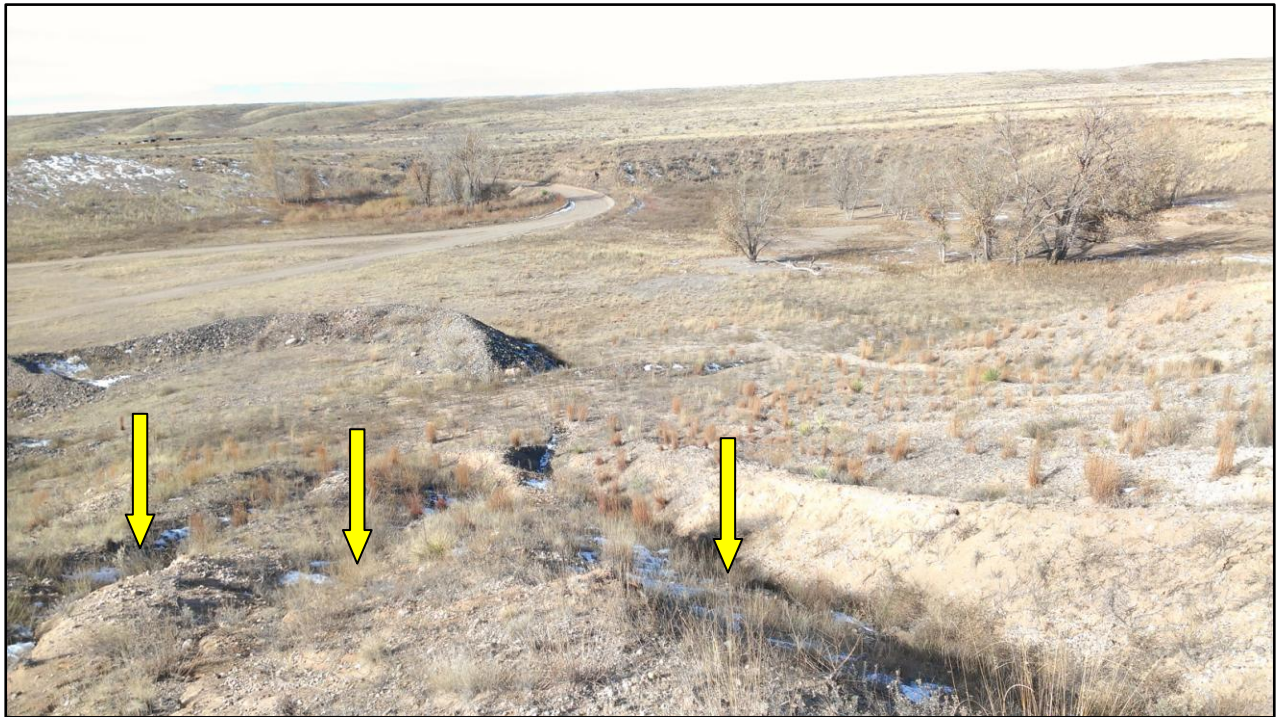
Photo 9. View looking west from top of eastern pit wall, showing a few gullies forming along the eastern slope (indicated). Note some establishment of native grasses across this slope. Also note pre-law disturbance (at right) separated from active pit by access road (at left).

The Division estimates that approximately 17 acres have been disturbed by the operation thus far (see enclosed Google Earth image of site), which is in compliance with the maximum allowed disturbance. However, before expanding much farther, the operator should consider submitting a Technical Revision to increase the maximum allowed disturbed acreage. Otherwise, some acreage will need to be reclaimed according to the approved reclamation plan to offset the additional disturbed acreage. Current disturbance includes an oval-shaped pit that is approximately 30 feet deep with slope gradients of 3H:1V or flatter (**Photos 2-7**), topsoil berms stored along the top edges of the pit walls (**Photo 8**), a few material stockpiles stored on the pit floor (see **Photos 2 and 5**), and a dirt haul road that runs along the western edge of the pit. Some erosional damage was observed mainly on the eastern and some portions of the western pit walls, including several rills and a few small gullies (**Photo 9**; also see **Photos 2 and 7**). However, a fair amount of native grasses and some yucca have begun to establish along these walls, which should help stabilize the slopes until they are expanded or reclaimed. The operator should continue to monitor and repair any erosional damage as necessary, which should include stabilizing gullies to prevent them from widening as mined slopes sit inactive.

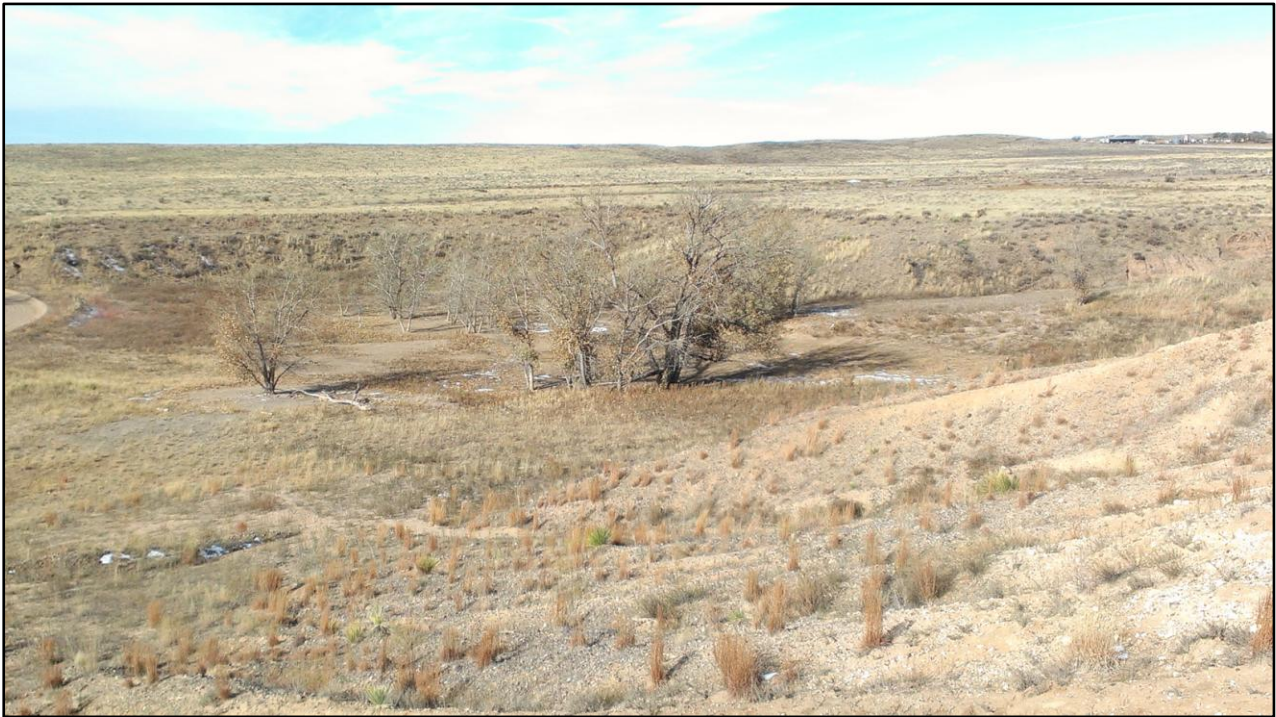
Photo 10. View looking northwest into pre-law disturbed area located north of active pit. Note native grasses, shrubs, and trees establishing throughout this area.

The approved reclamation plan calls for grading all mined slopes to 3H:1V or flatter, replacing a minimum of 6 inches of topsoil on disturbed areas, and revegetating the site to rangeland. It appears that the existing access road will also be reclaimed. As long as the operation does not disturb the area of pre-law disturbance located just north of the pit, this area will not require reclamation work. Some of the slopes in the pre-law disturbed area are steeper than 3H:1V (1H:1V in places), and have some minor erosional damage (a larger gully is present at the far northern edge of the area). However, overall, the area appears to be stable with native grasses, shrubs, and trees establishing throughout (**Photo 10**). It was suggested in the inspection report from 10/06/2005 that the operator at least regrade and seed the pre-law slopes when reclaiming the current pit, as to provide long-term

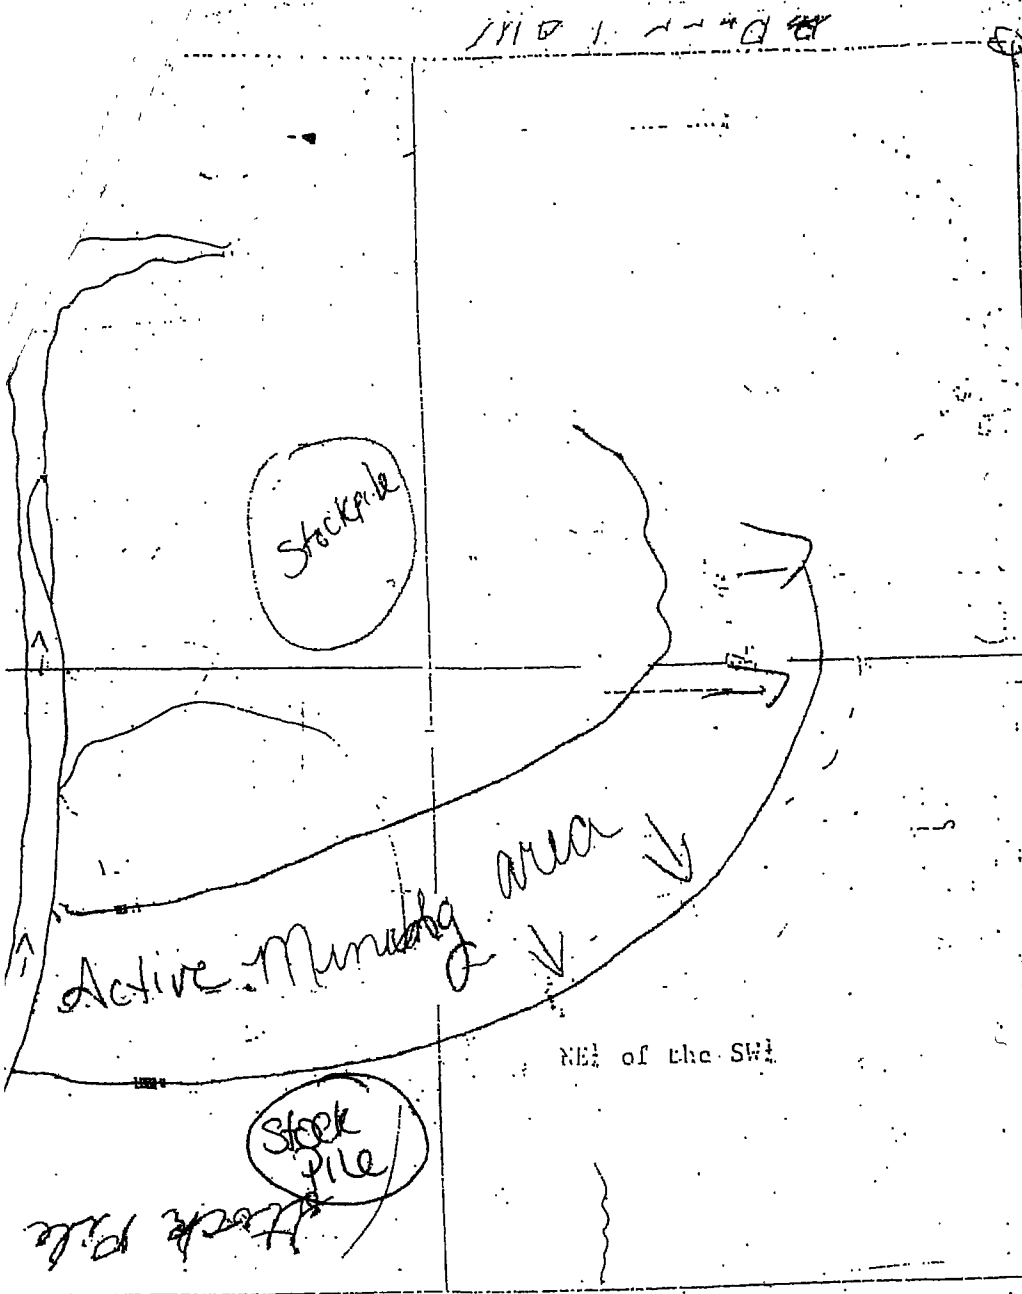
It should be noted here that the map included with recent annual reports (see enclosed annual report map submitted on 09/04/2014) does not adequately depict the permit boundary, the current affected area, the acreages to be affected or reclaimed in the next report year, or the location(s) of stockpiled topsoil. The Division recommends the operator submit a more accurate map with the next annual report (due by 09/11/2015). A Google Earth image with the above items indicated would be acceptable.
