**COLORADO DIVISION OF RECLAMATION, MINING AND SAFETY**  
**MINERALS PROGRAM INSPECTION REPORT**  
**PHONE: (303) 866-3567**

<b>MINE NAME:</b> Limestone Pit No. 10	<b>MINE/PROSPECTING ID#:</b> M-2011-036	<b>MINERAL:</b> Limestone (general), (general) and sand ar	<b>COUNTY:</b> Moffat
<b>INSPECTION TYPE:</b> Monitoring	<b>INSPECTOR(S):</b> Amy C. Yeldell, Stephanie Mitchell	<b>INSP. DATE:</b> June 16, 2015	<b>INSP. TIME:</b> 13:45
<b>OPERATOR:</b> Moffat County	<b>OPERATOR REPRESENTATIVE:</b> Billy Mack	<b>TYPE OF OPERATION:</b> 112c - Construction Regular Operation

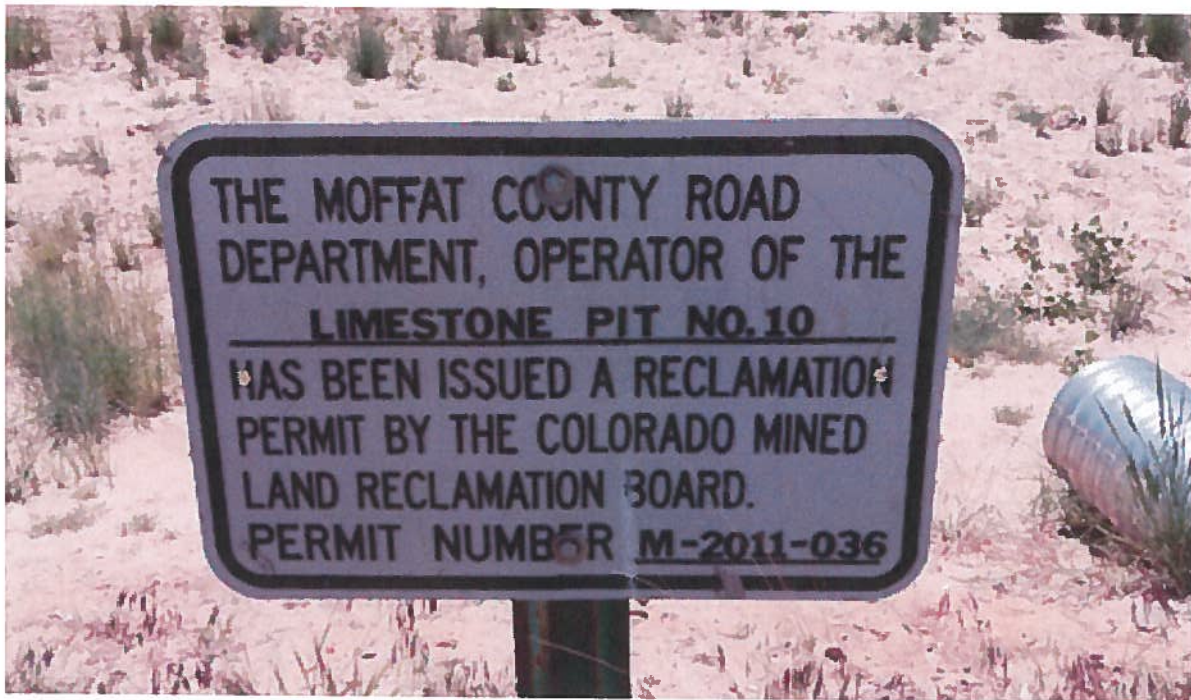
The mine identification sign and affected area boundary markers are in place and in compliance with Rule 3.1.12. The sign is located at the entrance to the site where the access road meets county road 10. The perimeter has been mowed/cleared just within the boundary and t-posts have been placed to clearly delineate permit boundaries. The key corners are also marked with posts that state "permit boundary".

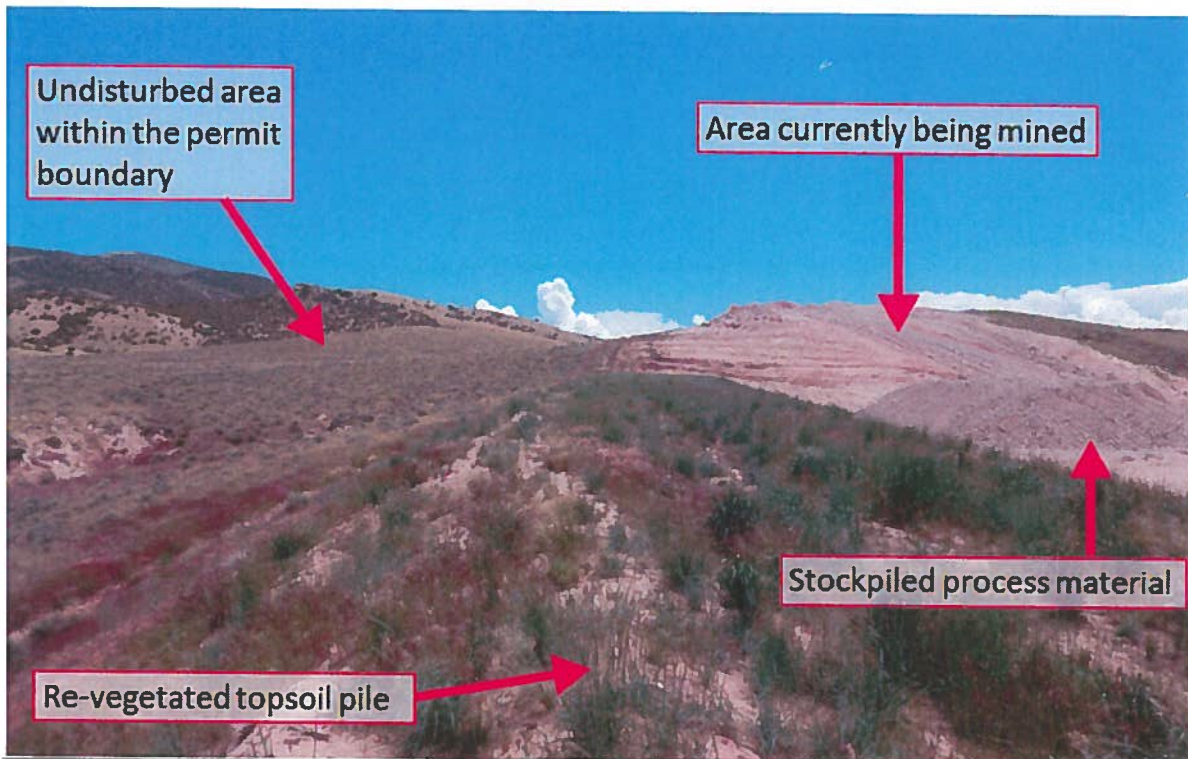
Stockpiled process materials were noted on site. Aggregates were separated based on size classes. Piles are stable with no evidence of erosion or sloughing. Site was inactive at the time of the inspection and no equipment was observed on site.

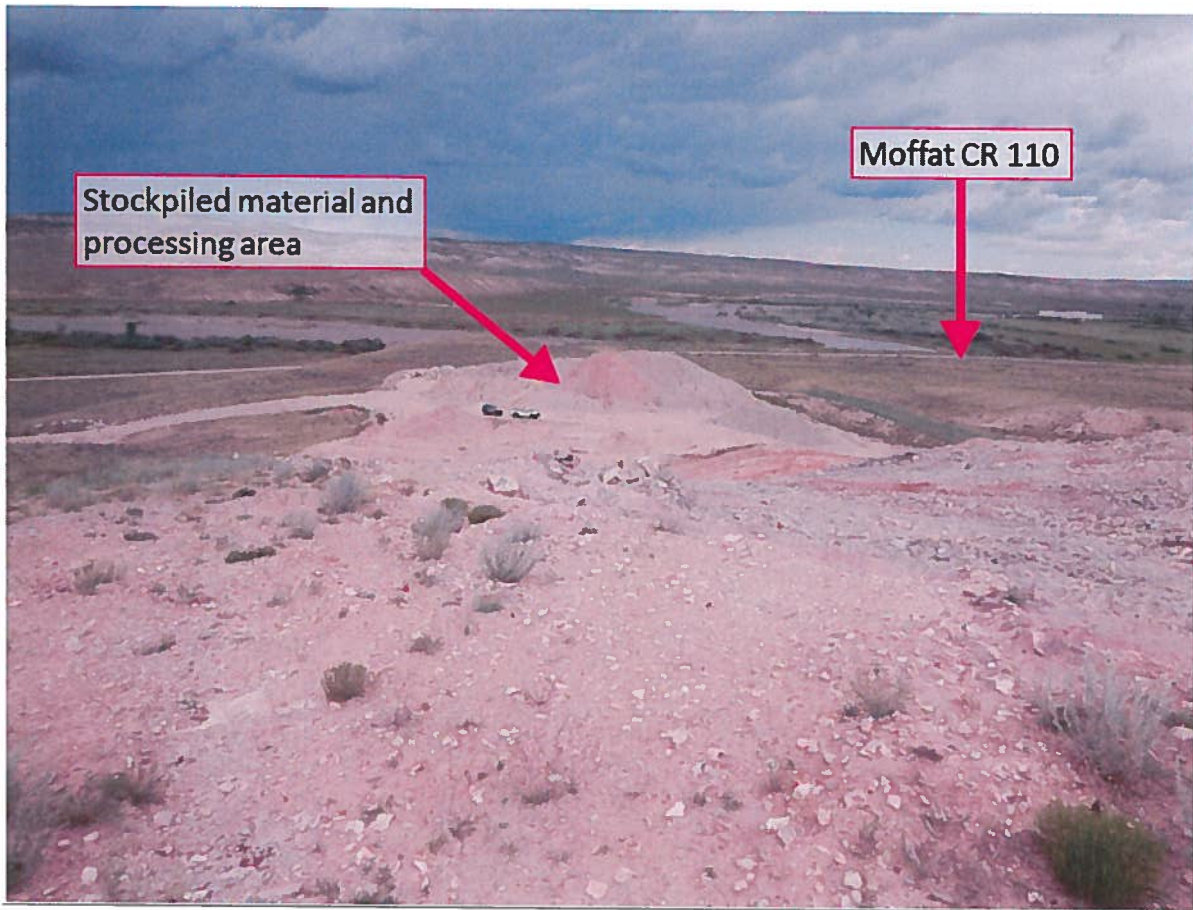
Several stormwater BMP's were observed in addition to two hydrologic discharge monitoring gauges. Berms were employed around the disturbed areas to prevent run-on or run-off from the site. Adequate ditching was used to convey water to sediment retention ponds and appropriate discharge locations. No water storage was observed, it appears that all stormwater infiltrates into the soil in a timely manner. Additionally several rock check dams were observed, all of which were installed correctly, clean and had adequate capacity.
