**COLORADO DIVISION OF RECLAMATION, MINING AND SAFETY**  
**MINERALS PROGRAM INSPECTION REPORT**  
**PHONE: (303) 866-3567**

<b>MINE NAME:</b> McVey Pit	<b>MINE/PROSPECTING ID#:</b> M-1978-225L	<b>MINERAL:</b> Sand and gravel	<b>COUNTY:</b> Baca
<b>INSPECTION TYPE:</b> Monitoring	<b>INSPECTOR(S):</b> Amy Eschberger	<b>INSP. DATE:</b> November 19, 2014	<b>INSP. TIME:</b> 11:00
<b>OPERATOR:</b> Baca County	<b>OPERATOR REPRESENTATIVE:</b> James Adams and Kurt Eskew	<b>TYPE OF OPERATION:</b> 112c - Construction Regular Operation

# M1978-225L / McVey Pit / Baca County

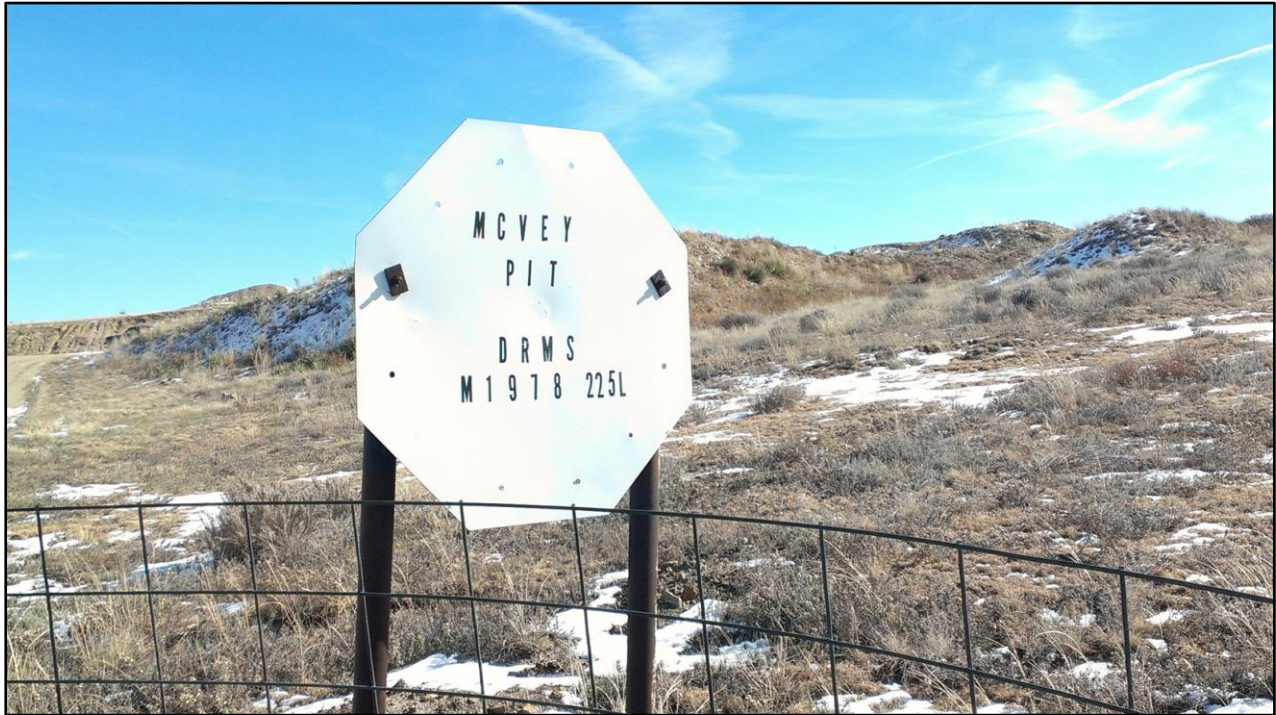
At the time of the inspection, the weather was clear, cold and sunny, and the ground had some snow cover. A permit identification sign was posted at the main site entrance off of Co Rd 2 (**Photo 1**). This sign includes the permit number as required; however, pursuant to Rule 3.1.12(1), it should also include the operator's name and a statement that the permit was issued by the Colorado Mined Land Reclamation Board (MLRB). The permit boundary was delineated by 4-strand barbed wire fencing. The mine was not active at the time of the inspection, and no equipment was present on site. However, the county has been hauling off from stockpiled product every year, which is in compliance with its intermittent status. At the time of the inspection, all stockpiled product had been removed from the site. Mr. Adams and Mr. Eskew indicated that the county intends to mine the pit again within the year. The operator should keep in mind that per C.R.S. 34-32.5-103(1)(b), if mining activities cease for more than a year (e.g., extraction, processing, and/or movement of stockpiled material), the operator will be required to either file a Notice of Temporary Cessation or begin final reclamation of the site.

**Photo 1.** View of permit sign posted at main site entrance off of Co Rd 2. A permit sign should include the permit number (already included here), the operator's name, and a statement that the permit was issued by the CO MLRB.

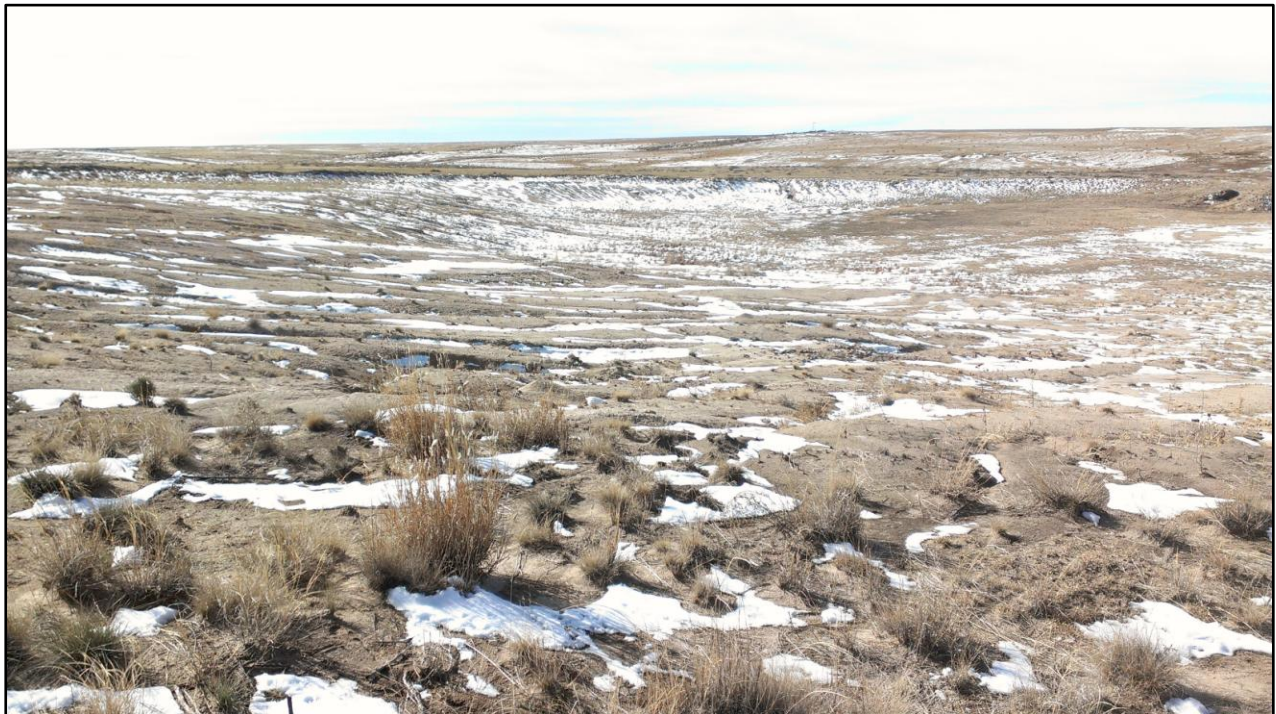
The Division estimates that approximately 16.5 acres have been disturbed by this operation (see enclosed Google Earth image of site), which is in compliance with the maximum allowed disturbance. Current disturbance includes an oval-shaped pit that is approximately 20-25 feet deep with slope gradients of mainly 3H:1V to 4H:1V (**Photos 2-4**), topsoil berms and a few topsoil stockpiles stored along the top edges of the pit walls (**Photos 5 and 6**), and a waste rock stockpile stored just south of the access road at the pit entrance (**Photo 7**). The topsoil stockpiles appeared to be stable with some vegetative cover at the time of the inspection. Native grasses and some shrubs and forbs are volunteering across the pit floor and along much of the highwalls (see **Photos 2-6**).

**Photo 2.** View looking southwest across pit from top of eastern highwall, showing slopes graded 4H:1V. Note some native grasses volunteering across slopes.

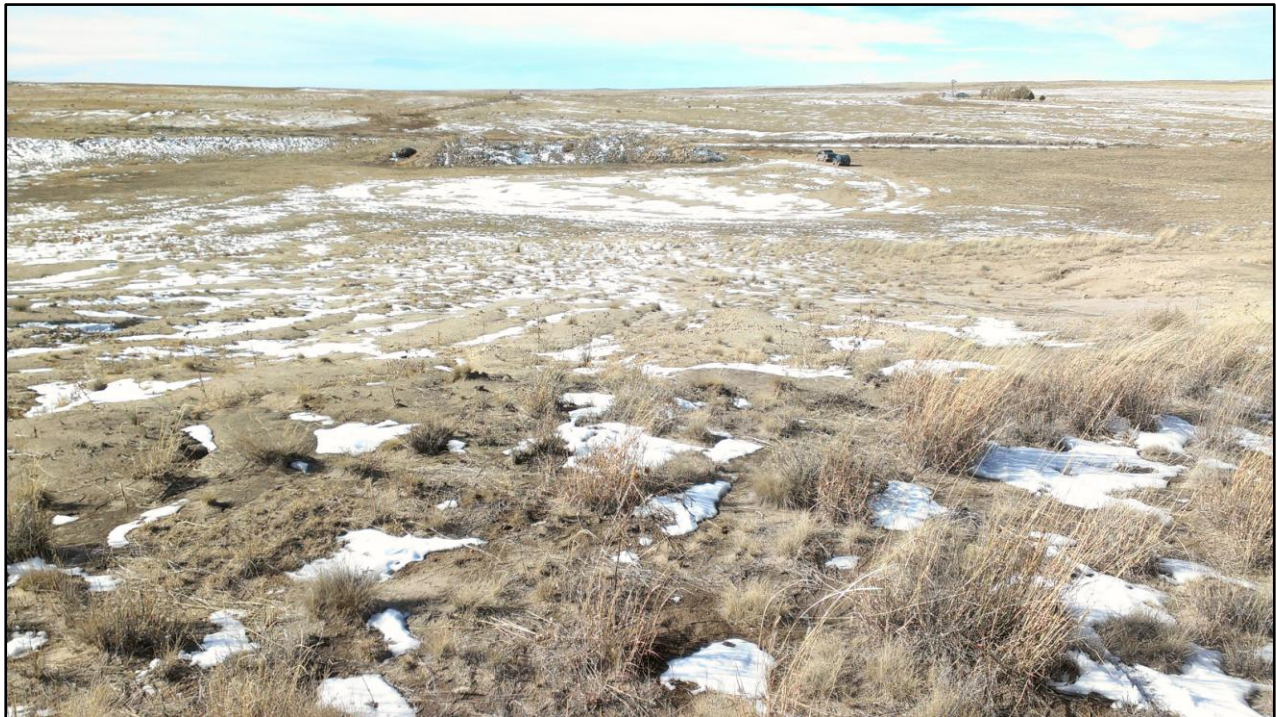
**Photo 3.** View looking west across pit from top of eastern highwall, showing slopes graded 4H:1V. Note some native grasses volunteering across slopes and pit floor.

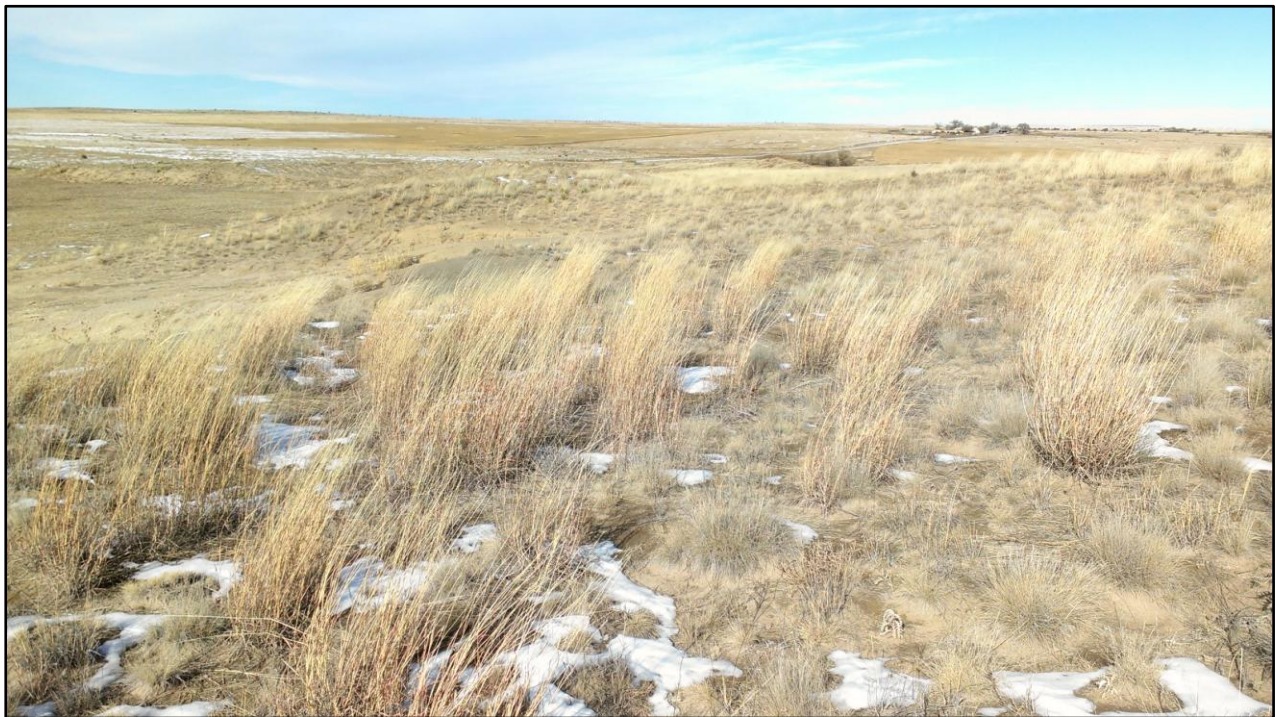
**Photo 4.** View looking north across pit slope from top of eastern highwall, showing slopes graded 4H:1V. Note native grasses volunteering across slopes.

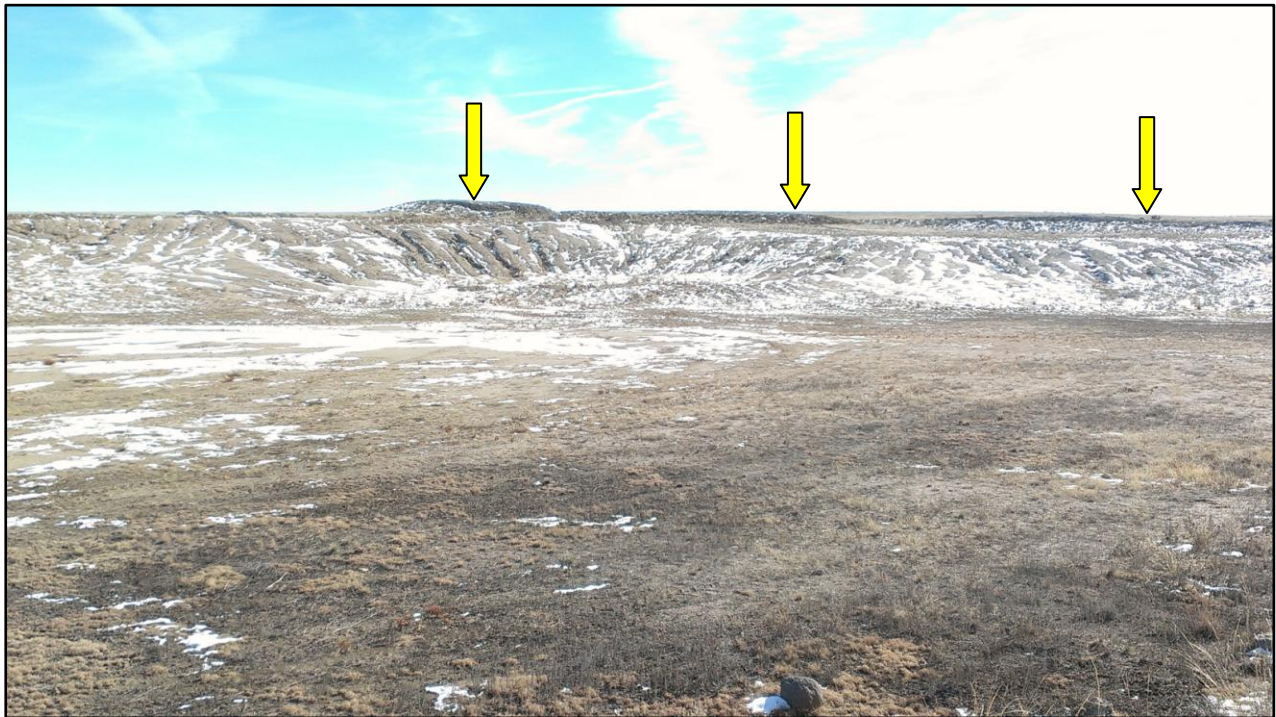
**Photo 5.** View looking southeast from western edge of pit floor, showing topsoil berm stored along top edge of pit walls (indicated). Note slopes graded 3H:1V or flatter and some native grasses volunteering across pit floor.

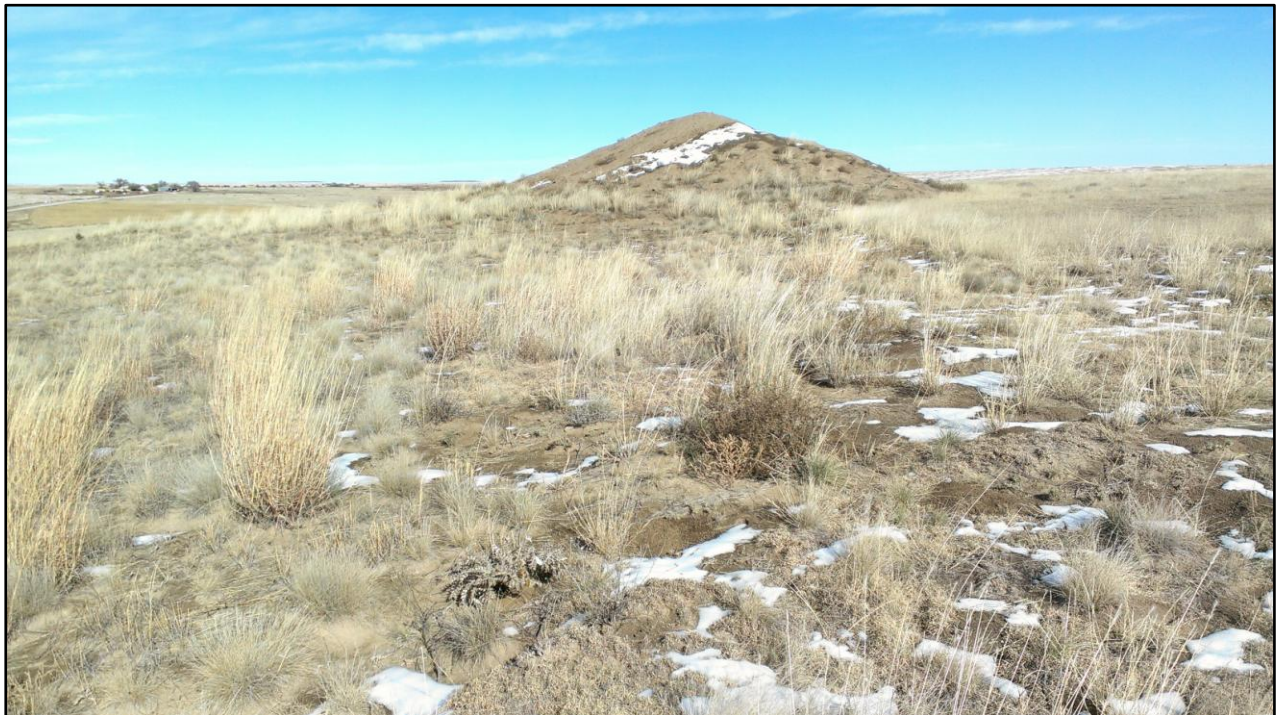
**Photo 6.** View looking north from top of eastern highwall, showing topsoil stockpile stored above pit.

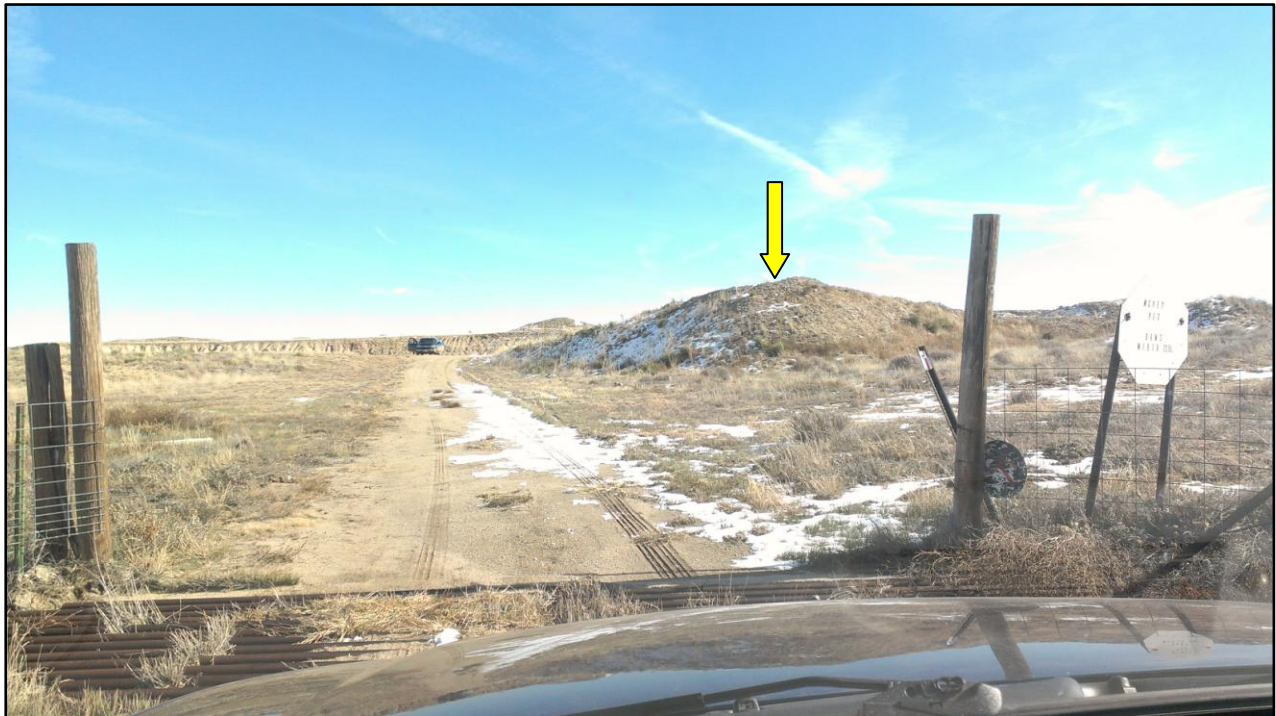
**Photo 7.** View looking east from site entrance, showing waste rock stockpile (indicated) stored just south of access road.

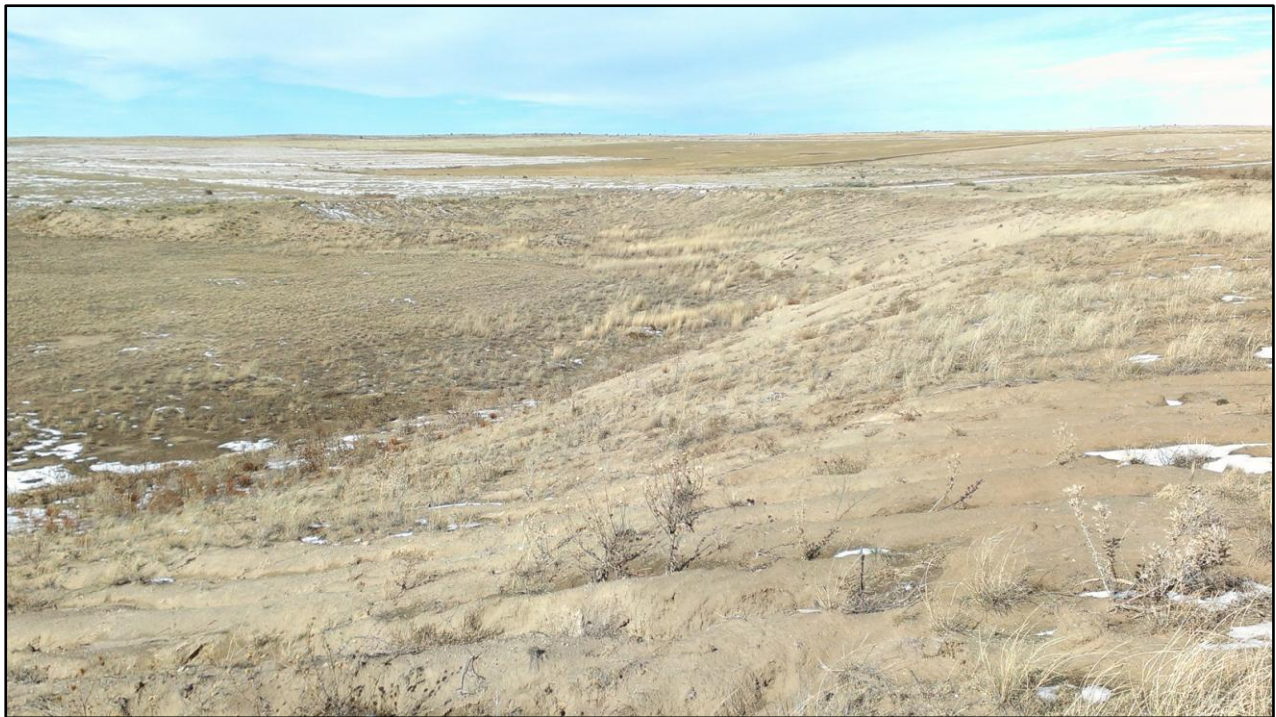
The northern portion of the pit (approximately 4 acres) appeared to be in reclamation as it was graded to 3H:1V or flatter and native grasses and shrubs are establishing throughout this area (**Photos 8 and 9**). Some annual weeds were also present, but did not appear to be hindering the growth of desired vegetation. It appeared that this area had not been disturbed for some time. Once this portion of the site is fully reclaimed, if it is never redisturbed by the operation, it does not have to be included in the maximum disturbed acreage. Much of the eastern (west-facing) highwall showed some erosional damage including several rills and small gullies. It appeared that stormwater runoff is particularly concentrating on the central portion of the eastern highwall (**Photo 10**), which also has steeper slopes (closer to 2H:1V) and less vegetative cover. Mr. Adams and Mr. Eskew committed to repairing the erosional damage soon after the inspection. This matter will be followed up during the next inspection.

**Photo 8.** View looking northwest from top of eastern highwall, showing portion of pit in reclamation. Note slopes graded 3H:1V or flatter and vegetative cover establishing throughout. Portion of slope in foreground will most likely require additional grading and seeding due to erosion and lack of vegetative cover.

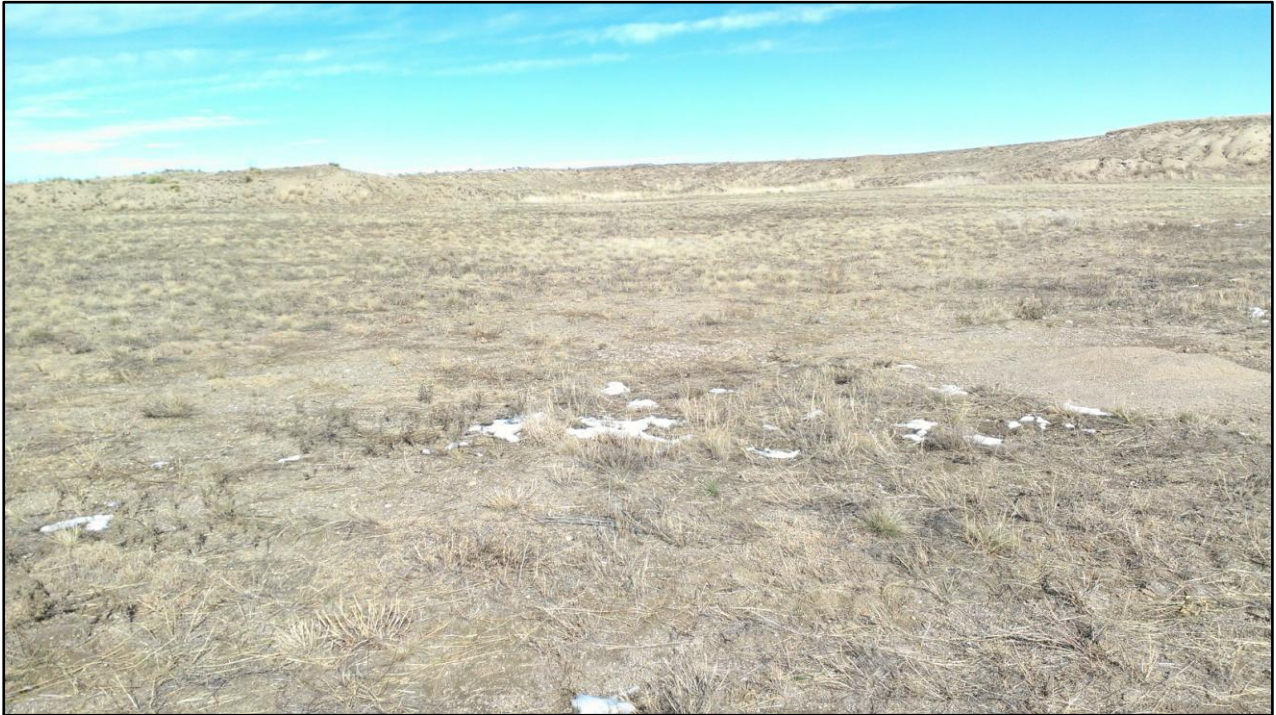
**Photo 9.** View looking northeast from pit entrance, showing portion of pit in reclamation. Note slopes graded 3H:1V or flatter and vegetative cover establishing throughout.

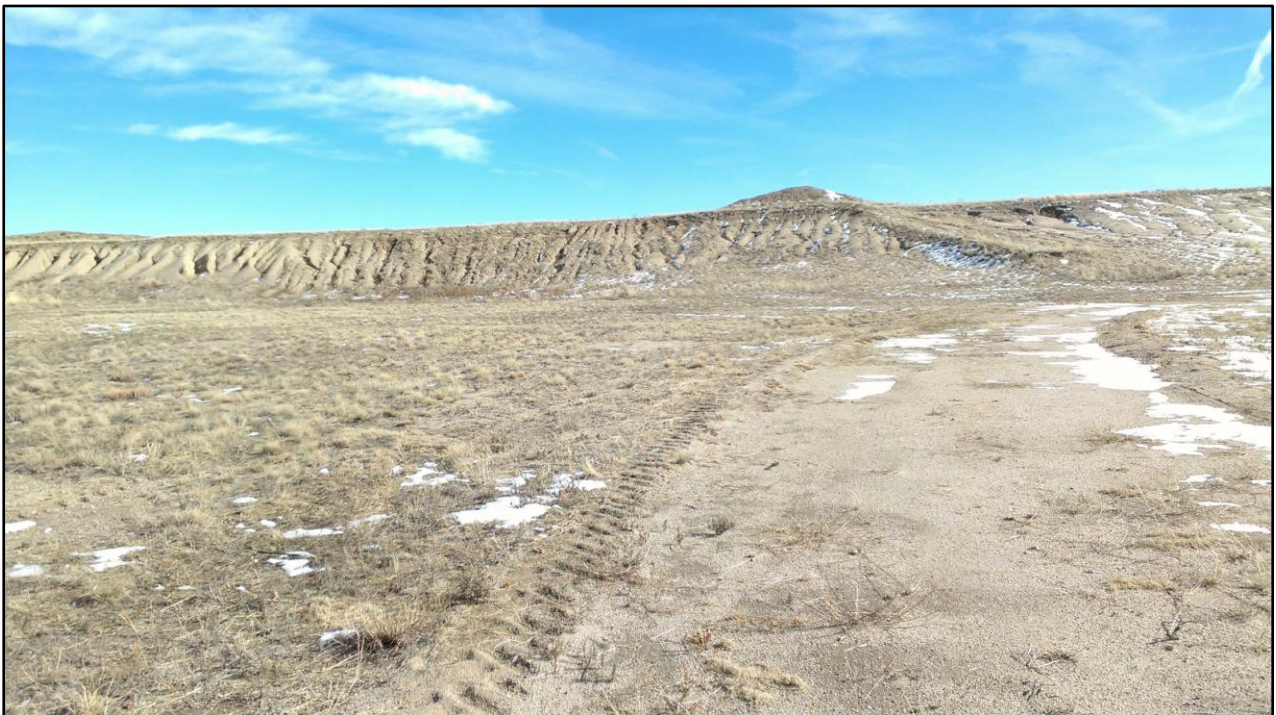
**Photo 10.** View looking east from access road, showing central portion of eastern highwall where erosional damage appears to be more significant (possibly due to slightly steeper slopes and less vegetative cover).
