COLORADO DIVISION OF RECLAMATION, MINING AND SAFETY
MINERALS PROGRAM INSPECTION REPORT
PHONE: (303) 866-3567

MINE NAME: Re-Open Gravel Pit #18 Pipe Springs Ranch LLC	MINE/PROSPECTING ID#: M-2003-019	MINERAL: Sand and gravel	COUNTY: Baca
INSPECTION TYPE: Monitoring	INSPECTOR(S): Amy Eschberger	INSP. DATE: November 19, 2014	INSP. TIME: 12:00
OPERATOR: Baca County	OPERATOR REPRESENTATIVE: James Adams and Kurt Eskew	TYPE OF OPERATION: 112c - Construction Regular Operation

M2003-019 / ReOpen Gravel Pit #18 Pipe Springs Ranch LLC / Baca County

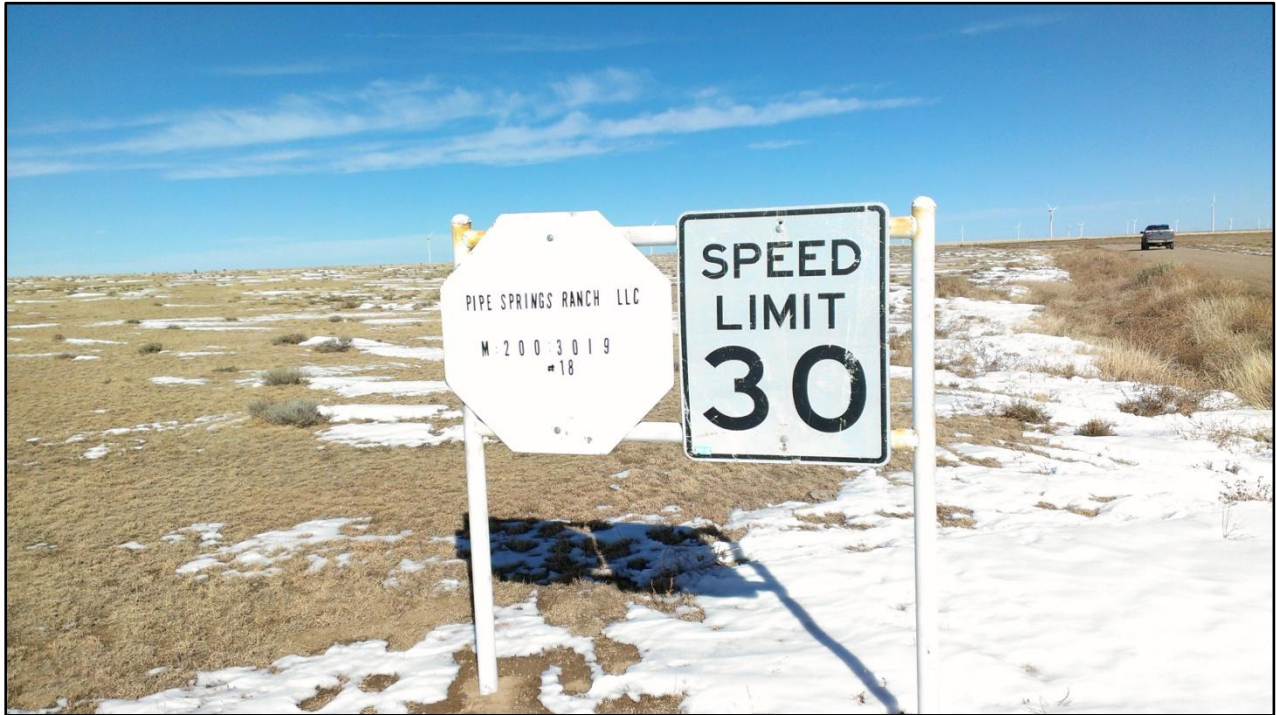
At the time of the inspection, the weather was clear, cold and sunny, and the ground had some snow cover. A permit identification sign was posted at the main entrance off of Co Rd Ww (**Photo 1**). This sign includes the permit number as required; however, pursuant to Rule 3.1.12(1), it should also include the operator's name, and a statement that the permit was issued by the Colorado Mined Land Reclamation Board (MLRB). The permit boundary was properly delineated with metal posts (**Photo 2**). The mine was not active at the time of the inspection, and no equipment was present on site. However, the county has been processing and hauling off from stockpiled material every year, which is in compliance with its intermittent status. According to aerial images shown in Google Earth, this site was last expanded (northward) at some time between late-2012 and mid-2014. Mr. Adams and Mr. Eskew indicated that the county intends to mine the pit again soon.

Photo 1. View of permit sign posted at site entrance off of Co Rd Ww. A permit sign should include the permit number (already included here), the operator's name, and a statement that the permit was issued by the CO MLRB.

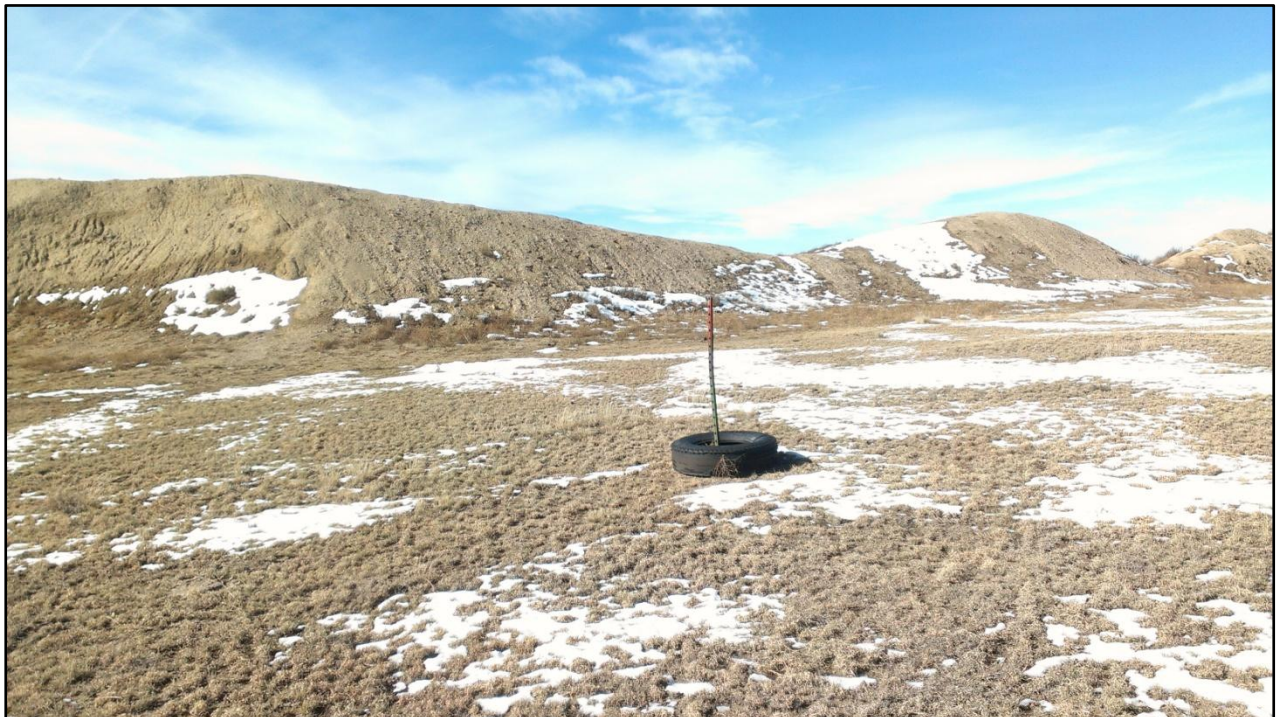
Photo 2. View of metal post marking northeastern corner of permit boundary. Topsoil berm shown in background.

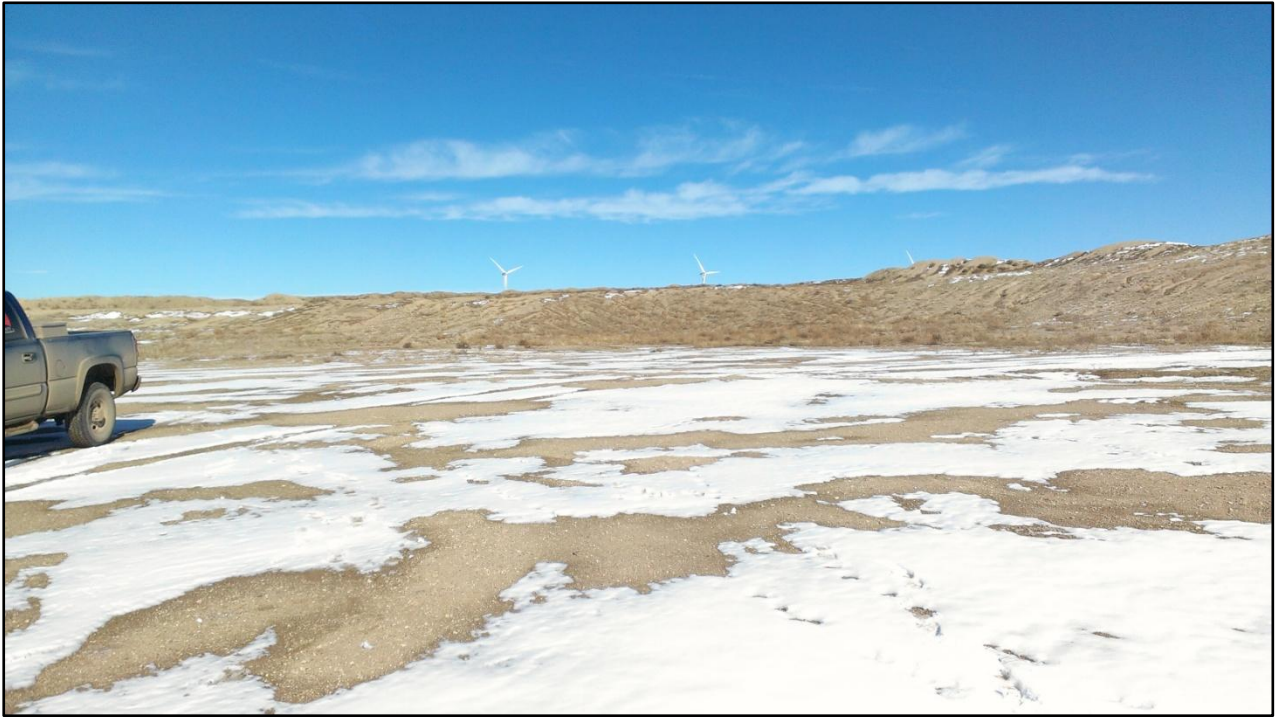
Photo 3. View looking northeast from center of pit floor, showing highwalls graded mainly 4H:1V.

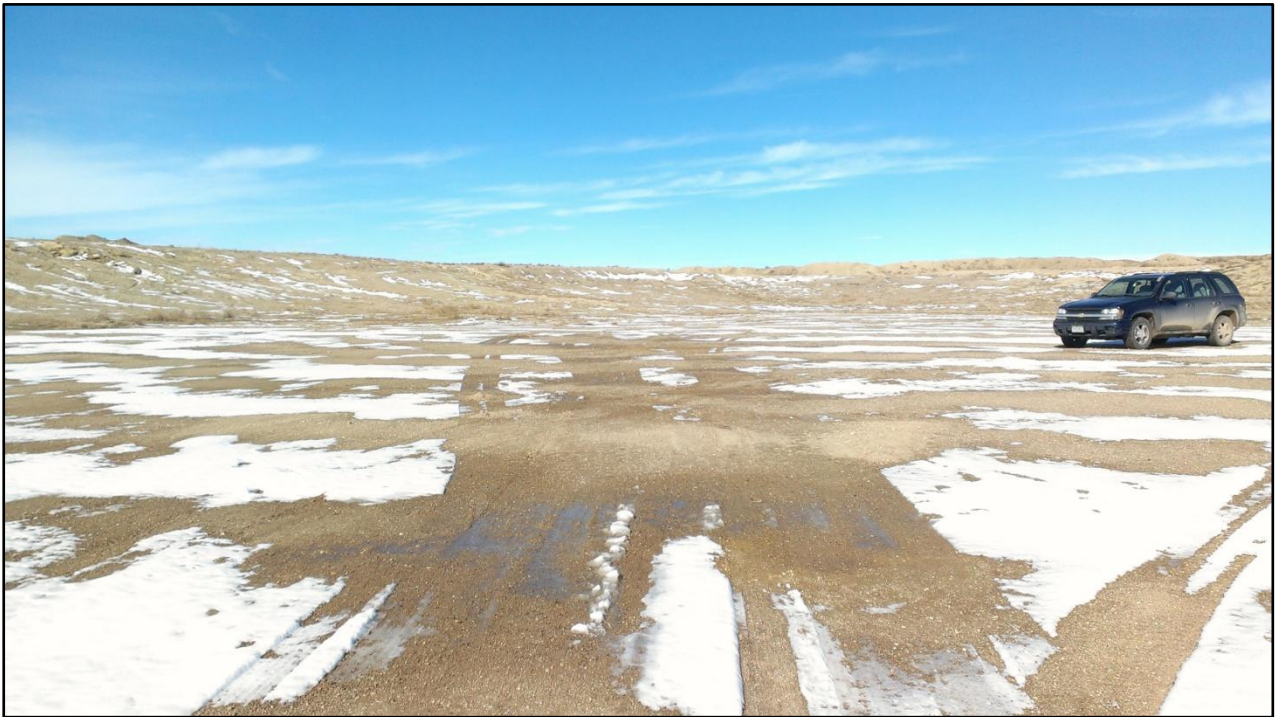
Photo 4. View looking northwest from center of pit floor, showing highwalls graded mainly 4H:1V.

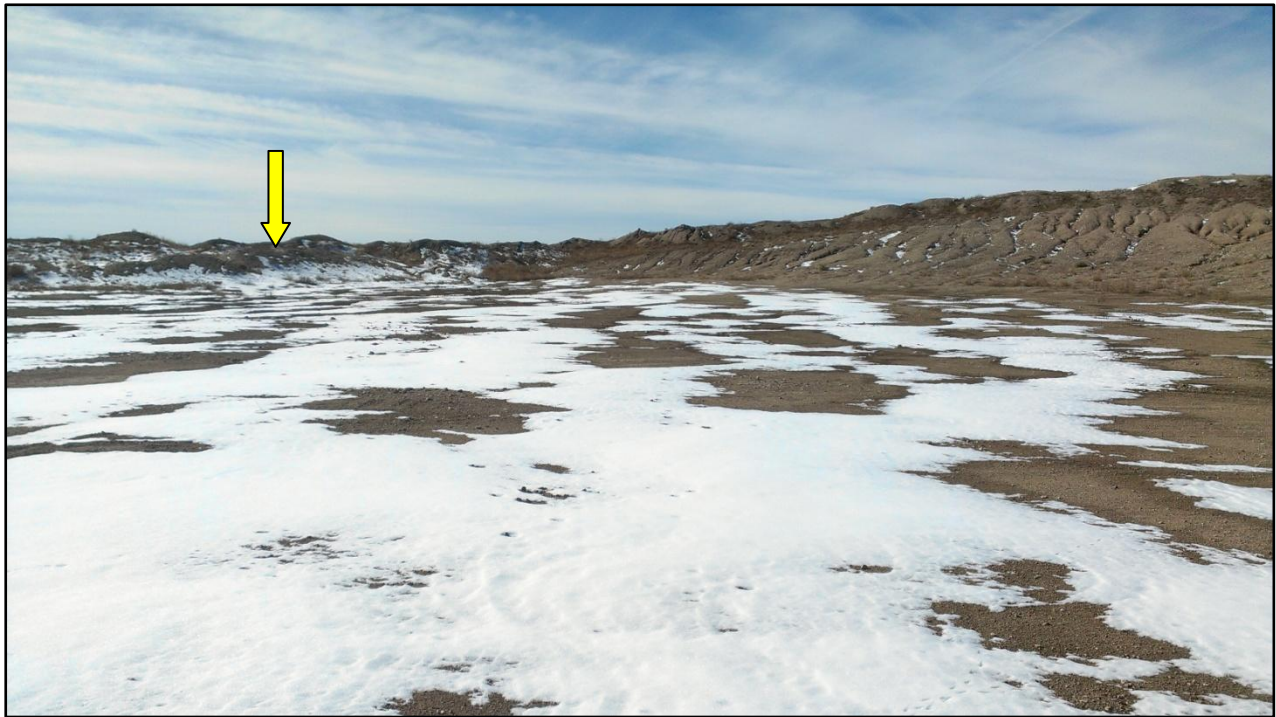
Photo 5. View looking southwest from center of pit floor, showing portion of highwall graded 3H:1V. Note gravel berm (indicated) constructed along southwestern (downgradient) edge of pit to help keep stormwater from leaving the site.

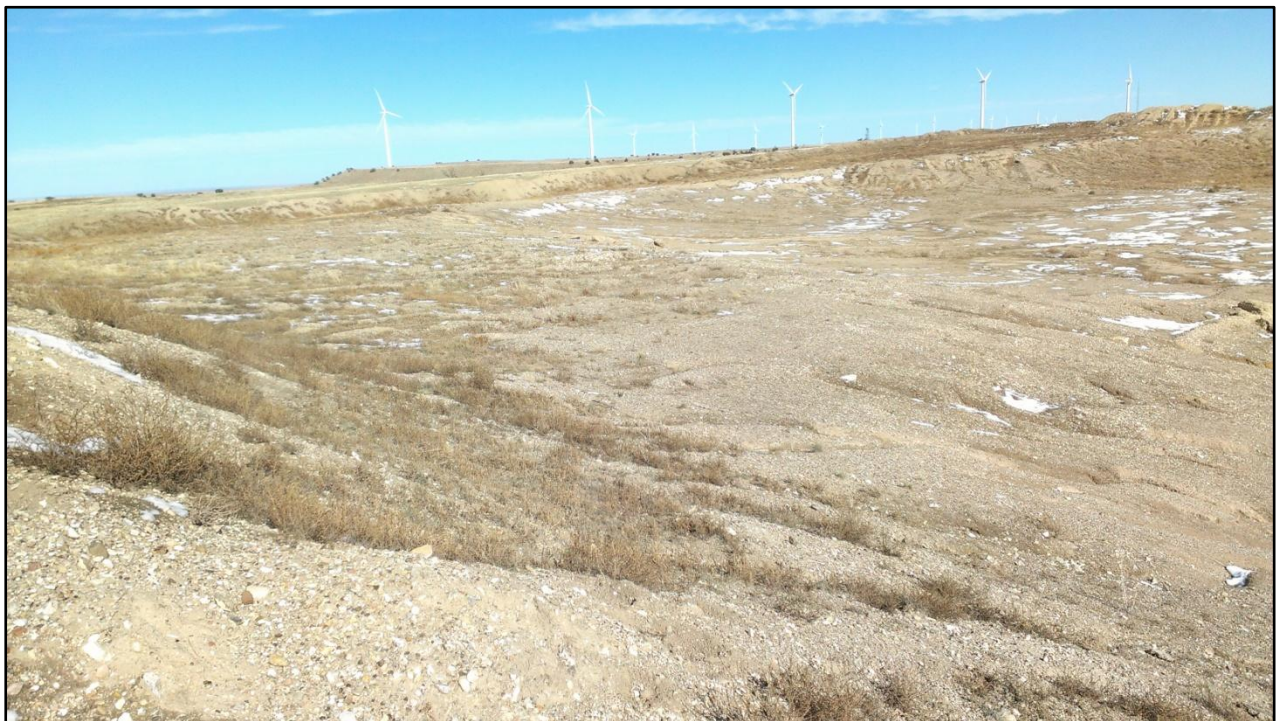
Photo 6. View looking northeast from western edge of pit, showing highwalls graded mainly 4H:1V.

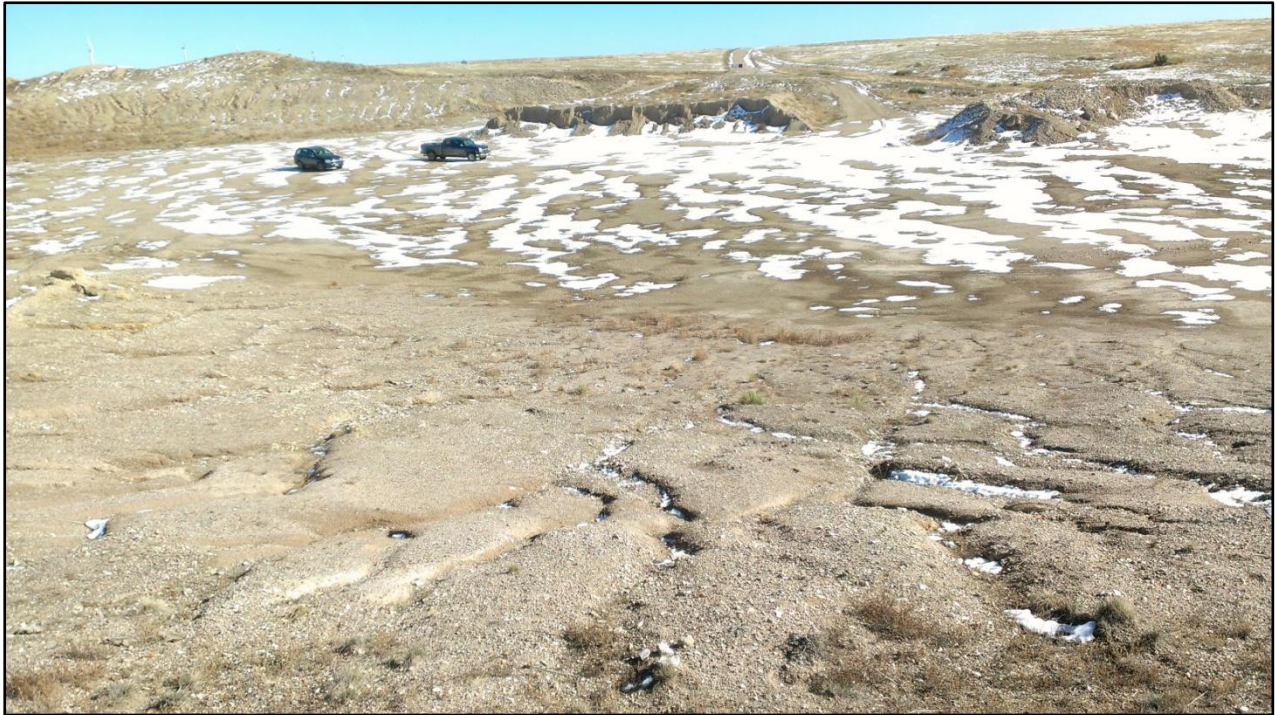
Photo 7. View looking east from western edge of pit, showing highwalls graded mainly 4H:1V. Note minor erosional damage along slopes.

The Division estimates that approximately 10.5 acres have been disturbed by this operation (see enclosed Google Earth image of site), which is in compliance with the maximum allowed disturbance. Current disturbance includes an oval-shaped pit that is approximately 20-25 feet deep with slope gradients of mainly 4H:1V or flatter (**Photos 3-7**), topsoil berms stored along the top edges of the pit walls (**Photo 8**), a material stockpile stored at the southeastern edge of the pit near the entrance (**Photo 9**), and a waste rock stockpile stored at the southern edge of the pit (**Photo 10**). All stockpiles and pit slopes appeared to be stable. Some warm-season perennial grasses were volunteering into the pit, mainly along the pit walls. Russian thistle was also present, which is very common throughout this region. Some minor erosional damage including several rills and some small gullies were present along portions of the pit walls (see **Photo 7**). The Division recommends the operator monitor and repair any erosional damage in disturbed areas as necessary to help protect the stability of the pit walls.

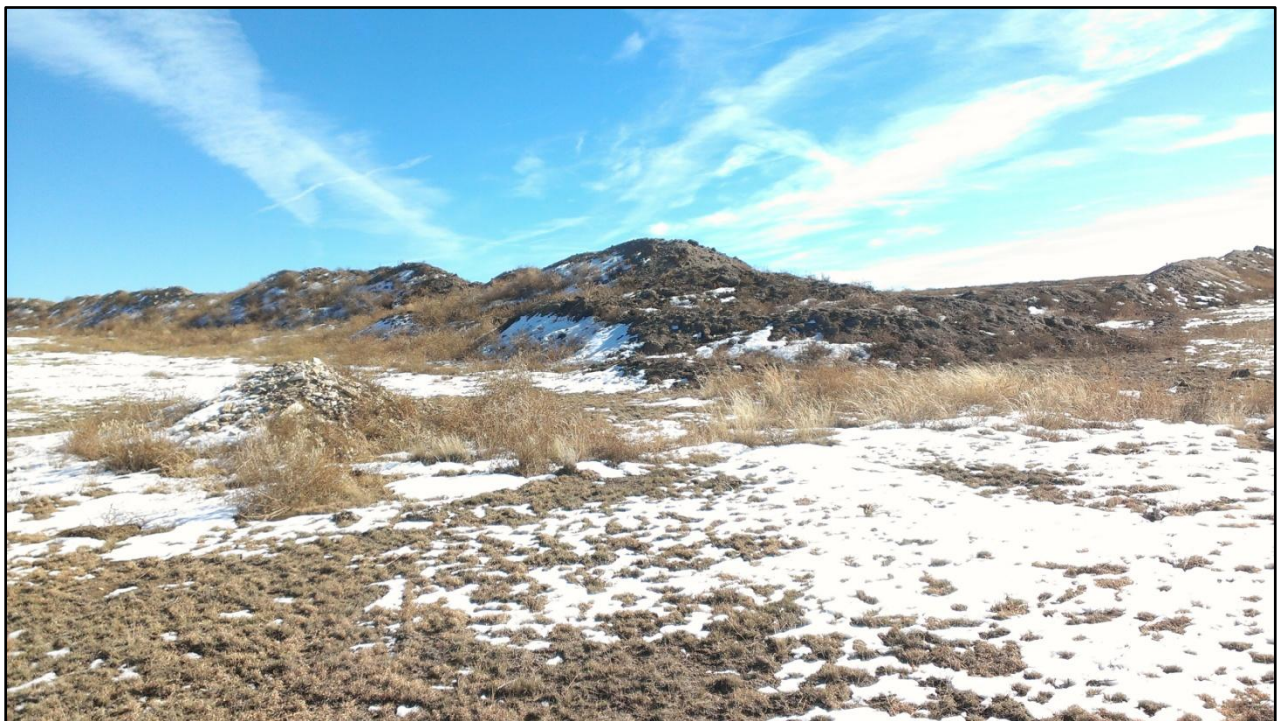
Photo 8. View of topsoil berm stored along top of northwestern edge of pit.

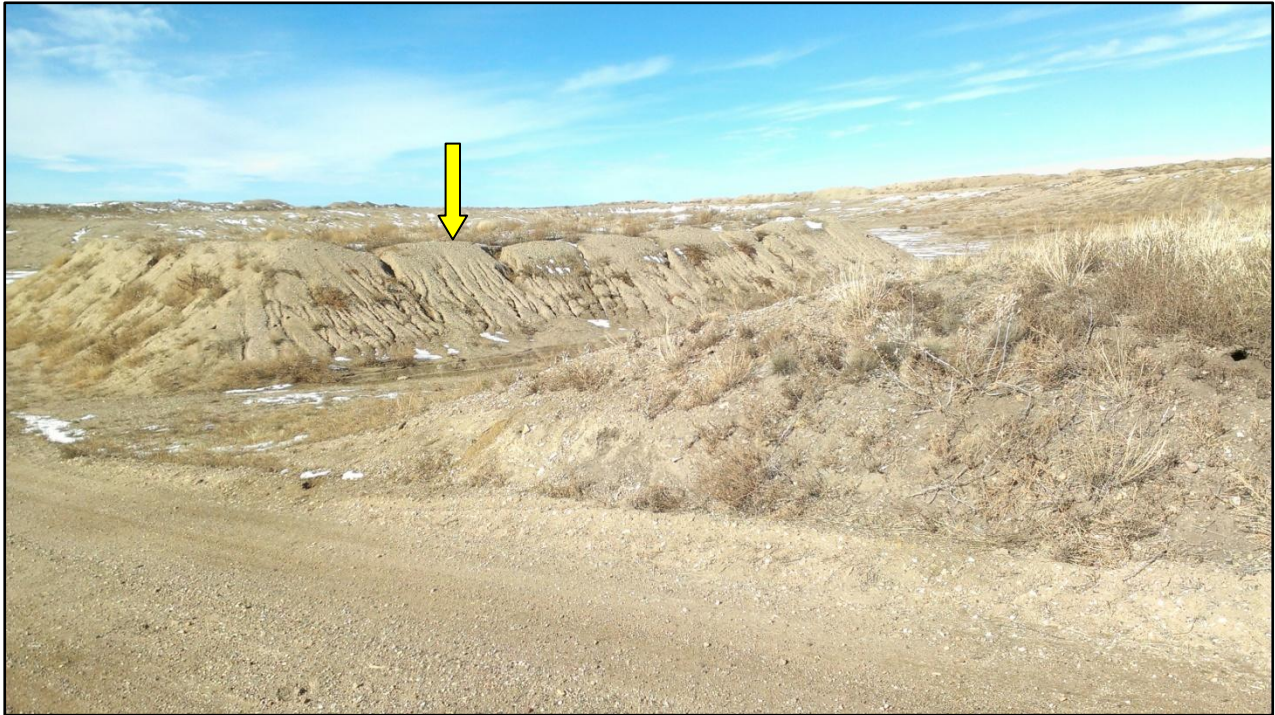
Photo 9. View looking northwest from access road, showing material stockpile (indicated) stored near pit entrance.

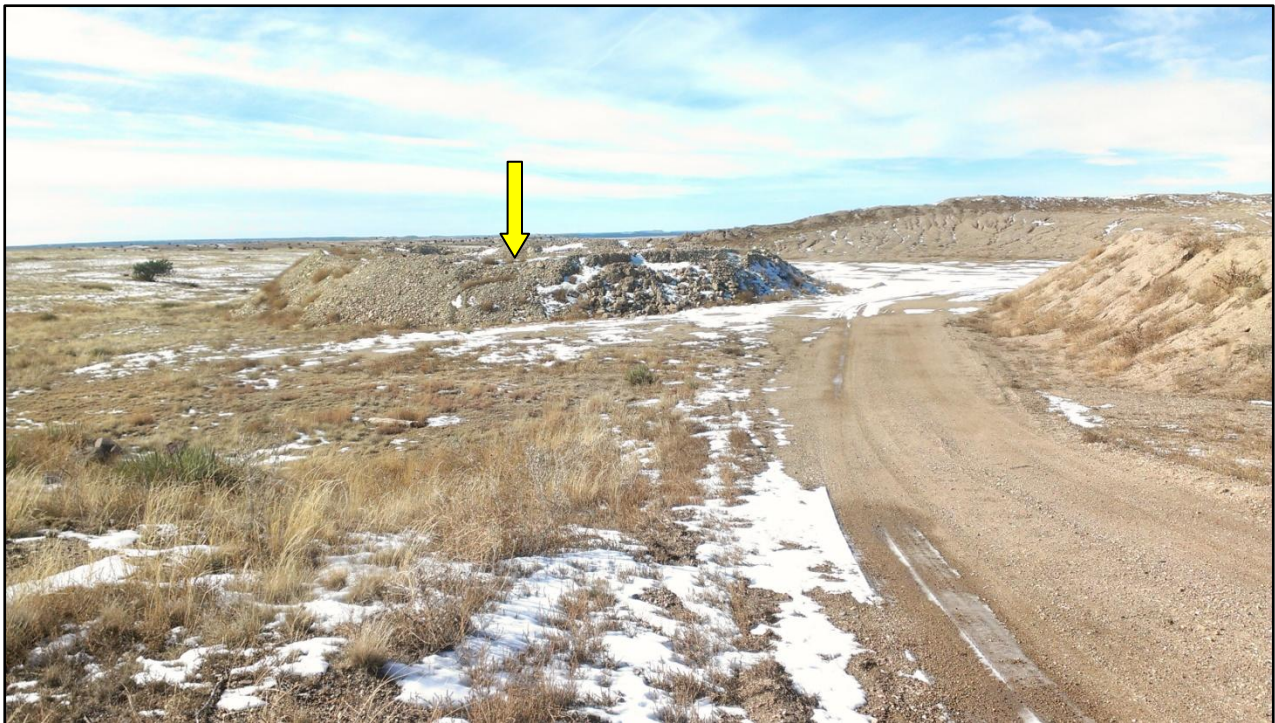
Photo 10. View looking west from access road, showing waste rock stockpile (indicated) stored at southern edge of pit.

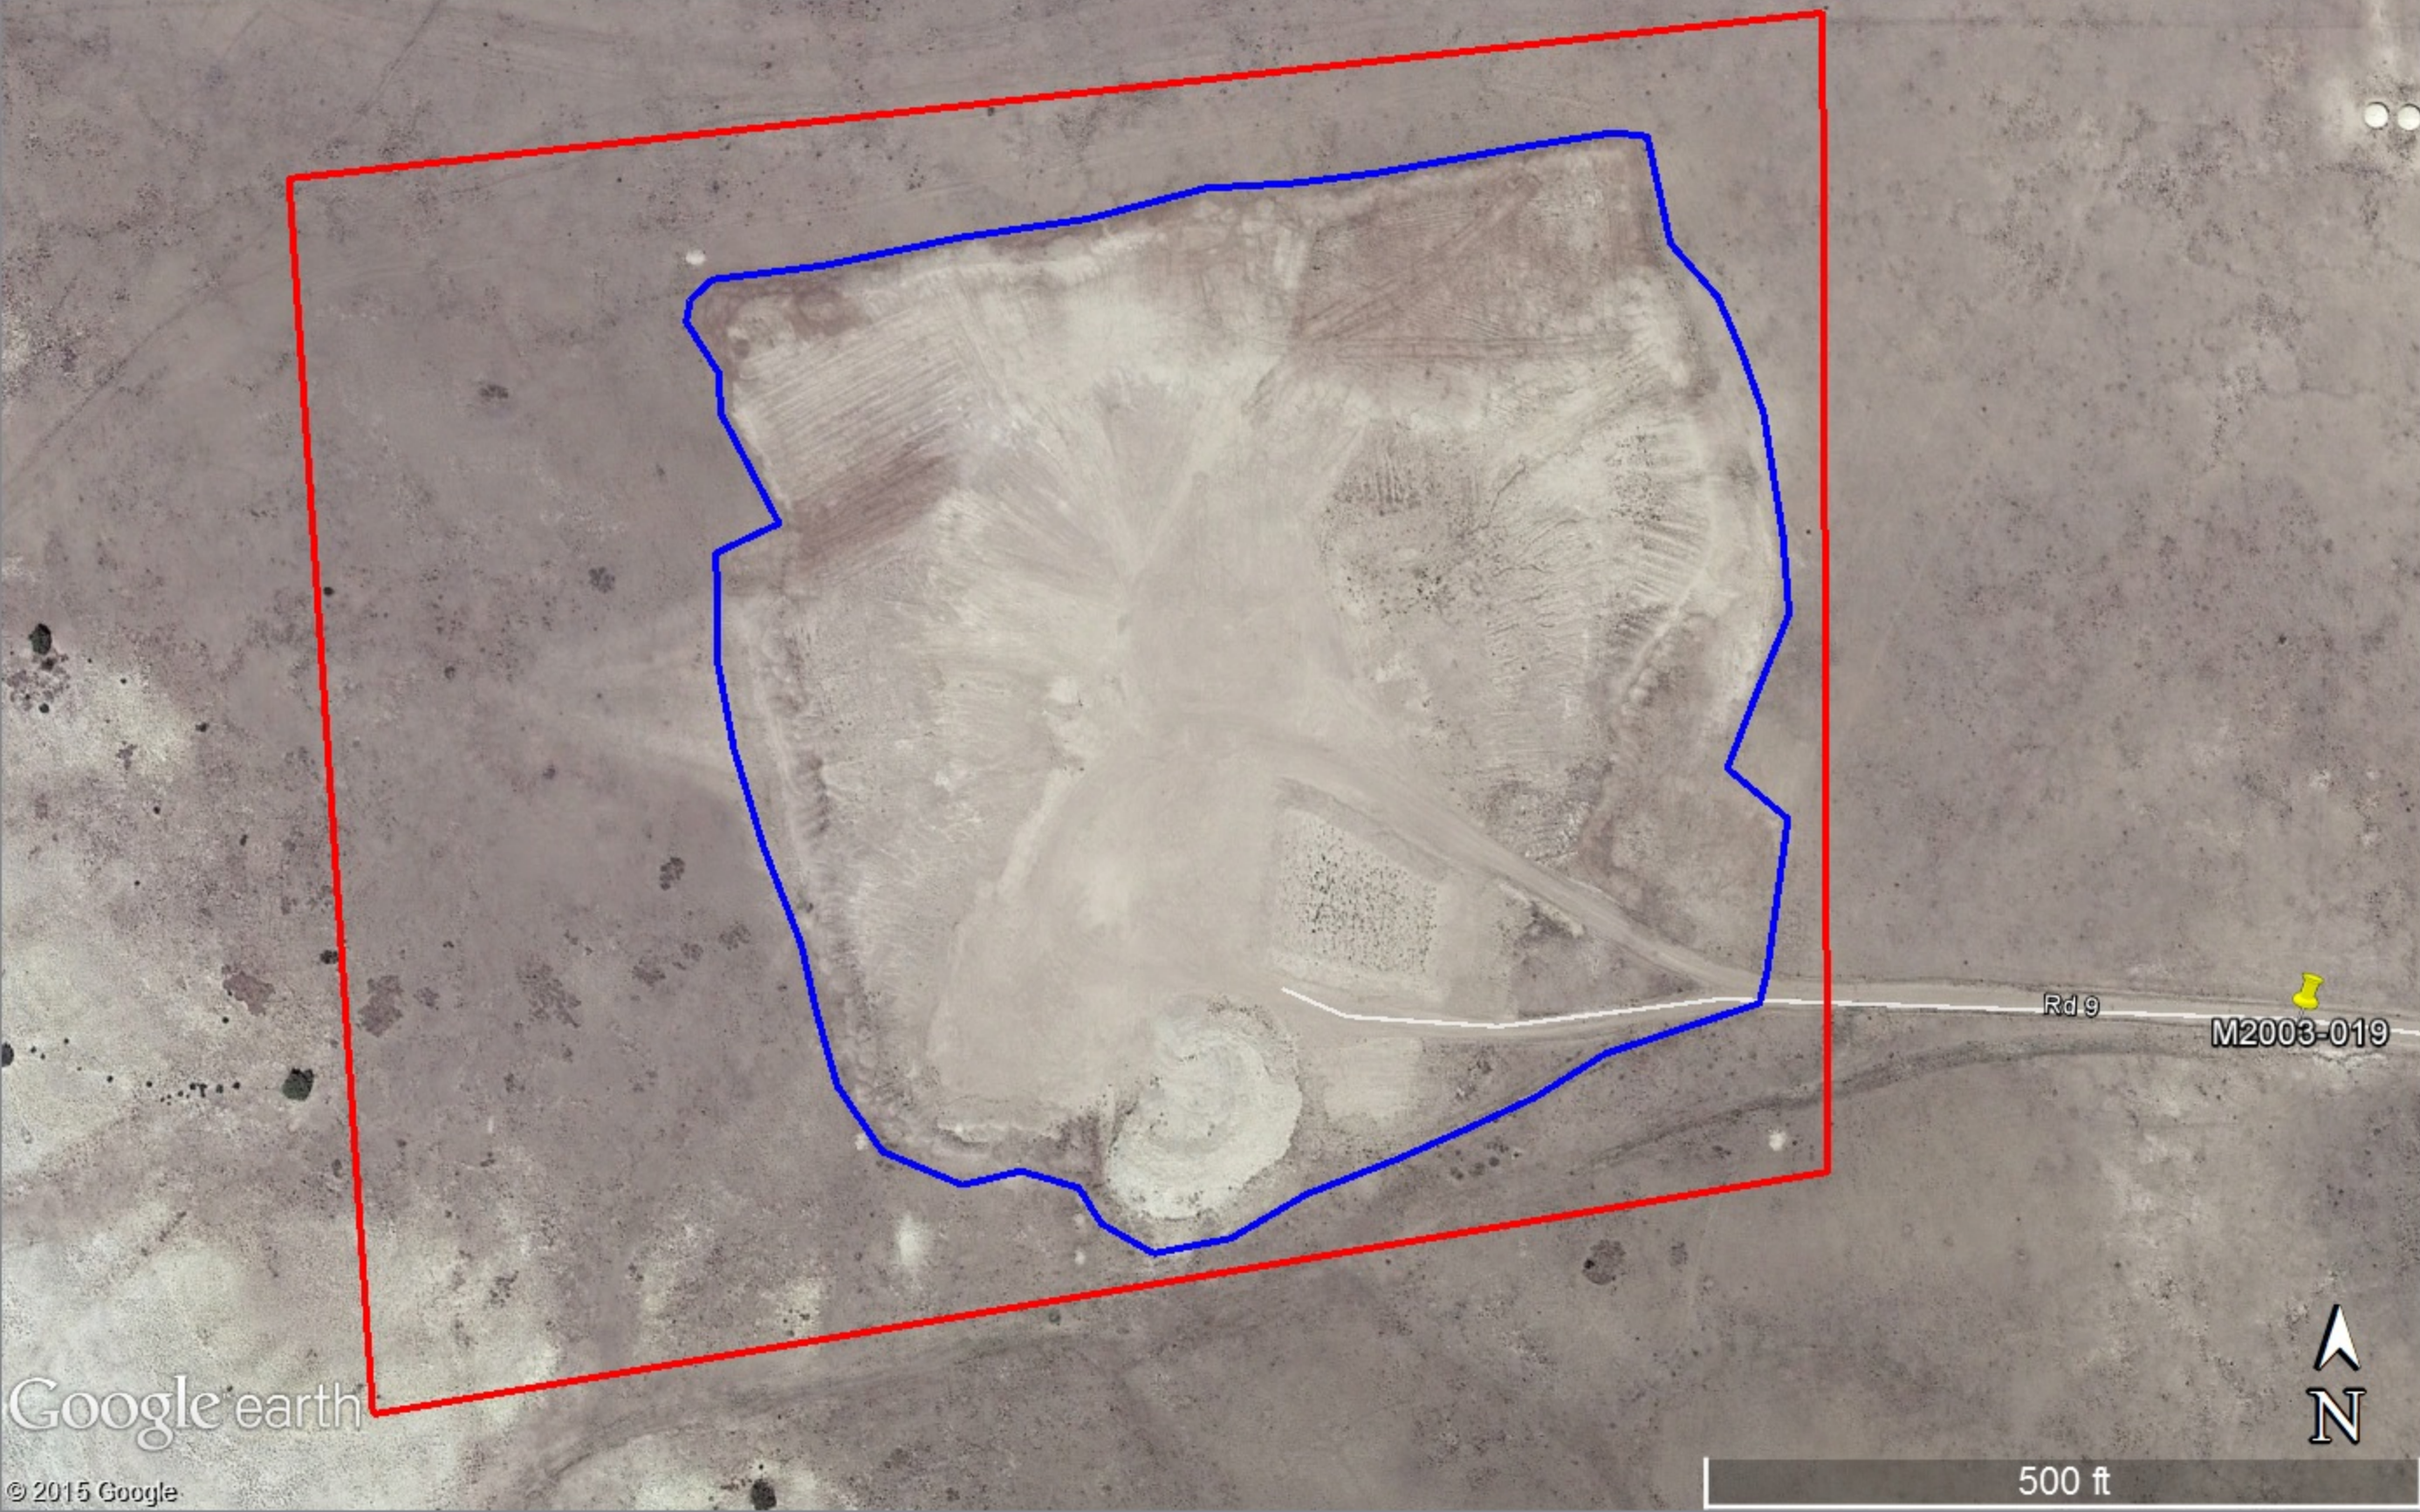
No problems were observed on site at the time of the inspection. However, it should be noted that portions of the disturbed area are currently very close to the eastern and southern permit boundaries (approximately 25-30 feet in places). Therefore, the operator should be careful not to disturb land outside of these boundaries. The permit area can be expanded at any time by submitting a permit Amendment.

Red Line = 20 acres = Approved Permit Area

Blue Line = 10.5 acres = Disturbed Area (as of 11/19/2014 inspection)
