COLORADO DIVISION OF RECLAMATION, MINING AND SAFETY
MINERALS PROGRAM INSPECTION REPORT
PHONE: (303) 866-3567

MINE NAME: Dollerschell Pit	MINE/PROSPECTING ID#: M-1986-074	MINERAL: Sand and gravel	COUNTY: Logan
INSPECTION TYPE: Pre-Operation Inspection	INSPECTOR(S): Elliott R. Russell	INSP. DATE: May 14, 2015	INSP. TIME: 10:20
OPERATOR: Kym A. Schure	OPERATOR REPRESENTATIVE: Kym Schure	TYPE OF OPERATION: 110c - Construction Limited Impact

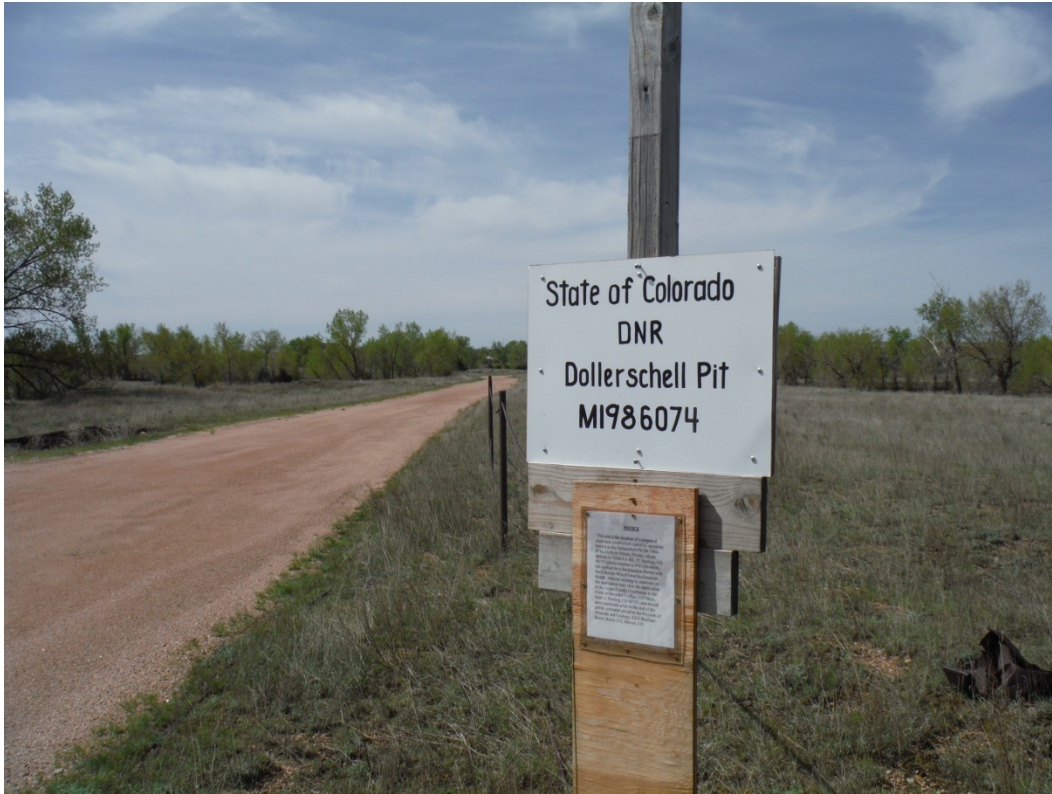
Notice and 110c permit identification sign at the mine entrance; looking south.

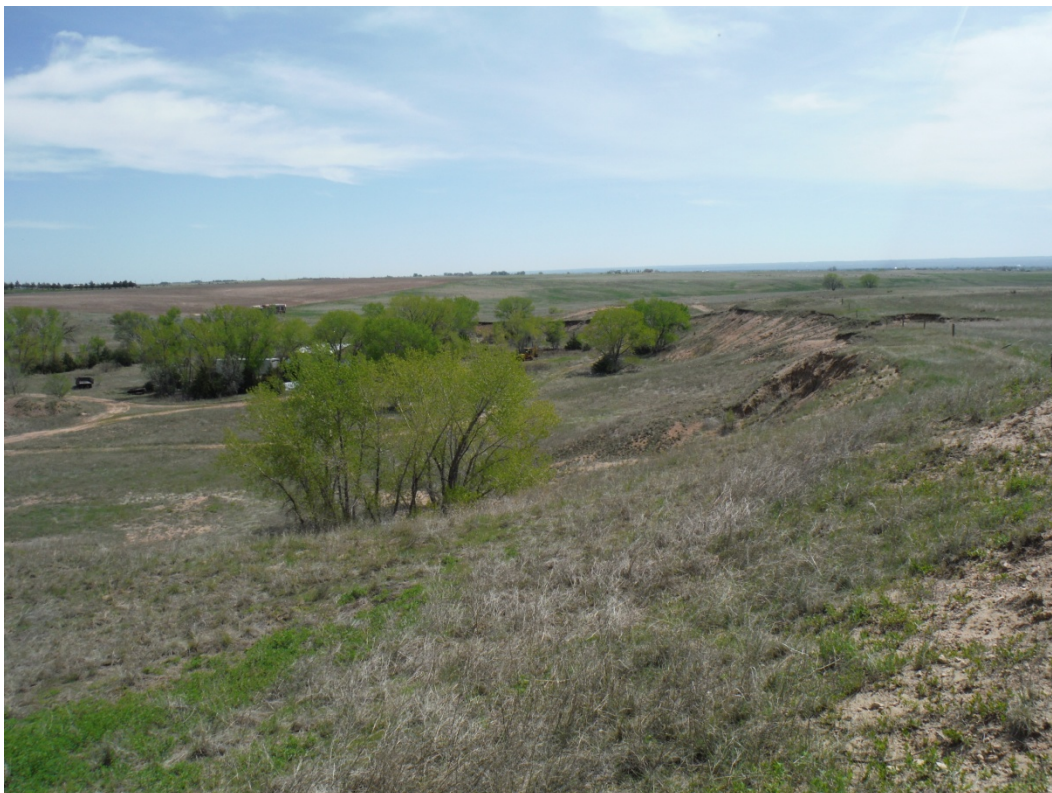
Proposed expansion area in the southeast; looking east.

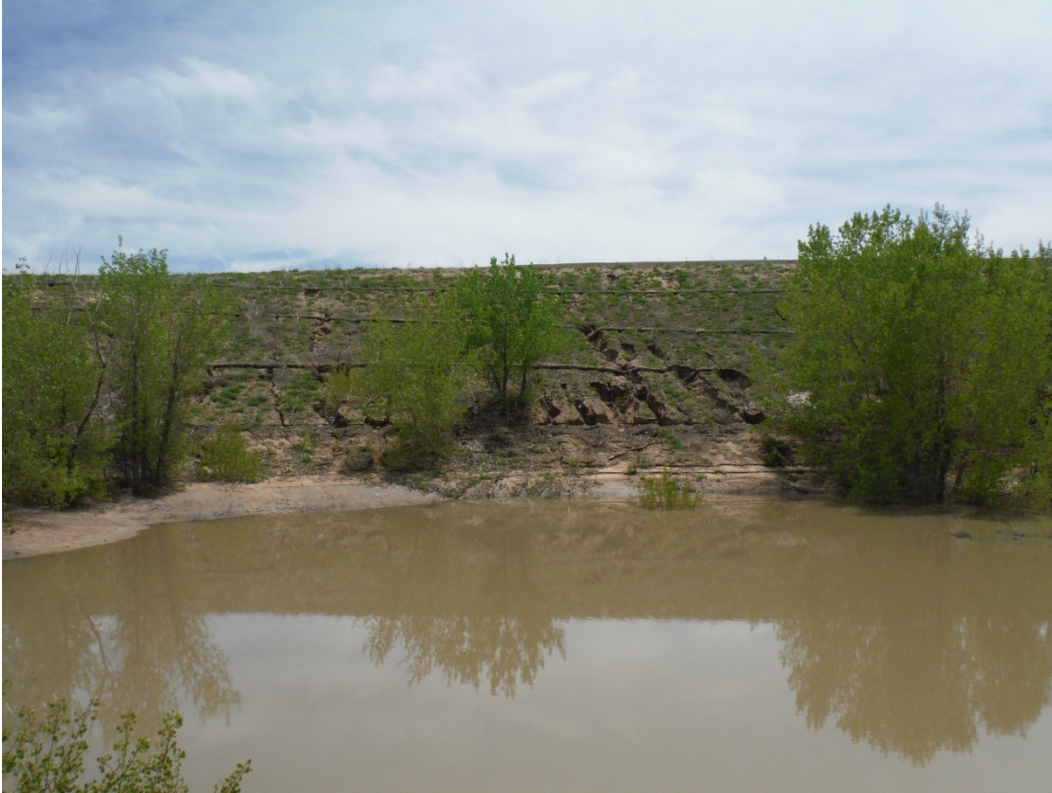
Northwest expansion area, adjacent mine permit's slope with erosion; looking south.

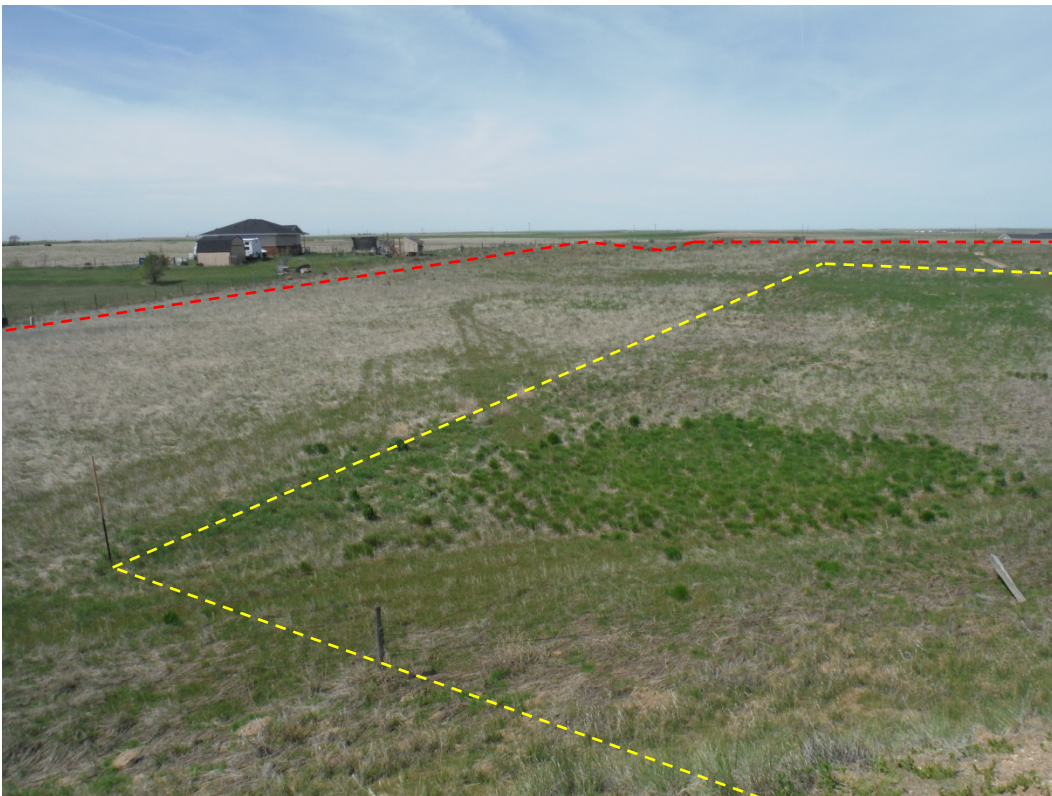
PROBLEM/POSSIBLE VIOLATION: Problem: The proposed affected area boundary markers are missing or incorrectly placed. This is a problem for failure to maintain boundary markers around the affected area as required by Rule 3.1.12(2).

Proposed permit boundary (red), original mining permit area (yellow line), both approximate; looking southwest.

CORRECTIVE ACTIONS: The operator shall conduct a survey and replace the boundary markers in the correct location(s). The operator shall provide coordinates and photographic proof to the Division that this has been done by the corrective action date.

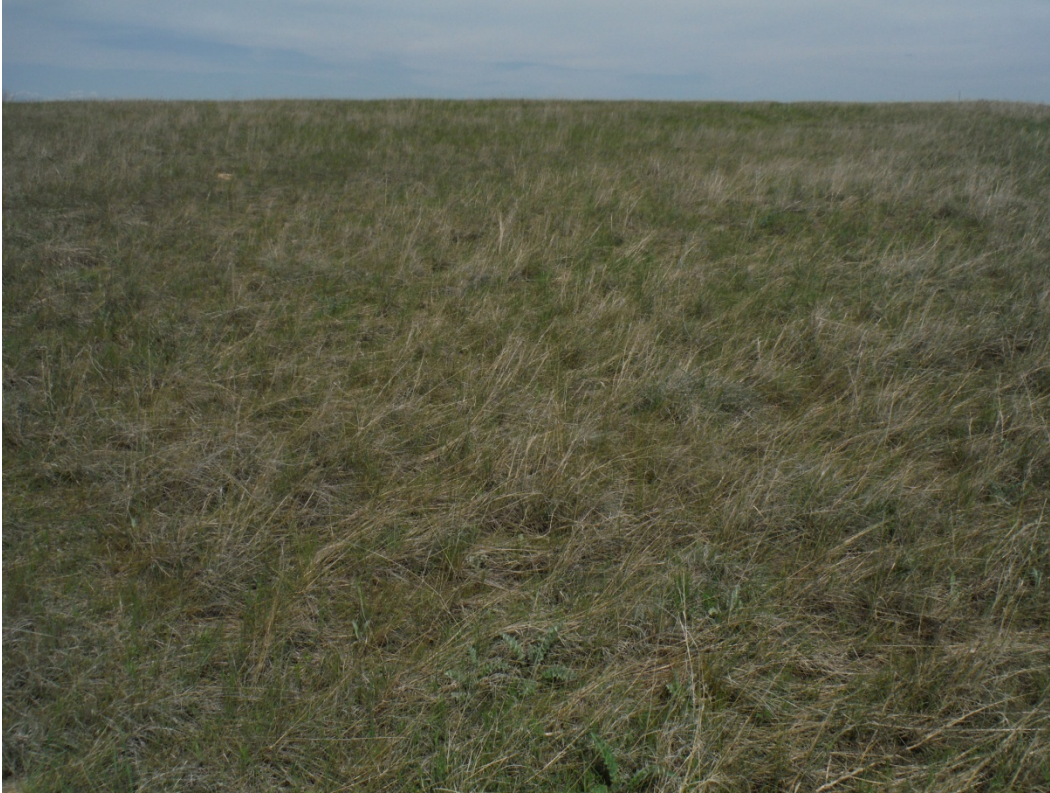
Sample photograph of general rangeland conditions within the proposed conversion area; looking northeast.
