**RE: Nolte Pit #1, Permit No. M-2012-016, Unresolved Problem(s) Noted in a Past Inspection Report**

**COLORADO DIVISION OF RECLAMATION, MINING AND SAFETY**  
**MINERALS PROGRAM INSPECTION REPORT**  
**PHONE: (303) 866-3567**

<b>MINE NAME:</b> Nolte Pit #1	<b>MINE/PROSPECTING ID#:</b> M-2012-016	<b>MINERAL:</b> Borrow material for	<b>COUNTY:</b> Garfield
<b>INSPECTION TYPE:</b> Monitoring	<b>INSPECTOR(S):</b> Stephanie J. Mitchell	<b>INSP. DATE:</b> January 27, 2015	<b>INSP. TIME:</b> 10:00
<b>OPERATOR:</b> Puckett Land Company	<b>OPERATOR REPRESENTATIVE:</b> Chuck Whiteman	<b>TYPE OF OPERATION:</b> 111 - Construction by Government Agency

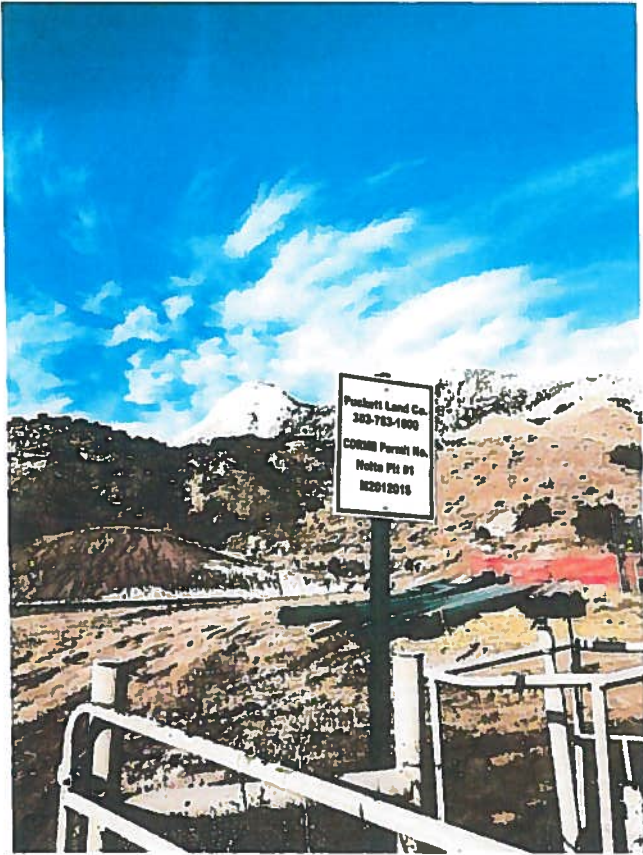
The permit is a 111 and the permit area is permitted for 22.34 acres and is not active at this time. All permit boundary markers were in place at the time of inspection. An adequate mine identification sign was in place.

Mine Identification Sign

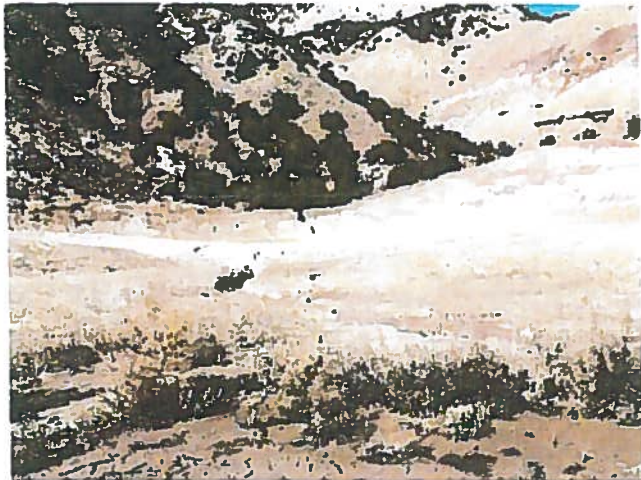
**PROBLEM/POSSIBLE VIOLATION:** Problem: Erosion gullies and ruts were observed on-site. This is a problem at this time for failure to protect the affected land from erosion pursuant to C.R.S. 34-32.5-116 (4) (j).

Follow-up inspection topics included vegetation establishment and weed control, erosion control measures and final grading. The rills and gullies observed in December 2012 are still evident. It does not appear that the Operator has conducted any maintenance on the site since it was last inspected by the Division. Weeds are still on site, but in less quantity than noted in December 2012. On the north side of the permit area, there are two rip rapped drainage channels that need maintenance. They both are not conveying water and sediment as engineered. There are rills and gullies forming on the outsides of the channels. This is noted as a problem at the beginning of the inspection report. The two ponds that retain water for over 72 hours are required to have a permit through the Colorado Division of Water Resources. The Division's records show that we do not have a copy of the permit or the Stormwater Management Plan. This is noted as a problem at the beginning of the inspection report and will need to be submitted by April 1, 2015. Final grading has not been conducted and has been noted as a problem as well at the beginning of the inspection report. More grading is necessary to complete the final grade of 3:1 slopes as submitted in the reclamation plan.

Rilling within the permit boundary- North area of permit boundary

**CORRECTIVE ACTIONS:** The operator shall provide photo documentation to the Division verifying erosion gullies and ruts have been repaired, and that the site has have been reconstructed and stabilized to prevent erosion damage by the corrective action date.

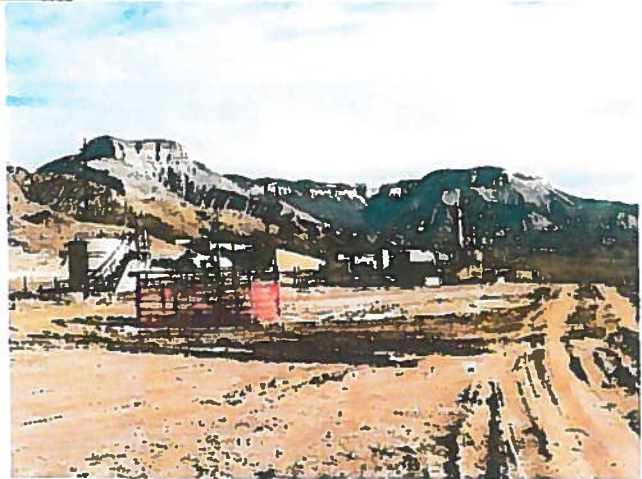
There is a lot of oil and gas activity on the site, including a gas line that is currently being installed through the permit area. The Operator mentioned that they may want to change the post mining land use to commercial land use. According to RULE 1.10.2, no amendments are allowed by State Statute. An Operator may only make changes defined under Rule 1.1(49). The result is that the Operator must submit a new permit as a 112(c) application. The fee associated with the new permit application is \$2,696.00. Much of the permit application exhibits can be used from the original 111 permit application, but re-submitted in the new application package. The Division would like to see a 112c Permit Application submitted by Puckett Land Company when all future land use is finalized with the entities involved. The present post mining land use submitted in the original 111 application is Rangeland. With all of the current oil and gas activity and the proposed use of a commercial site, the post mining land use shall be changed to Industrial/Commercial (IC) in the 112 c permit application.

Oil and Gas Activity

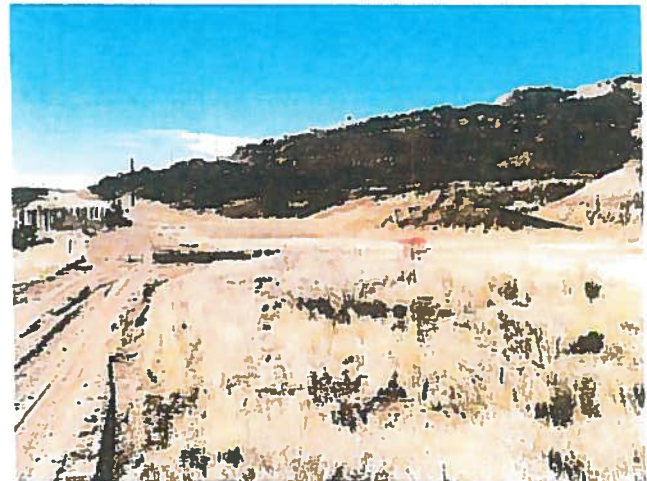
Looking West- Gas Line will be installed under road

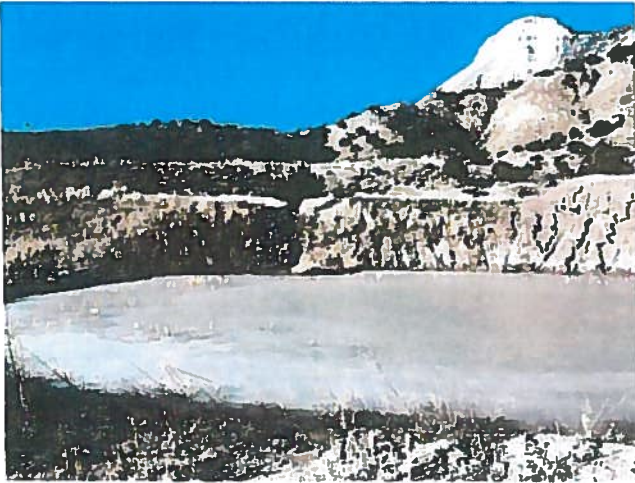
Pond in western part of permit area

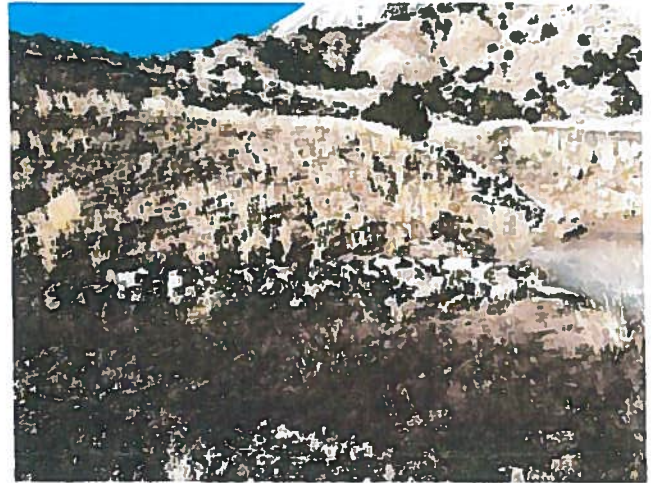
2 Channels needed maintenance

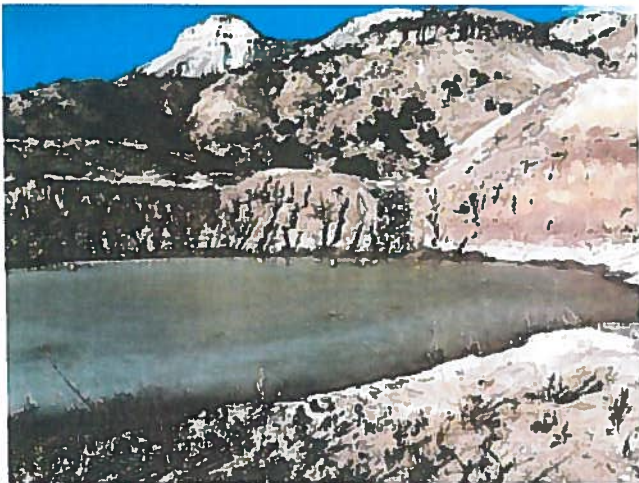
Rilling and Gullies forming

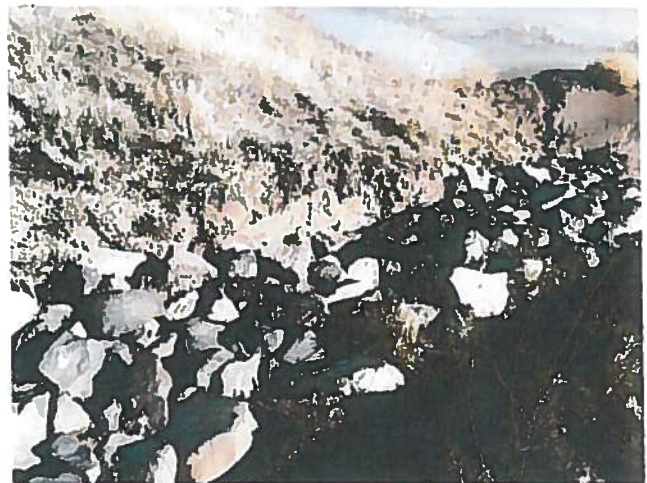
Rip Rapped Channels that need maintenance
