**COLORADO DIVISION OF RECLAMATION, MINING AND SAFETY**  
**MINERALS PROGRAM INSPECTION REPORT**  
**PHONE: (303) 866-3567**

<b>MINE NAME:</b> West Rifle Pit	<b>MINE/PROSPECTING ID#:</b> M-1981-006	<b>MINERAL:</b> Sand and gravel	<b>COUNTY:</b> Garfield
<b>INSPECTION TYPE:</b> Surety Release Inspection	<b>INSPECTOR(S):</b> Amy C. Yeldell	<b>INSP. DATE:</b> June 22, 2015	<b>INSP. TIME:</b> 08:00
<b>OPERATOR:</b> Central Aggregates, Inc.	<b>OPERATOR REPRESENTATIVE:</b> Gilbert Lee	<b>TYPE OF OPERATION:</b> 112c - Construction Regular Operation

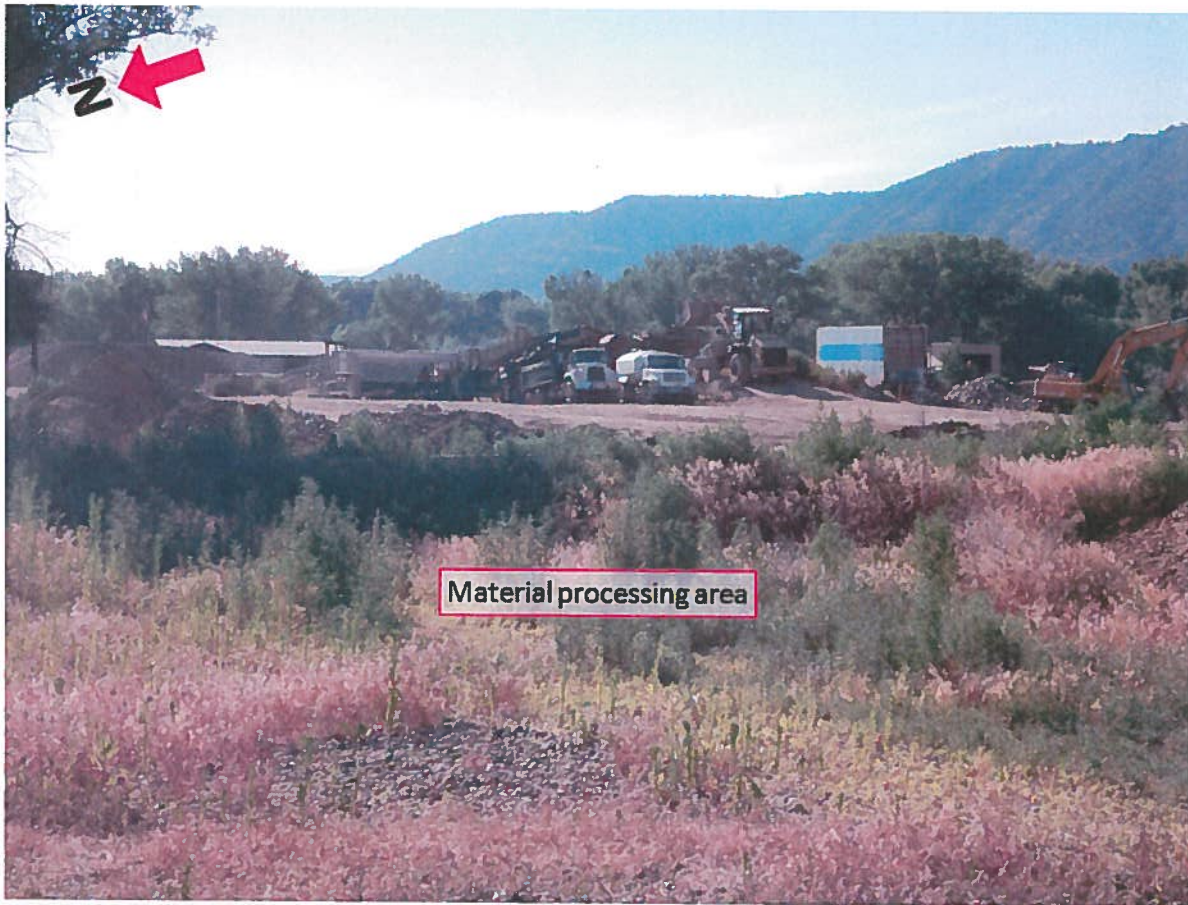
Material processing area

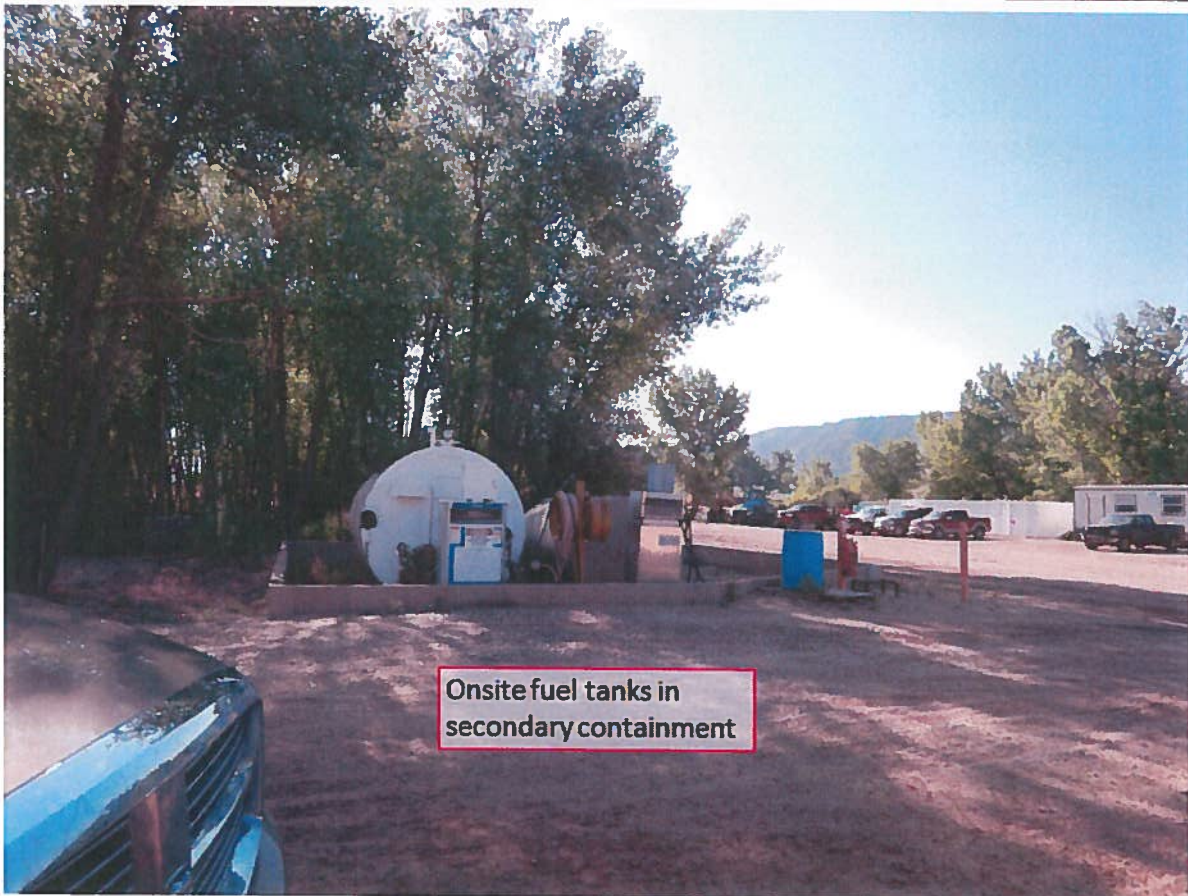
Onsite fuel tanks in  
secondary containment
