COLORADO DIVISION OF RECLAMATION, MINING AND SAFETY
MINERALS PROGRAM INSPECTION REPORT
PHONE: (303) 866-3567

MINE NAME: Dick Casey Concrete Pit	MINE/PROSPECTING ID#: M-1978-349	MINERAL: Sand and gravel	COUNTY: Garfield
INSPECTION TYPE: Monitoring	INSPECTOR(S): Stephanie J. Mitchell	INSP. DATE: March 4, 2015	INSP. TIME: 11:30
OPERATOR: Oldcastle SW Group, Inc. dba United Compas County	OPERATOR REPRESENTATIVE: Jason Burkey	TYPE OF OPERATION: 112c - Construction Regular Operation

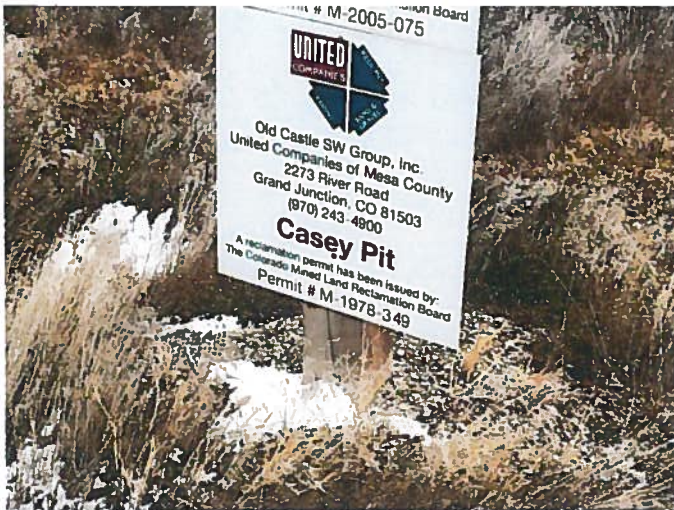
Adequate mine identification signage was noted at the entrance to the site.

Mine Identification Sign

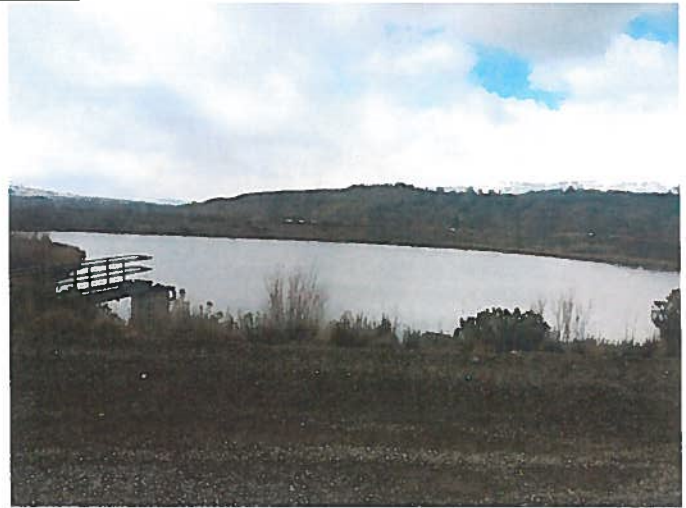
Fuel containers observed on site were stored in adequate secondary containment structures. The pit slopes appeared to be left at approximately 3H:1V around the pond.

Pond with 3:1 Slopes

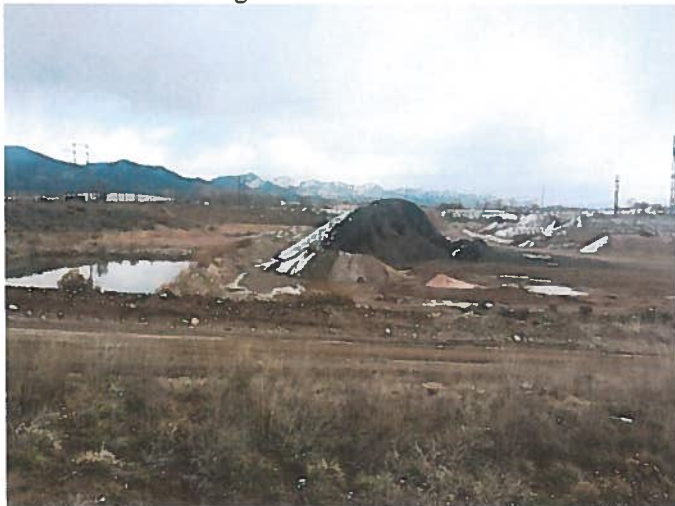
Material Stockpiles

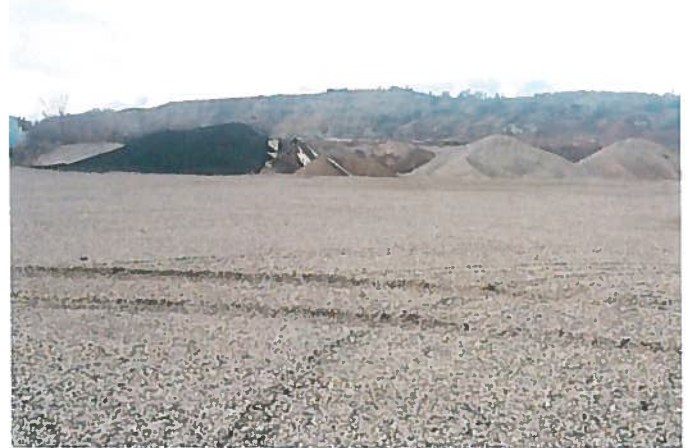
Material Stockpiles

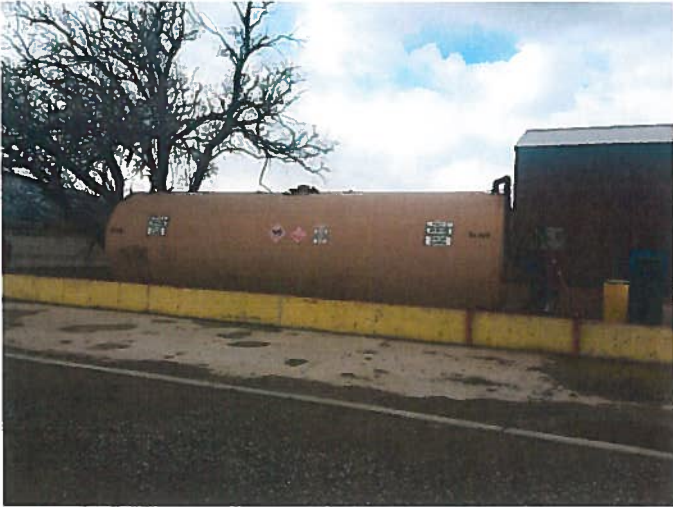
Fuel Storage
