COLORADO DIVISION OF RECLAMATION, MINING AND SAFETY
MINERALS PROGRAM INSPECTION REPORT
PHONE: (303) 866-3567

| MINE NAME: Sievers Pit | MINE/PROSPECTING ID#: M-1977-098 | MINERAL: Sand and gravel | COUNTY: Garfield |
| INSPECTION TYPE: Monitoring | INSPECTOR(S): Stephanie J. Mitchell | INSP. DATE: March 11, 2015 | INSP. TIME: 10:00 |

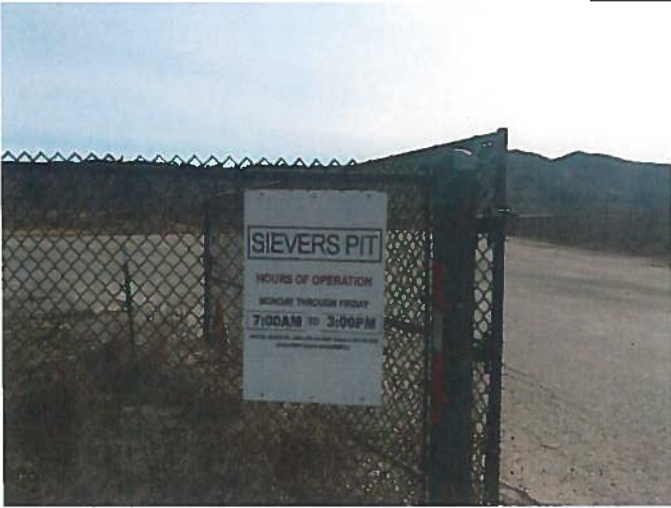
Adequate mine identification signage was noted at the entrance to the site. The affected area was adequately marked with fencing. The Southeast permit boundary was protected by a berm.

Mine Identification Sign

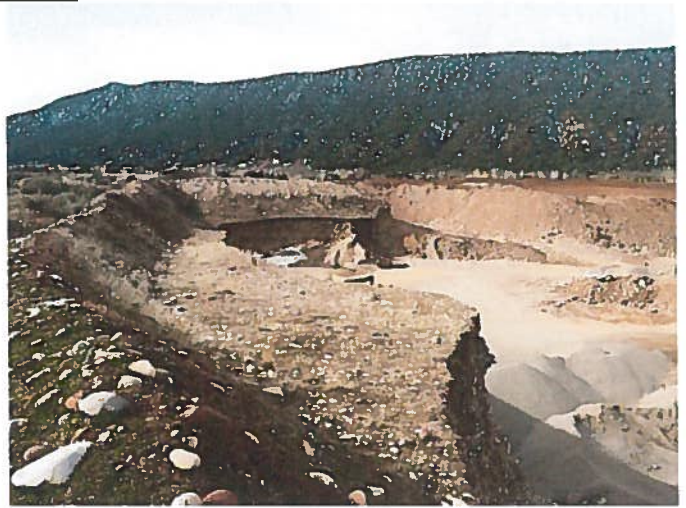
Slopes along the west, north and east pit perimeter had been graded to 3H:1V or less and vegetated. The active highwall, approximately 20 feet high or less, was located at the south side of the pit. There was a water storage tank for dust suppression.

Highwall

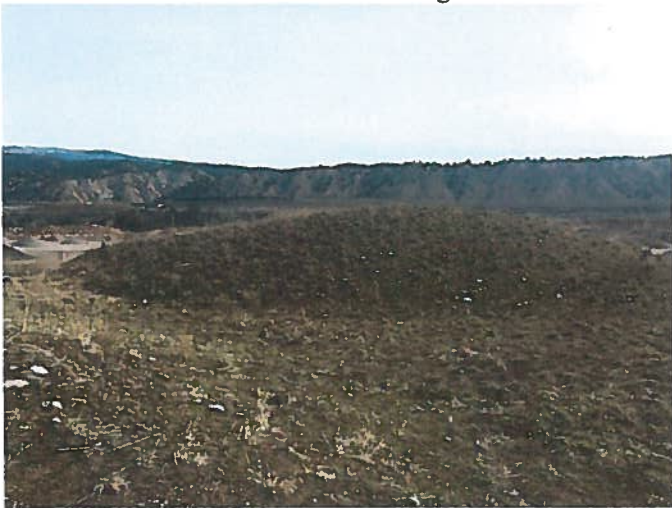
Topsoil stockpiles are protected with adequate vegetation. Fuel containers observed on site were stored in adequate secondary containment structures.

Topsoil stockpile well vegetated

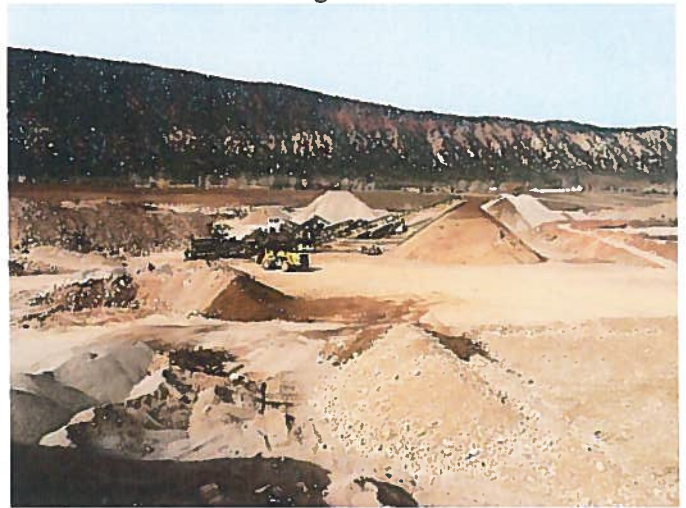
Portable Crusher

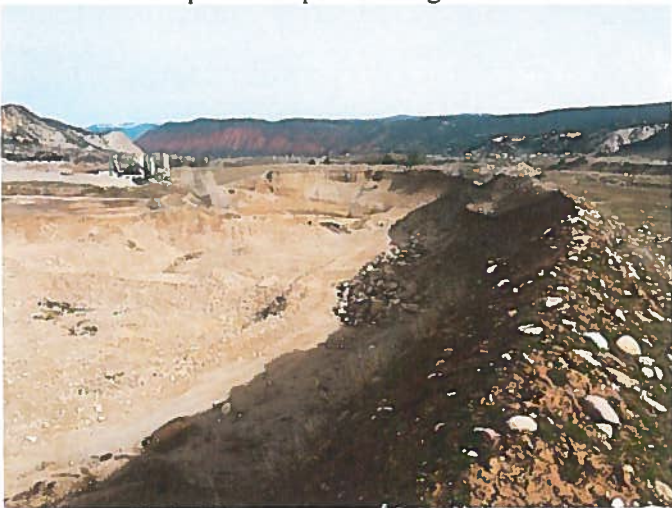
Southeast perimeter protected by berm

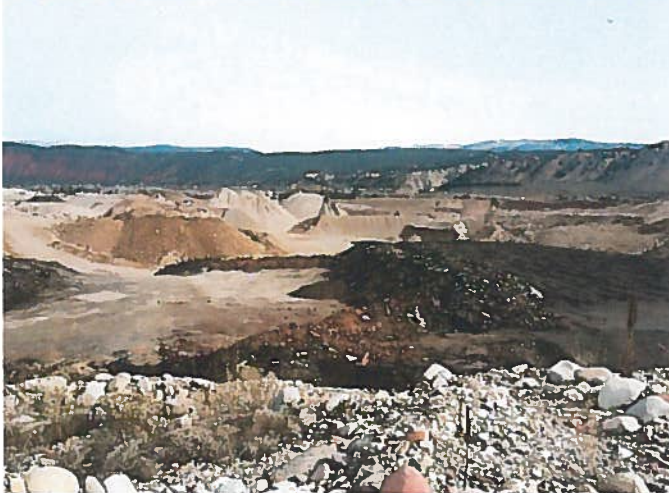
Material Stockpiles

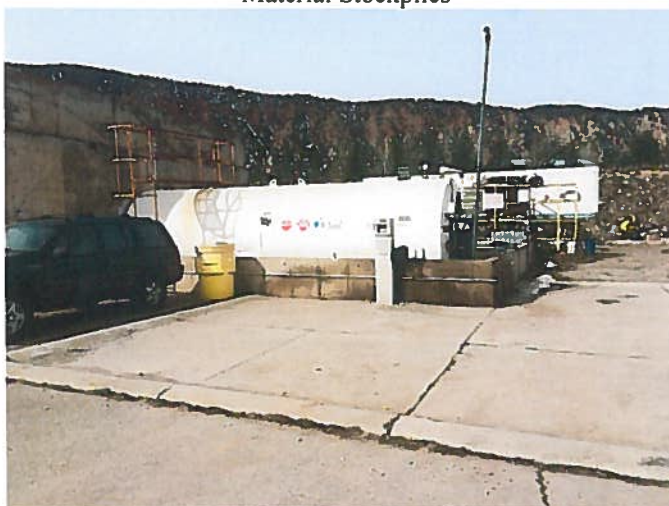
Fuel Storage
