COLORADO DIVISION OF RECLAMATION, MINING AND SAFETY
MINERALS PROGRAM INSPECTION REPORT
PHONE: (303) 866-3567

MINE NAME: Chambers Pit	MINE/PROSPECTING ID#: M-1979-205	MINERAL: Sand and gravel	COUNTY: Garfield
INSPECTION TYPE: Monitoring	INSPECTOR(S): Stephanie J. Mitchell	INSP. DATE: March 11, 2015	INSP. TIME: 12:00
OPERATOR: Oldcastle SW Group, Inc. dba United Compas County	OPERATOR REPRESENTATIVE: Jason Burkey	TYPE OF OPERATION: 112c - Construction Regular Operation

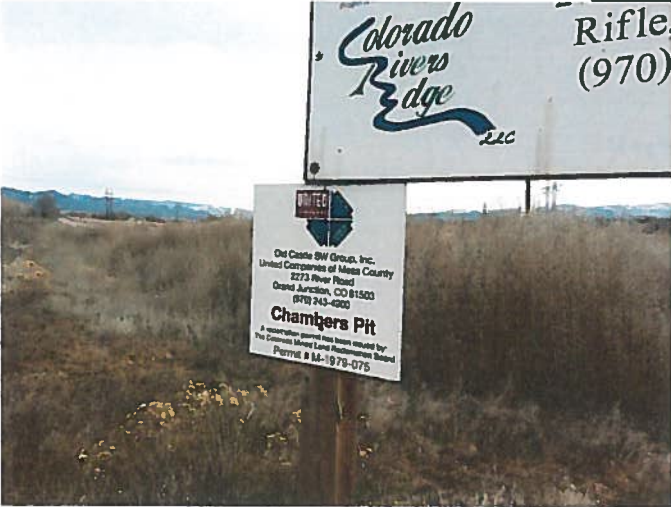
Mine ID Sign

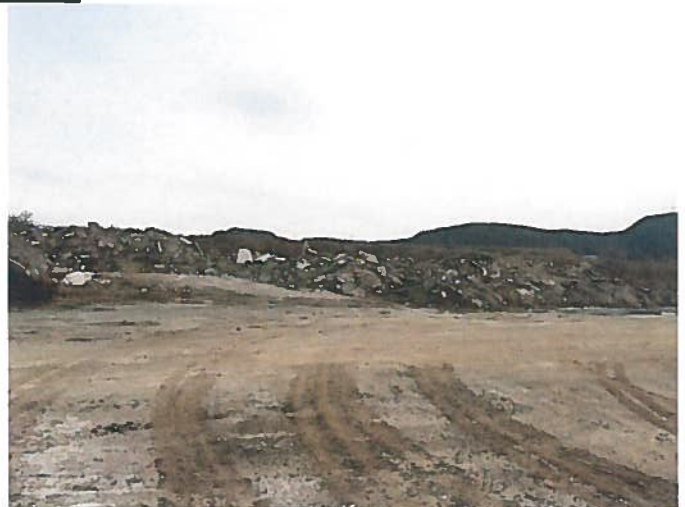
Recycled Material Area

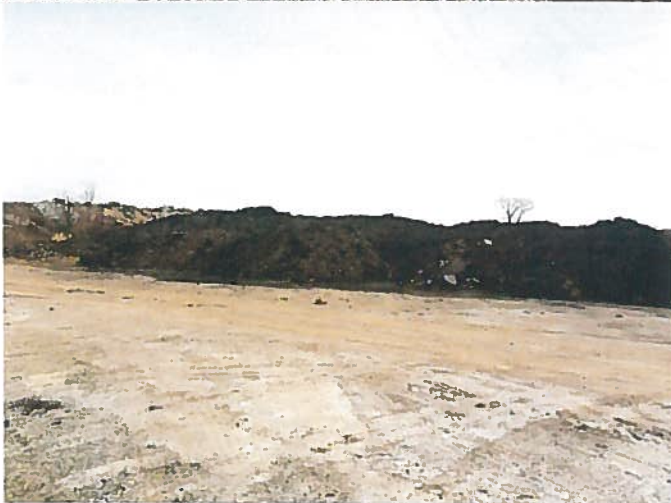
Recycled Asphalt

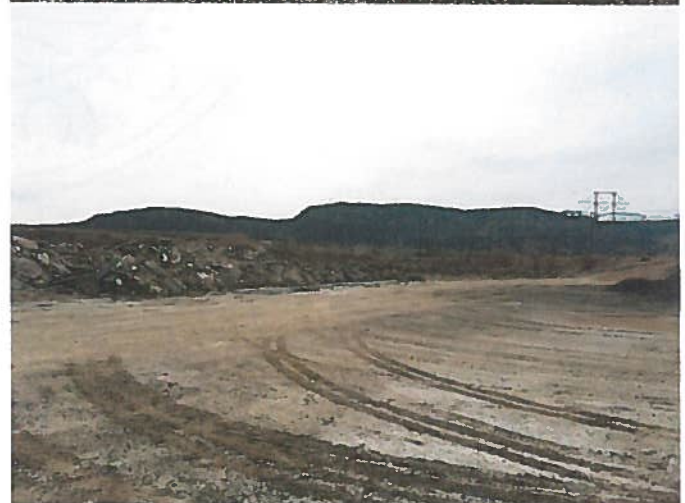
Recycled Concrete

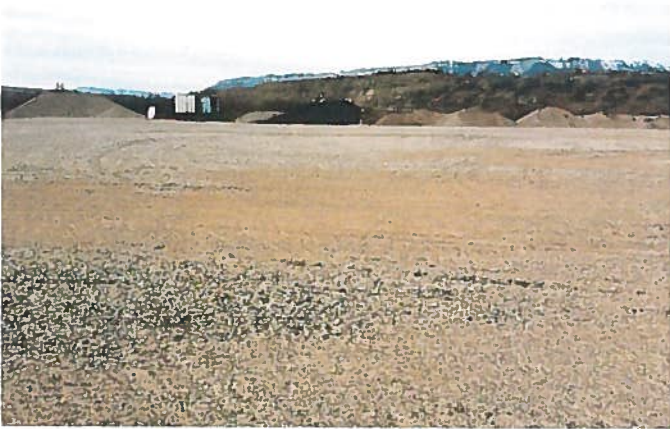
The majority of the resource has been removed from this site, and the site is primarily used for stockpile and storage of material from the Glen Pit and Dick Casey pit.

Material Stockpiles

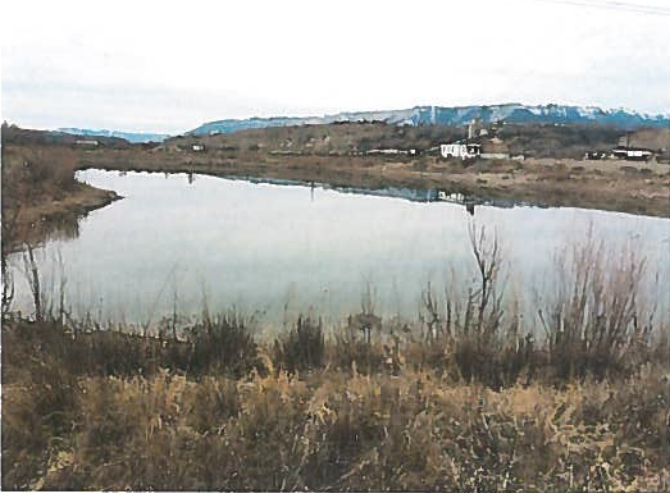
The pond located in the southern portion of the permit area has largely been reclaimed. The slopes have been graded to 3H:1V or less, with vegetation becoming well established along the pond banks. Tamarisk was observed in the reclaimed pond area, although some shoots were noted in the main unreclaimed pit area. These should be treated as soon as possible in order to prevent further infestation.

Tamarisk on shore of pond
