**COLORADO DIVISION OF RECLAMATION, MINING AND SAFETY**  
**MINERALS PROGRAM INSPECTION REPORT**  
**PHONE: (303) 866-3567**

<b>MINE NAME:</b> Walsh Pit No. 2	<b>MINE/PROSPECTING ID#:</b> M-1977-479	<b>MINERAL:</b> Sand and gravel	<b>COUNTY:</b> Baca
<b>INSPECTION TYPE:</b> Monitoring	<b>INSPECTOR(S):</b> Amy Eschberger	<b>INSP. DATE:</b> November 20, 2014	<b>INSP. TIME:</b> 08:00
<b>OPERATOR:</b> Baca County	<b>OPERATOR REPRESENTATIVE:</b> Jason Freiburger and Race Chenoweth	<b>TYPE OF OPERATION:</b> 112c - Construction Regular Operation

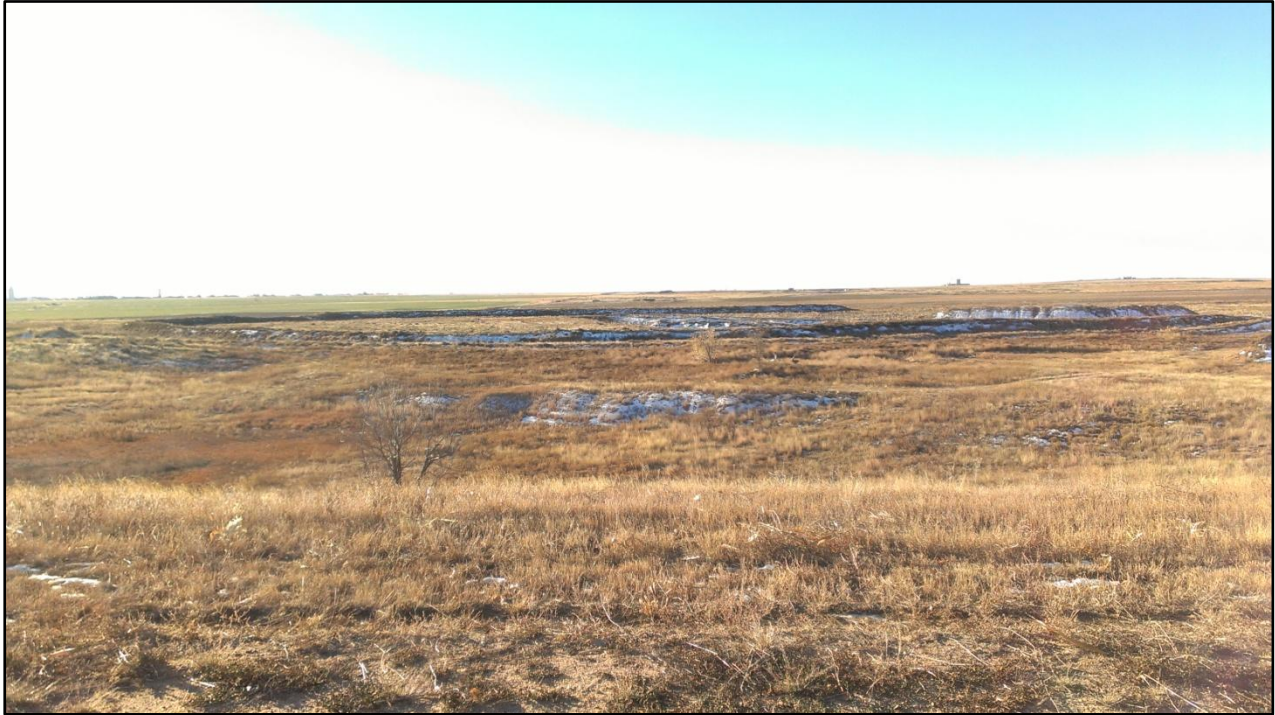
This is a 112c operation permitted for 80 acres to mine sand and gravel for use in county road maintenance. The maximum mining depth is approximately 35-40 feet. The maximum allowed disturbance at any time is the entire permitted area of 80 acres (as of TR-02 approved on 01/21/2011). The operation maintains approximate 3H:1V slopes as material is extracted. This operation began mining in the northwestern portion of the site (north of Bear Creek), and continued in the southwestern portion of the site (south of Bear Creek). Mining continues eastward as the western portions are reclaimed. The site includes several areas of pre-law disturbance which have been reclaimed to varying degrees (mainly the northeastern, southwestern, and far northwestern portions of the permit area). Much of the pre-law disturbance was backfilled to roughly 3H:1V slopes and may have been seeded. Native grasses, some forbs, shrubs, and perennial weeds are now establishing across much of these areas (**Photo 1**). This operation may later redisturb the northeastern reclaimed area.

**Photo 1.** View looking south from Co Rd Ff, showing reclaimed northeastern portion of permit area.

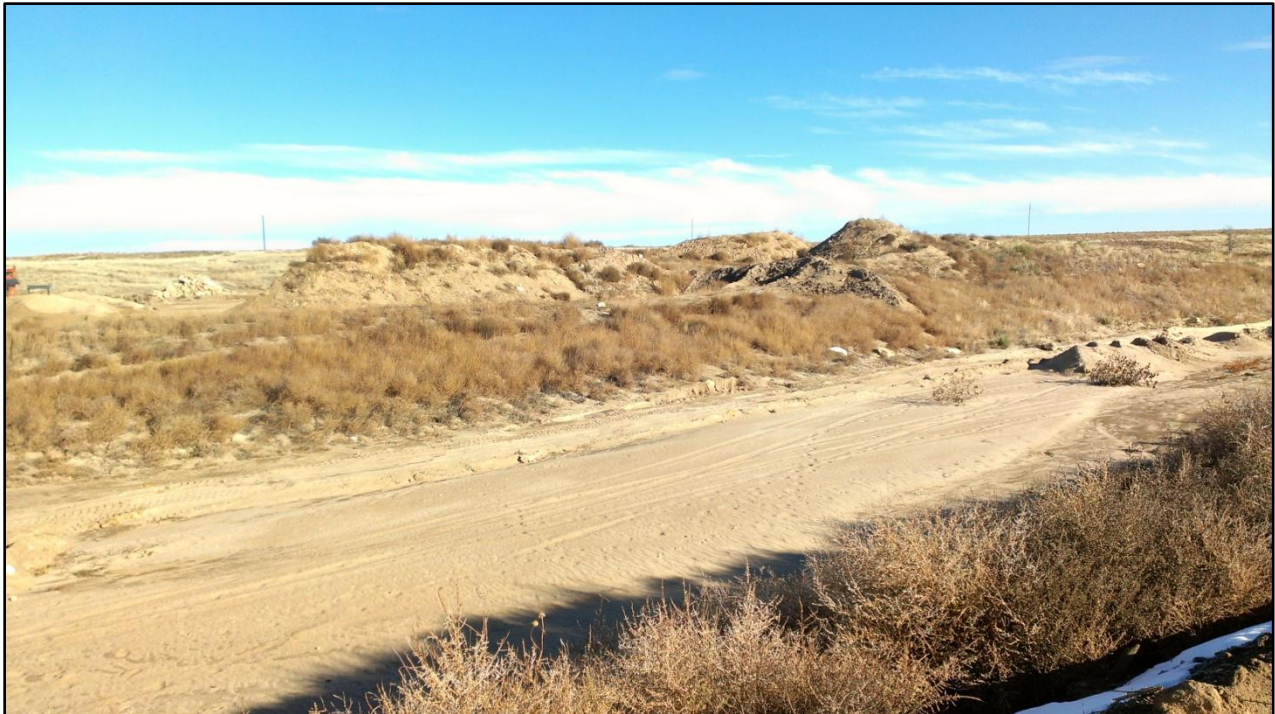
At the time of the inspection, the weather was clear, cool and sunny, and the ground was dry. No water was observed in Bear Creek or Dry Creek (**Photos 2 and 3**). A permit identification sign was posted at the eastern site entrance off of Co Rd Ff (**Photo 4**). This sign includes the permit number and operator name; however, pursuant to Rule 3.1.12(1), it should also include a statement that the permit was issued by the Colorado Mined Land Reclamation Board (MLRB). Because the sign has weathered making it hard to read, the Division recommends the operator replace this sign, making sure to include the required information listed above. The permit boundary was delineated by Co Rd Ff to the north, a pre-existing dirt road to the east (used for mine access), and metal posts for the southern and western corners. The mine was not active during the inspection; however, screening equipment and a few small trucks were stored in the processing area located north of Bear Creek (**Photo 5**). The county has been processing and hauling off from stockpiled material every year, which is in compliance with its intermittent status.

**Photo 2.** View looking northeast at Bear Creek, which was dry during the inspection.

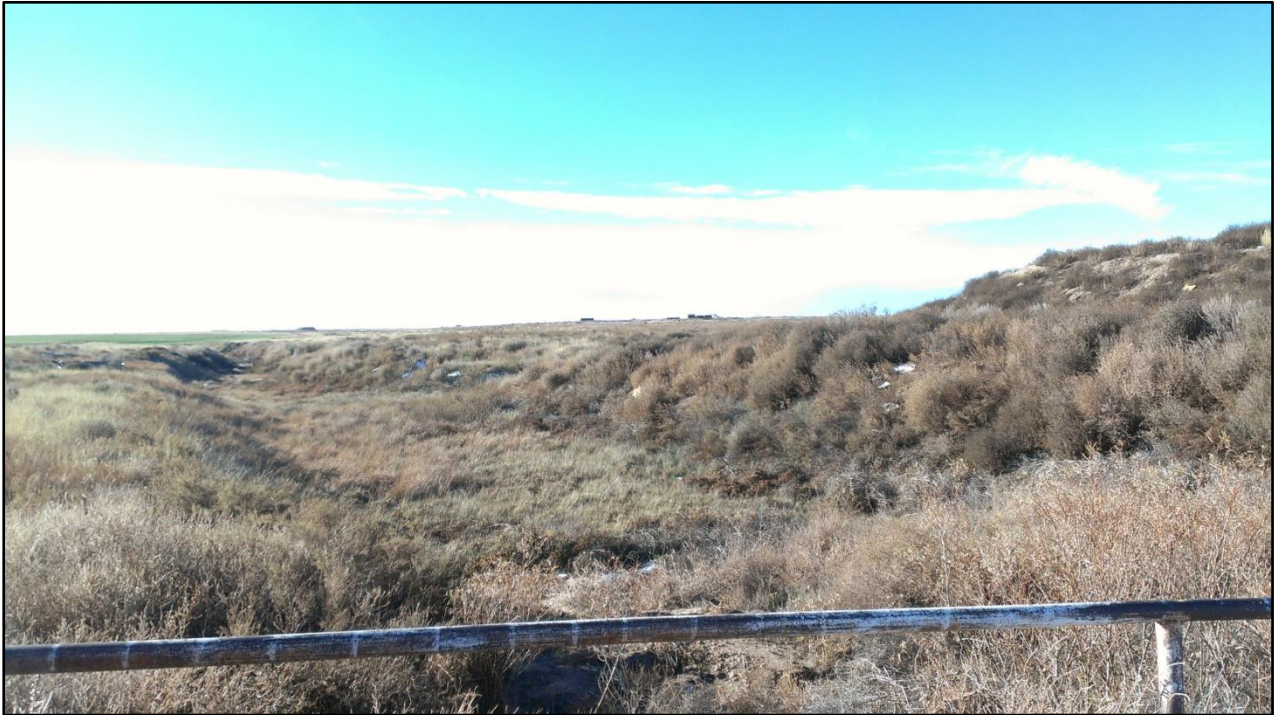
**Photo 3.** View looking south at Dry Creek, which was dry during the inspection.

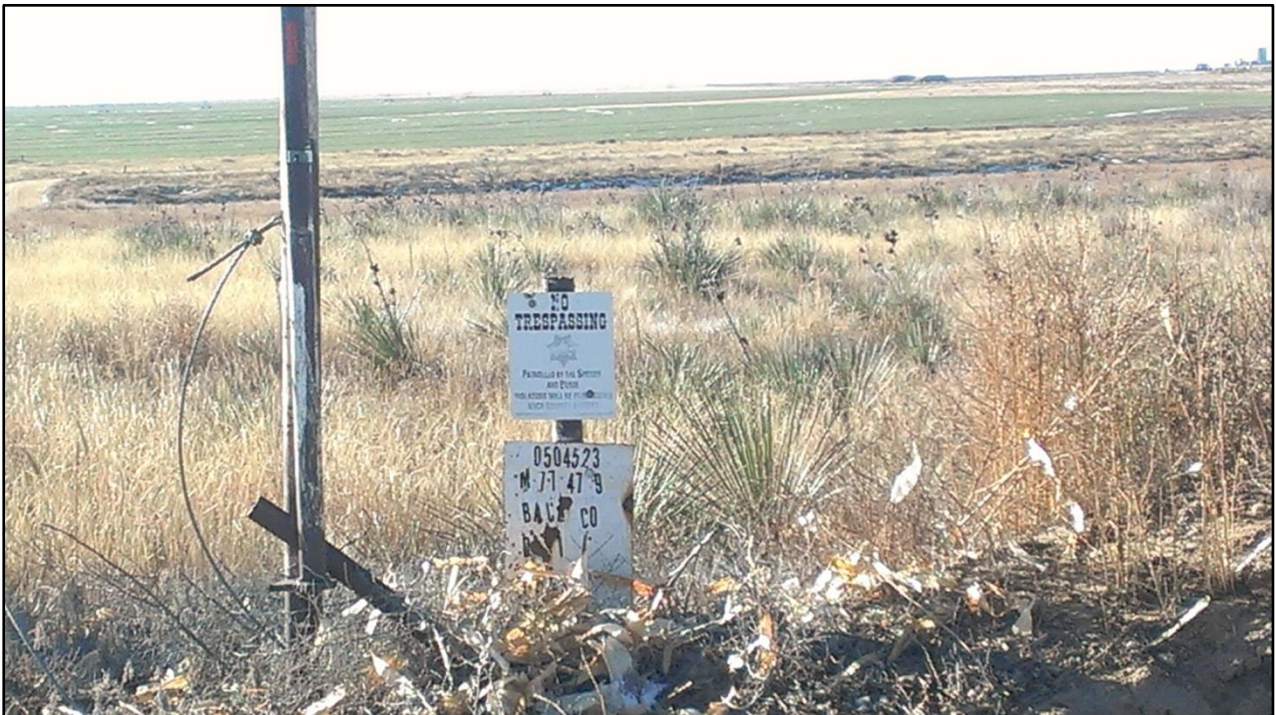
**Photo 4.** View of permit sign posted at northeastern entrance to site off of Co Rd Ff. This sign is hard to read and should be replaced, including the permit number, operator name, and a statement that the permit was issued by the CO MLRB.

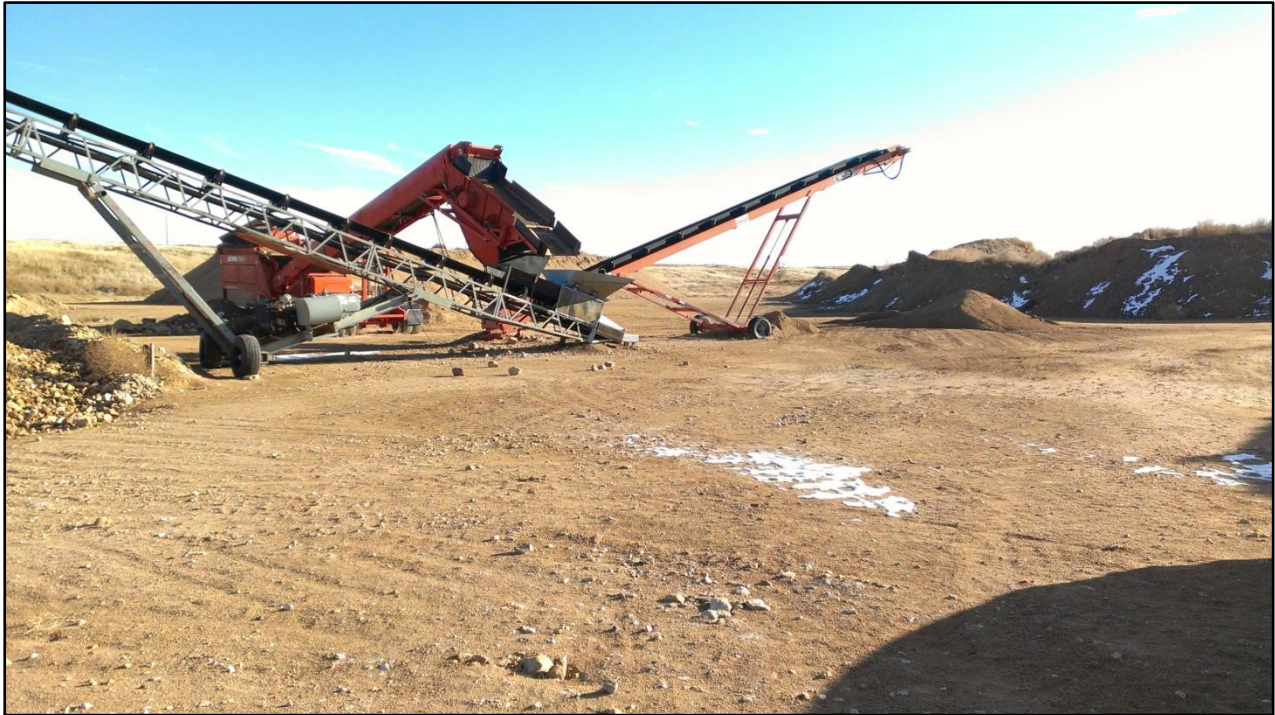
**Photo 5.** View of processing area located north of Bear Creek in northwestern portion of site.

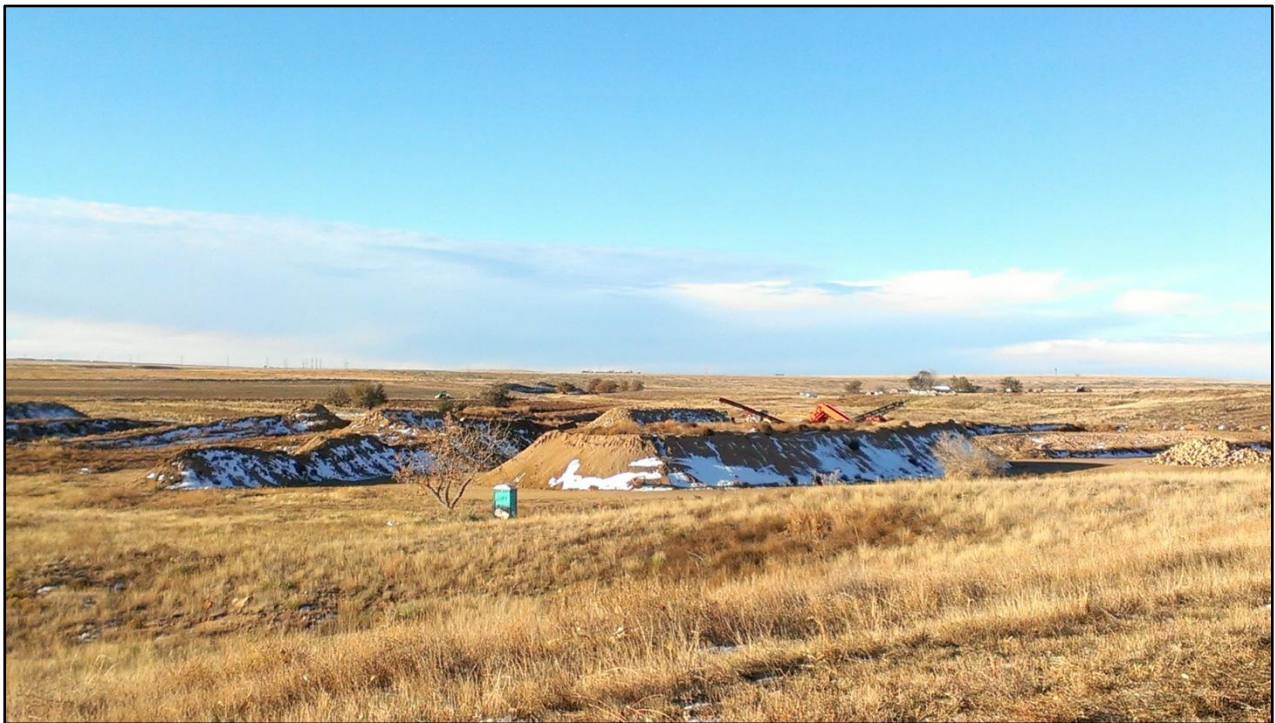
**Photo 6.** View looking southwest from Co Rd Ff, showing northwestern portion of permit area where material is processed and stockpiled.

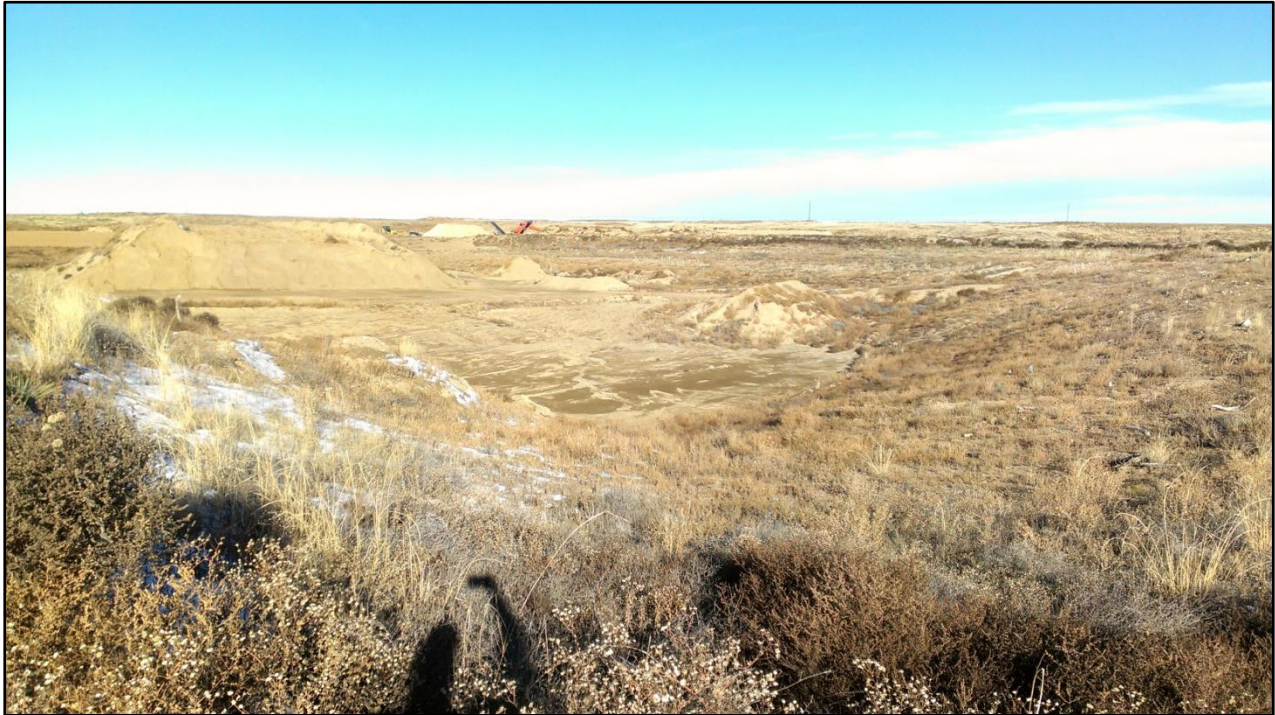
**Photo 7.** View looking northwest from southeastern edge of disturbance, showing stockpiling and mining area located south of Bear Creek. Note large sand stockpile in background (at left).

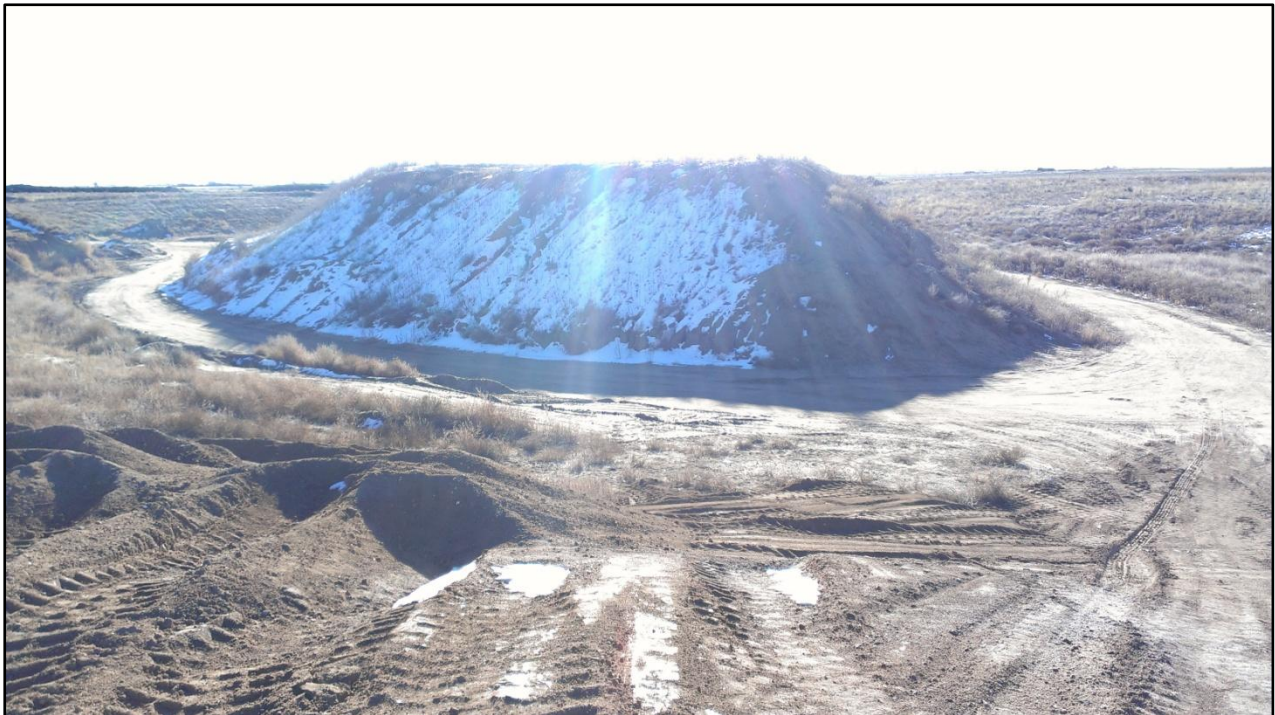
**Photo 8.** View looking south, showing large sand stockpile stored south of Bear Creek.

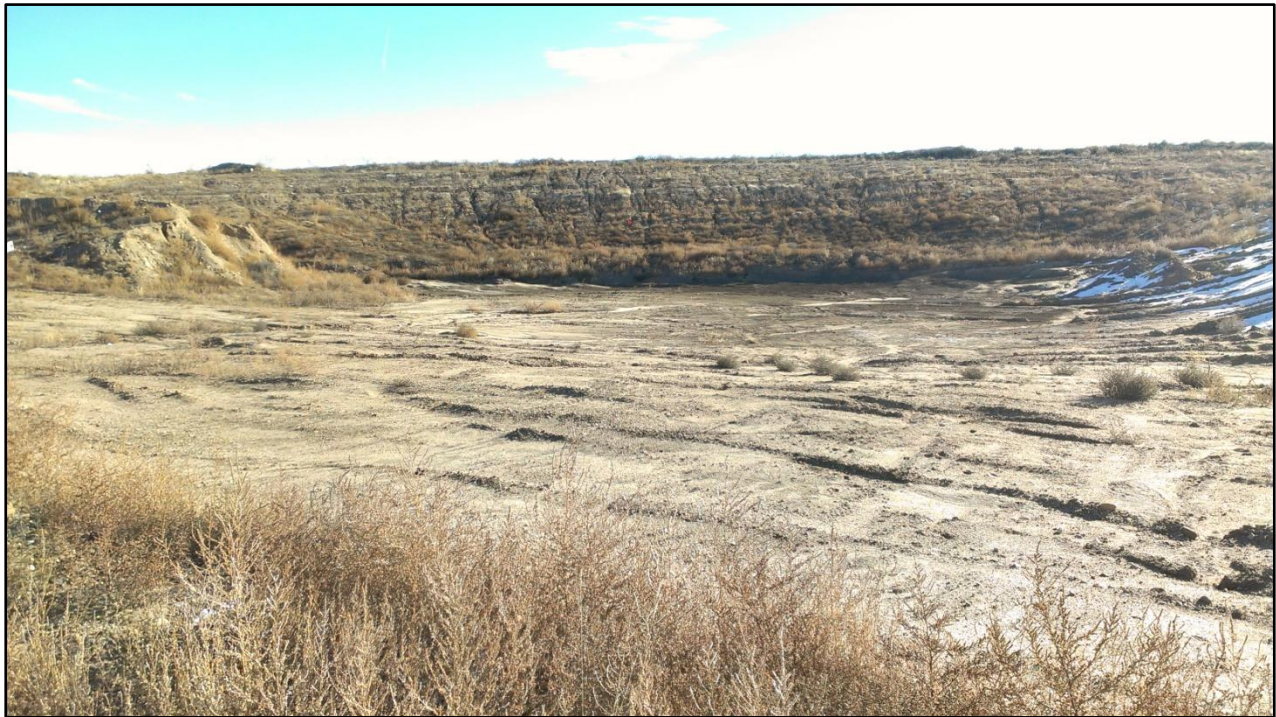
**Photo 9.** View looking east, showing area of most recent mining located south of Bear Creek. Note highwall approximately 10-15 feet in height with 3H:1V slopes and some vegetative cover.

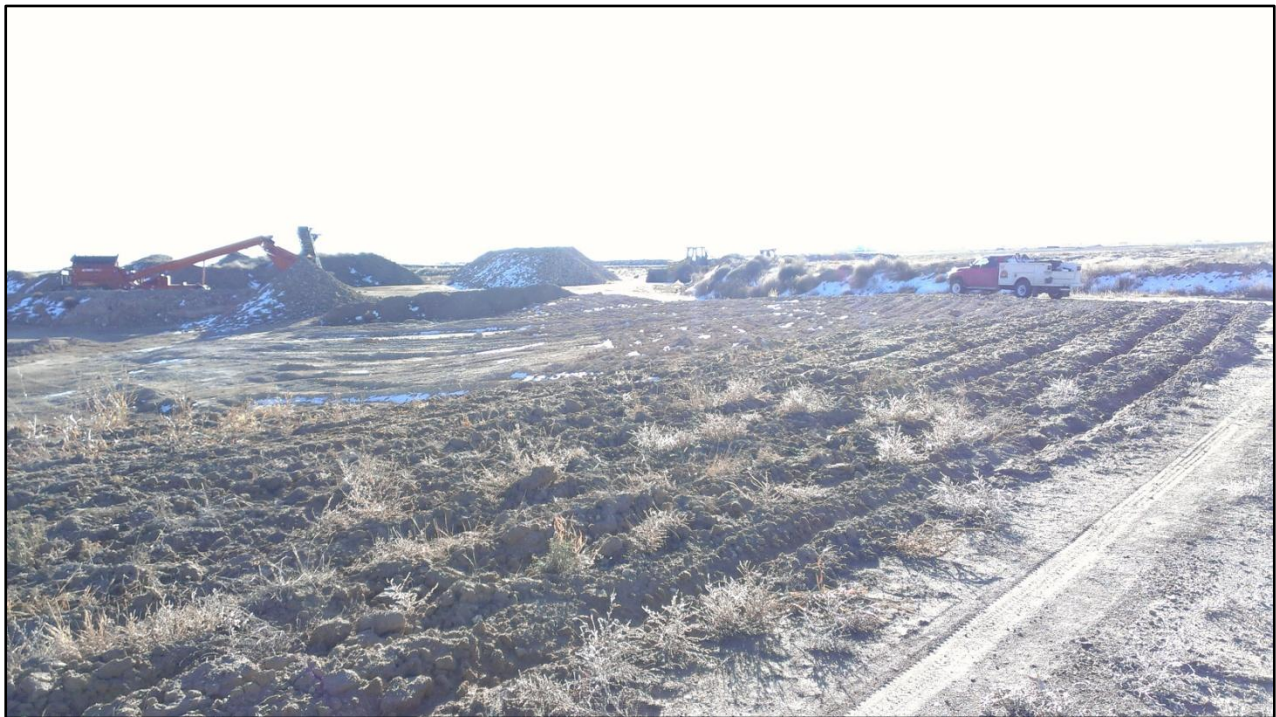
**Photo 10.** View looking southeast across northwestern portion of permit area (near main entrance) that is in reclamation.

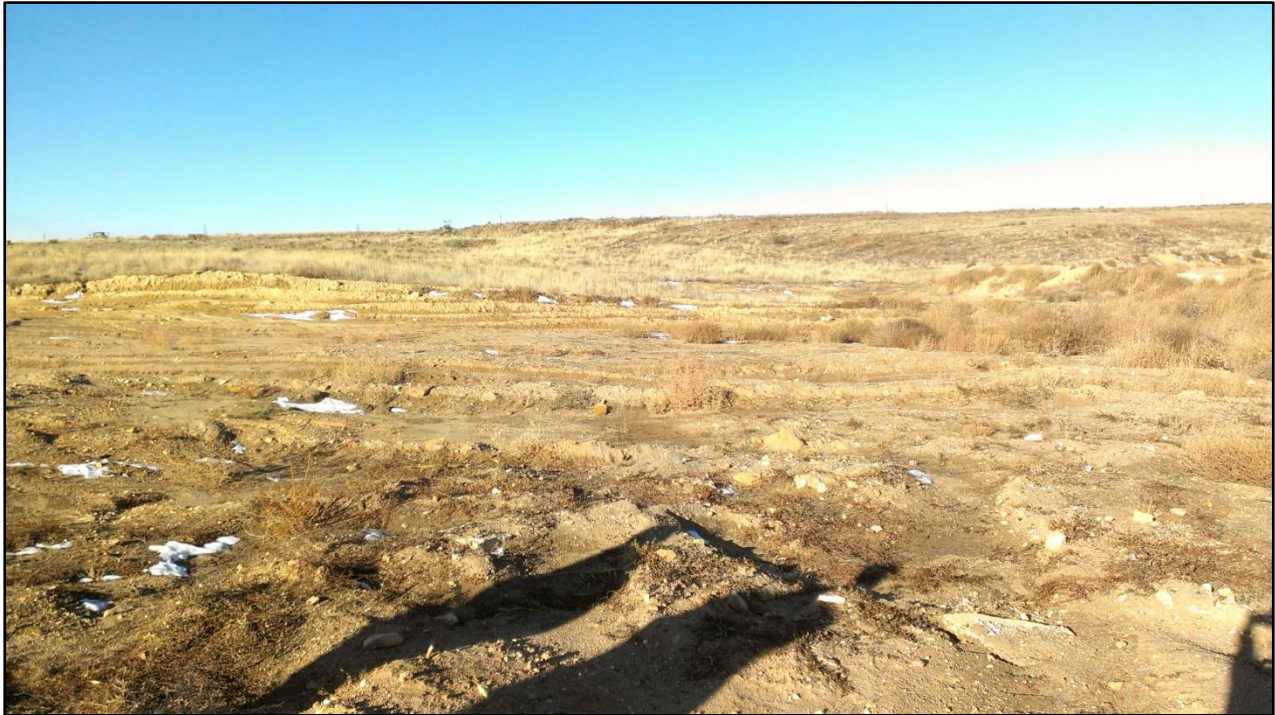
**Photo 11.** View looking southwest across northwestern portion of permit area (near Bear Creek) that is in reclamation.

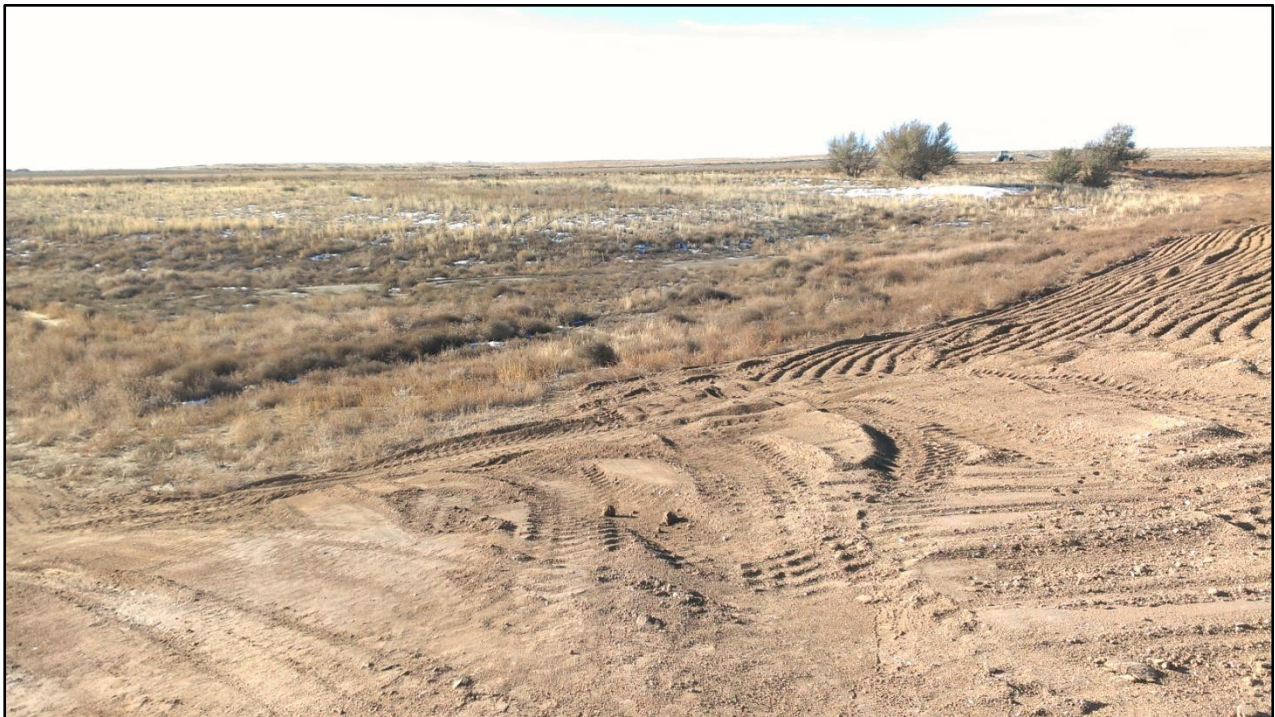
**Photo 12.** View looking southwest across southwestern portion of permit area that is in reclamation.

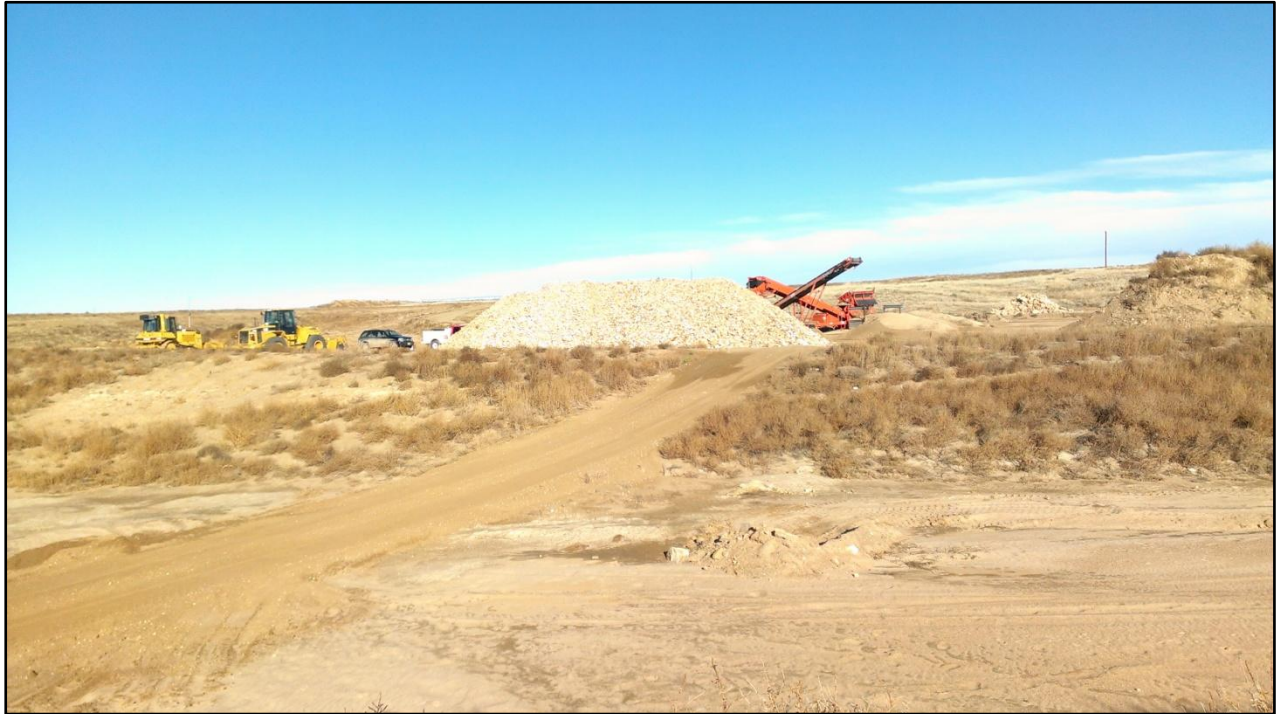
Mine staff maintain a dirt haul road that crosses Bear Creek to connect the northern portion of the permit area to the southern portion (**Photo 13**). The creek washed into the southwestern portion of the site during a major storm event many years ago. Because of this, the operator constructed earthen berms adjacent to the creek banks

to keep the creek from flooding the pit again. These berms are approximately 10-20 feet in height, and are regularly maintained by the county. According to Mr. Freiburger and Mr. Chenoweth, the berms were almost breached again during storm events in spring of 2014, and they had to be raised another 2-3 feet. The Division recommends the operator continue to monitor the stability and effectiveness of these berms, and work to minimize any disturbance of the creek bottom.

**Photo 13.** View looking northwest from south bank of Bear Creek, showing haul road constructed across creek bed to access southern portion of site.

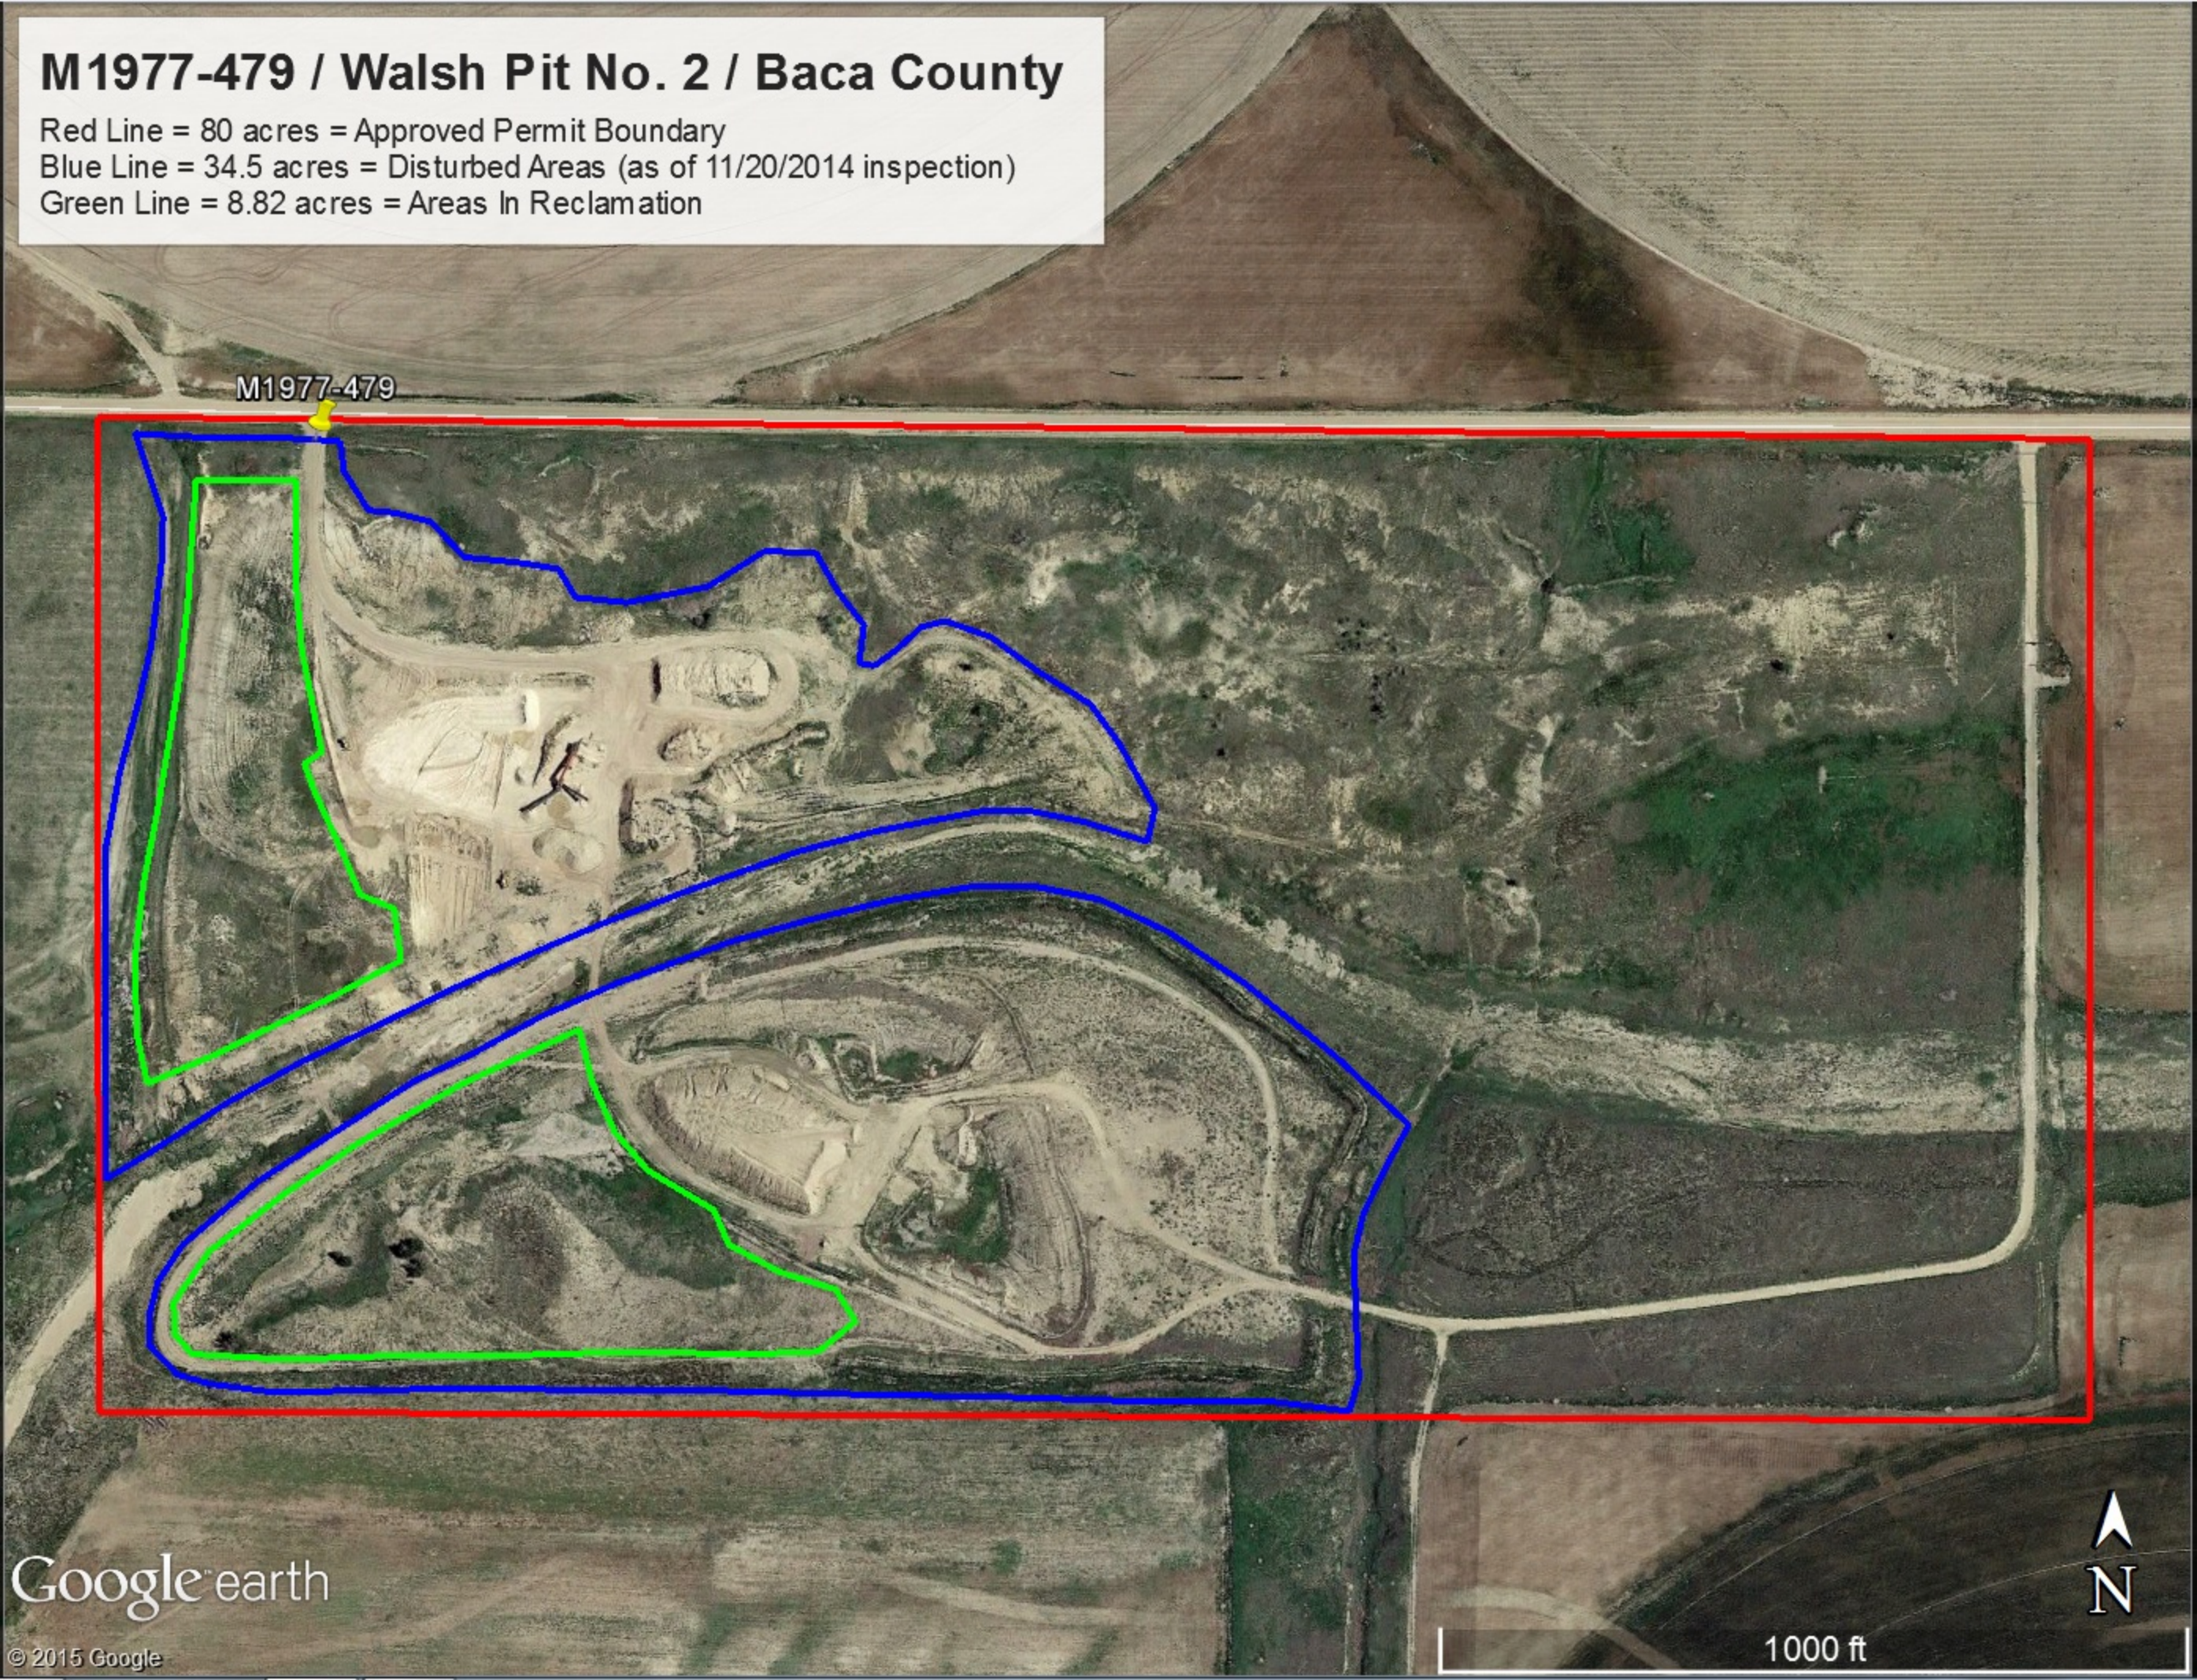
# M1977-479 / Walsh Pit No. 2 / Baca County

The Division estimates that approximately 35 acres have been disturbed by this operation (see enclosed Google Earth image of site), which is in compliance with the maximum allowed disturbance. Current disturbance includes the processing and stockpiling area with several material stockpiles of various sizes located north of Bear Creek (**Photo 6**; also see **Photo 5**), a stockpiling area (**Photos 7 and 8**) and most recent active pit (**Photo 9**) located south of the creek, and topsoil berms stored along the edges of disturbance. The topsoil berms appeared to be stable with some vegetative cover. A total of approximately 8.82 acres of the western portions of the disturbed area are in reclamation. The northwestern area was recently graded to near flat and requires seeding (**Photos 10 and 11**). Reclamation of the southwestern area began in 2011, and vegetative cover is establishing in this area (mentioned in 2<sup>nd</sup> paragraph above; **Photo 12**). A large sand stockpile is stored in the southern pit area (see **Photos 7 and 8**). Active mining last occurred just east of this stockpile (see **Photos 7 and 9**). All mined slopes are 3H:1V or flatter and appear to be stable with some vegetative cover, showing no evidence of erosion.

Blue Line = 34.5 acres = Disturbed Areas (as of 11/20/2014 inspection)

Green Line = 8.82 acres = Areas In Reclamation
