COLORADO DIVISION OF RECLAMATION, MINING AND SAFETY
MINERALS PROGRAM INSPECTION REPORT
PHONE: (303) 866-3567

MINE NAME: Mundell Estate No. 32	MINE/PROSPECTING ID#: M-1995-019	MINERAL: Gravel	COUNTY: Baca
INSPECTION TYPE: Monitoring	INSPECTOR(S): Amy Eschberger	INSP. DATE: November 20, 2014	INSP. TIME: 09:30
OPERATOR: Baca County	OPERATOR REPRESENTATIVE: Jason Freiburger and Race Chenoweth	TYPE OF OPERATION: 112c - Construction Regular Operation

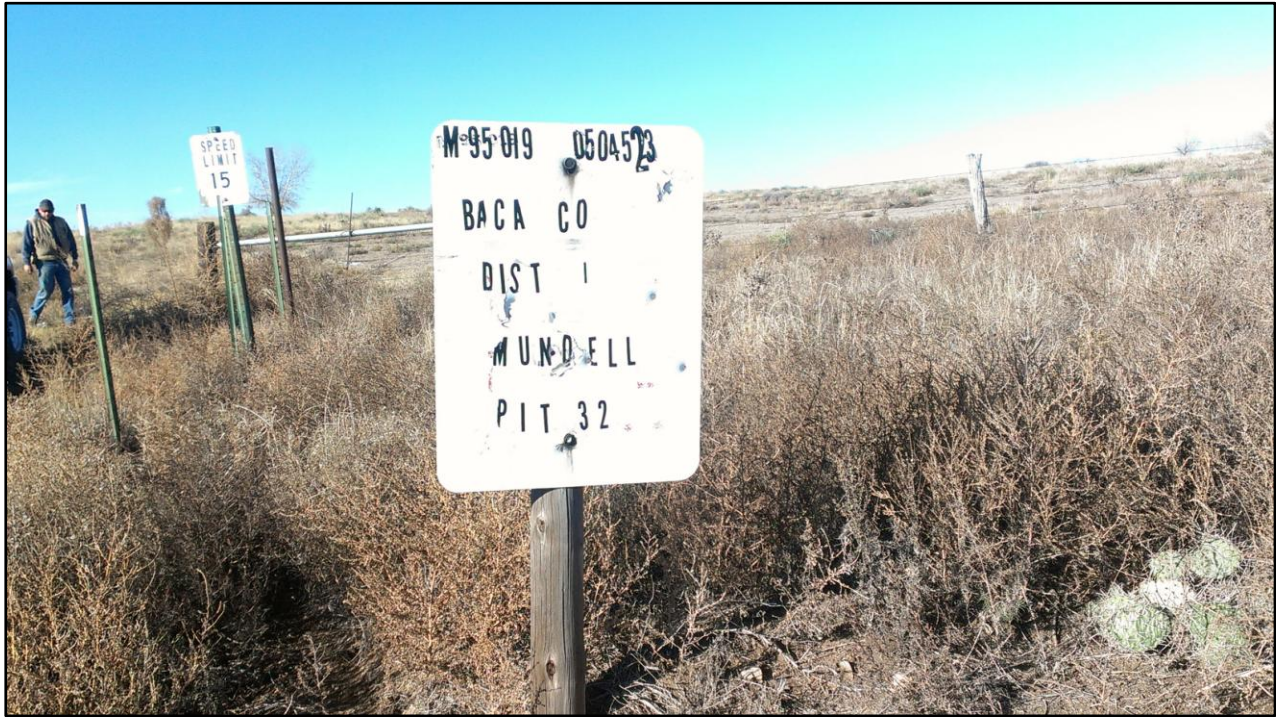
At the time of the inspection, the weather was clear, cool and sunny, and the ground was dry. A permit identification sign was posted at the main entrance to the site off of Co Rd 52 (**Photo 1**). This sign included the permit number, and operator name; however, pursuant to Rule 3.1.12(1), it should also include a statement that the permit was issued by the Colorado Mined Land Reclamation Board (MLRB). The permit boundary corners were marked by metal posts painted yellow (**Photo 2**). The mine was not active during the inspection, and no material stockpiles remain. This permit has been approved for intermittent status, which allows the site to be active for less than 180 days per year. However, according to Annual Reports submitted by the operator, the site has been inactive since 2006. Since then, the county has only conducted reclamation activities on site. The Division informed Mr. Freiburger and Mr. Chenoweth during the inspection that, per C.R.S. 34-32.5-103(11)(b) and Rule 1.13.5(1), operators must file a notice of Temporary Cessation (see enclosed form) whenever they intend to, or do, temporarily cease production for more than a one year period. Because Mr. Freiburger and Mr. Chenoweth indicated that the county intends to mine this site again within the year, a Problem will not be cited in this report for the years of inactivity. However, this matter will be followed up on during the next inspection.

Photo 1. View of permit sign posted at main site entrance off of Co Rd 52. This sign should also include a statement that the permit was issued by the MLRB.

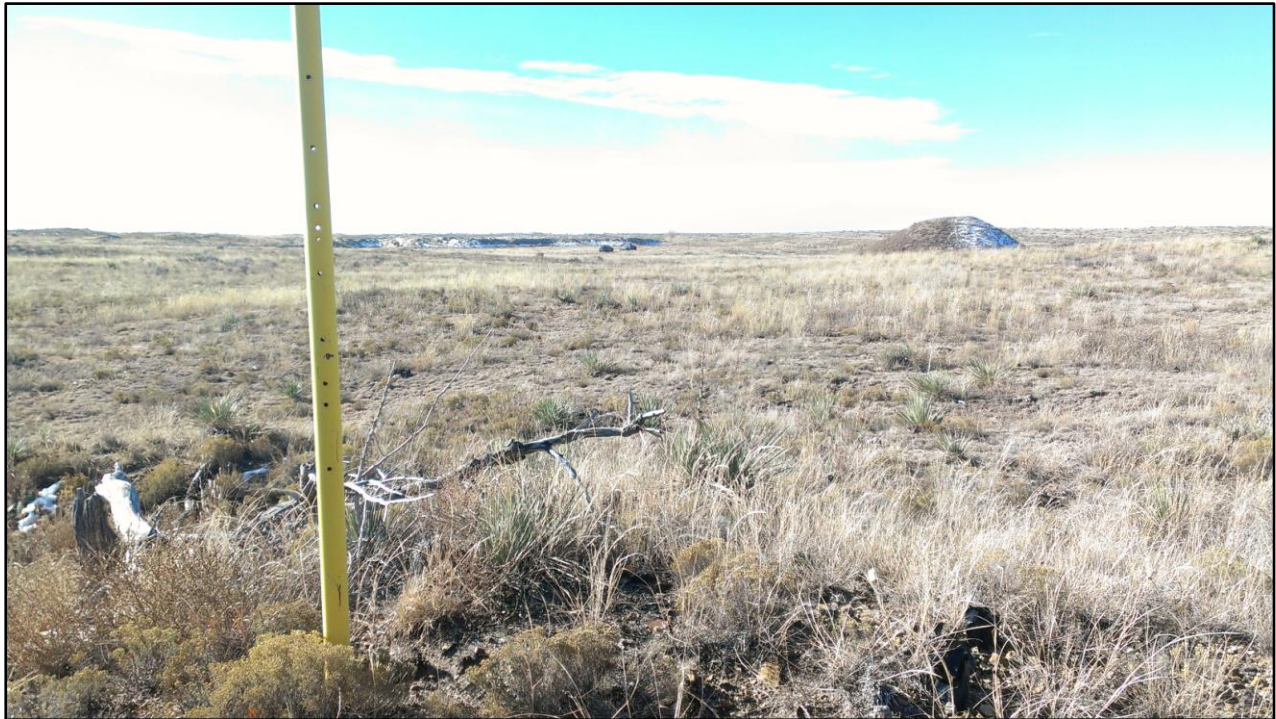
Photo 2. View looking south, showing metal post marking northeastern corner of permit boundary.

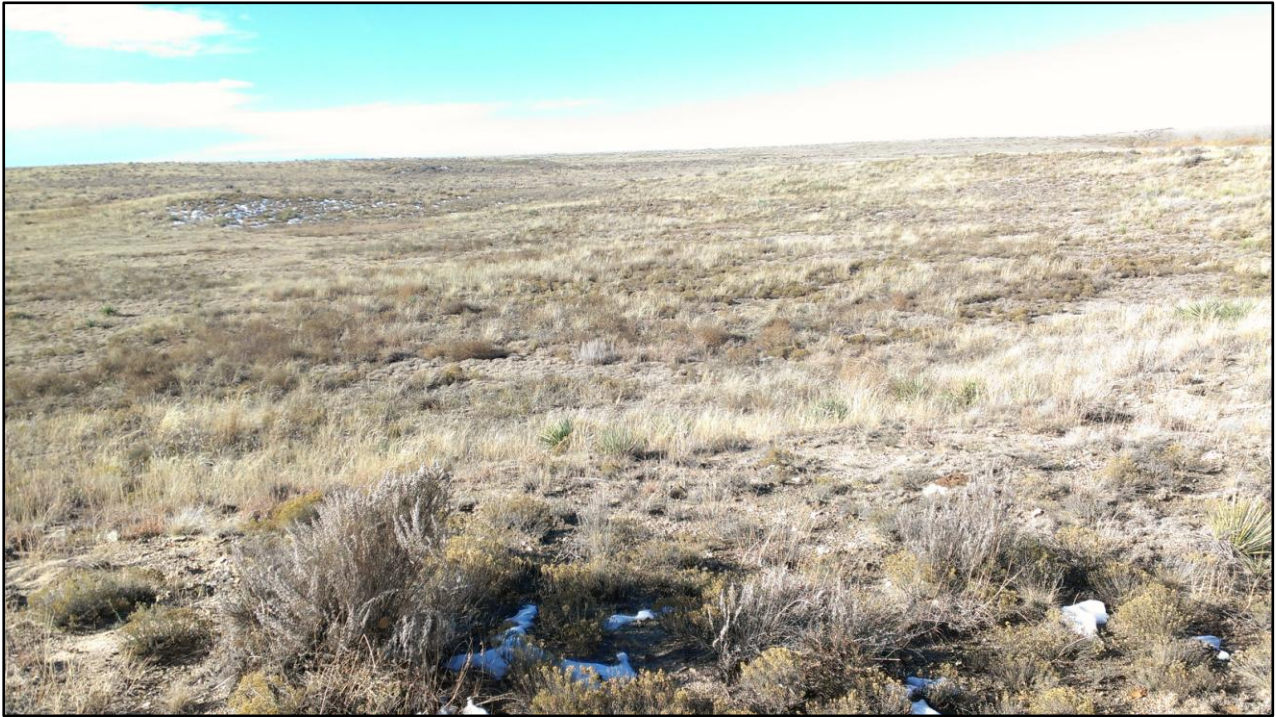
Photo 3. View looking southwest across reclaimed northern portion of site. Note slopes graded 3H:1V or flatter and establishment of native vegetation.

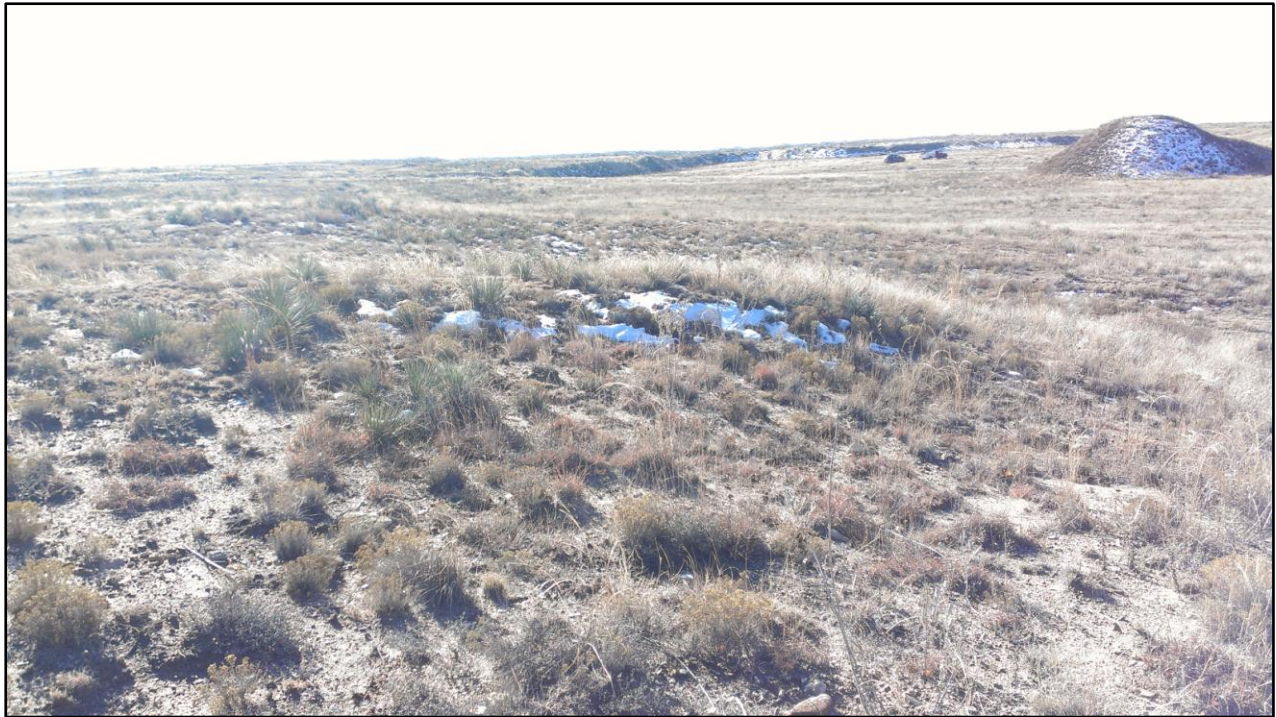
Photo 4. View looking southeast across reclaimed northern portion of site. Note slopes graded 3H:1V or flatter and establishment of native vegetation.

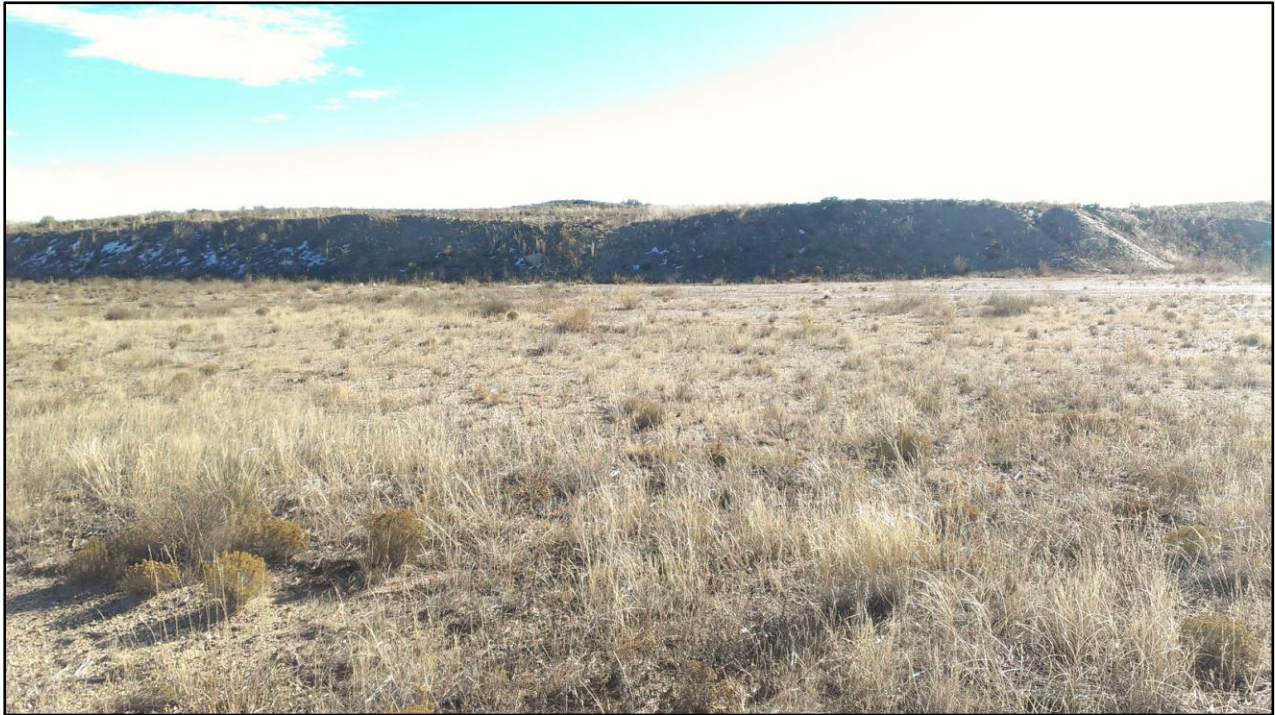
Photo 5. View looking east from center of pit, showing eastern highwall approximately 10-12 feet in height, with slope gradients of approximately 1H:1V. Note native vegetation establishing on pit floor.

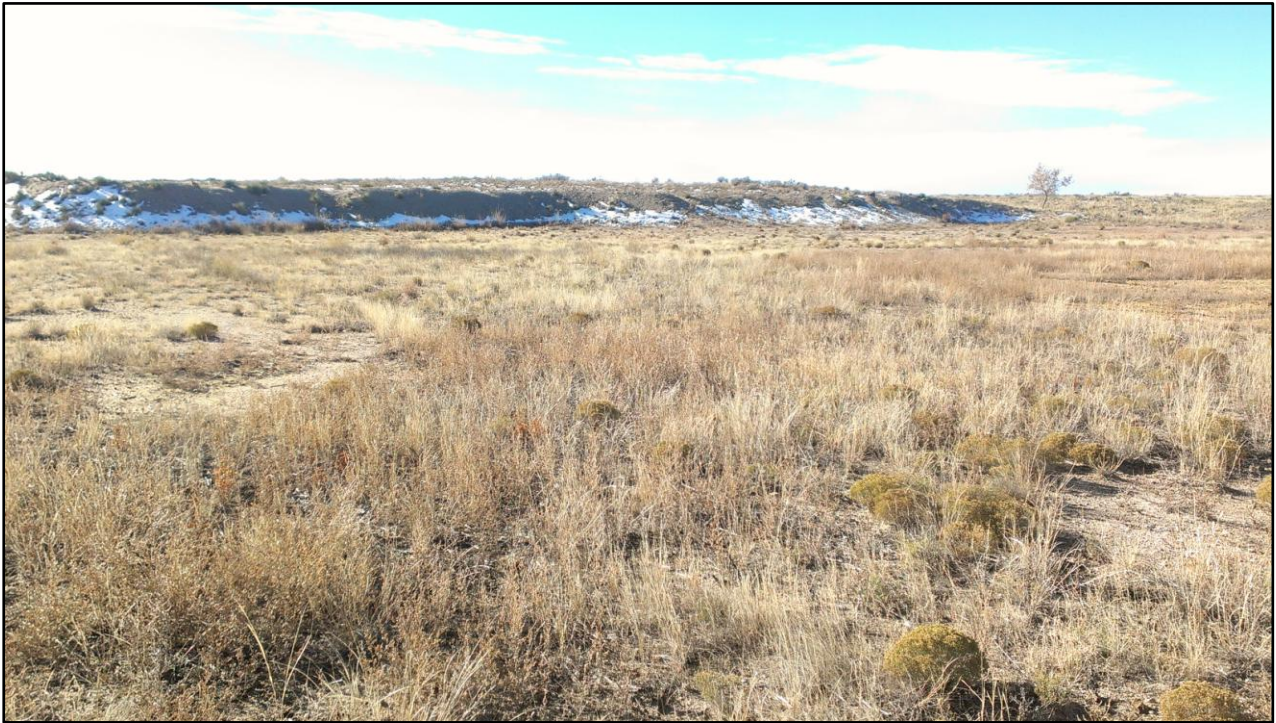
Photo 6. View looking southeast from center of pit, showing eastern highwall approximately 10-12 feet in height, with slope gradients of approximately 1H:1V to 2H:1V. Note native vegetation establishing on pit floor.

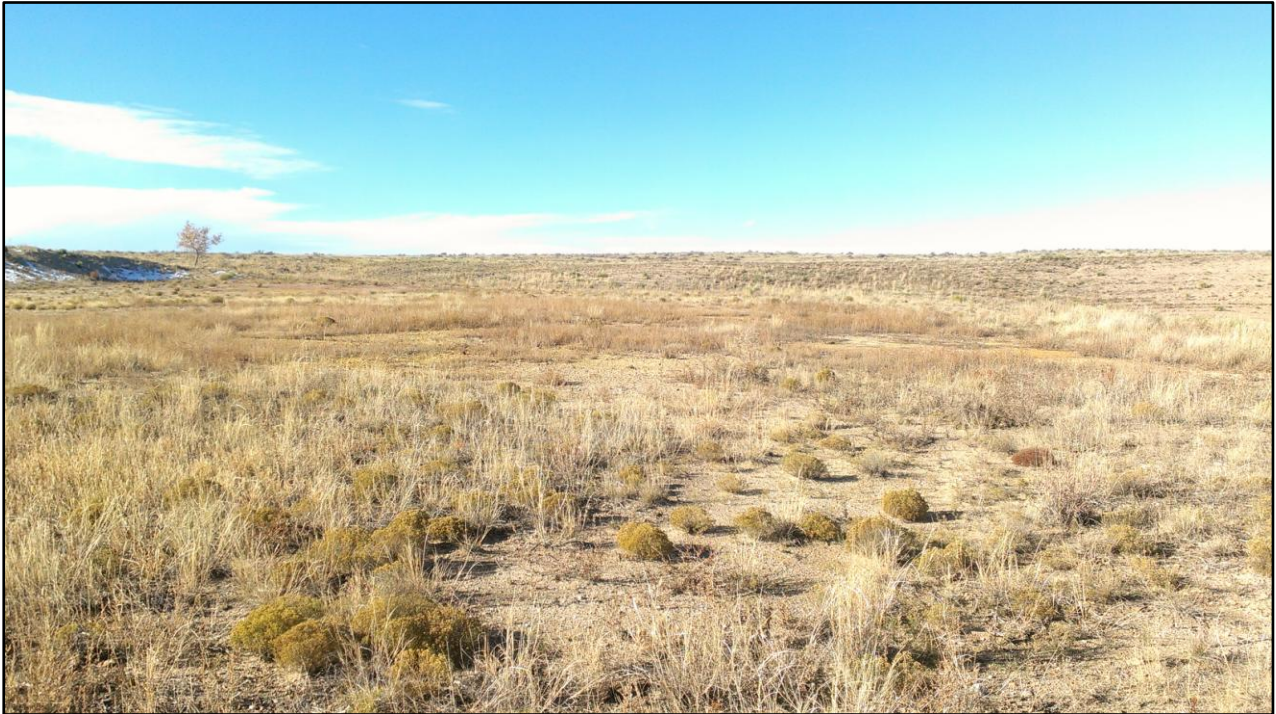
Photo 7. View looking south from center of pit, showing southern mined slope (in distance) with slope gradients of 3H:1V or flatter. Note native vegetation establishing across pit floor and pit walls.

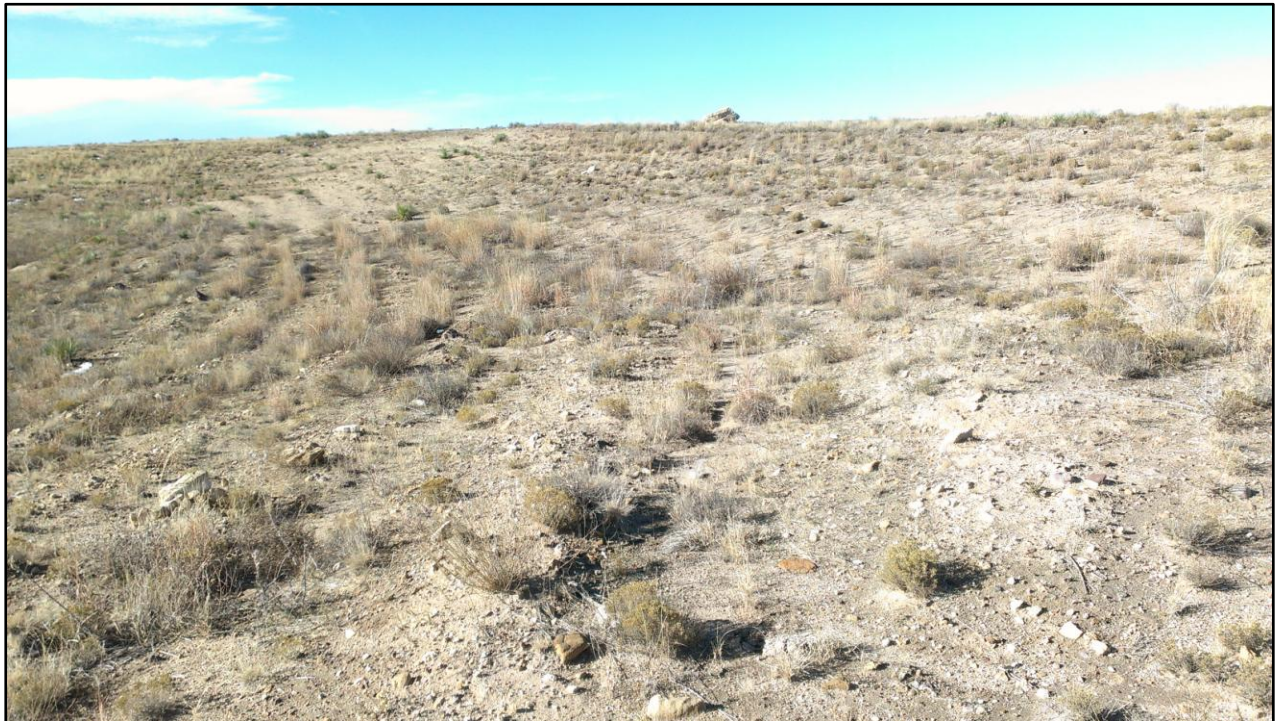
Photo 8. View looking southwest, showing western mined slope with slope gradients flatter than 3H:1V. Note native vegetation establishing across this area.

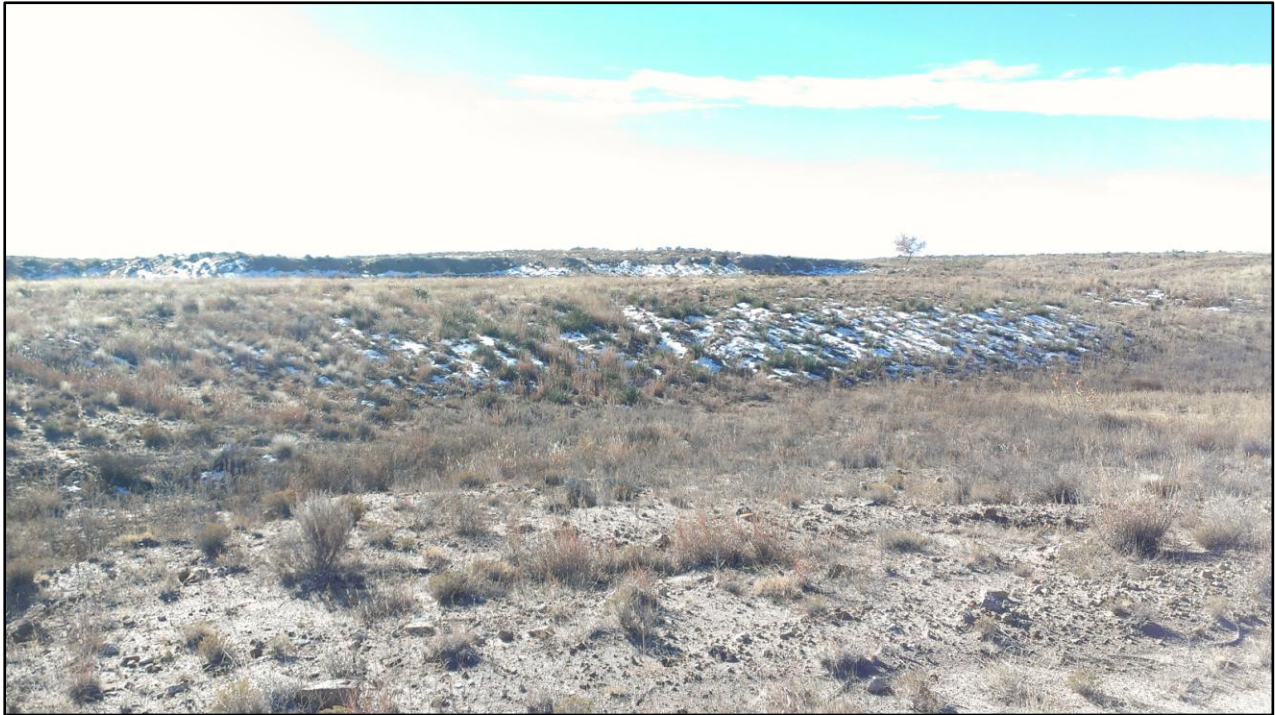
Photo 9. View looking southeast, showing western mined slope with slope gradients of 3H:1V or flatter. Note native vegetation establishing across this area.

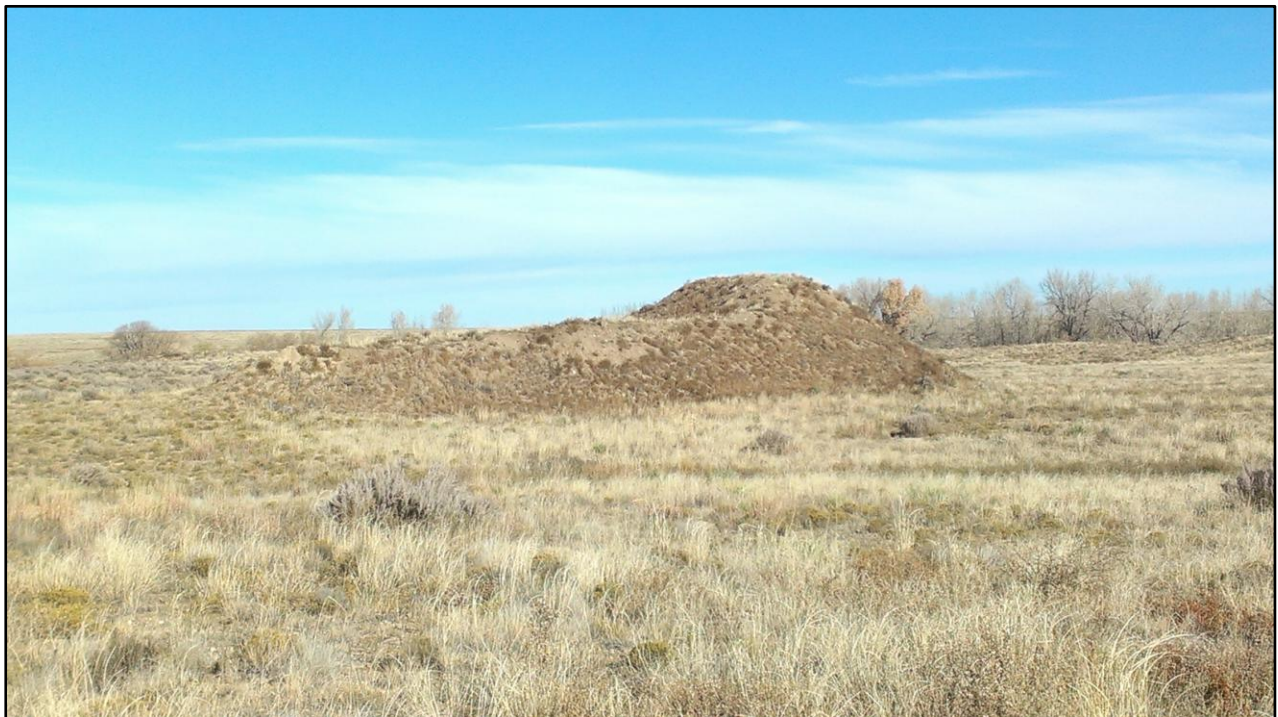
Photo 10. View looking northwest, showing topsoil stockpile stored at northern edge of pit. Note stockpile stable with vegetative cover.

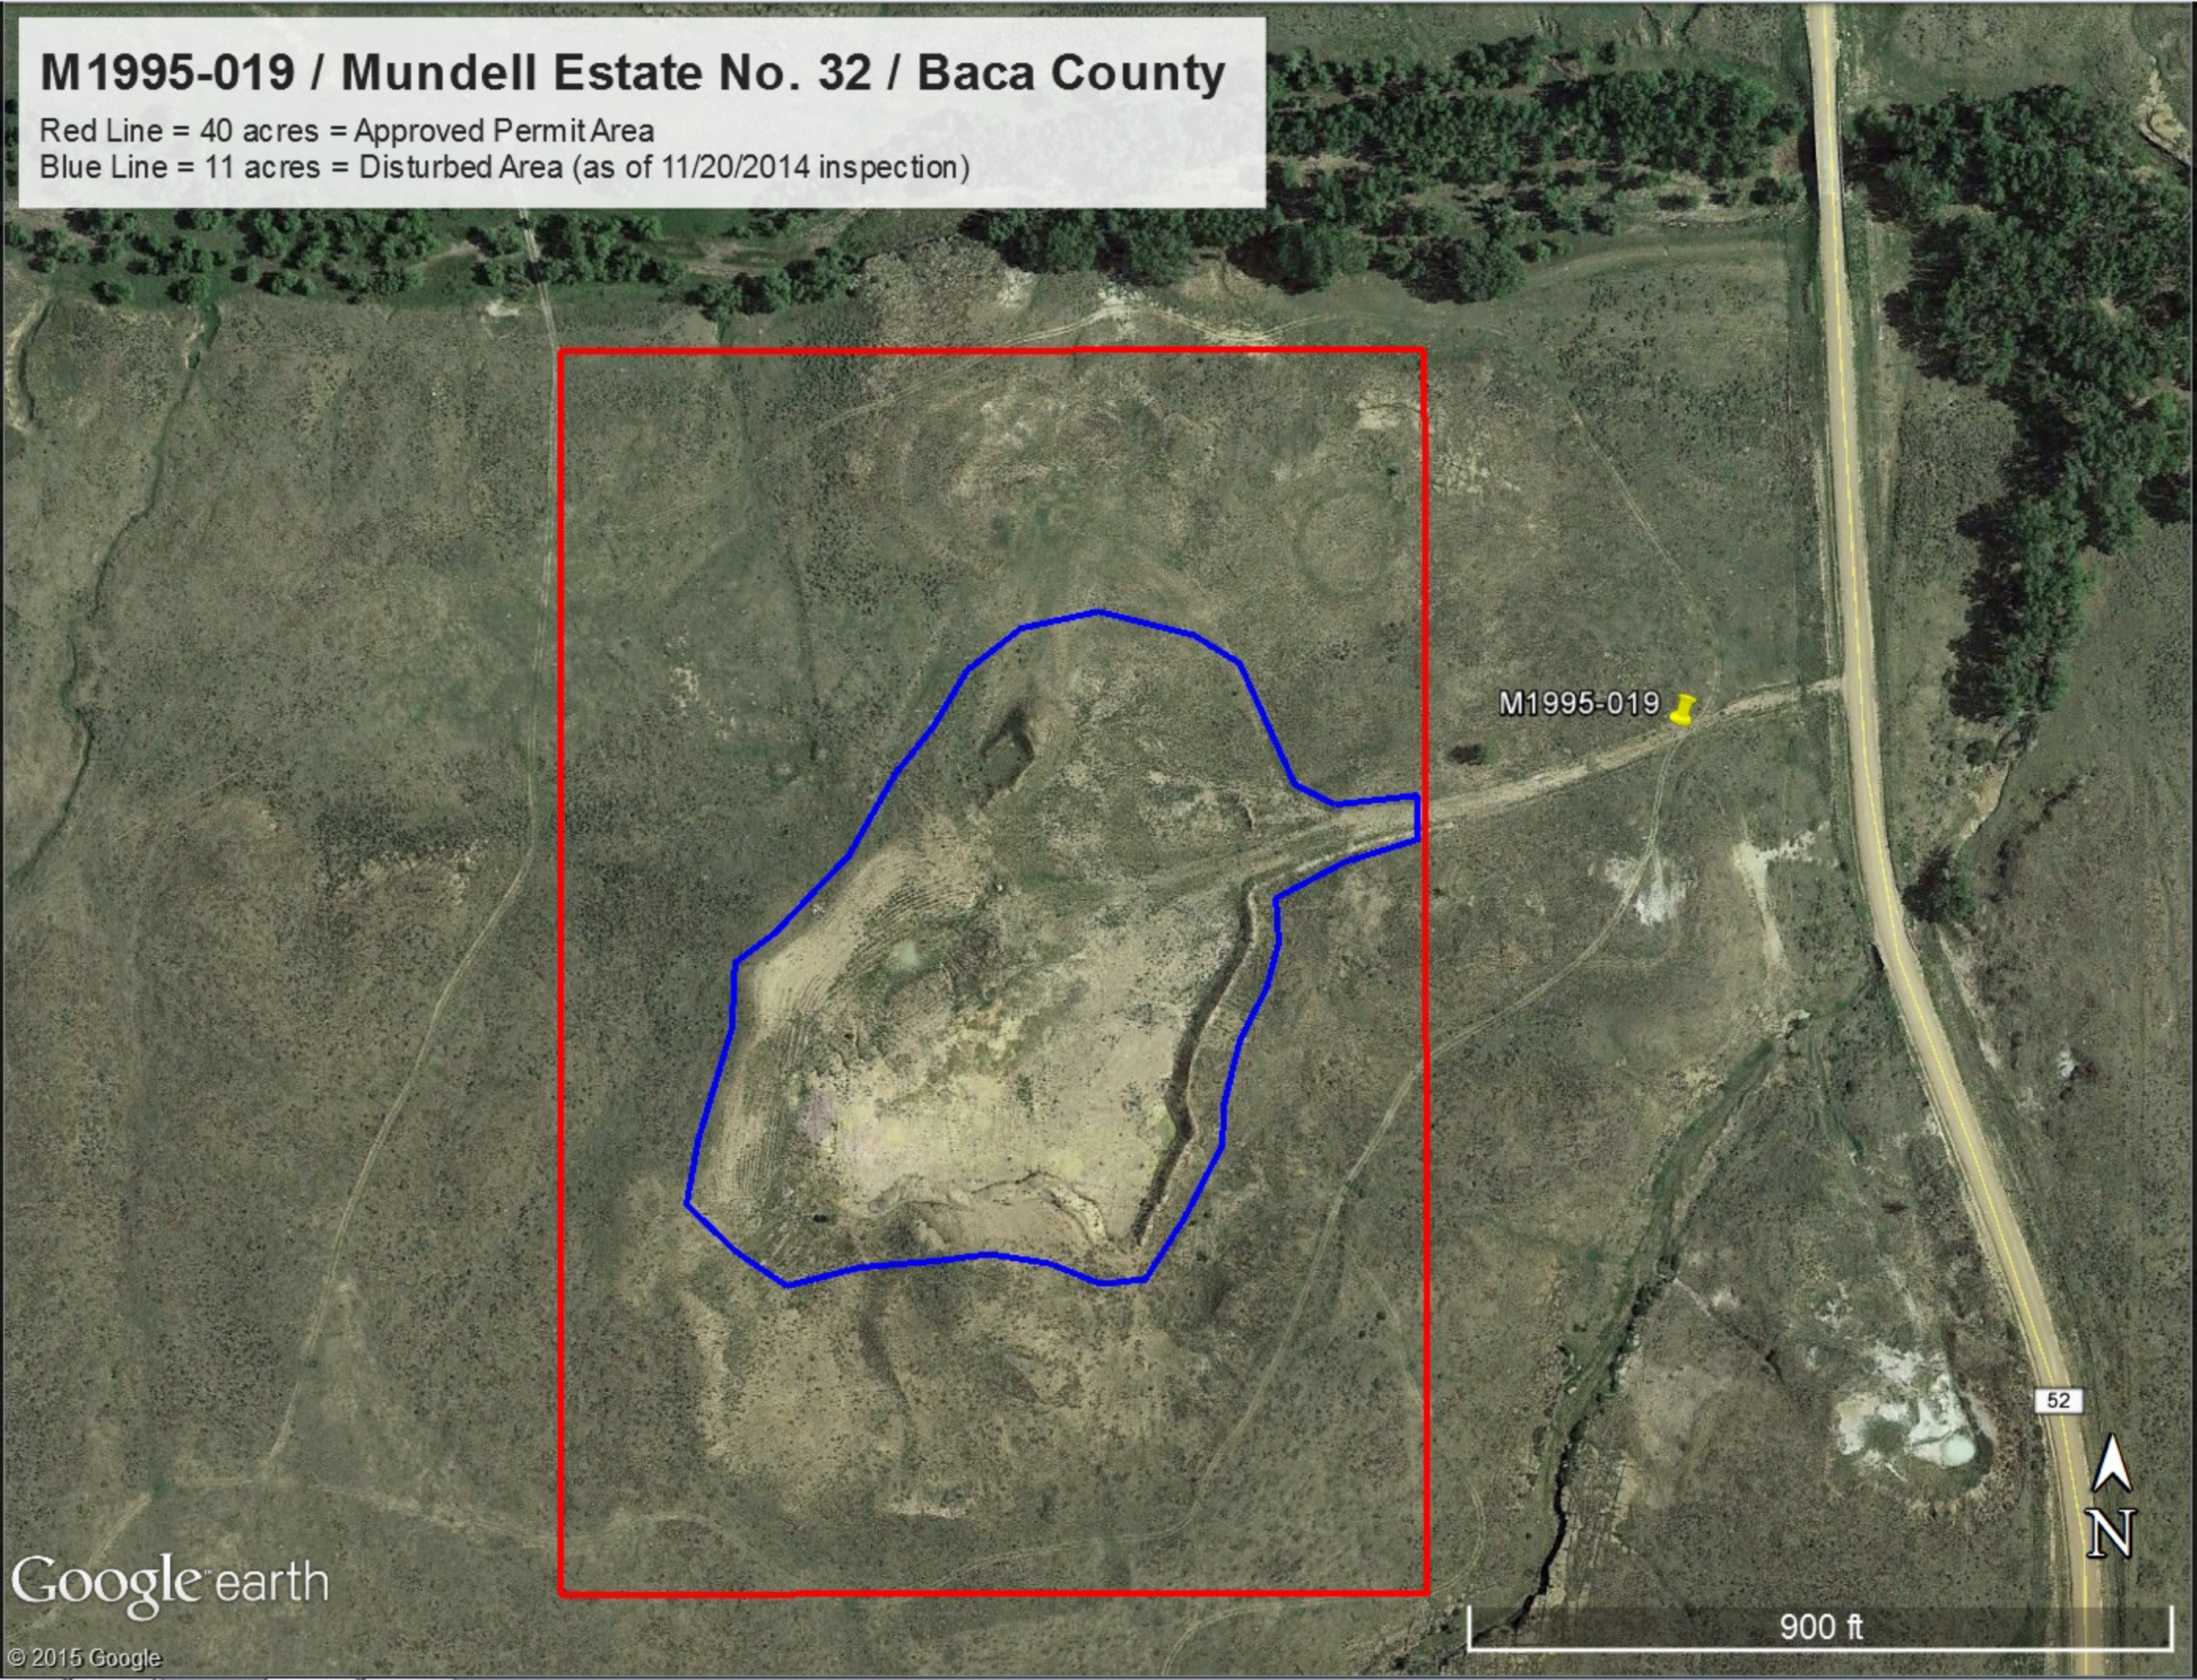
M1995-019 / Mundell Estate No. 32 / Baca County

The Division estimates that approximately 11 acres have been disturbed (and not yet reclaimed) by this operation (see enclosed Google Earth image of site). This amount of disturbance is well within the maximum allowed disturbance of 20 acres. The northern portion that was previously mined was graded to match the surrounding topography, and vegetation in this area is well established, including native grasses, yucca, sand sagebrush, and brome snakeweed (**Photos 3 and 4**). Current disturbance includes a horseshoe shaped pit located in the center of the permit area, and a topsoil stockpile stored at the northern edge of the pit. The highwall along the eastern edge of the pit is approximately 10-12 feet in height with slope gradients of 1H:1V to 2H:1V (**Photos 5 and 6**). The southern and western mined walls have been graded to 3H:1V or flatter (**Photos 7-9**). All mined slopes appeared to be stable, showing no evidence of erosion. The topsoil stockpile appeared to be stable with vegetative cover (**Photo 10**). Native vegetation has begun to establish throughout the site due to the length of inactivity. No problems with state-listed noxious weeds were observed.

Blue Line = 11 acres = Disturbed Area (as of 11/20/2014 inspection)
