COLORADO DIVISION OF RECLAMATION, MINING AND SAFETY
MINERALS PROGRAM INSPECTION REPORT
PHONE: (303) 866-3567

MINE NAME: Mineral Mountain Project	MINE/PROSPECTING ID#: M-2014-045	MINERAL: Gold	COUNTY: Teller
INSPECTION TYPE: Preoperation Inspection	INSPECTOR(S): Timothy A. Cazier	INSP. DATE: July 7, 2015	INSP. TIME: 12:00
OPERATOR: Mineral Mountain Gold, LLC	OPERATOR REPRESENTATIVE: Lance Barker	TYPE OF OPERATION: 110d - Designated Limited Impact

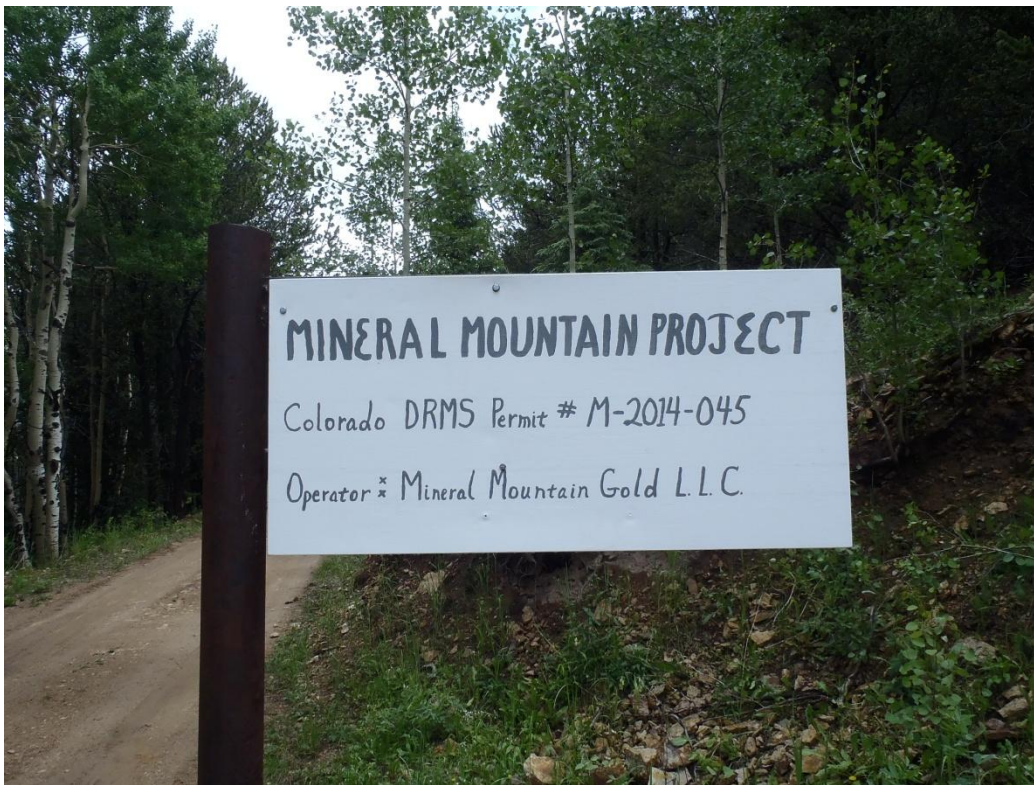
A permit sign was displayed at the site entrance (see **Photo 1**). Permit boundary markers were visible during the inspection (see **Photo 2**). An escapeway/air vent has been constructed near the road above the adit (see **Photo 3**).

Photo 1. Permit sign displayed on right side of the access road at the site entrance.

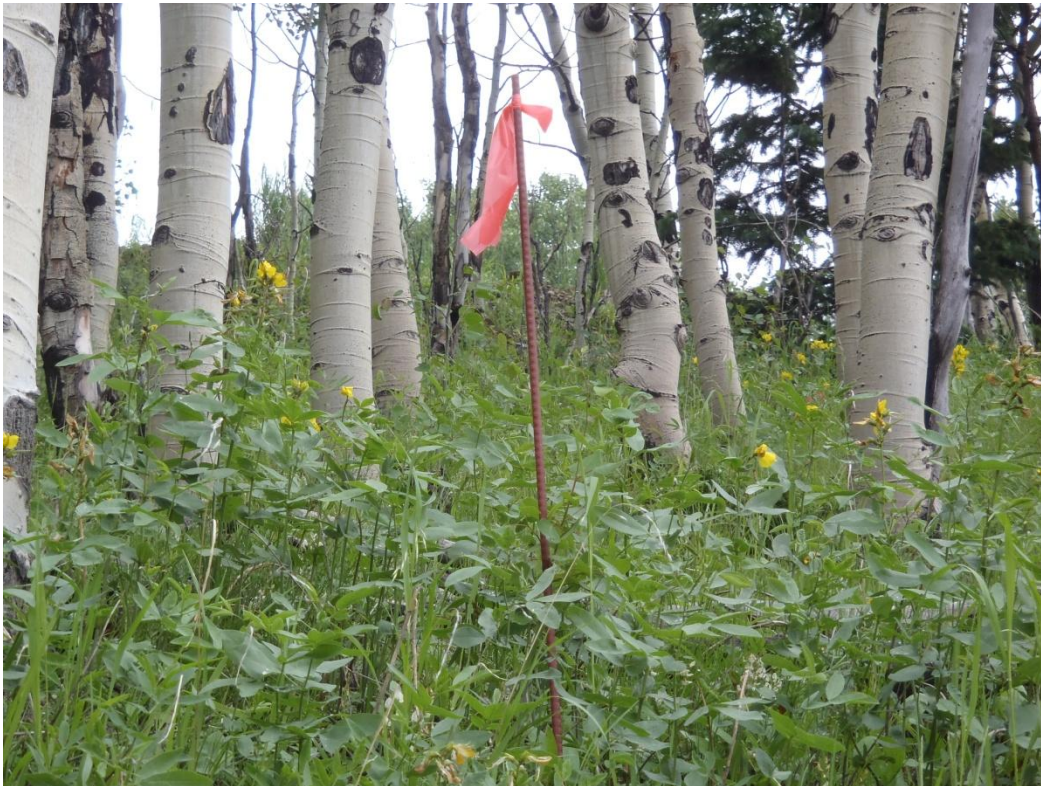
Photo 2. Typical permit boundary marker.

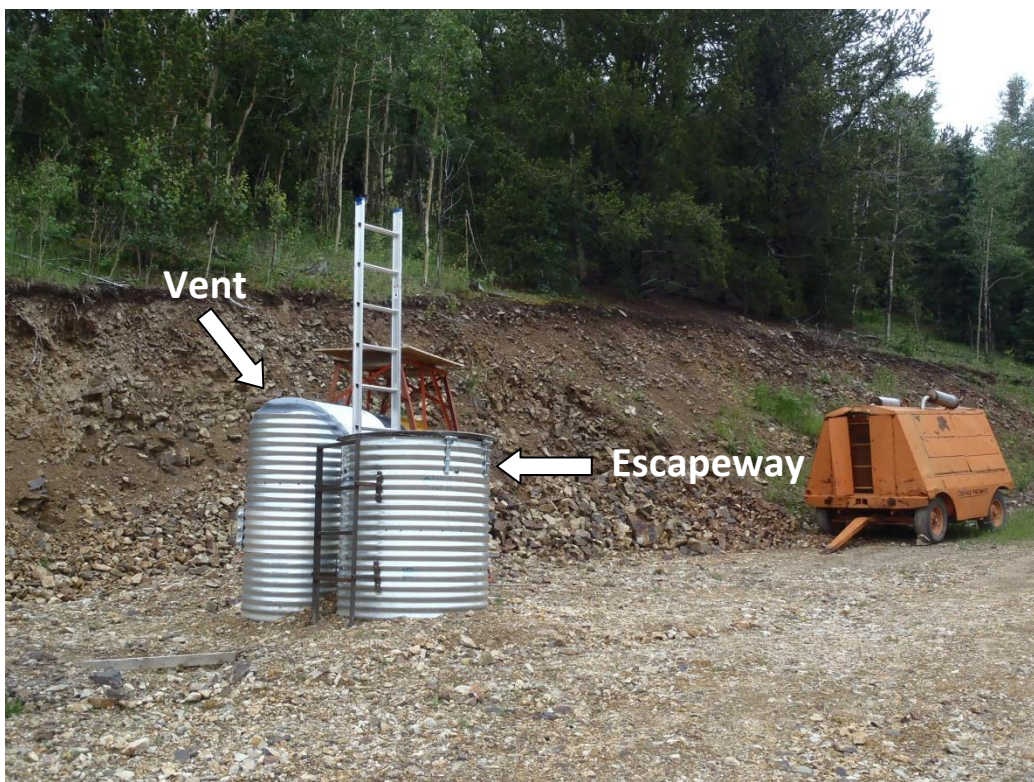
Photo 3. Escapeway/air vent near road above the adit (looking SW).

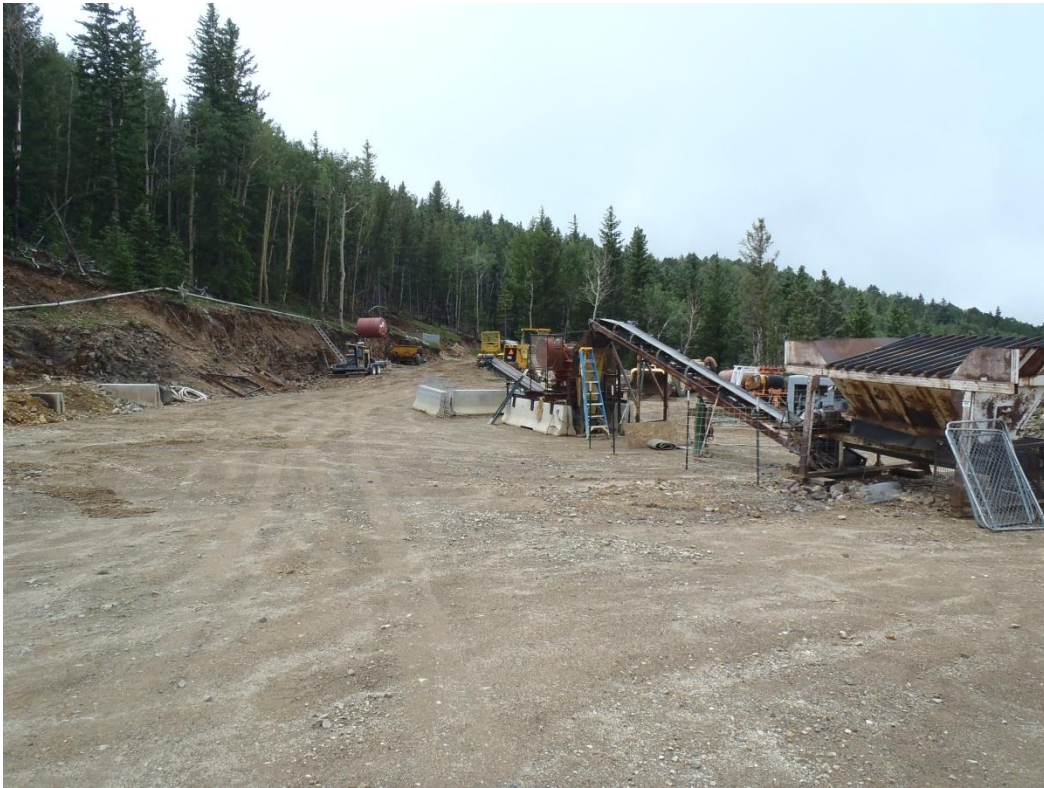
Adit Area & Bench: There was more mining equipment (see **Photo 4**) on the bench than during the previous Little Hope Mine inspection on October 22, 2013. Some evidence of drainage from the adit was observed (see **Photo 5**). Mr. Barker indicated it was meteoric water from the very wet spring/early summer seeping into the escapeway/vent which acts as a conduit for the infiltrated water. Mr. Barker pointed out the dripping water from the escapeway/vent (see **Photo 6**). This inspector noted there is a slight incline in the adit from the entrance to the escapeway/vent which was wet with some puddles. The drift dips past the escapeway/vent and the floor is dry in this area, indicating all the drained water is meteoric in nature and NOT mine drainage.

Photo 4. Mining equipment on adit bench (looking SW).

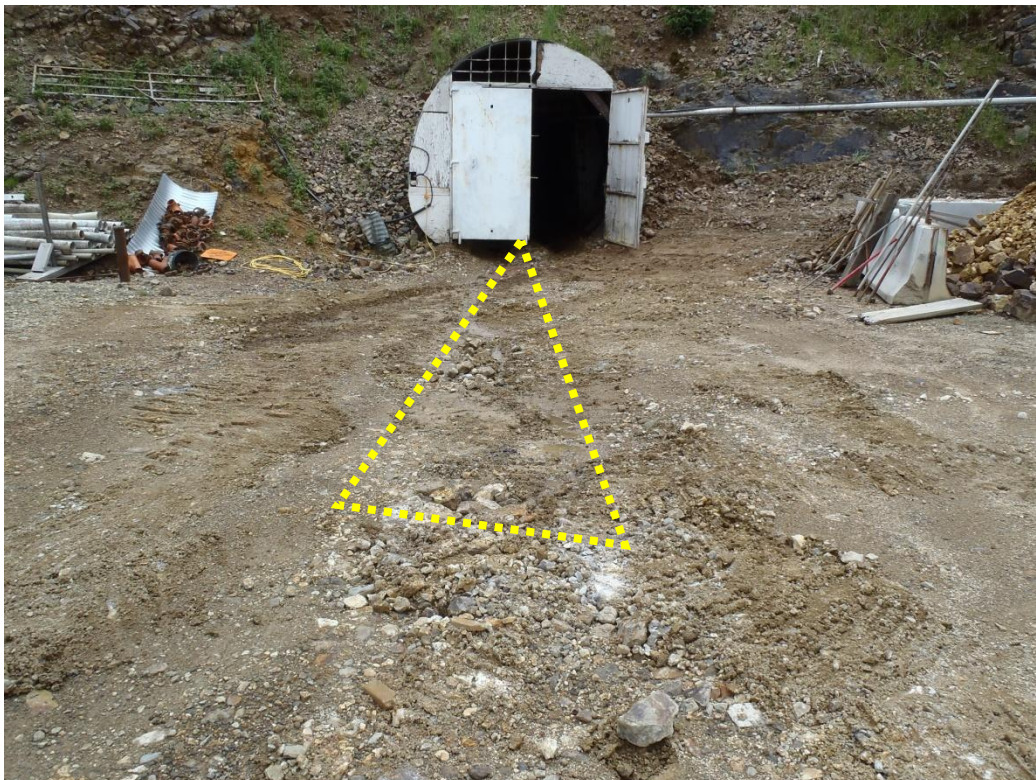
Photo 5. Observed evidence of drainage from the adit (looking SE).
Note: this was determined NOT to be mine drainage

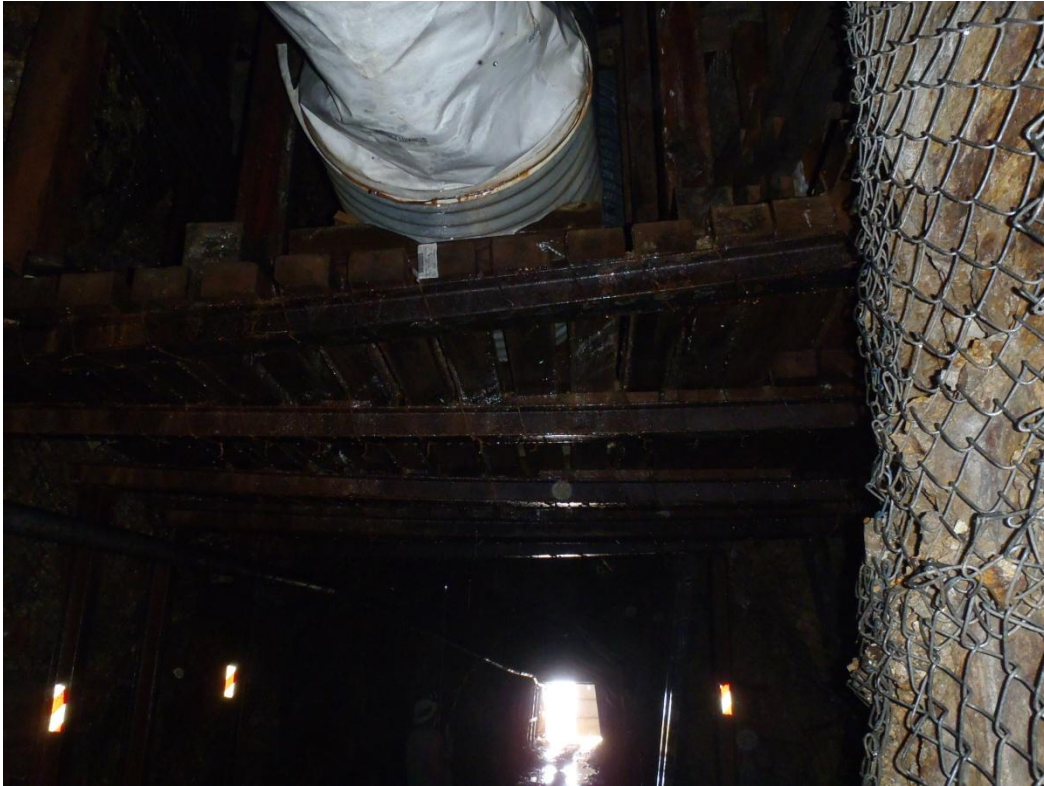
Photo 6. Water dripping from escapeway/vent inside adit (looking towards entrance).
