**COLORADO DIVISION OF RECLAMATION, MINING AND SAFETY**  
**MINERALS PROGRAM INSPECTION REPORT**  
**PHONE: (303) 866-3567**

<b>MINE NAME:</b> Gunkel Pit No 31	<b>MINE/PROSPECTING ID#:</b> M-1993-088	<b>MINERAL:</b> Gravel	<b>COUNTY:</b> Baca
<b>INSPECTION TYPE:</b> Monitoring	<b>INSPECTOR(S):</b> Amy Eschberger	<b>INSP. DATE:</b> November 20, 2014	<b>INSP. TIME:</b> 11:00
<b>OPERATOR:</b> Baca County	<b>OPERATOR REPRESENTATIVE:</b> Jason Freiburger and Race Chenoweth	<b>TYPE OF OPERATION:</b> 112c - Construction Regular Operation

# M1993-088 / Gunkel Pit No. 31 / Baca County

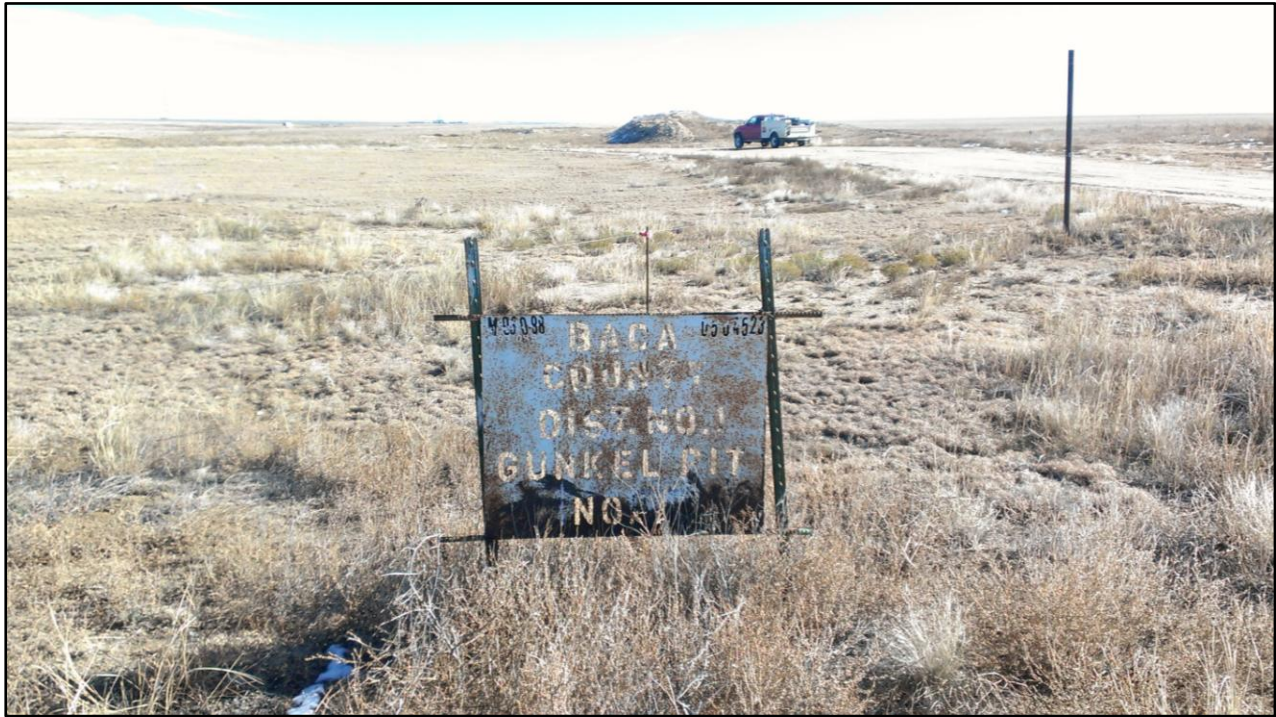
At the time of the inspection, the weather was clear, cool and sunny, and the ground was dry. A permit identification sign was posted at the main entrance to the site off of Co Rd 23 (**Photo 1**). This sign included the operator name; however, the permit number was weathered and hard to read. Also, pursuant to Rule 3.1.12(1), it should include a statement that the permit was issued by the Colorado Mined Land Reclamation Board (MLRB). The Division recommends the operator replace this sign and include, at a minimum, the information listed above. The permit boundary was delineated by property fencelines. The mine was not active during the inspection, and no equipment was present on site. However, the county extracts and/or hauls material off site every year, which is in compliance with its intermittent status.

**Photo 1.** View of permit sign posted at main site entrance off of Co Rd 23. Permit number in top-left corner is hard to read. The Division requires permit signs to include the permit number, operator name, and a statement that the permit was issued by the CO MLRB.

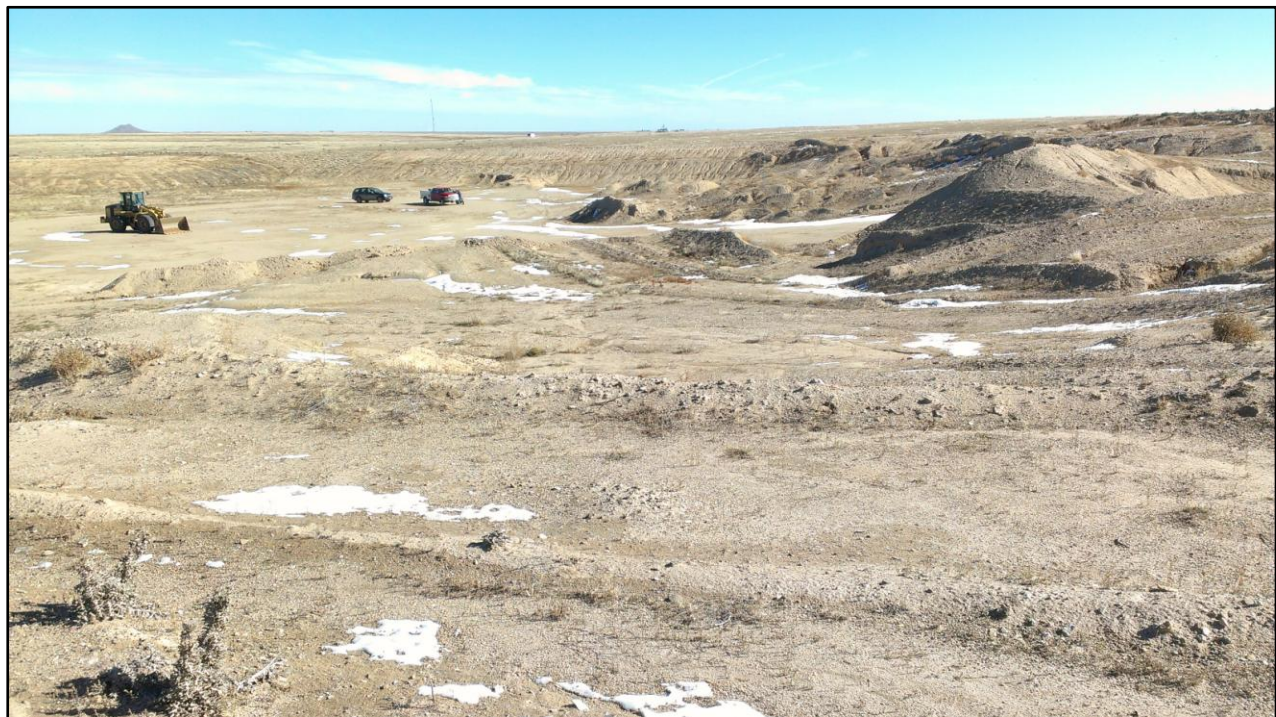
**Photo 2.** View looking east across pit from southwestern edge. Only a portion of the southern mining wall is shown at right.

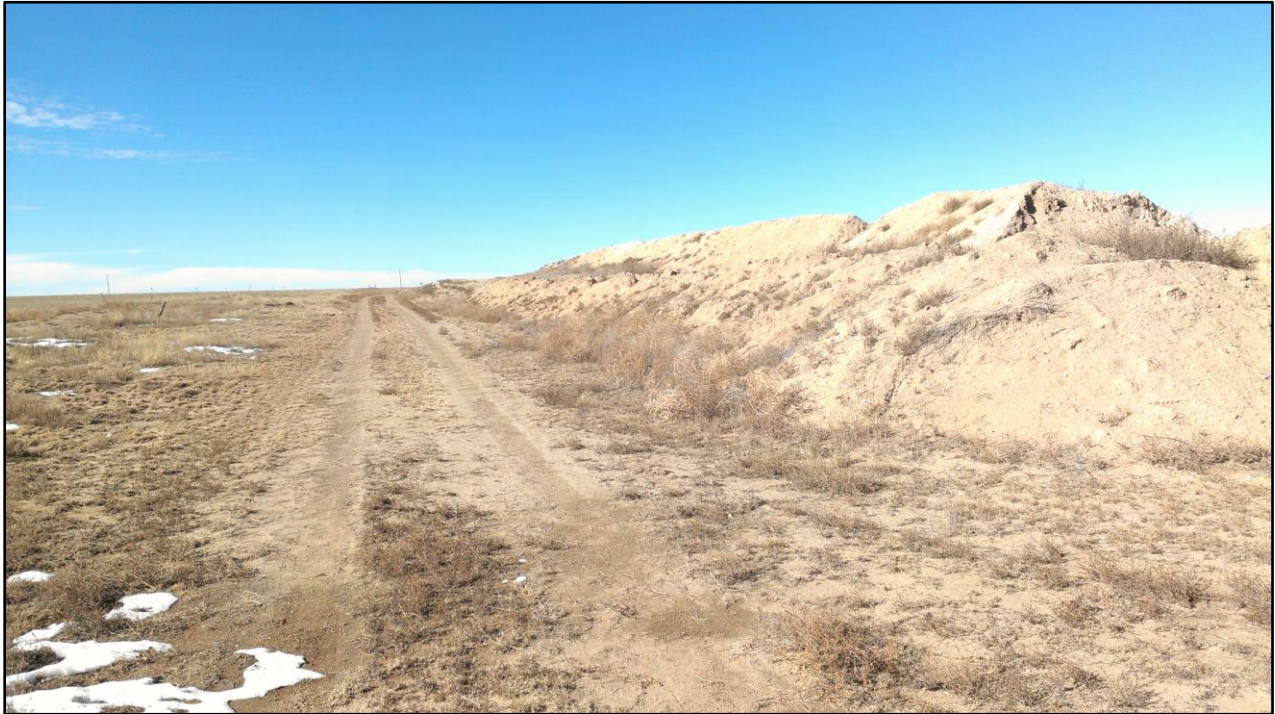
**Photo 3.** View looking west from southeastern edge of disturbance, showing topsoil stockpile (at right) stored along southern edge of pit, adjacent to southern permit boundary (at left, marked by fenceline).

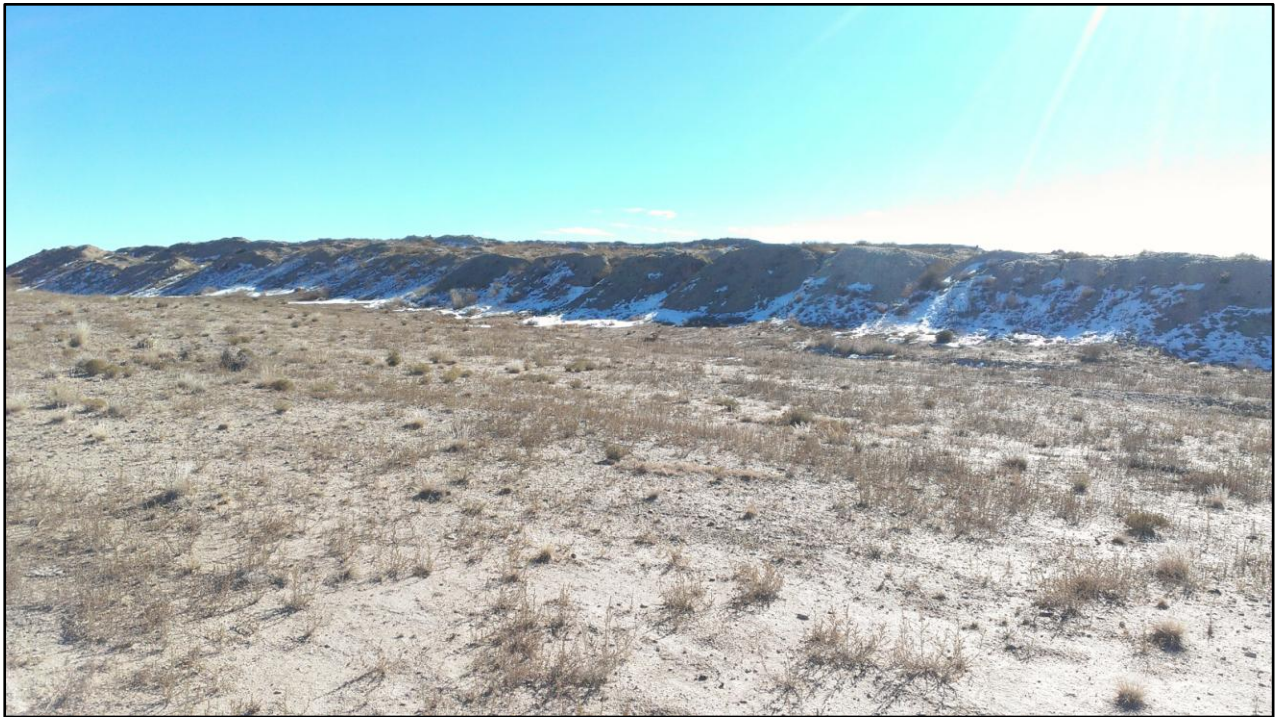
**Photo 4.** View looking southeast from southwestern edge of disturbance, showing overburden stockpile stored above pit, adjacent to topsoil stockpile shown in **Photo 3**.

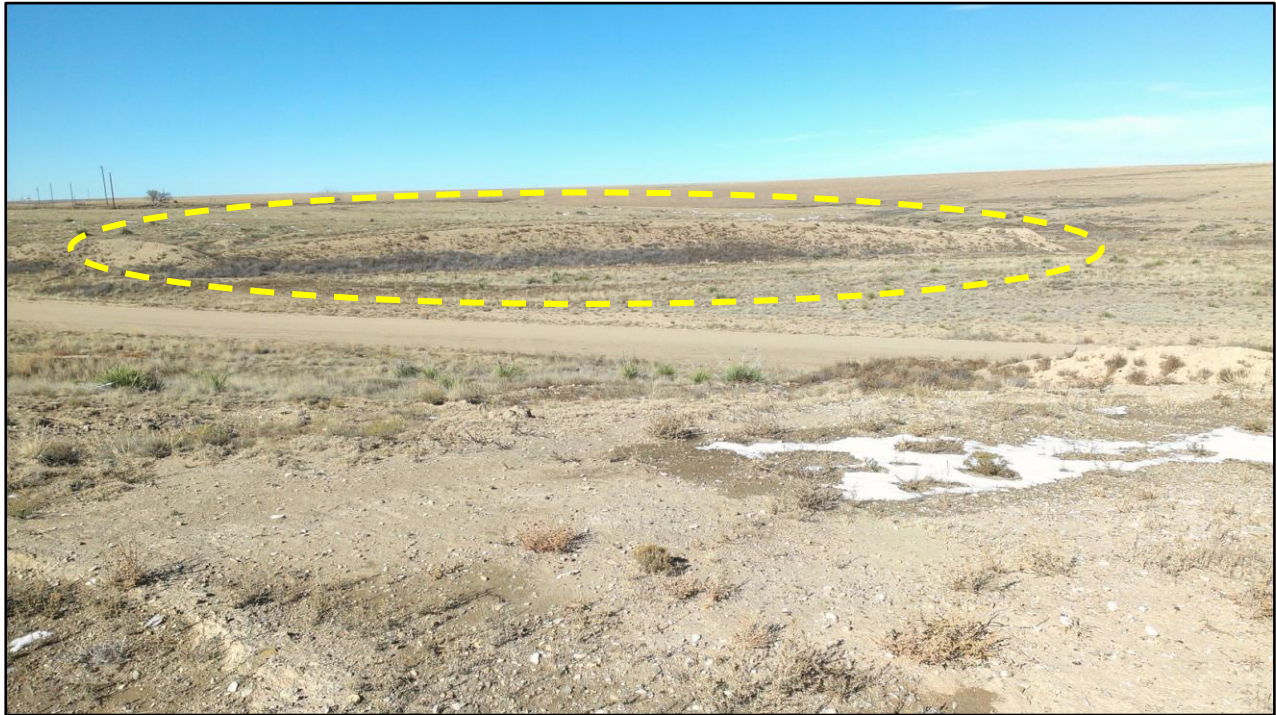
**Photo 5.** View looking northwest from southwestern edge of disturbance, showing topsoil stockpile (indicated) stored immediately north of haul road.

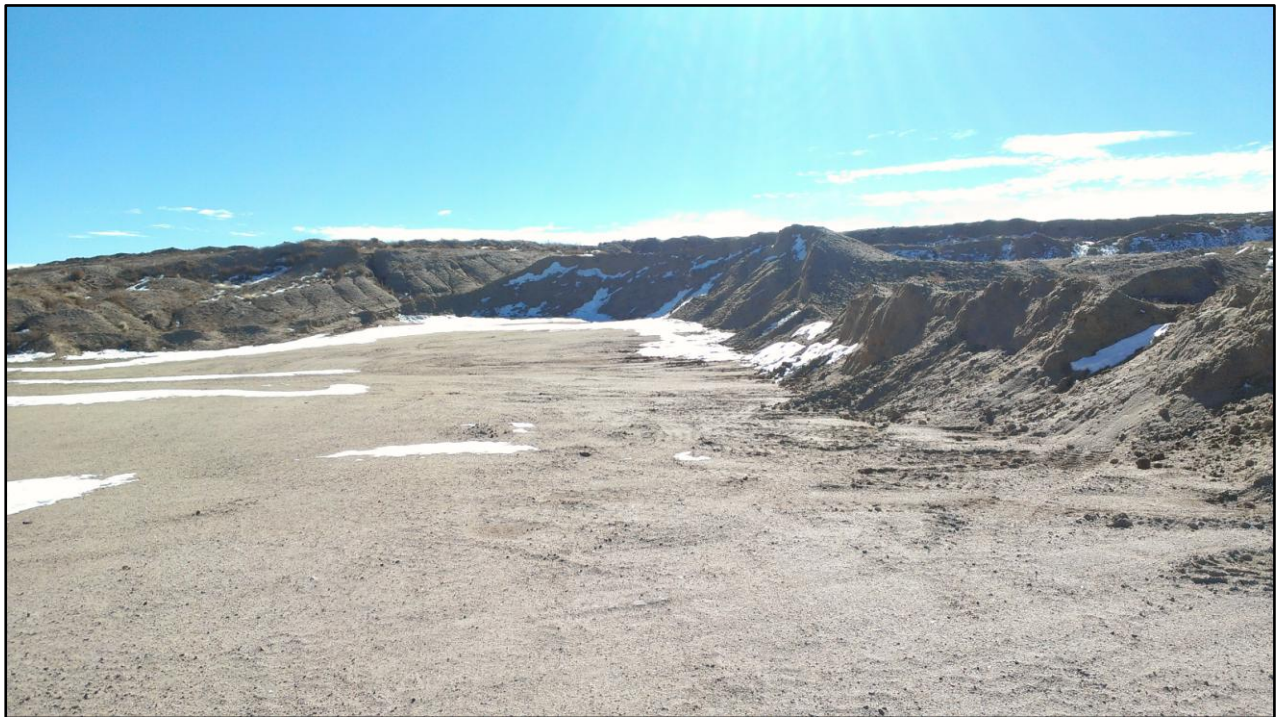
**Photo 6.** View looking south from pit floor, showing southern mining walls with slope gradients of mainly 2H:1V to 3H:1V.

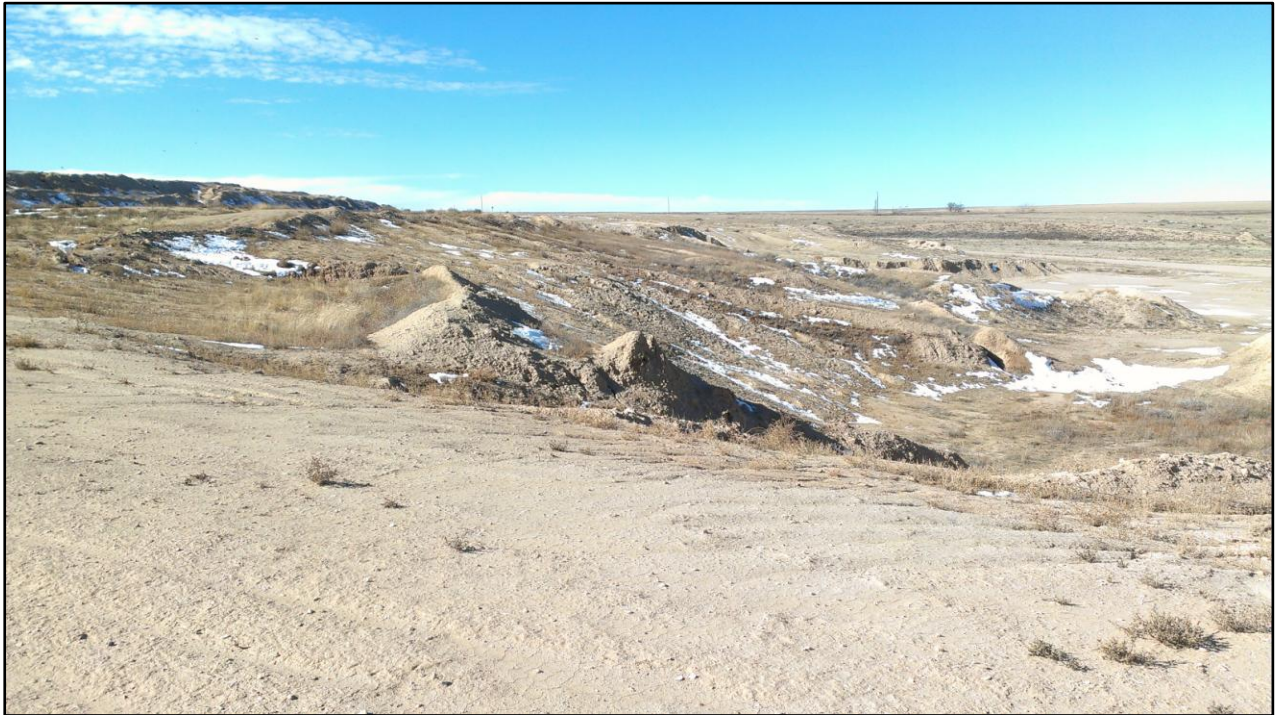
**Photo 7.** View looking west from southeastern edge of pit, showing southern mining walls with slope gradients of mainly 2H:1V to 3H:1V.

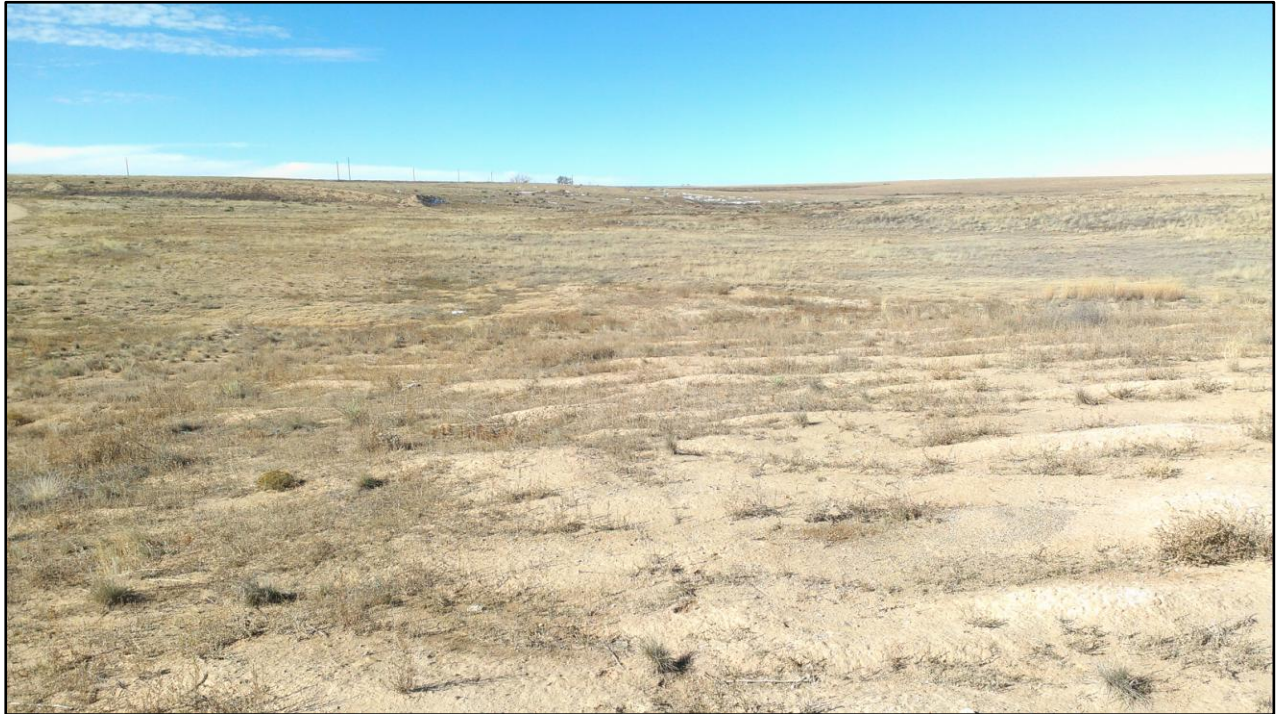
The northern mined slopes were graded to 4H:1V or flatter and have some native grasses, yucca, and weeds establishing across them (**Photo 9**). However, the county has had some difficulties establishing vegetative cover on the uppermost portion of the northern slope (**Photo 10**). In this area, the ground is mainly bare with some patchy vegetative growth. During the inspection, Mr. Freiburger and Mr. Chenoweth indicated the county intends to interseed this portion of the northern slope and will either crimp in straw mulch or apply manure to the area. The approved reclamation plan allows for either of these methods. All mined slopes appeared to be stable, showing no evidence of excessive erosion. No problems with state-listed noxious weeds were observed.

**Photo 9.** View looking east across northern mined slopes graded 4H:1V or flatter. Note vegetative cover establishing across area, particularly portion in background.

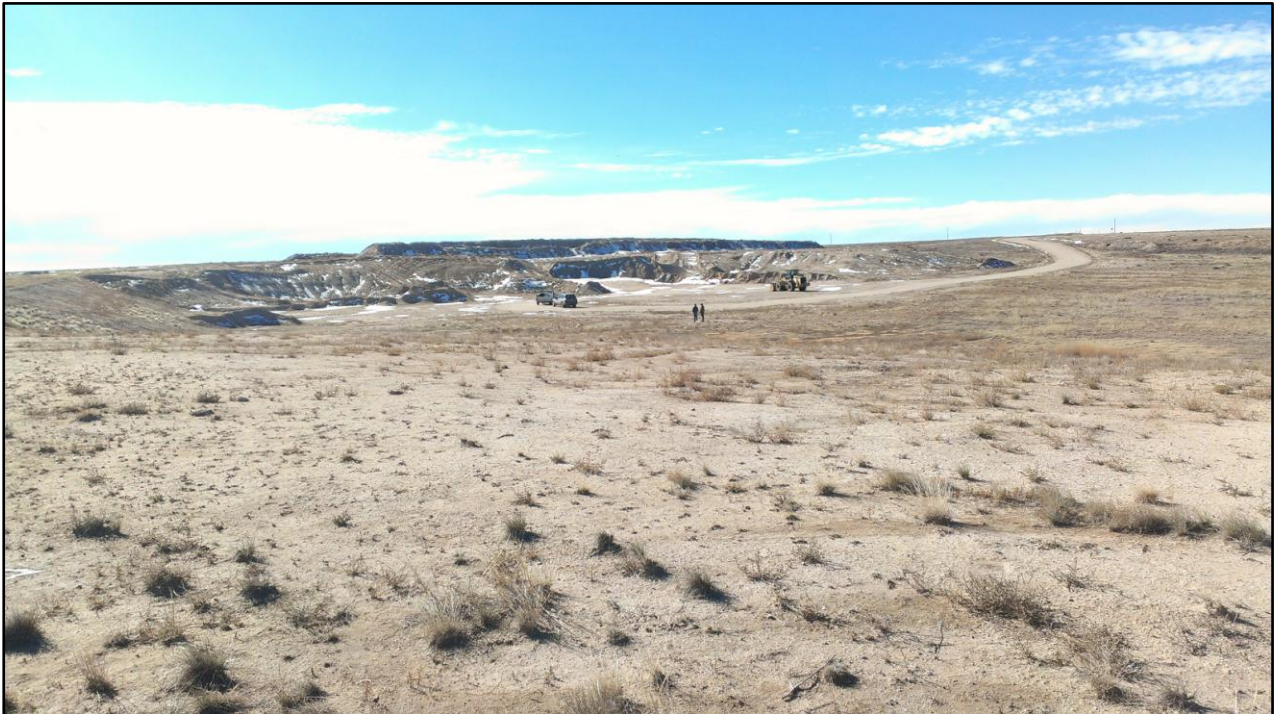
**Photo 10.** View looking south from northern mined slope, showing upper portion of northern slope where establishing desired vegetation has been more difficult.

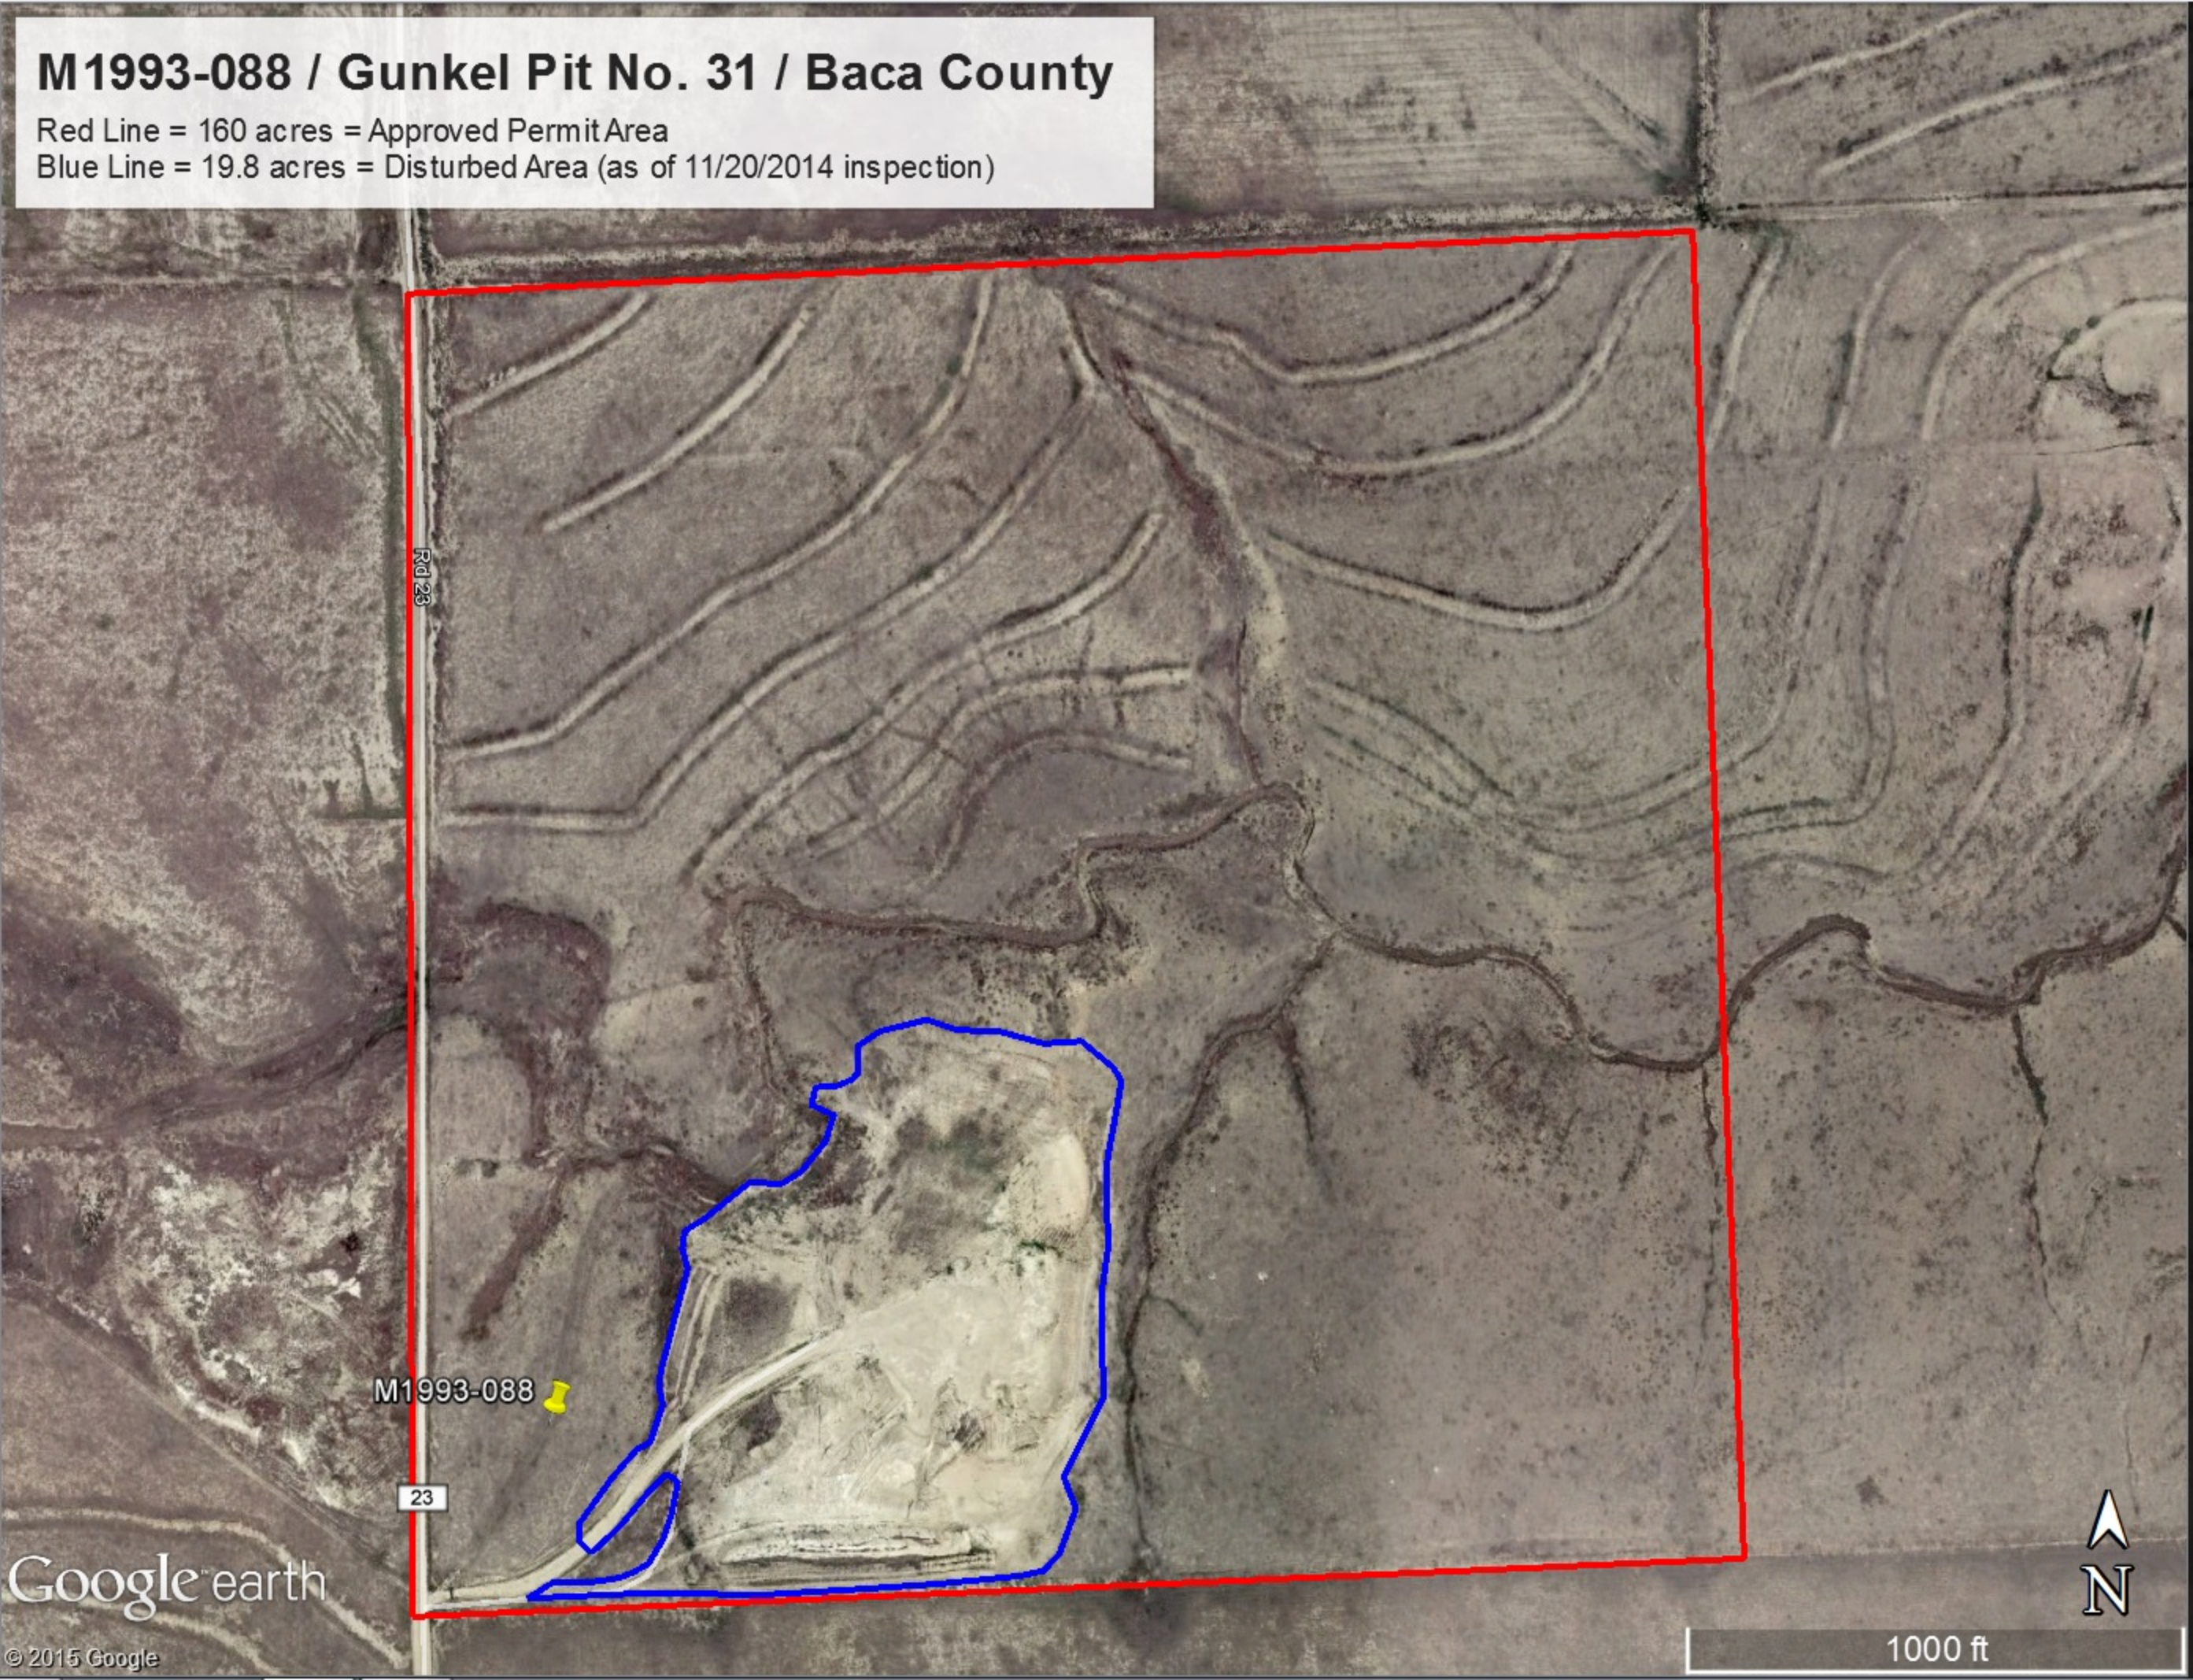
The Division estimates that approximately 19.8 acres have been disturbed by this operation (see enclosed Google Earth image of site), which is in compliance with the maximum allowed disturbance. However, before expanding the pit much farther, the operator will need to either fully reclaim a portion of the site (according to the approved reclamation plan) or submit a Technical Revision (see enclosed form) to the approved mining plan to increase the maximum allowed disturbed acreage to more than 20 acres. Current disturbance includes a horseshoe shaped pit with mined walls mainly daylighting to the north and west (**Photo 2**), topsoil and overburden stockpiles stored above the pit along the southern permit boundary (**Photos 3 and 4**), and a separate topsoil stockpile stored immediately north of the main access road (**Photo 5**). The topsoil and overburden stockpiles appeared to be stable with some vegetative cover. The southern (north-facing) highwalls are approximately 25-30 feet in height and have slope gradients of 2H:1V to 3H:1V (**Photos 6 and 7**). The eastern mined slopes were graded to mainly 4H:1V and have some native grasses volunteering across them (**Photo 8**).

Red Line = 160 acres = Approved Permit Area  
Blue Line = 19.8 acres = Disturbed Area (as of 11/20/2014 inspection)
