COLORADO DIVISION OF RECLAMATION, MINING AND SAFETY
MINERALS PROGRAM INSPECTION REPORT
PHONE: (303) 866-3567

MINE NAME: Blue Jet Mine	MINE/PROSPECTING ID#: M-1978-135-HR	MINERAL: Gold, silver and copper	COUNTY: Moffat
INSPECTION TYPE: Monitoring	INSPECTOR(S): Amy Yeldell, Russ Means	INSP. DATE: July 9, 2015	INSP. TIME: 09:00
OPERATOR: Blue Jet Mining Inc	OPERATOR REPRESENTATIVE: Orvie Zimmerman	TYPE OF OPERATION: 110(2) - Hard Rock Limited Impact

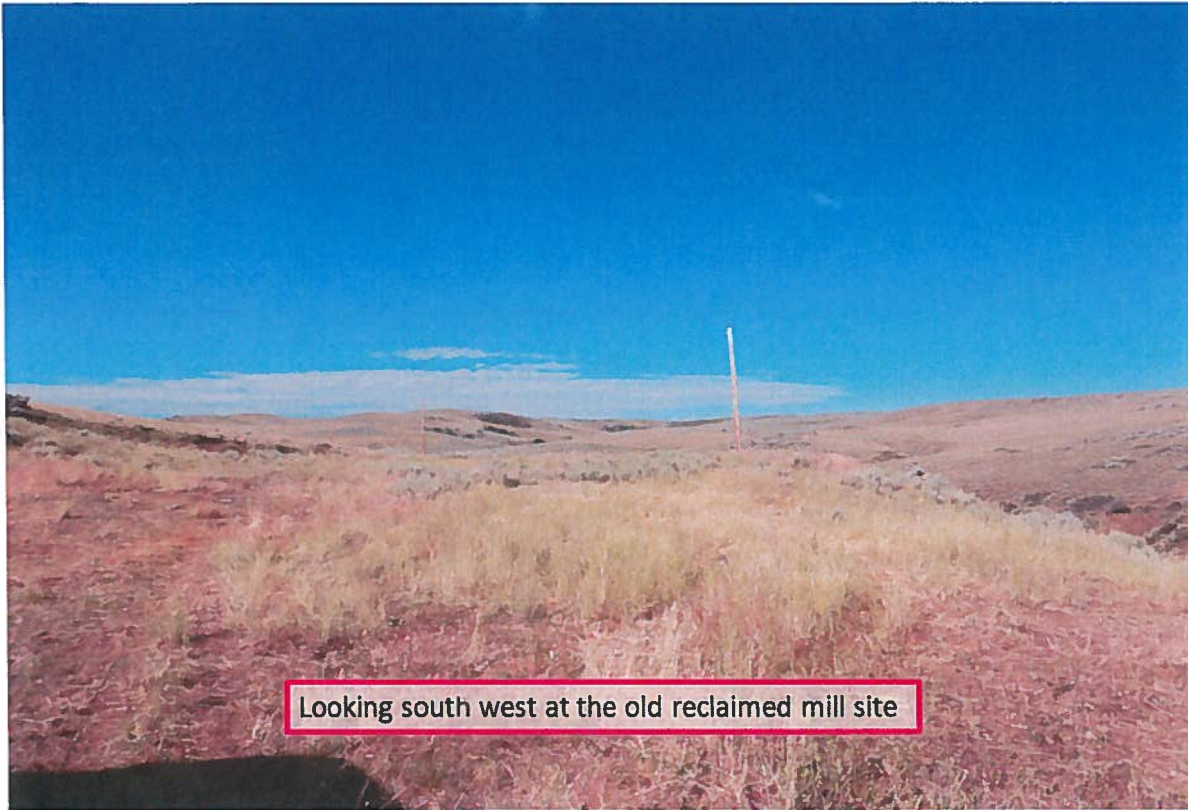
Looking south west at the old reclaimed mill site

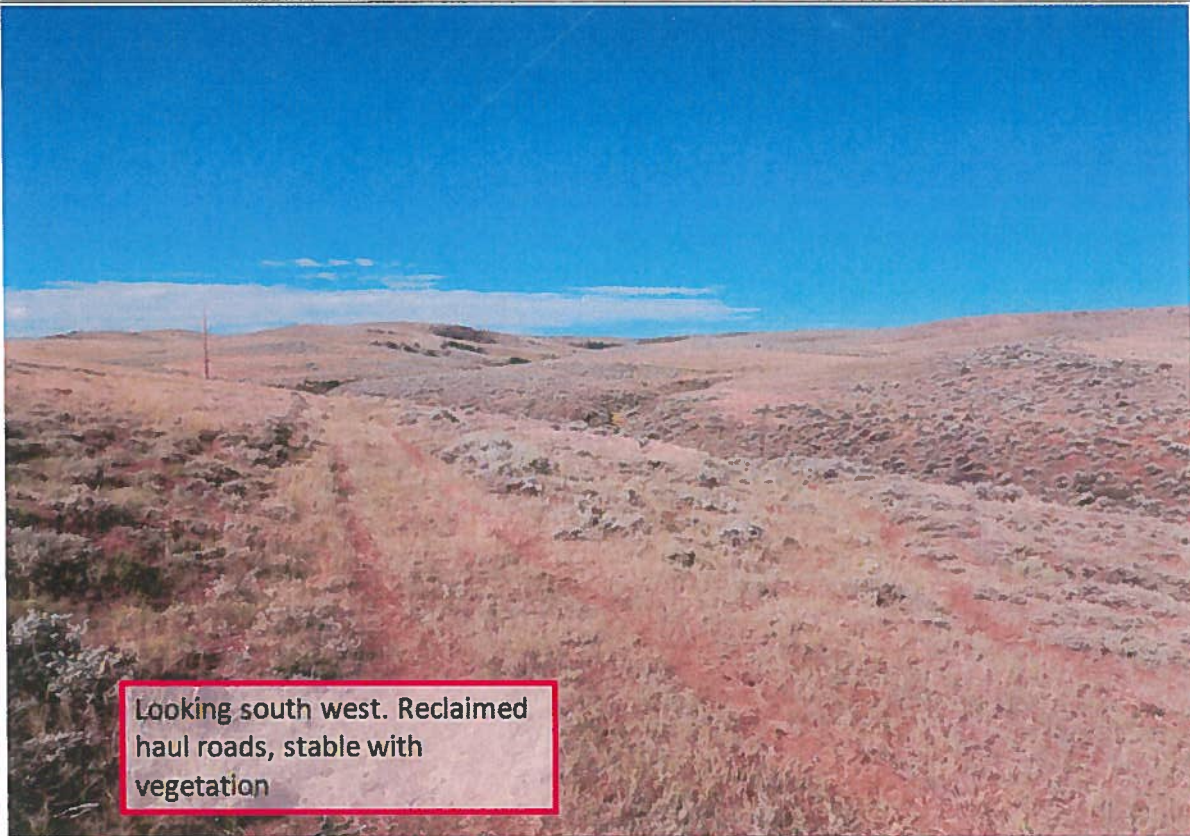
Looking south west. Reclaimed
haul roads, stable with
vegetation
