**COLORADO DIVISION OF RECLAMATION, MINING AND SAFETY**  
**MINERALS PROGRAM INSPECTION REPORT**  
**PHONE: (303) 866-3567**

<b>MINE NAME:</b> Cresson Project	<b>MINE/PROSPECTING ID#:</b> M-1980-244	<b>MINERAL:</b> Gold	<b>COUNTY:</b> Teller
<b>INSPECTION TYPE:</b> Monitoring	<b>INSPECTOR(S):</b> Timothy A. Cazier	<b>INSP. DATE:</b> July 21, 2015	<b>INSP. TIME:</b> 10:00
<b>OPERATOR:</b> Cripple Creek & Victor Gold Mining Company	<b>OPERATOR REPRESENTATIVE:</b> Chris Hanks	<b>TYPE OF OPERATION:</b> 112d-3 - Designated Mining Operation

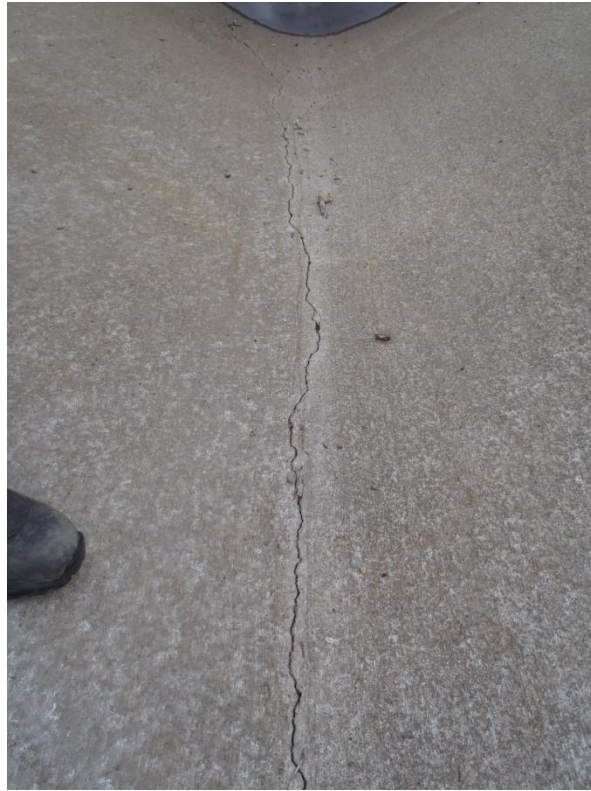
Ron DiDonato was on site for the Squaw Gulch underdrain pond inspection. Small cracks were observed in all four corners of each of the two ponds (see **Photo 1**), but not in the overflow chute between the two ponds (see **Photo 2**). Mr. DiDonato explained the standing water in the ponds (see **Photo 3**) would be pumped out prior to installing the GCL/geomembrane liner approved by the Division as part of TR-74. The liner installation should be completed in less than a week's time. He also pointed out the location of the proposed pumpback pump enclosure (see **Photo 4**) between the upgradient pond and the stormwater diversion ditch at the toe of the Hwy 67 embankment. Mr. DiDonato confirmed the mine would provide a quality assurance certification report for the installation of the liner; separate from the SGVLF Phase I certification report. The pumpback line had been installed and buried in a trench along the north Hwy 67 embankment contact (see **Photo 5**).

Photo 1. Typical small crack observed in corners of each underdrain pond.

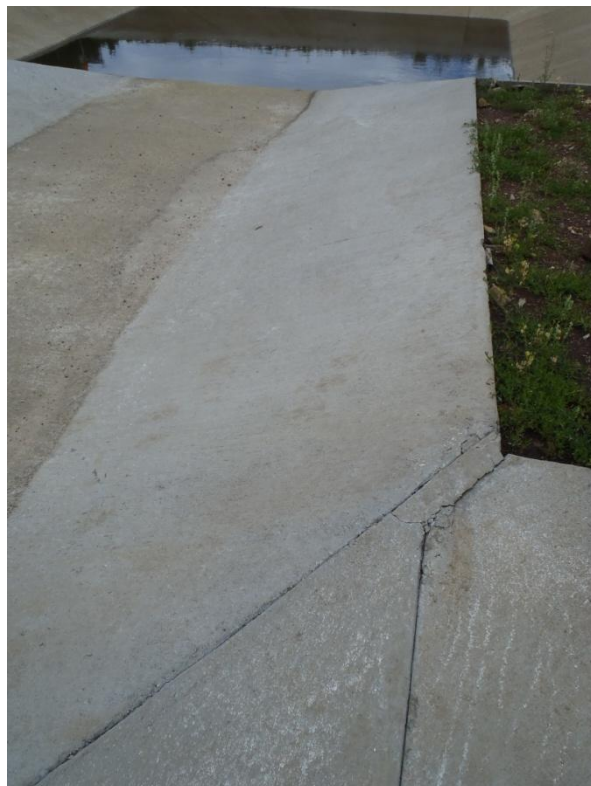
Photo 2. No cracks observed in underdrain overflow chute.

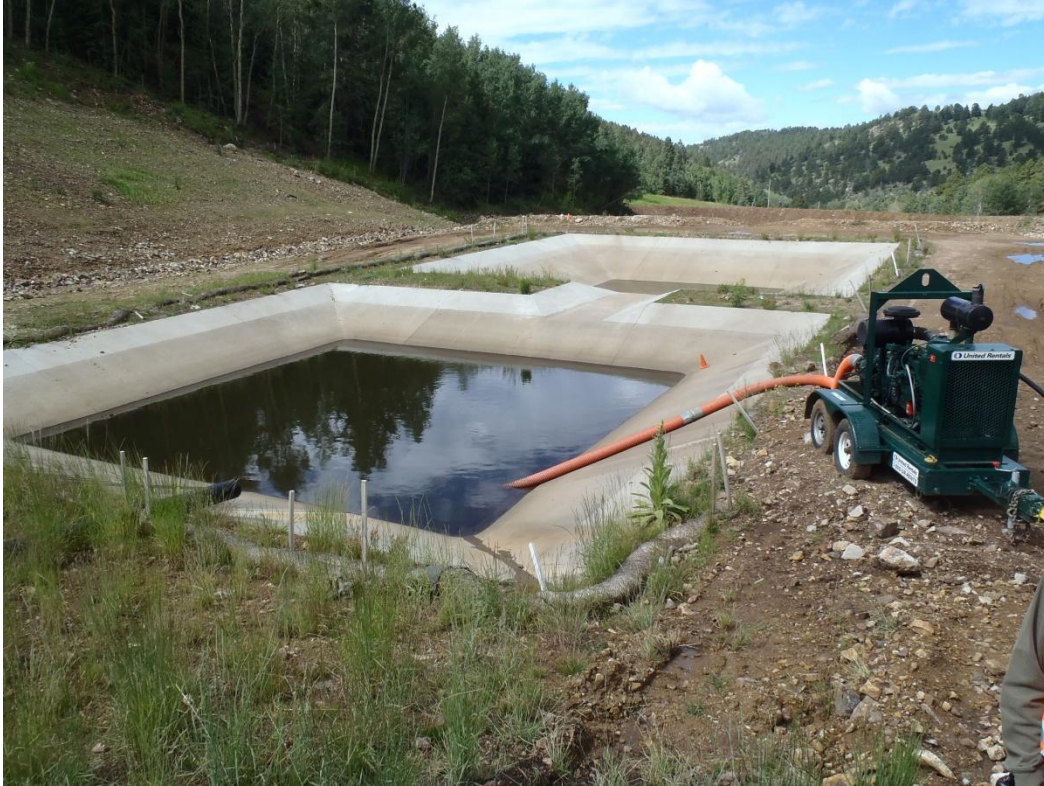
Photo 3. Temporary pump setup for underdrain ponds (looking south).

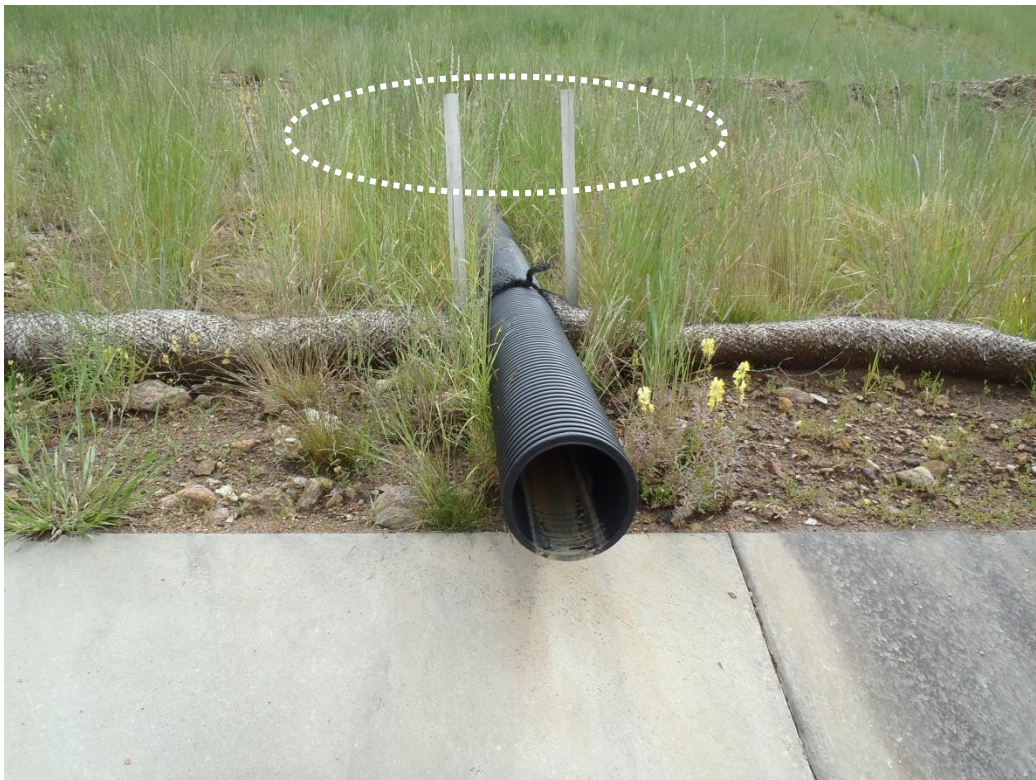
Photo 4. Location of proposed pumpback pump enclosure (looking NE).

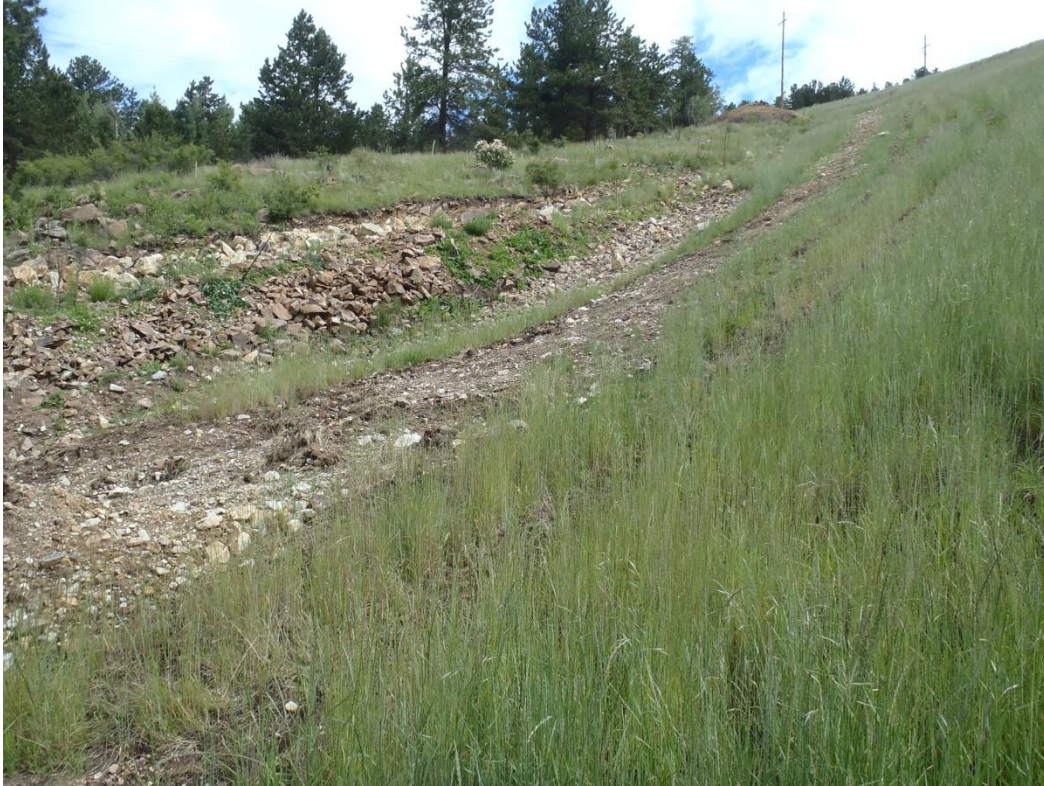
Photo 5. Pumpback line trench along the north Hwy 67 embankment contact (looking north).

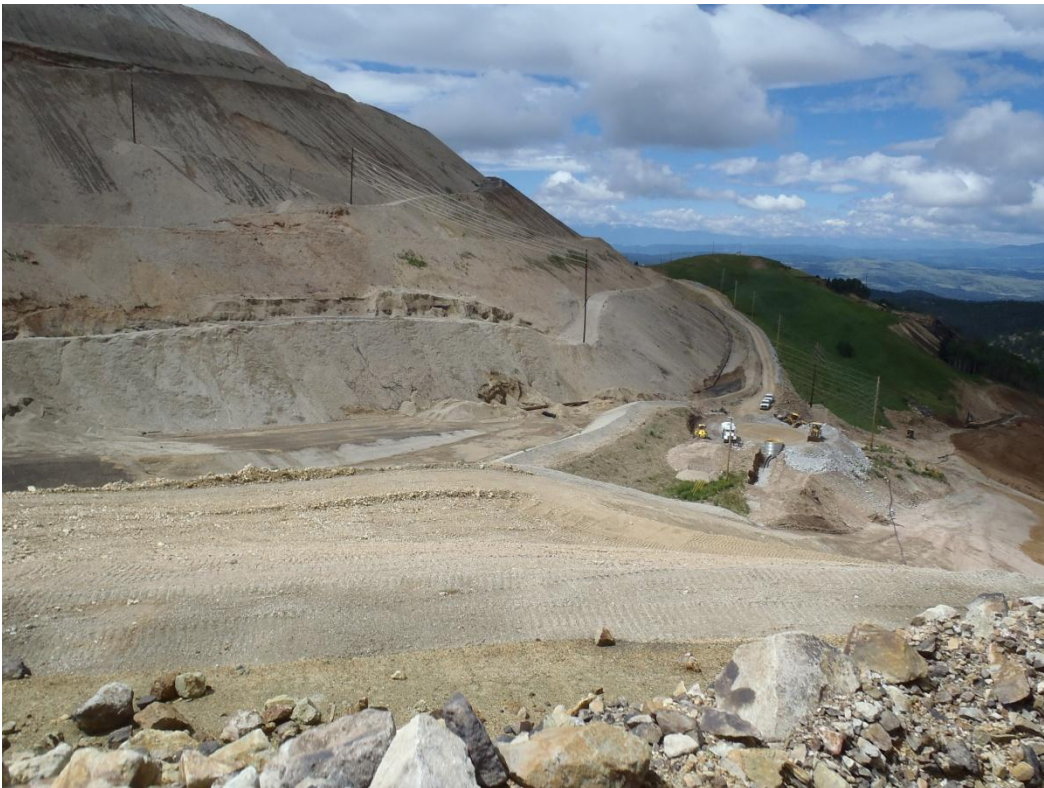
Jeff Winterton was on site for the Mill Platform Area Drain Line Containment Area inspection. Mr. Winterton explained the temporary setup for conveying water collected in mill area sumps CB-3, CB-4, and CB-5 (west to east) to the SGVLF approved Pregnant Solution Storage Area (PSSA) necessary until the SGVLF Phase I and II liner is tied into the mill platform liner. As Mr. Winterton explained, some mill process water gets combined with meteoric water in the mill area. This water is collected in sumps CB-3, CB-4, and CB-5, the drained via gravity in the CPE Storm Drain ultimately through the HGM Drain Line to the Mill Platform Area Drain Line Containment Area (see **Photo 6**), where it was transferred to the SGVLF PSSA. However, due to the low acidity, precipitates were clogging the drain pipes. The mine is now pumping approximately 100 gpm of the low acidity water (pH ~ 4) directly from CB-3 (see **Photo 7**) to the SGVLF PSSA. This will no longer be necessary once there is an approved continuous liner between the PSSA and the mill area liner.

Photo 6. Mill Platform Area Drain Line Containment Area (looking west).

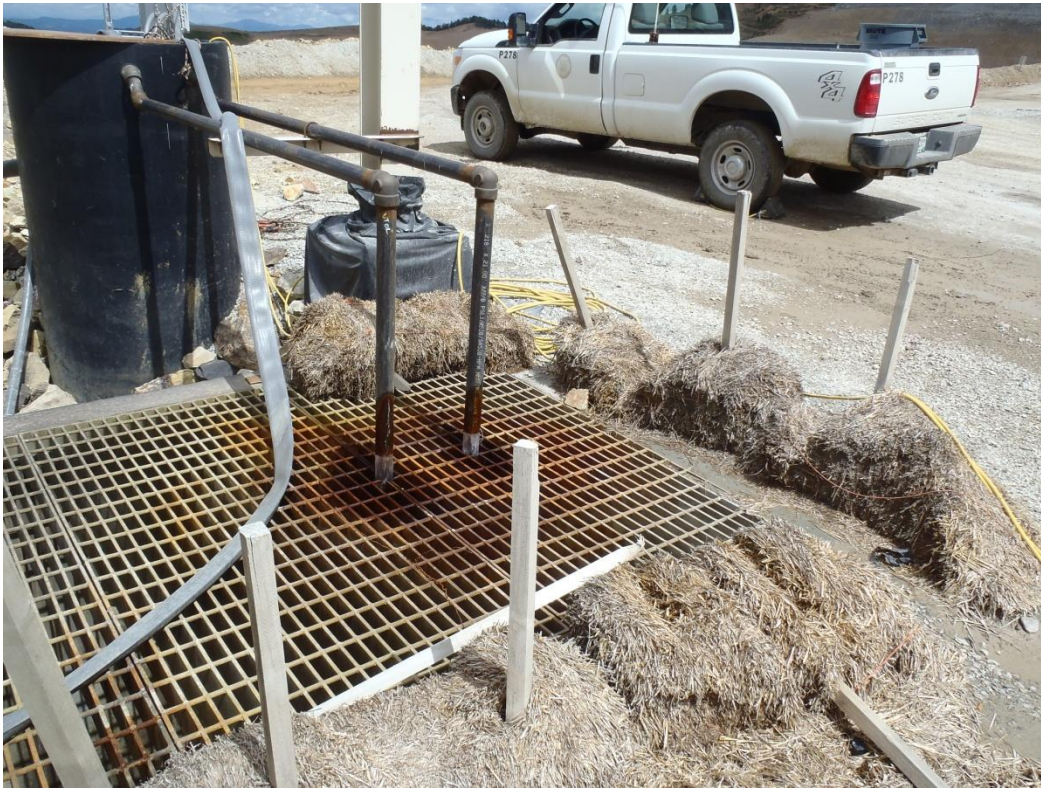
Photo 7. Mill Platform Area sump CB-3 (looking north).

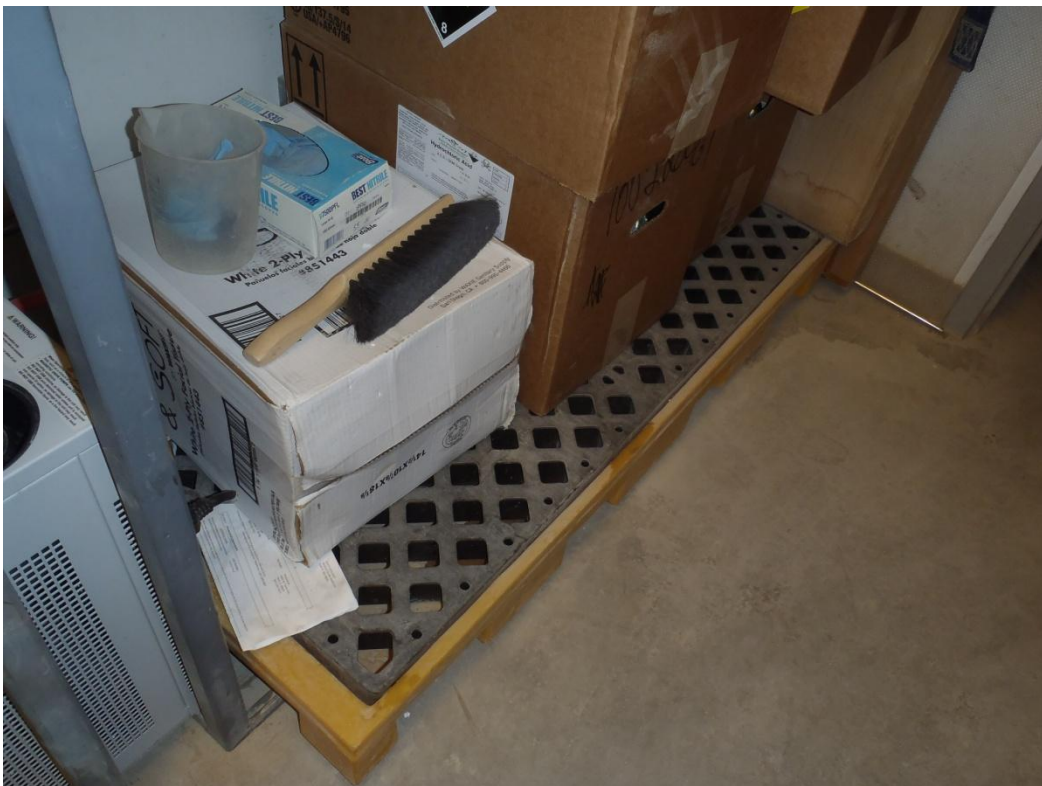
A mine representative familiar with each respective facility escorted this inspector through and around both buildings. The Division noted proper secondary containment protocols in place, such as in the reagent storage area of the assay lab (see **Photo 8**) and that the majority of containers stored outside were labeled properly (see **Photo 9**). This inspector noted labels on some five-gallon buckets used for storing purchased inert gravel (used in some lab testing) had worn off.

Photo 8. Secondary containment in the Assay Lab reagent storage area.

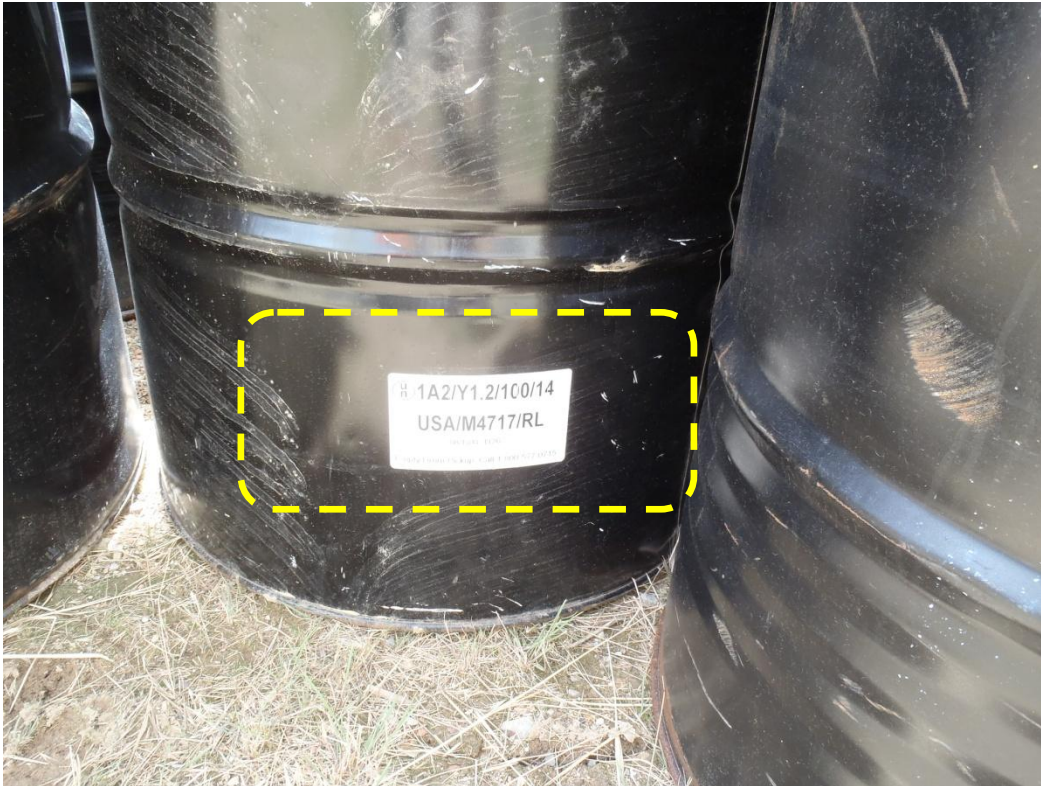
Photo 9. Labeled 55-gallon drums outside ADR / no leaks were observed.

- 1) As most, but not all the containers in the area outside the assay lab, the Division recommends the mine review their hazard communication and materials handling plans to ensure proper labeling, storage and segregation of used materials is practiced.
- 2) Due to the unexpected constant water levels recorded by the Division during the last five water level inspections, the Division recommends verifying the Phase II Pond Piezometer is functioning properly. Therefore, the Division requests the mine's logs be available for review during the August 2015 inspection.

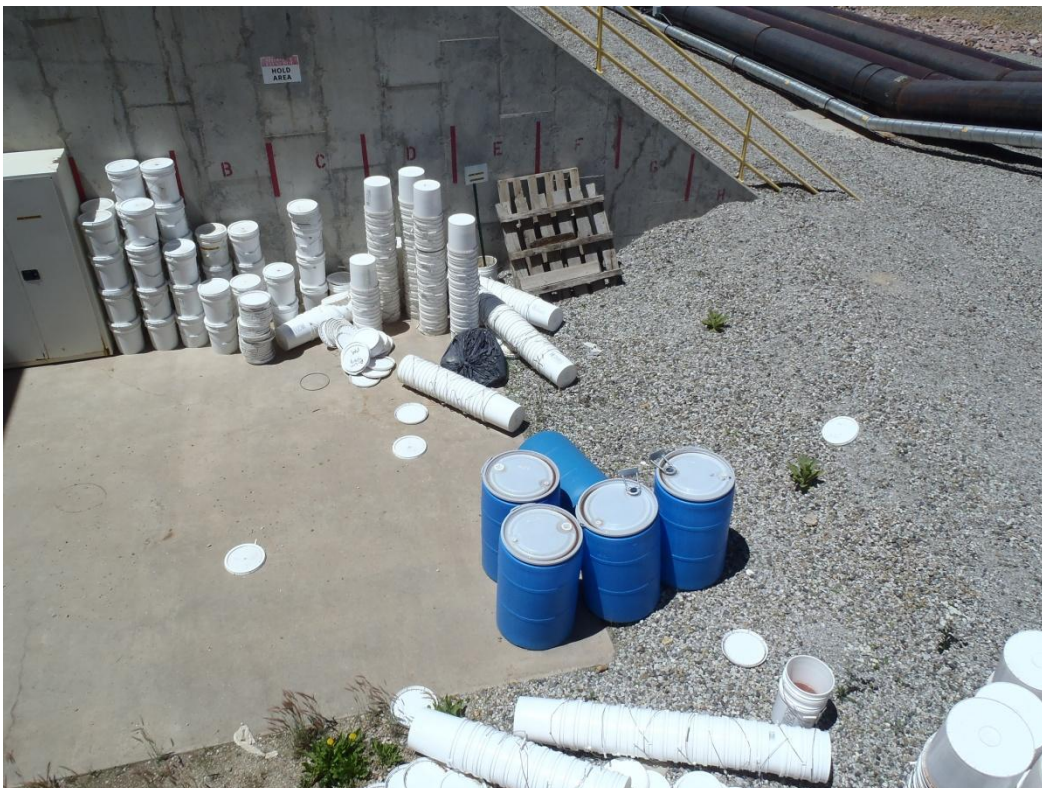
Mine personnel were assigned to marking those containers prior to this inspector leaving the facility. This inspector observed some large blue plastic drums (see **Photo 10**) on the north side of the assay lab. The lab representative was unsure what was inside and opened one up to reveal it contained small bags of drill cuttings. Because of the uncertainty of its contents and the proximity to the lab where potentially hazardous substances are used, the Division recommends all containers be labeled (even with "Non-hazardous Material" or "Inert Material" if appropriate) and properly segregated in order to avoid accidental exposure. No leaking or damaged containers were observed.

Photo 10. Large blue plastic drums on the north side of the assay lab.
