COLORADO DIVISION OF RECLAMATION, MINING AND SAFETY
MINERALS PROGRAM INSPECTION REPORT
PHONE: (303) 866-3567

MINE NAME: Mule Creek Pit	MINE/PROSPECTING ID#: M-2000-077	MINERAL: Gravel	COUNTY: Teller
INSPECTION TYPE: Monitoring	INSPECTOR(S): Timothy A. Cazier	INSP. DATE: July 7, 2015	INSP. TIME: 10:35
OPERATOR: PK Enterprises, Inc.	OPERATOR REPRESENTATIVE: Greg Loop	TYPE OF OPERATION: 112c - Construction Regular Operation

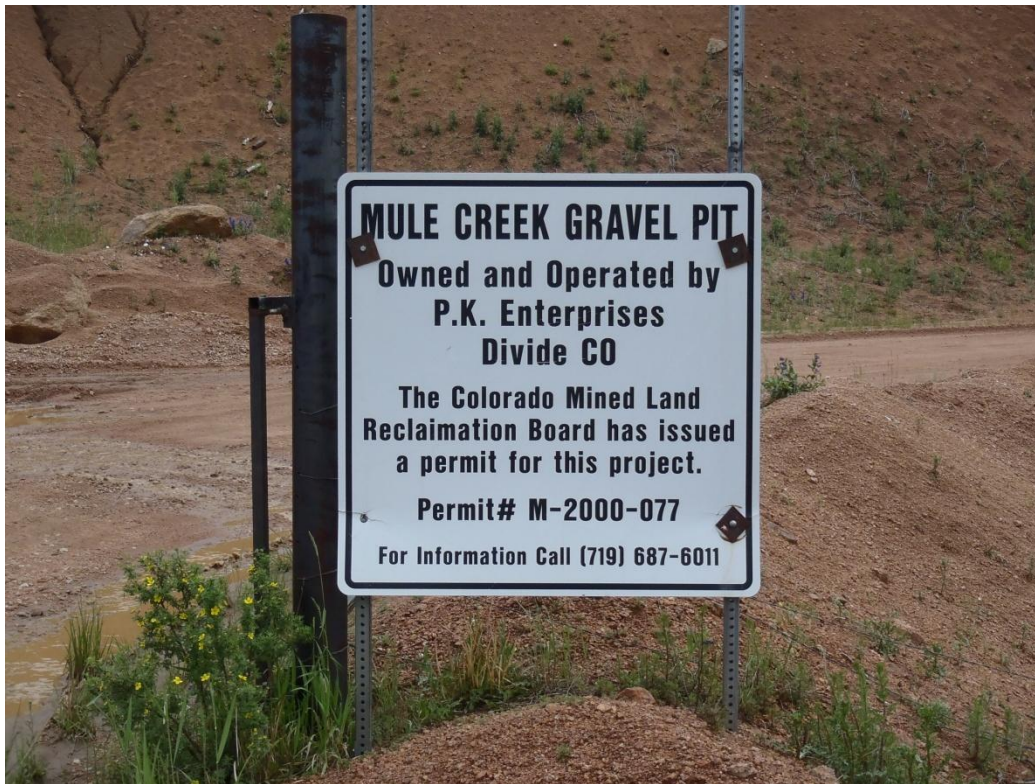
Markers & Boundary – A permit sign was displayed at the site entrance (see **Photo 1**). Due to recent heavy rains the upper portion of the pit could not be accessed safely. Mr. Loop described the boundary markers and pointed out the visible portion of the north boundary fence (see **Photo 2**).

Photo 1. Permit identification sign.

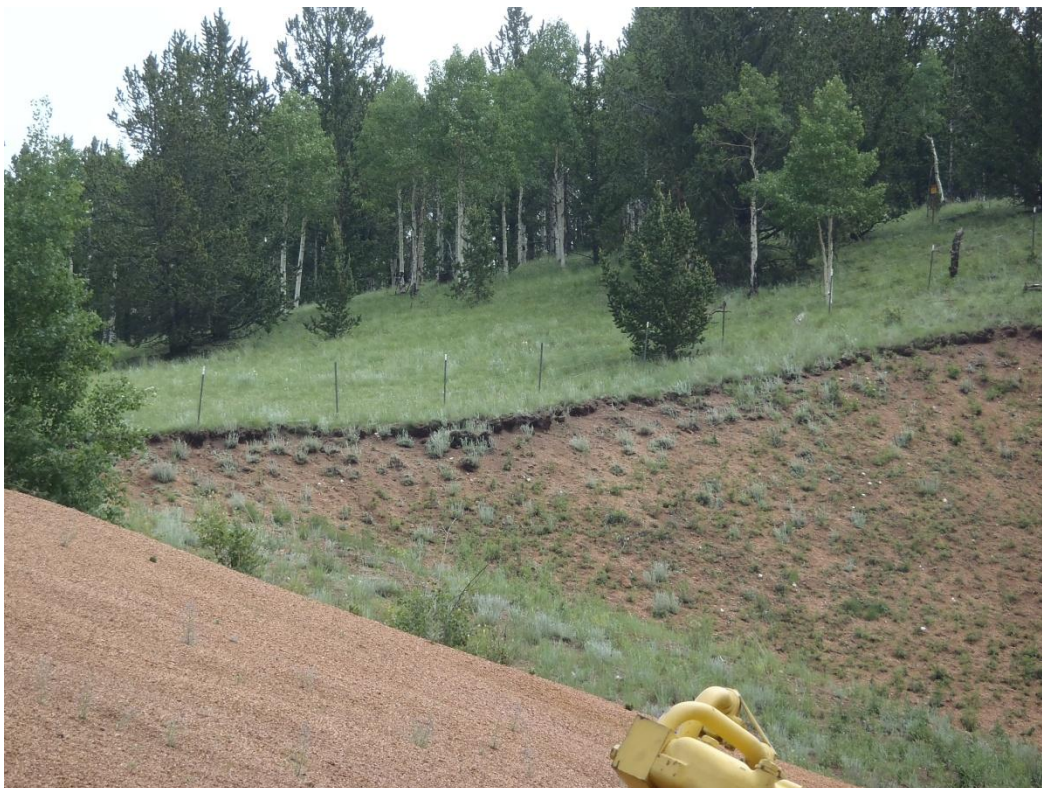
Photo 2. Typical permit boundary fence (looking north).

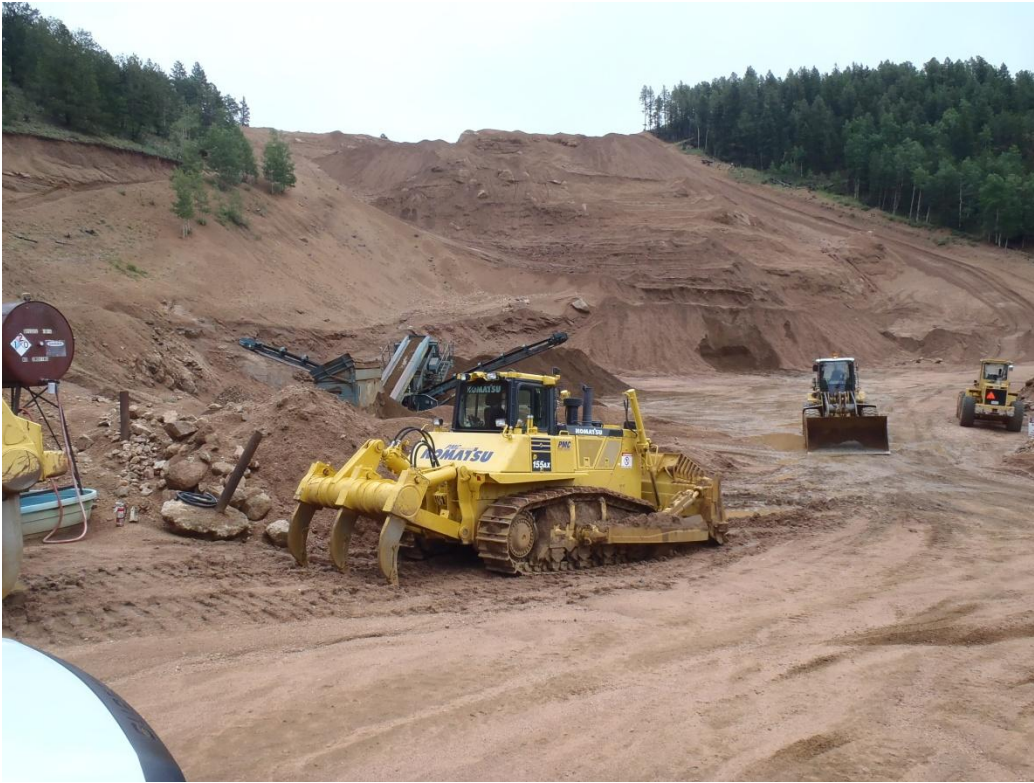
Mining Plan – The mine operation appeared to be following the approved mine plan. A large mass of unrippable rock has been exposed in the middle of the pit (see **Photo 3**), and may pose a minor challenge to the approved reclamation plan. Mr. Loop stated he was coordinating reclamation options with respect to the bedrock outcrop with Jeff Hovermale with the US Forest Service (Colorado Springs office).

Photo 3. Pit highwall – *note rock outcrop in center* (looking east).

Reclamation – No reclamation had been initiated. As noted above, some modification to the approved reclamation plan may be necessary. Mr. Loop was told a formal revision (likely a technical revision and probably not an amendment) may be required by the Division.
