COLORADO DIVISION OF RECLAMATION, MINING AND SAFETY
MINERALS PROGRAM INSPECTION REPORT
PHONE: (303) 866-3567

| MINE NAME: Fisher Pit | MINE/PROSPECTING ID#: M-1977-163-SG | MINERAL: Sand and gravel | COUNTY: Lincoln |
| INSPECTION TYPE: Surety Release Inspection | INSPECTOR(S): Amy Eschberger | INSP. DATE: July 23, 2015 | INSP. TIME: 10:45 |

| REASON FOR INSPECTION: Surety Release Requested | BOND CALCULATION TYPE: None | BOND AMOUNT: NA |

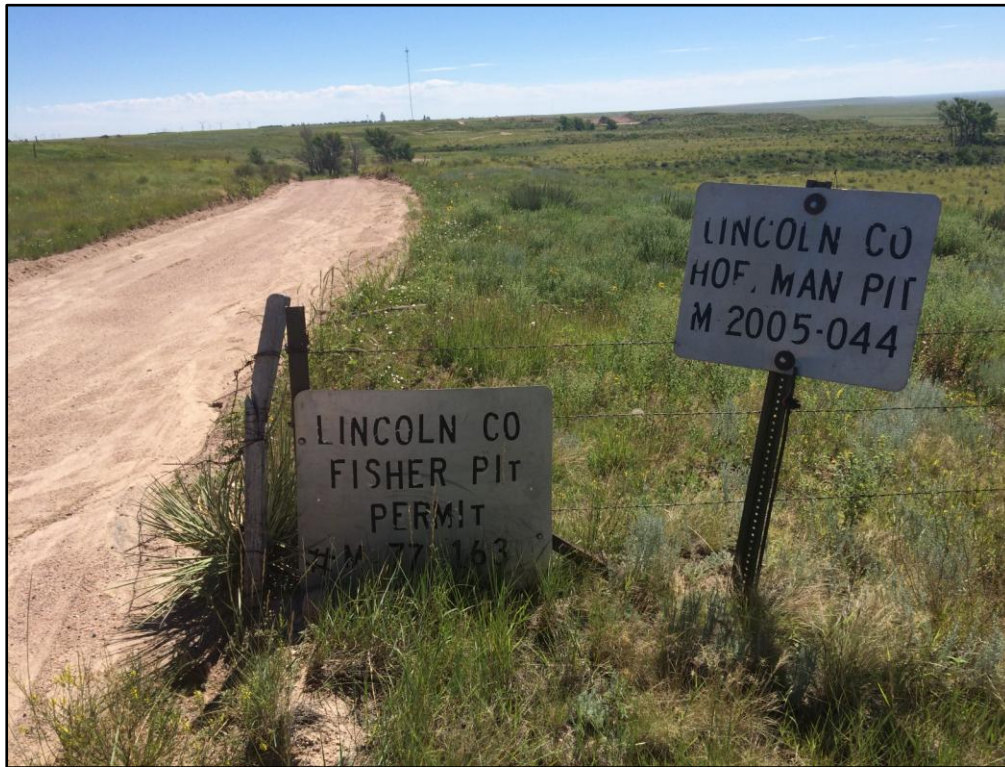
At the time of the inspection, the weather was clear, warm and sunny, and the ground was dry. A permit identification sign was posted at the main site entrance off of Co Rd 28 (**Photo 1**). The haul road that traverses the site was in use by the Hoffman Pit operation. The portion of the site located south of the haul road had slope gradients of 3H:1V or flatter, and a fairly diverse and well-established vegetative cover (**Photos 2-14**). According to the operator, disturbed land in the southern portion of the site was retopsoiled and seeded many years ago, with some interseeding completed by the county since that time. Vegetation in these areas now includes a fairly dense stand of native grasses such as blue grama, western wheatgrass, and sand dropseed, some forbs, sand sage, and yucca. Much smaller populations of yellow sweet clover, Canada thistle, wild sunflowers, horseweed, and field bindweed were also present amongst the grasses and shrubs, but did not appear to be hindering the growth of desired vegetation. There were portions of the southeastern ridge tops where bedrock was outcropping at the ground surface. These areas had less vegetative cover due to the rocky surface. However, these more sparsely vegetated areas were negligible compared with the rest of the fairly densely vegetated southern portion of the site. The Division has determined that the southern portion of the site (south of the haul road) and the northwestern portion of the site (north of the haul road) have been reclaimed in accordance with the approved reclamation plan, and are releasable at this time.

Photo 1. View of permit sign posted at main site entrance off of Co Rd 28. Note adjacent permit sign posted for Hoffman Pit, accessed by the same road.

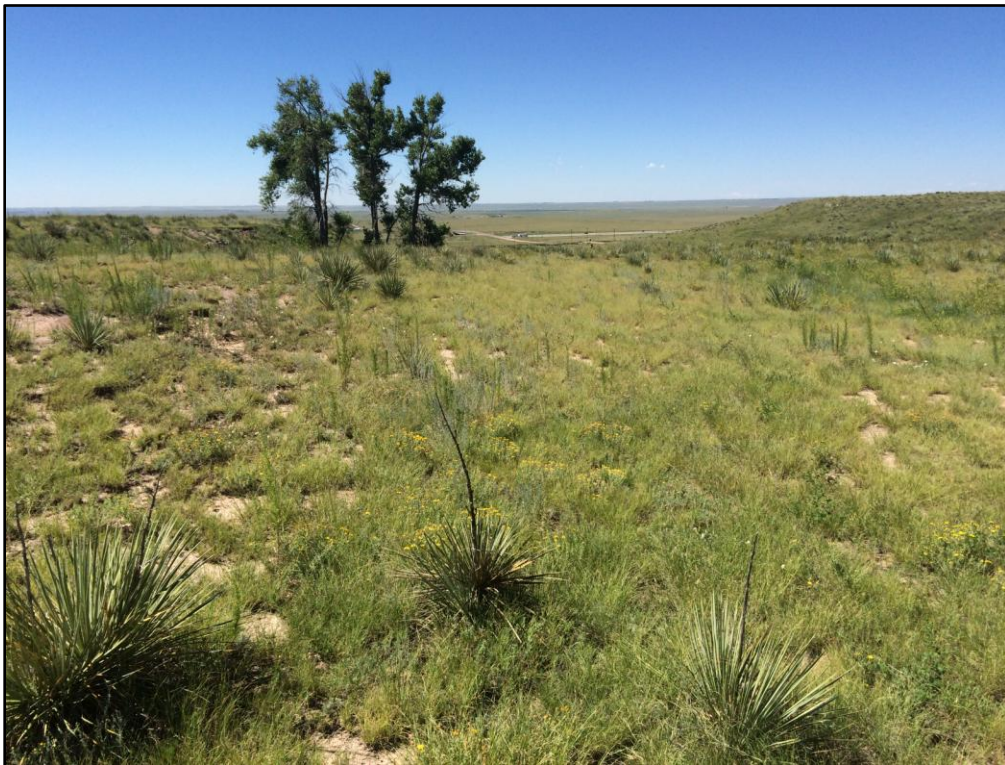
Photo 2. View looking south across reclaimed southwestern portion of site.

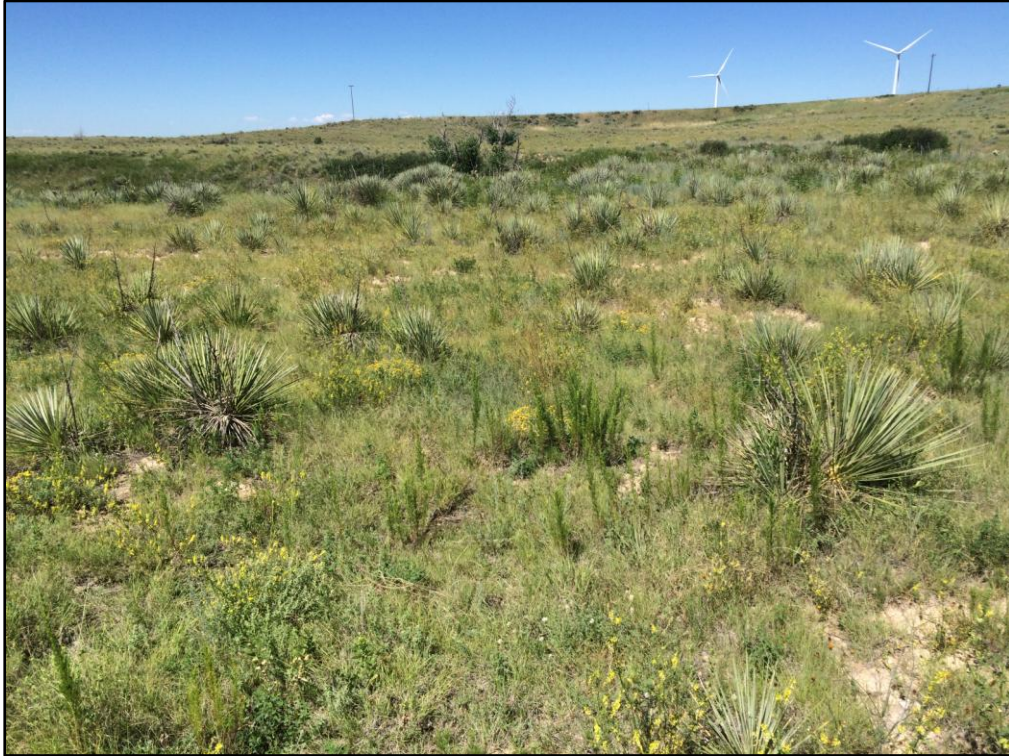
Photo 3. View looking west across reclaimed southwestern portion of site.

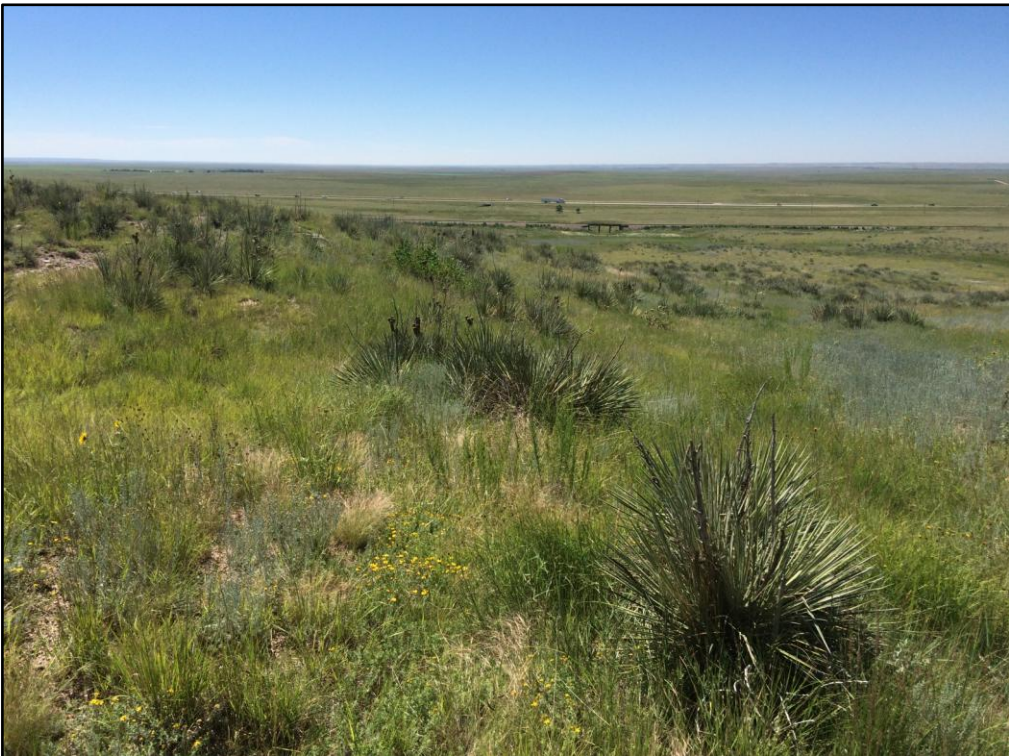
Photo 4. View looking south across reclaimed southwestern portion of site.

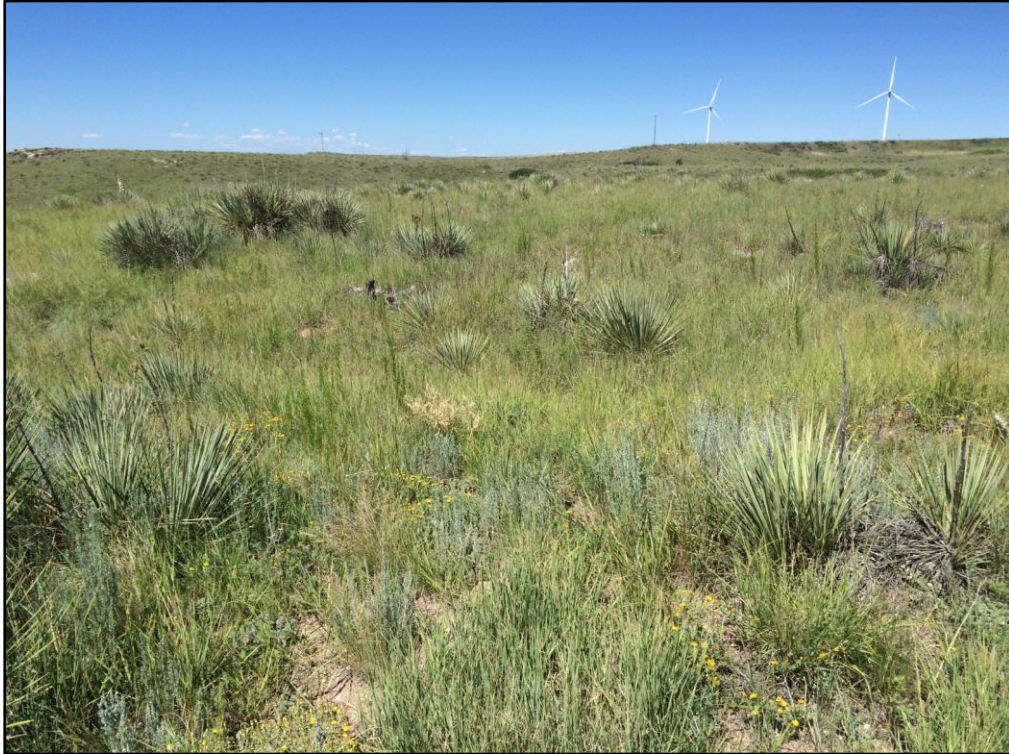
Photo 5. View looking west across reclaimed southern portion of site.

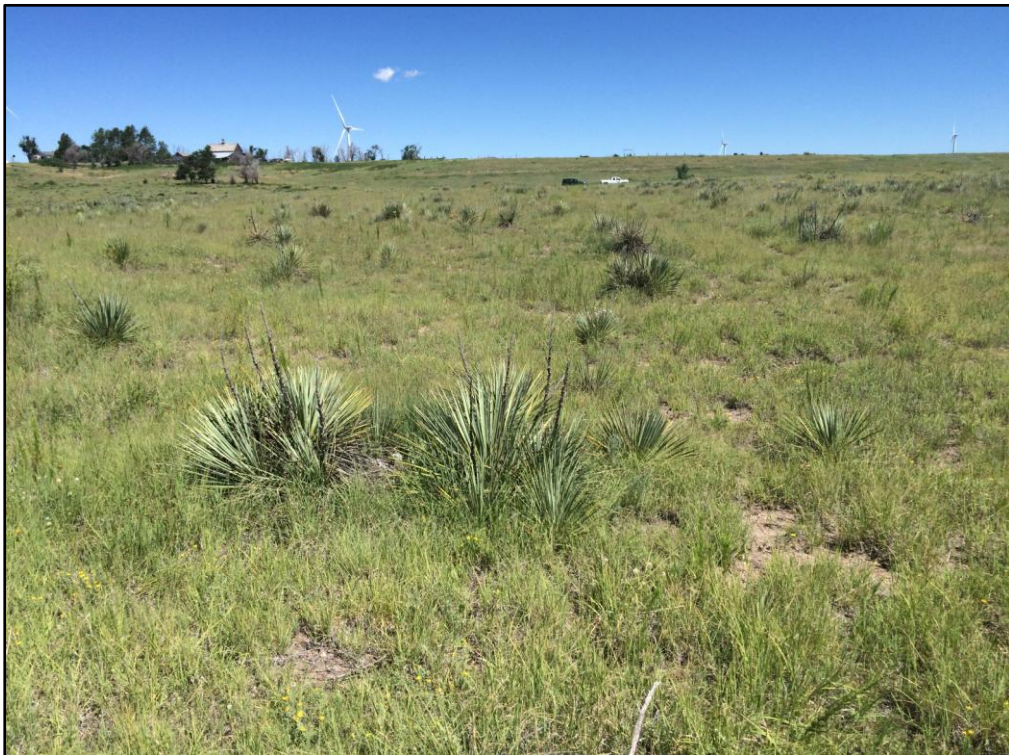
Photo 6. View looking northwest across reclaimed southern portion of site.

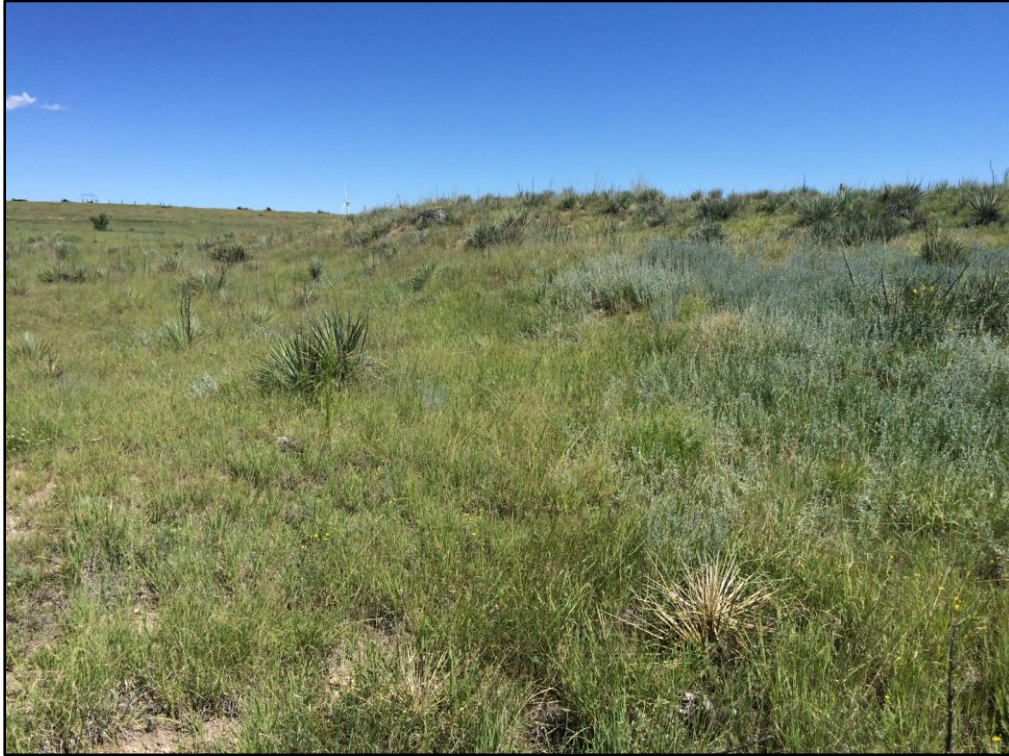
Photo 7. View looking west across reclaimed southern portion of site.

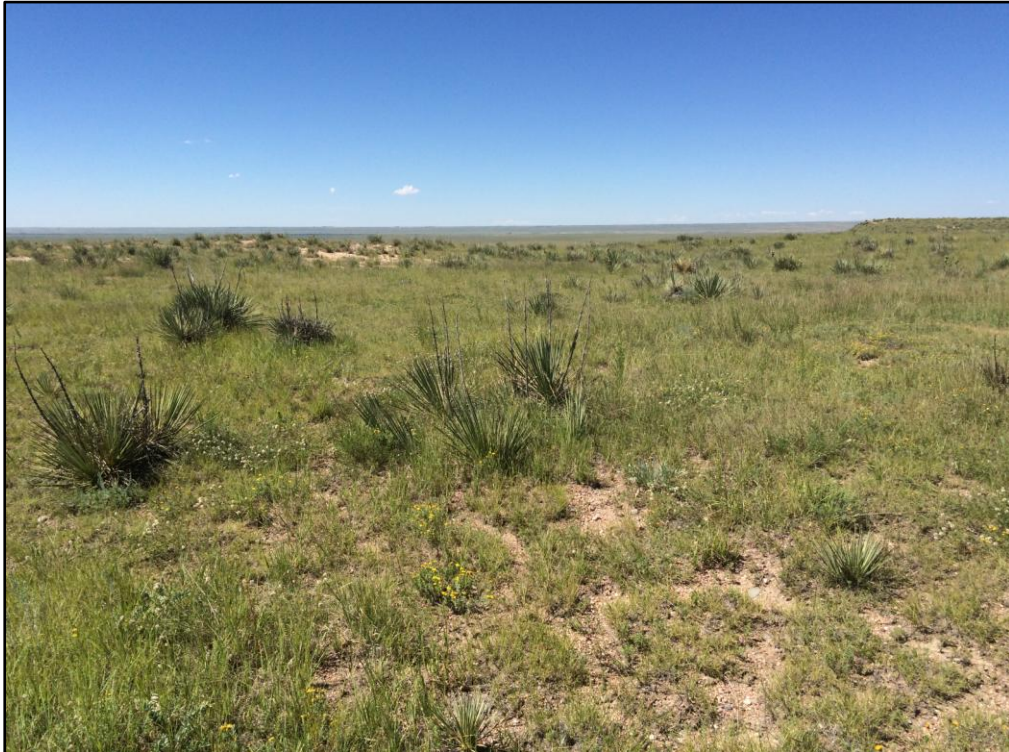
Photo 8. View looking south across reclaimed southern portion of site.

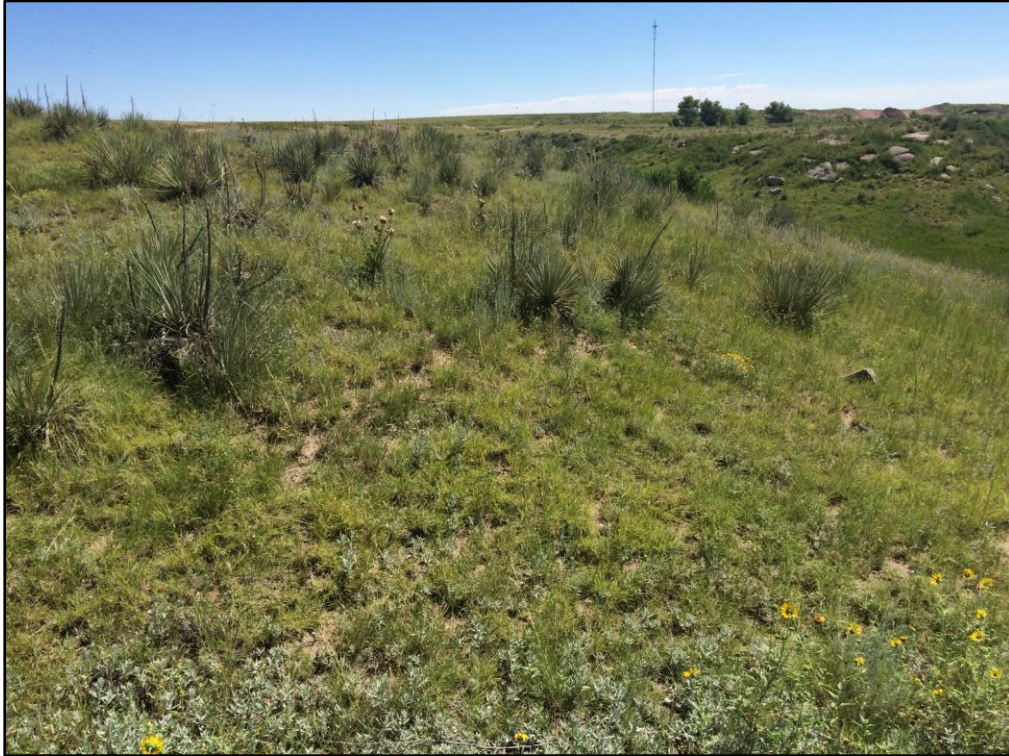
Photo 9. View looking east across reclaimed central portion of site.

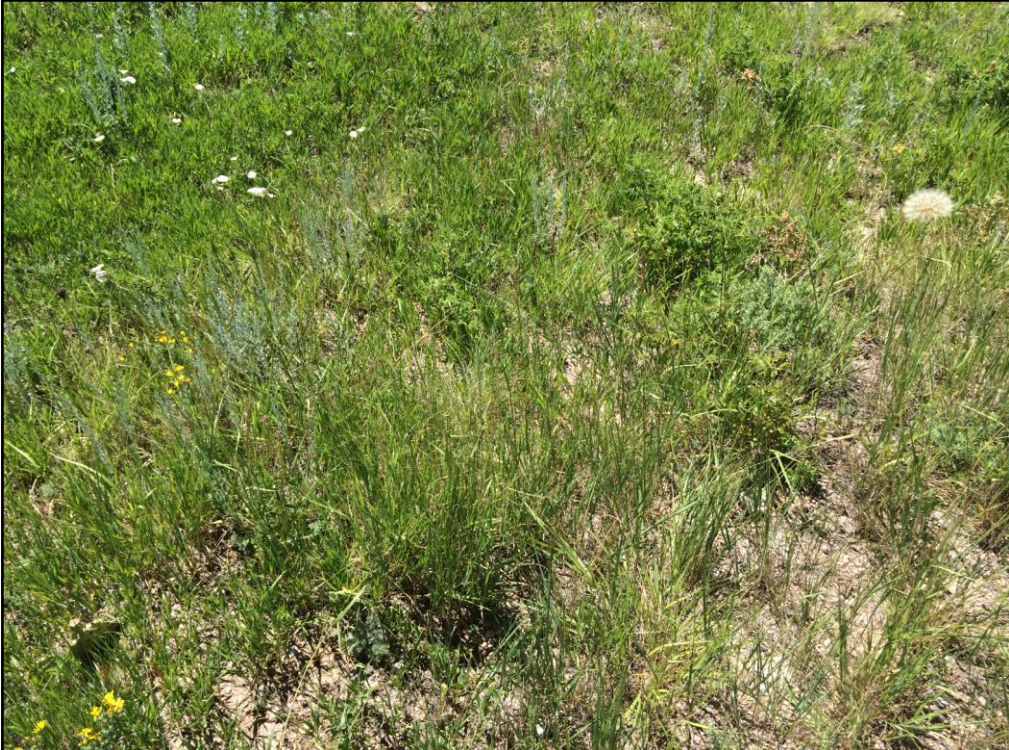
Photo 10. Representative close-up view of vegetation present in reclaimed southern portion of site.

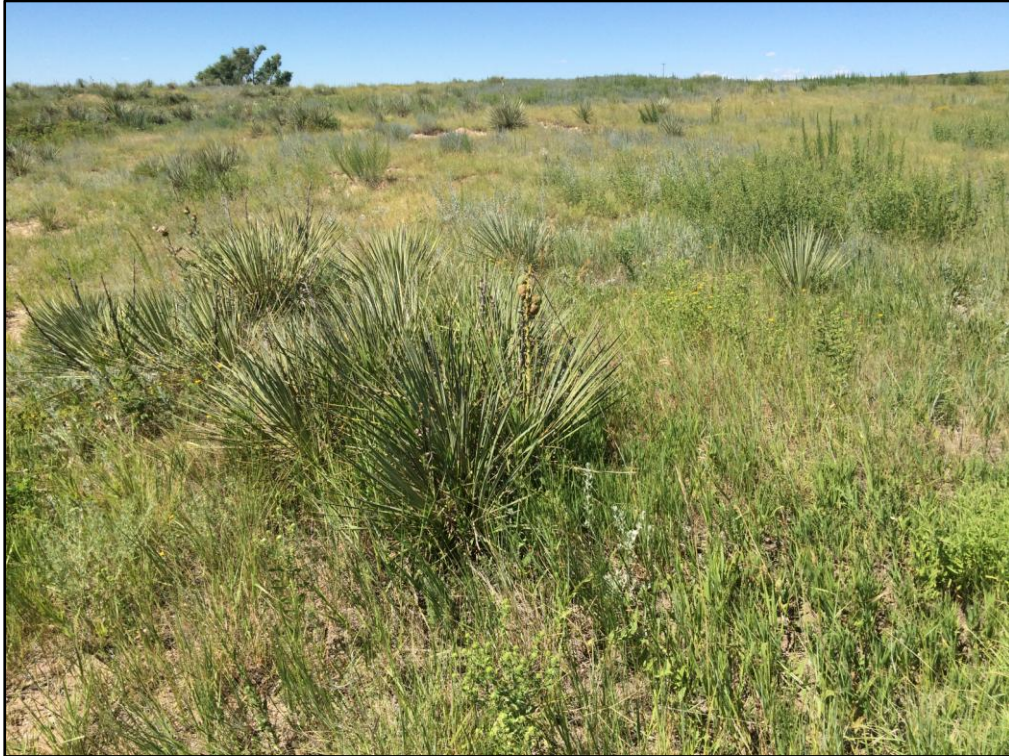
Photo 11. View looking west across reclaimed southeastern portion of site.

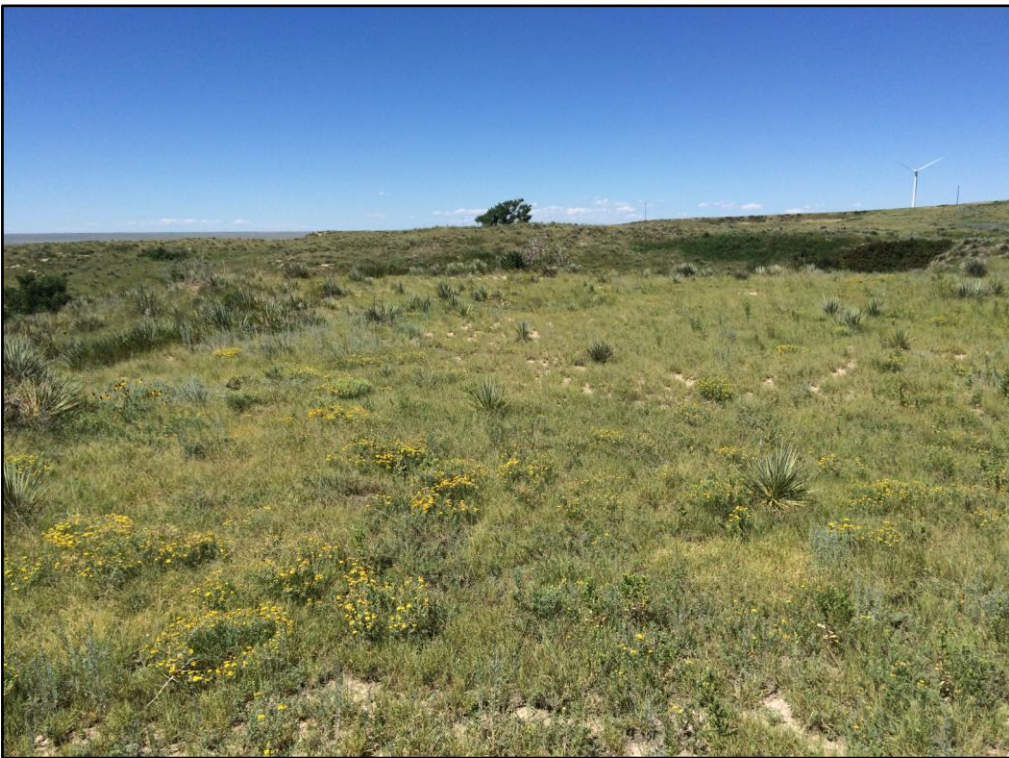
Photo 12. View looking west across reclaimed southeastern portion of site.

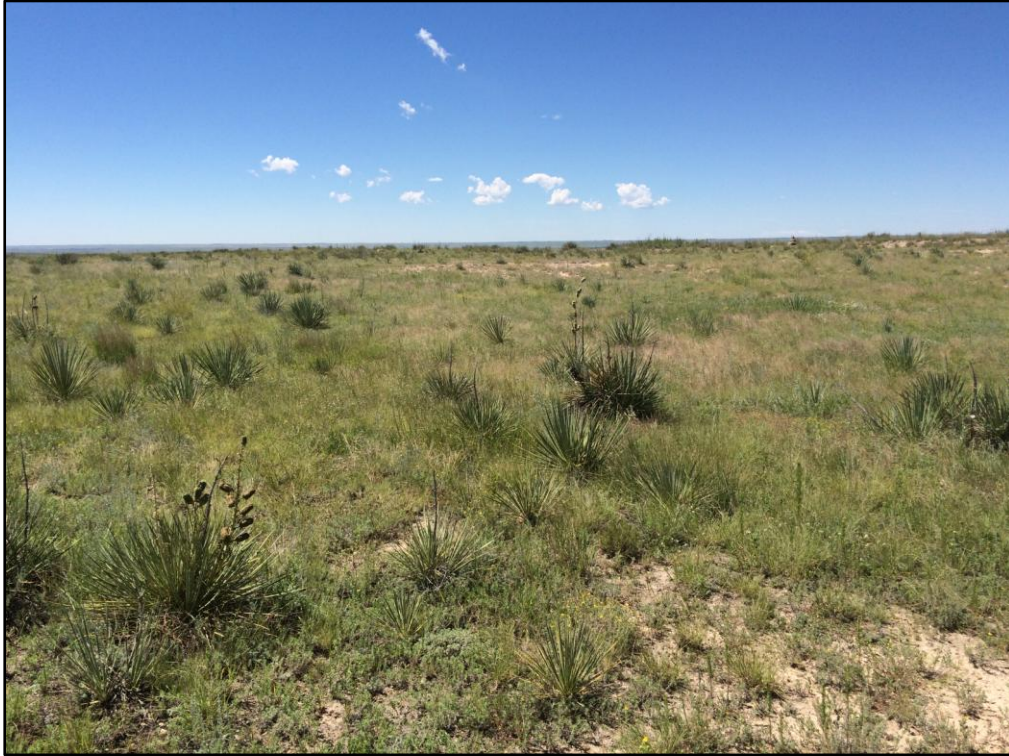
Photo 13. View looking south across reclaimed southeastern portion of site.

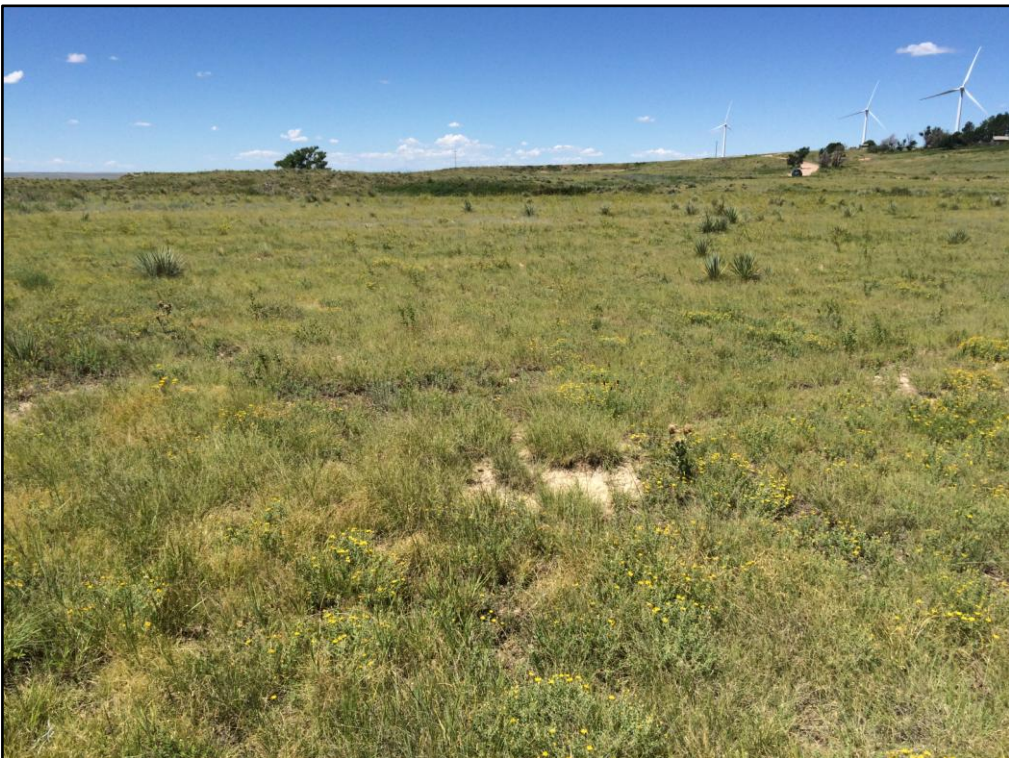
Photo 14. View looking northwest across reclaimed southeastern portion of site.

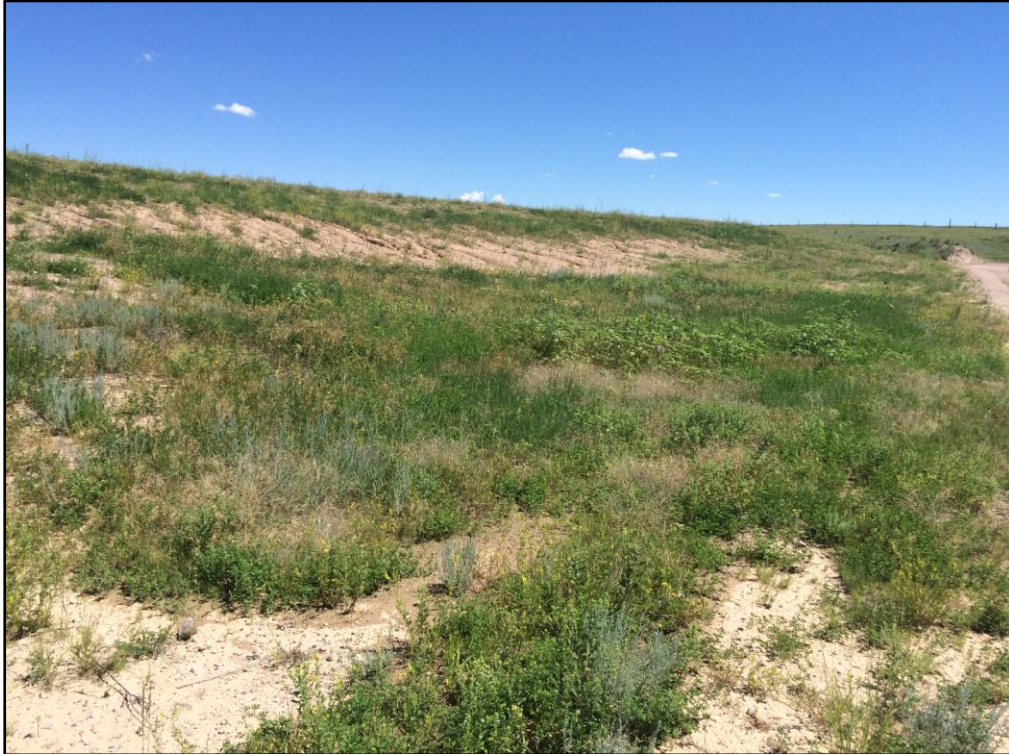
The most recently mined northeastern portion of the site showed different results from reclamation efforts. The south- and southwest-facing mined slopes were graded to 3H:1V or flatter, and appeared to be stable with some vegetative cover. However, the vegetation in these areas consisted primarily of yellow sweet clover and weeds such as field bindweed (**Photos 15-22**). There were some grasses growing in these areas, but not much along the slopes (see **Photo 20**). According to the operator, topsoil was never replaced in this area. This might at least partially explain the difference in vegetative growth here compared with the areas south of the haul road where grass establishment was more successful. The Division has determined that the northeastern portion of the site is not releasable at this time. The Division recommends the operator replace topsoil in this area, particularly along the slopes, and reseed with the approved seed mixture. This area will also require proper weed control and management to keep the weeds from outcompeting the grasses. A topsoil stockpile remains on site just southwest of the mined area north of the haul road. According to the operator, the previous landowner requested that the stockpile not be disturbed due to its grass cover. This stockpile is barely recognizable as it blends in well with the surrounding topography and has adequate grass growth. If this topsoil is not used for reclamation, the operator will need to import topsoil, which will require the submittal of a Technical Revision to the approved reclamation plan.

Photo 15. View looking east across south-facing mined slope located in northeastern portion of site. Note vegetation is patchy and consists primarily of weeds.

The Division will not approve the Full Release request (SL-01) submitted by the operator. However, per the Division's recommendations, the operator submitted an Acreage Reduction request on 07/27/2015 (AR-01) to release all but the northeastern portion (7.6 acres) which requires additional reclamation work. This request also states the operator's desire to withdraw the Full Release request. No objections were received by the Division within the comment period that ended on 07/11/2015. Therefore, the Division will withdraw the Full Release request and approve the Acreage Reduction request for a permit area reduction of 29.3 acres (see enclosed Google Earth image). The approval letter will be mailed to the operator under separate cover.

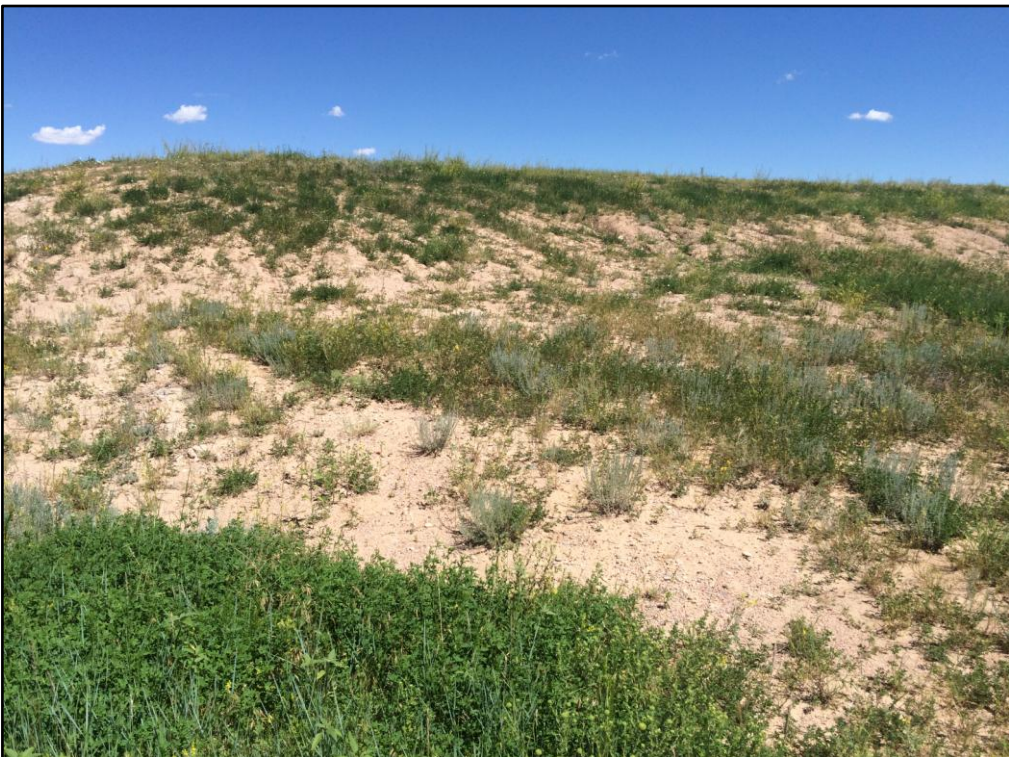
Photo 16. View looking north across south-facing mined slope located in northeastern portion of site. Note vegetation is patchy and consists primarily of weeds.

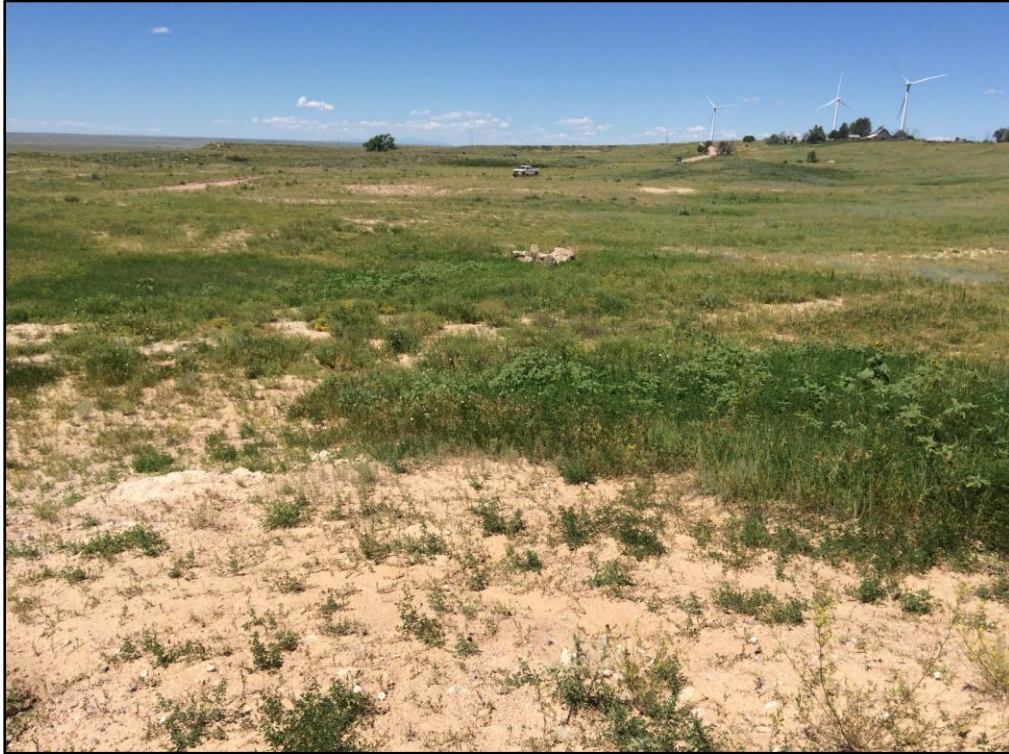
Photo 17. View looking west from top of southwest-facing mined slope located in northeastern portion of site. Note vegetation is patchy and consists primarily of weeds (foreground).

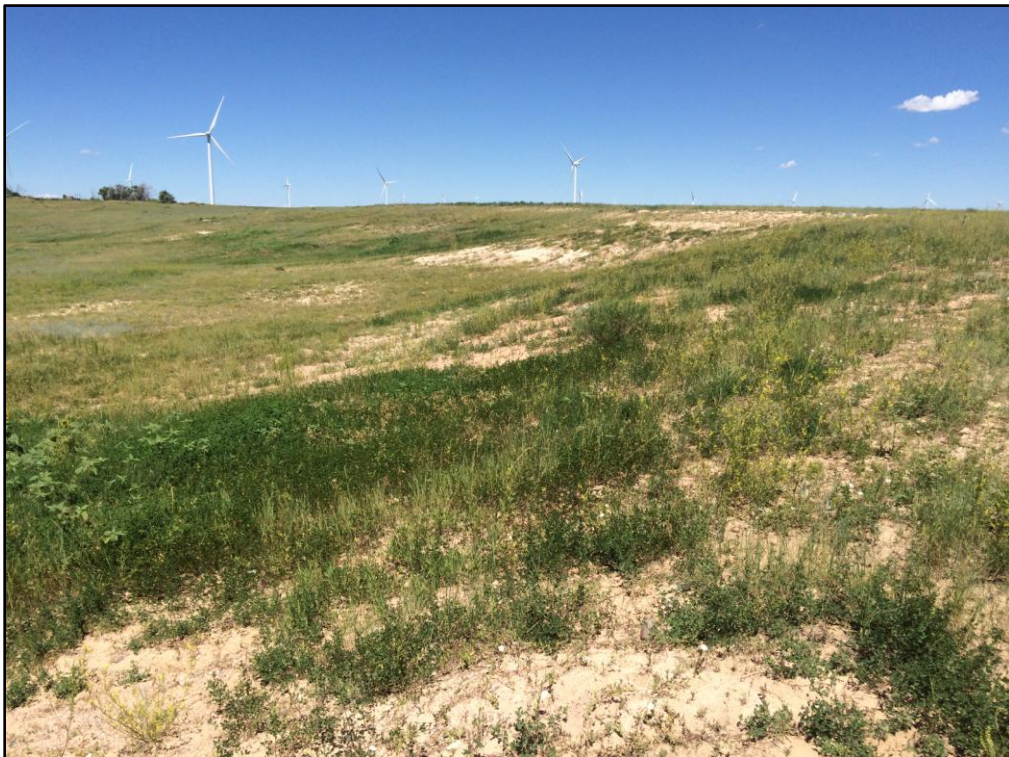
Photo 18. View looking northwest across southwest-facing mined slope located in northeastern portion of site. Note vegetation is patchy and consists primarily of weeds.

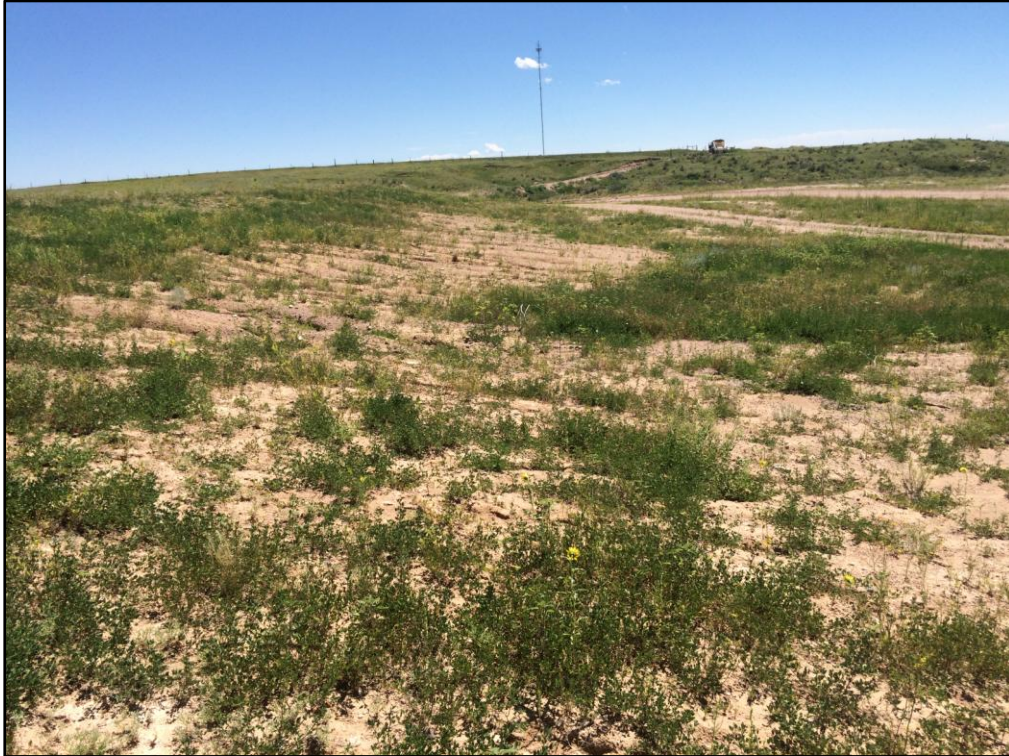
Photo 19. View looking east across south-facing mined slope located in northeastern portion of site. Note vegetation is patchy and consists primarily of weeds.

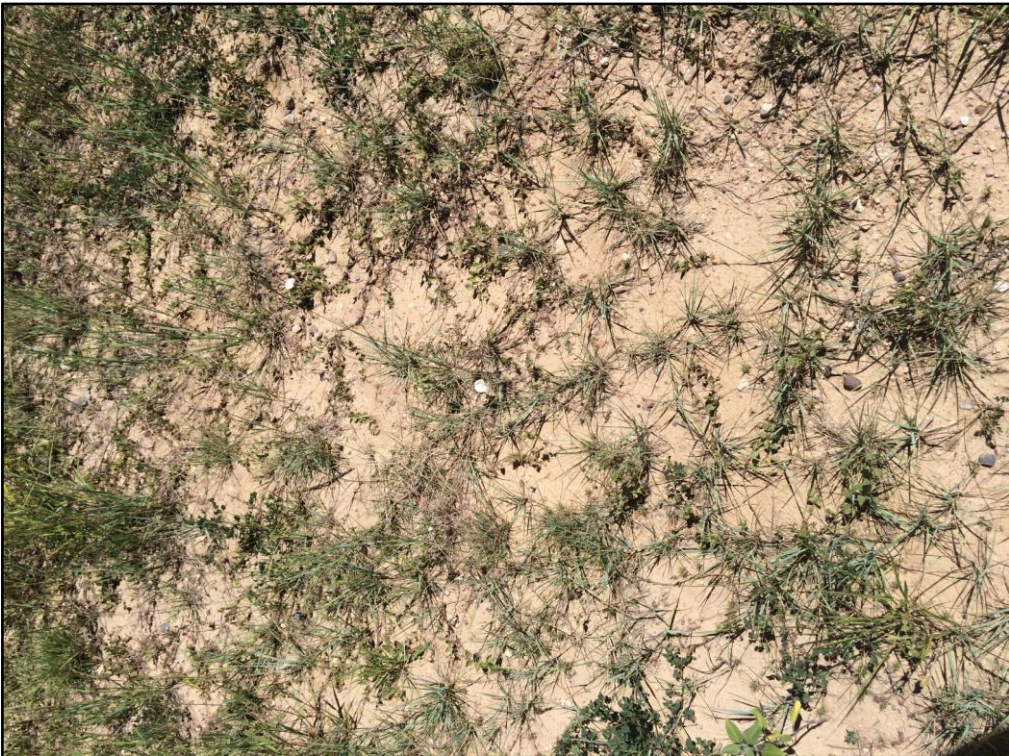
Photo 20. Close-up view of ground in northeastern portion of site, showing some grasses present in places.

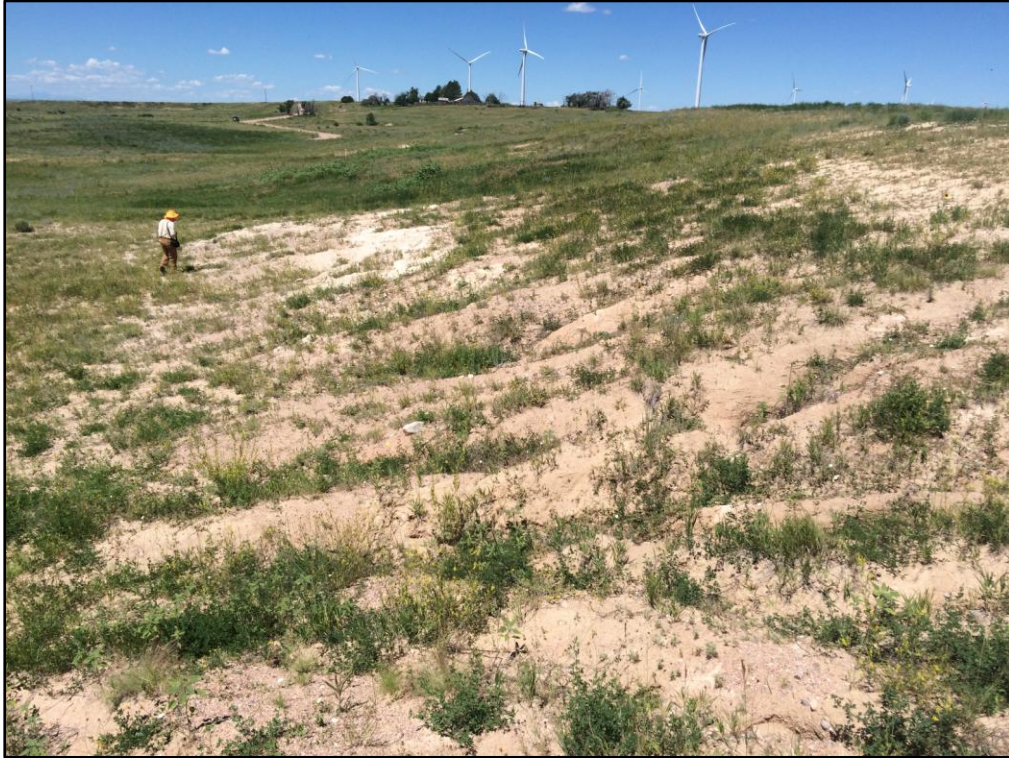
Photo 21. View looking northwest across southwest-facing mined slope located in northeastern portion of site. Note vegetation is patchy and consists primarily of weeds.

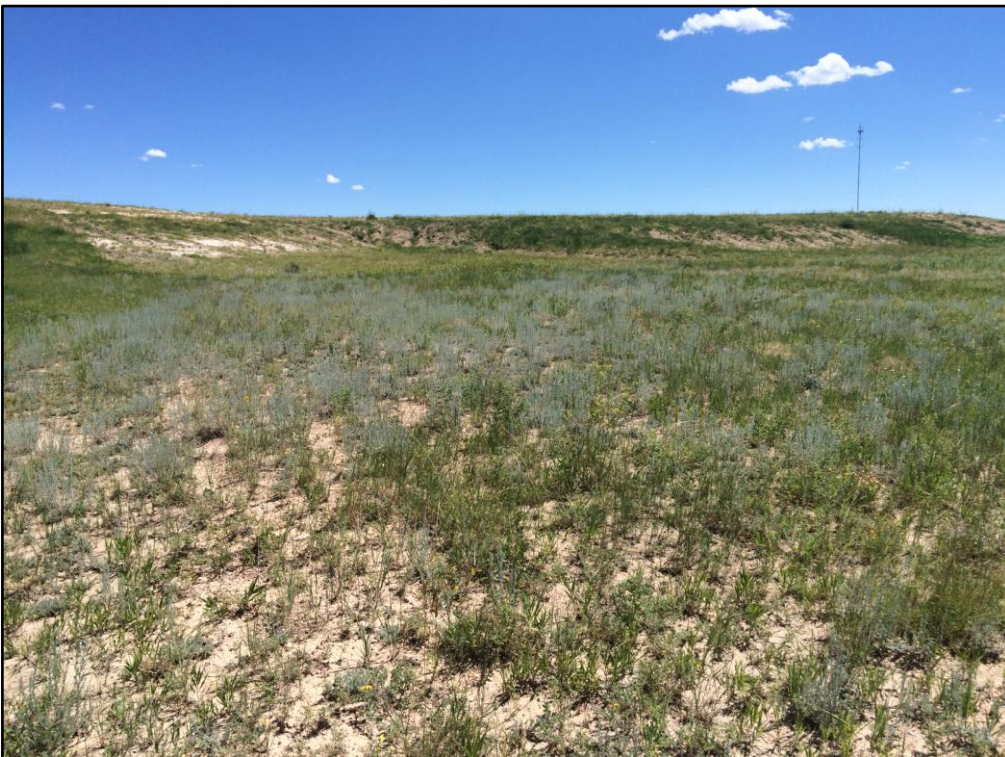
Photo 22. View looking east across northeastern portion of site, showing southwest-facing mined wall in background.

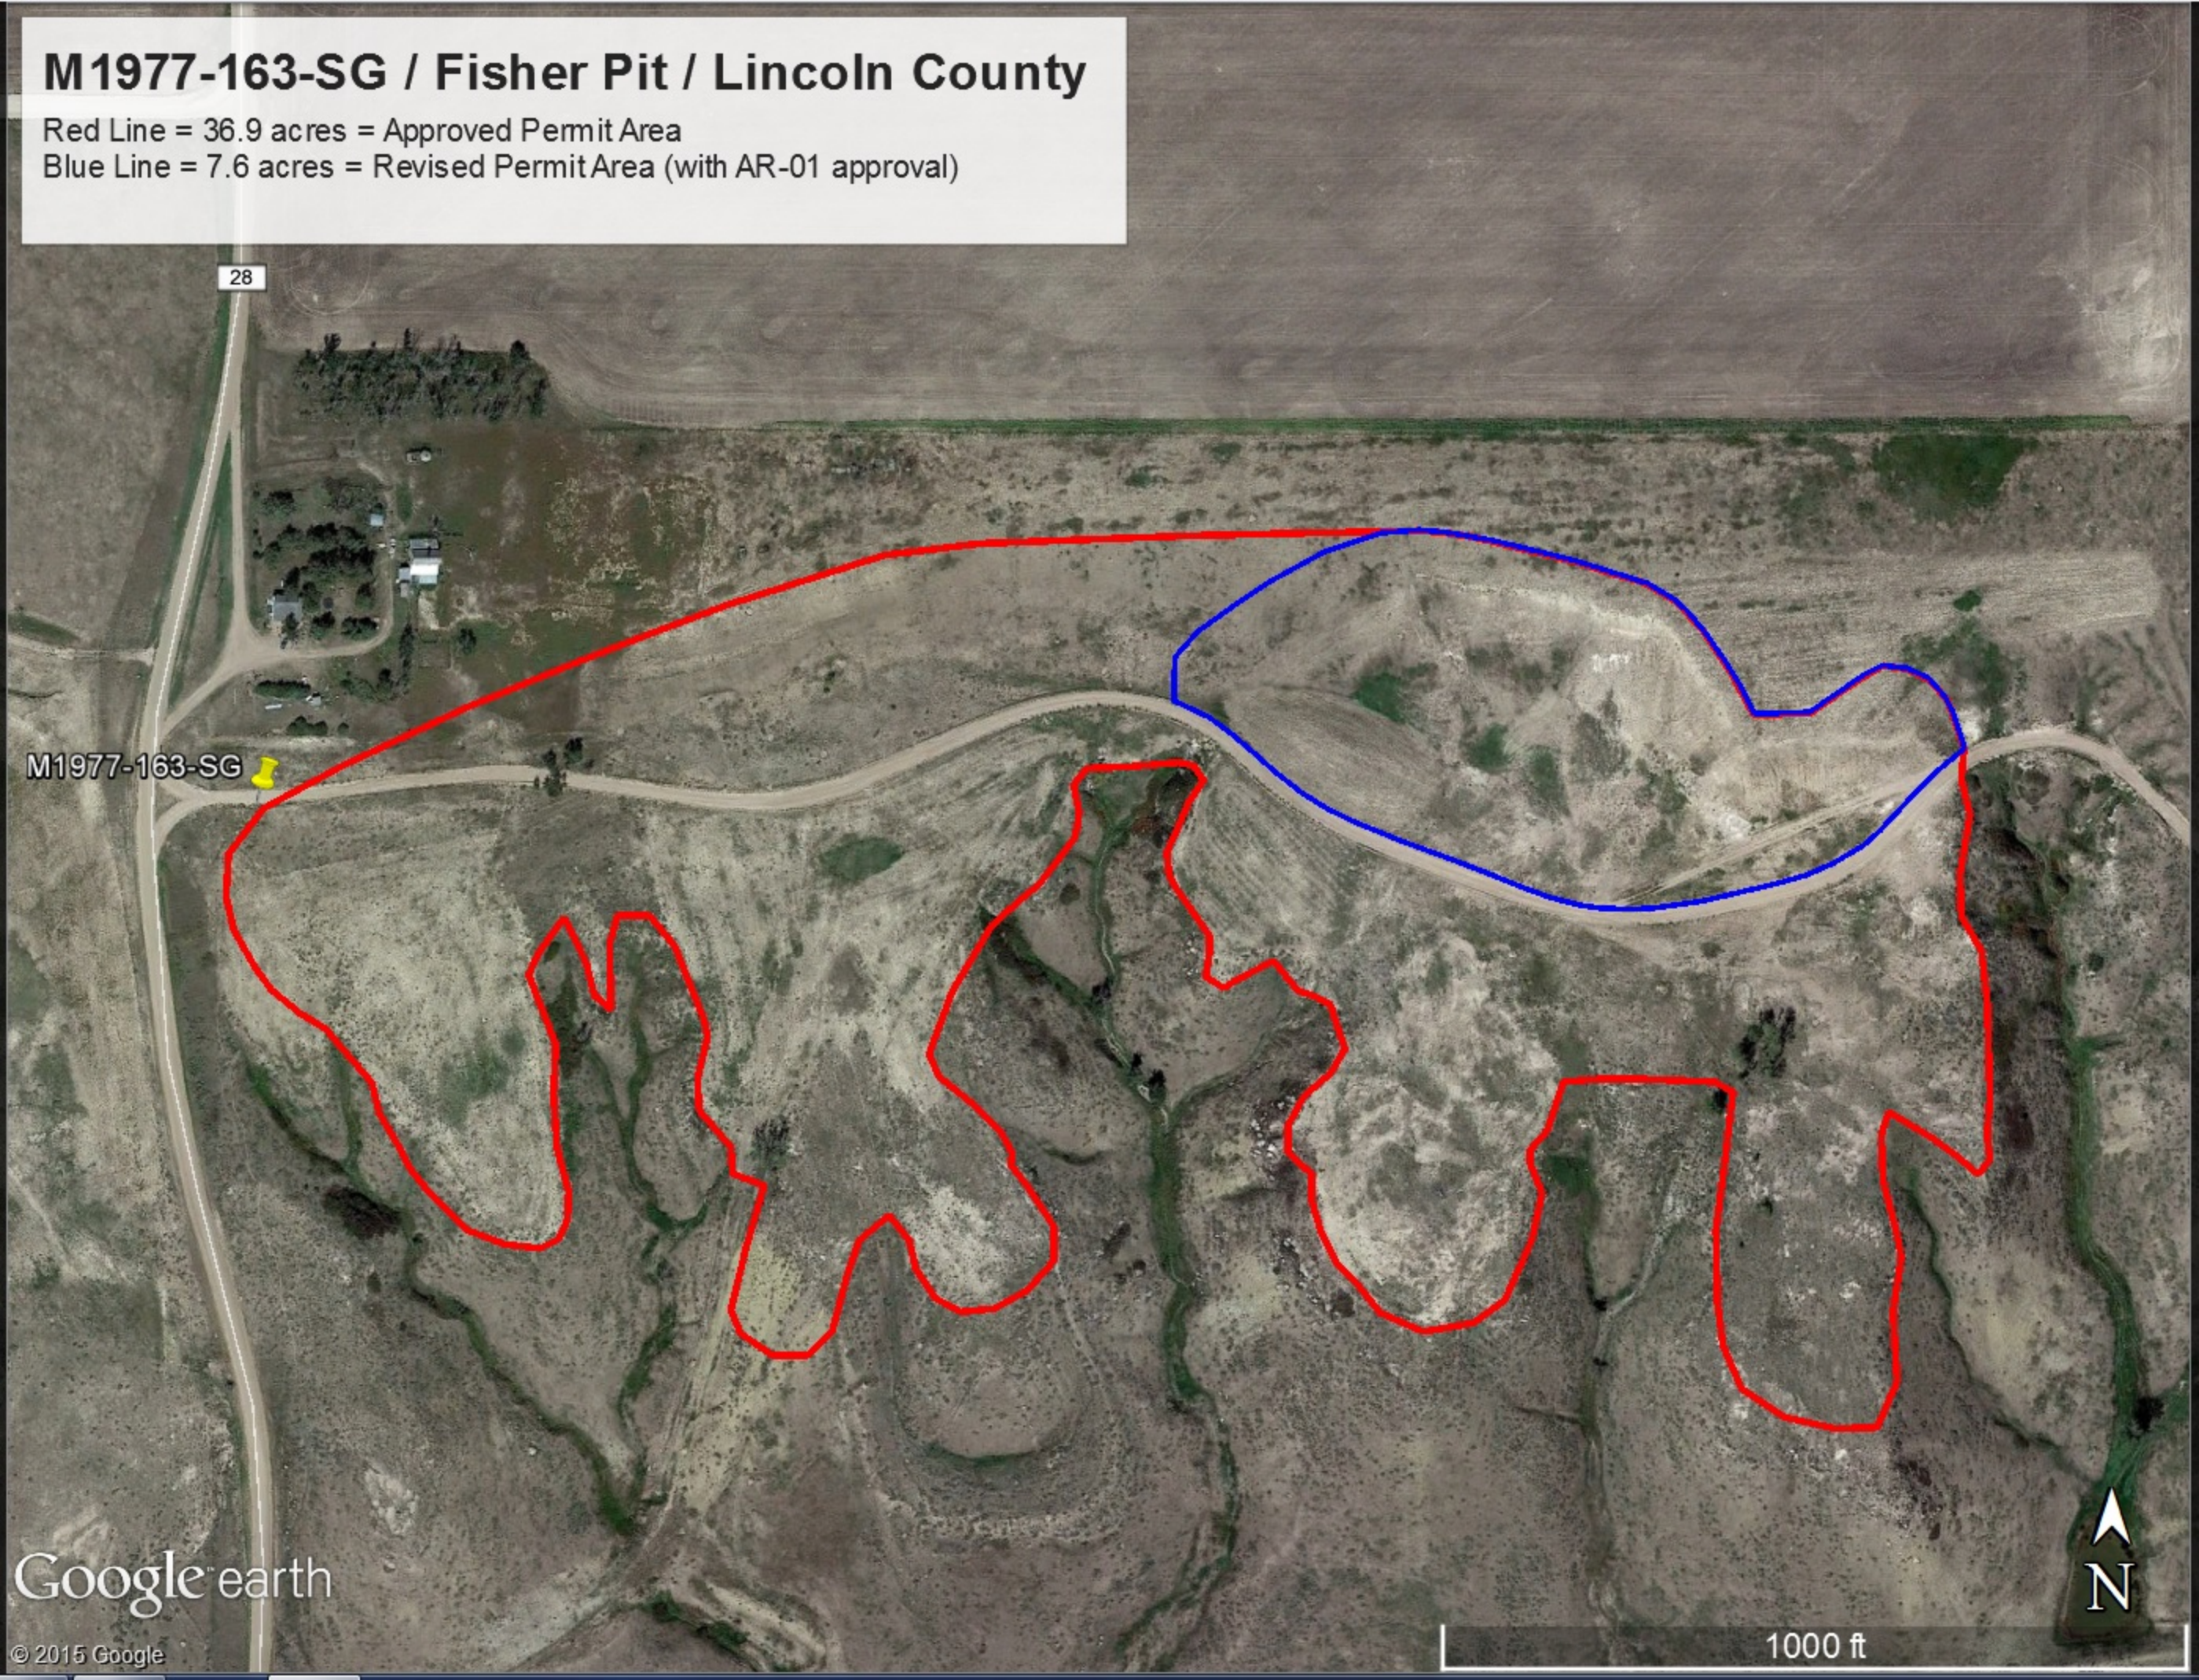
M1977-163-SG / Fisher Pit / Lincoln County

Red Line = 36.9 acres = Approved Permit Area

Blue Line = 7.6 acres = Revised Permit Area (with AR-01 approval)
