COLORADO DIVISION OF RECLAMATION, MINING AND SAFETY
MINERALS PROGRAM INSPECTION REPORT
PHONE: (303) 866-3567

MINE NAME: Pine Ridge Pit	MINE/PROSPECTING ID#: M-1998-104	MINERAL: Aggregate	COUNTY: Lake
INSPECTION TYPE: Monitoring	INSPECTOR(S): Dustin M. Czapla	INSP. DATE: July 1, 2015	INSP. TIME: 10:00
OPERATOR: ACA Products, Inc.	OPERATOR REPRESENTATIVE: Josh Criswell	TYPE OF OPERATION: 112c - Construction Regular Operation

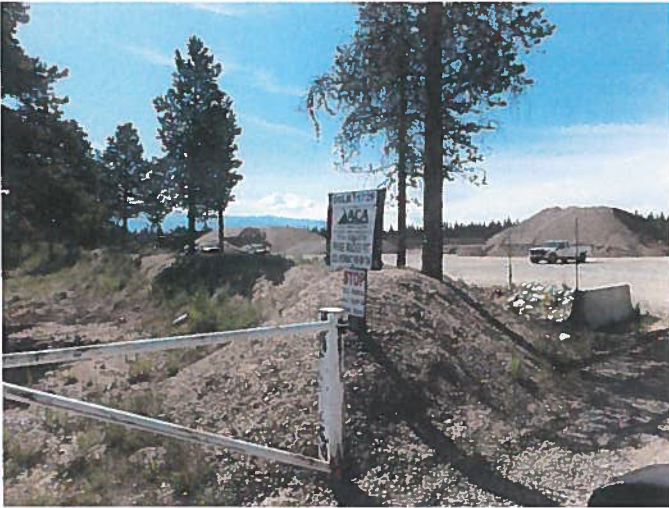
Adequate mine identification signage was noted at the entrance to the site.

Figure 1: Adequate sign at mine entrance

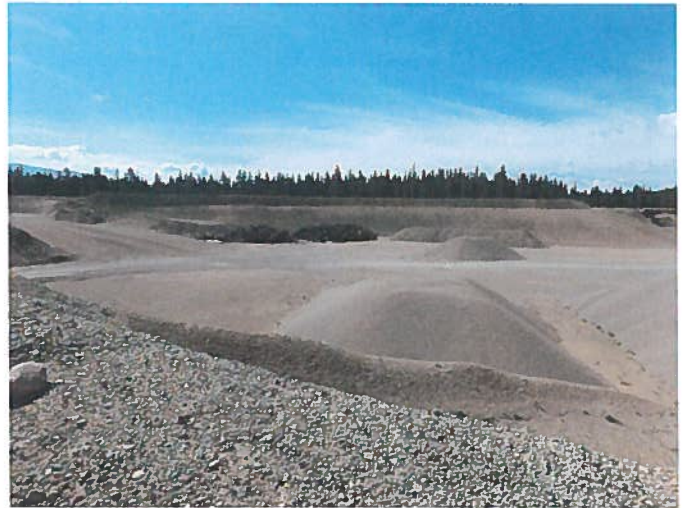
Reduction of the highwall slope is progressing in the east part of the pit. Mining is progressing southward.

Figure 2: View from north side of pit toward southeast highwall where slope reduction is occurring.

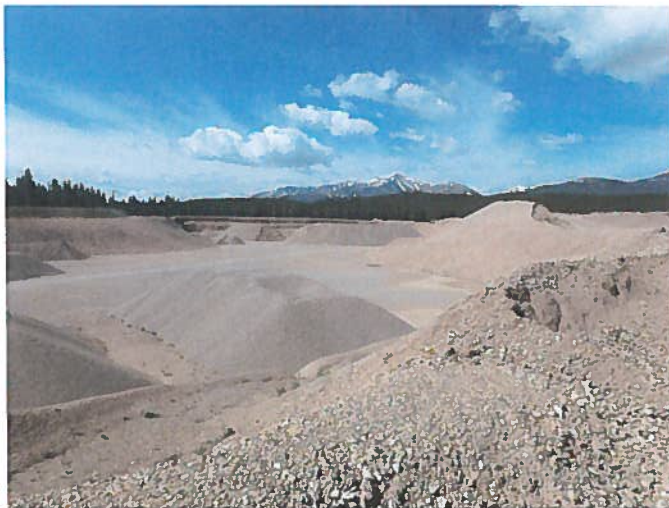
Figure 3: View from northeast side of pit facing south

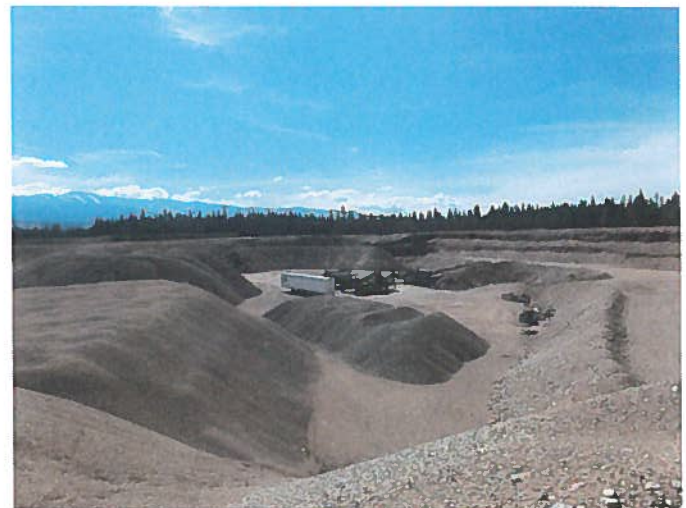
Figure 4: View of active mining area from northwest side of pit

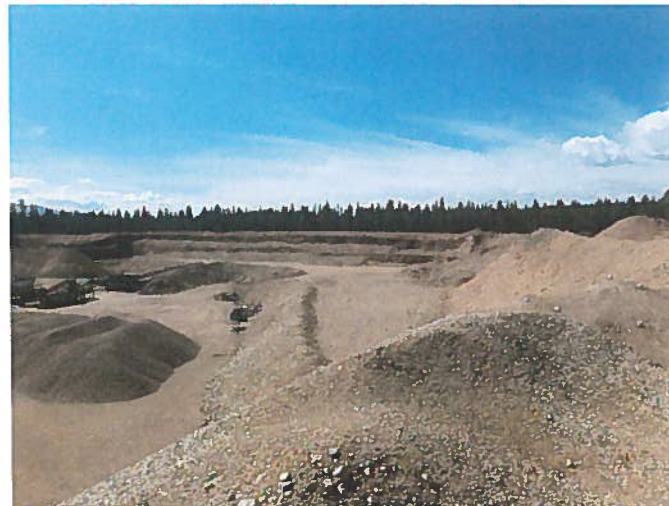
Figure 5: View of active mining area from northwest side of pit

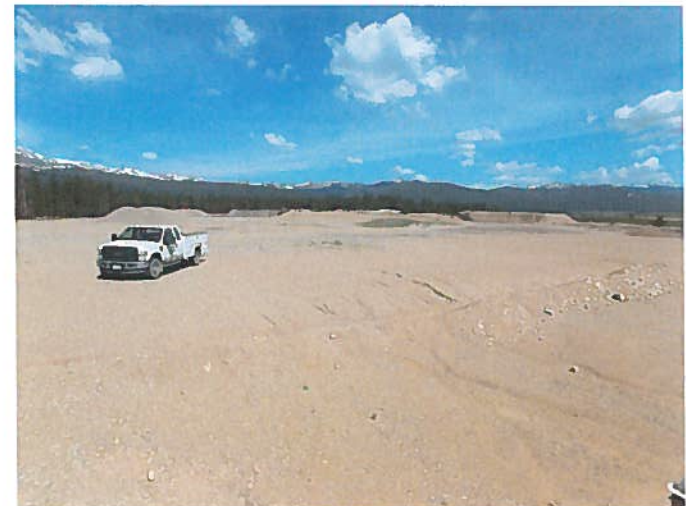
The temporary asphalt plant that was onsite in 2011 has been removed and the area cleaned up.

Figure 6: Previous location of temporary asphalt plant
