COLORADO DIVISION OF RECLAMATION, MINING AND SAFETY
MINERALS PROGRAM INSPECTION REPORT
PHONE: (303) 866-3567

MINE NAME: O'Dwyer	MINE/PROSPECTING ID#: M-2002-017	MINERAL: Sand and gravel	COUNTY: Lincoln
INSPECTION TYPE: Monitoring	INSPECTOR(S): Amy Eschberger	INSP. DATE: July 23, 2015	INSP. TIME: 12:15
OPERATOR: Lincoln County	OPERATOR REPRESENTATIVE: John DeWitt	TYPE OF OPERATION: 110c - Construction Limited Impact

M-2002-017 / O'Dwyer Pit / Lincoln County

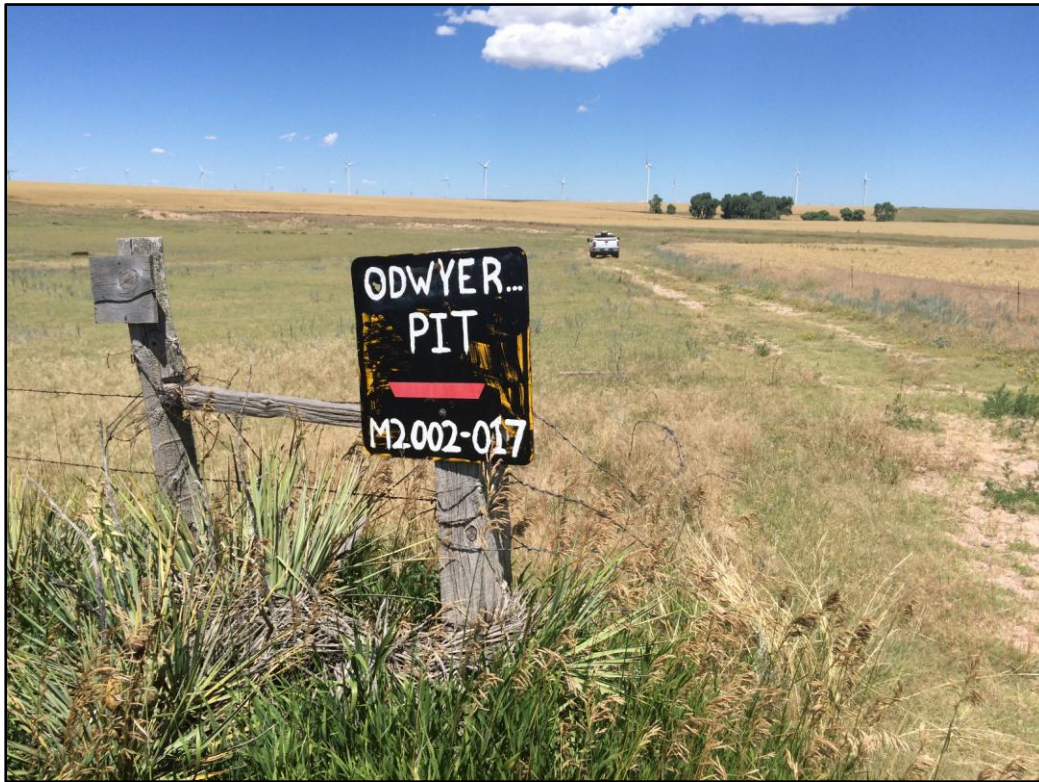
Photo 1. View of permit sign posted at main site entrance off of Co Rd 3t.

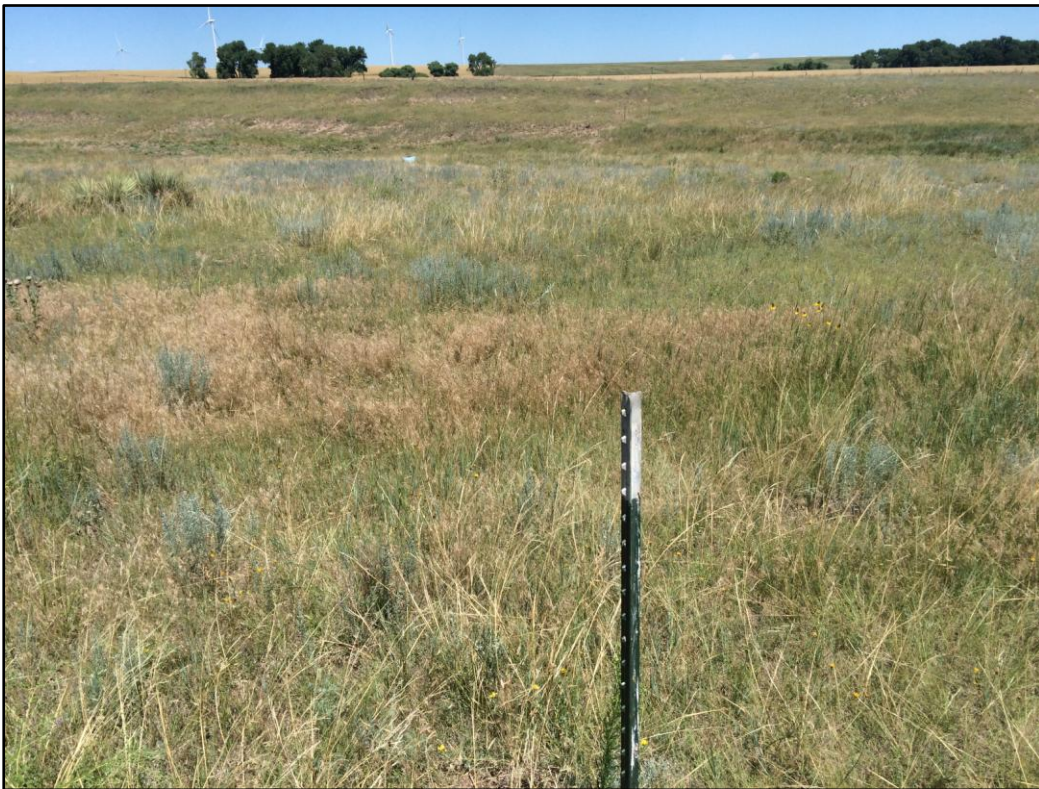
Photo 2. View looking north from southeastern corner permit boundary marker.

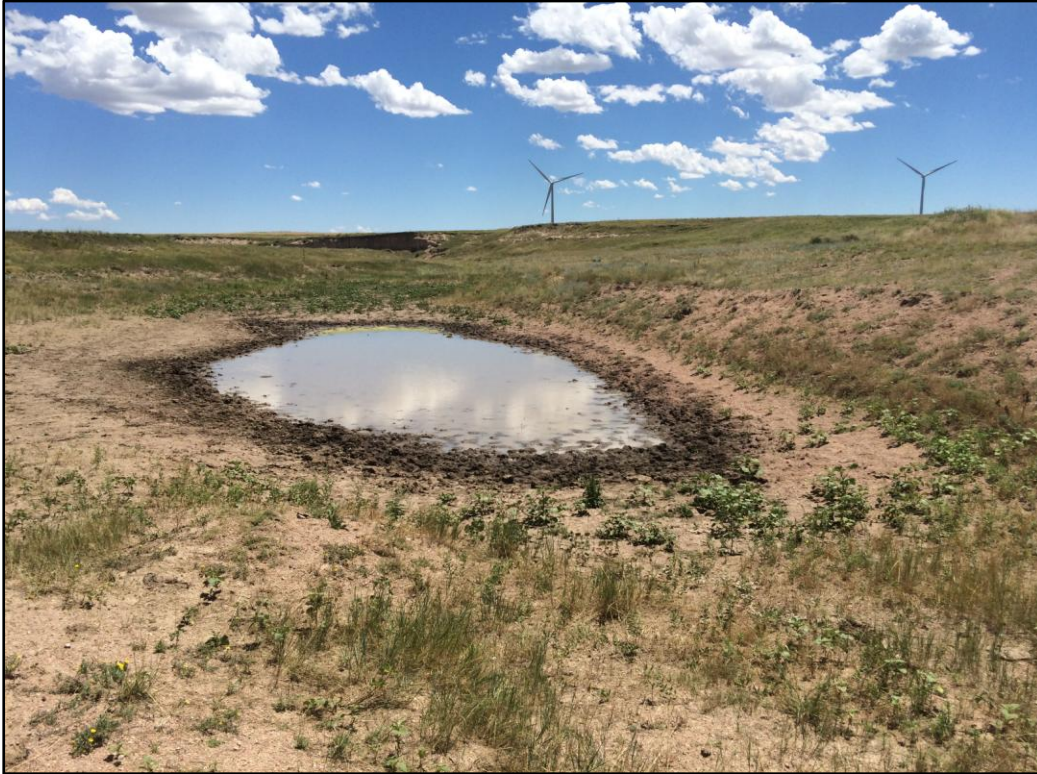
Photo 3. View looking west from eastern edge of site, showing some water pooled in riverbed from recent rain event.

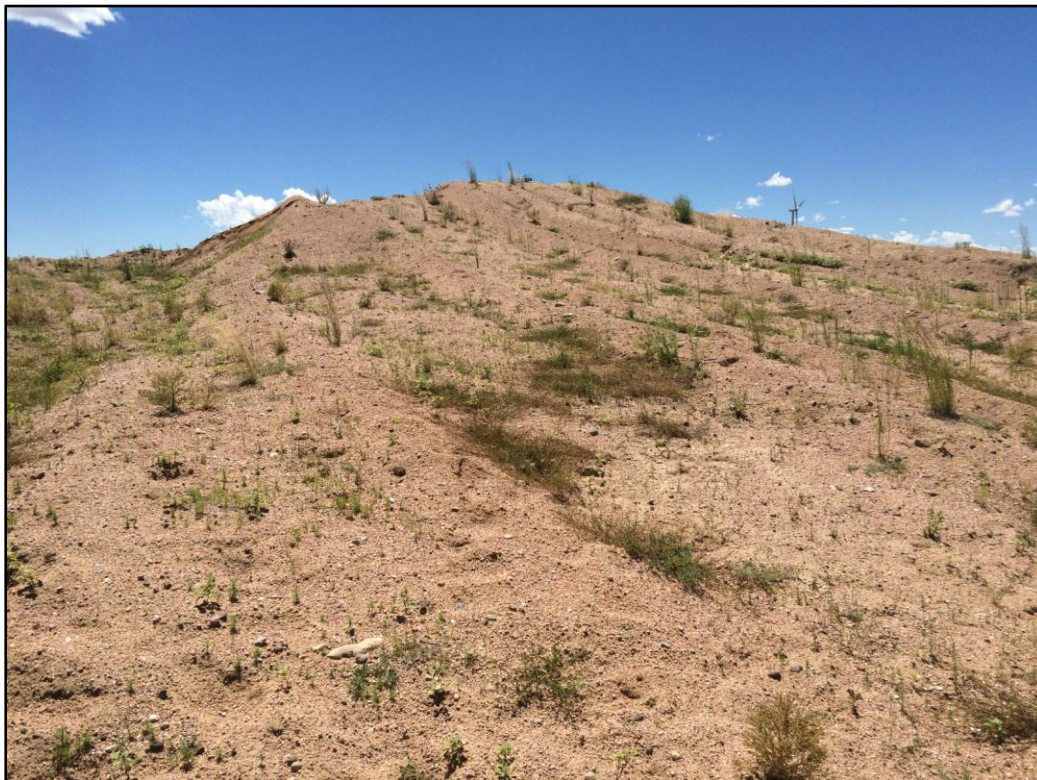
Photo 4. View looking up from riverbed at material stockpile pushed onto south river bank.

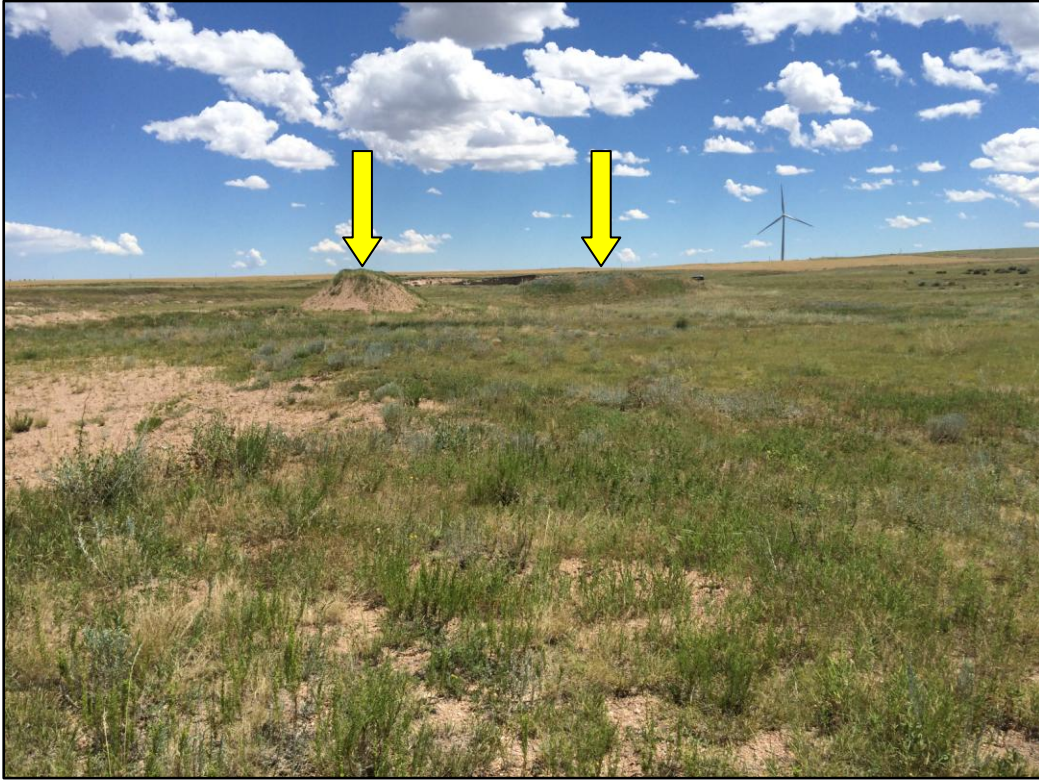
Photo 5. View looking east across loading area in southern portion of site, showing overburden and topsoil stockpiles stable with vegetative cover (indicated).

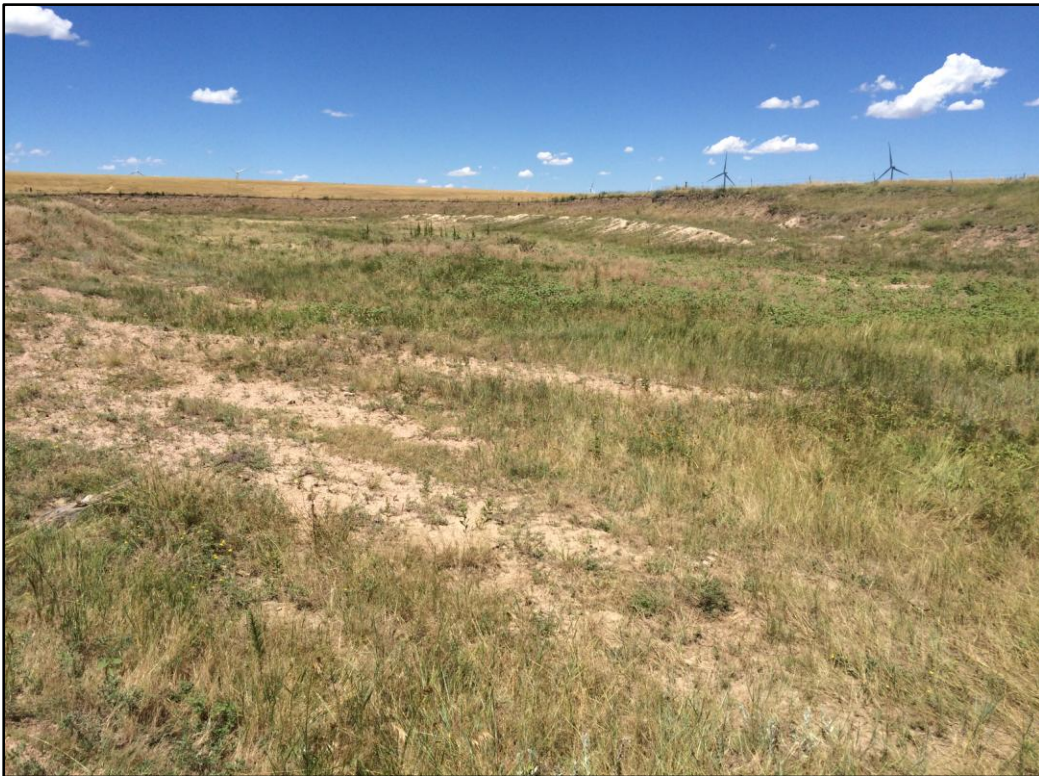
Photo 6. View looking northwest across riverbed from eastern portion of site, showing native grasses and forbs volunteering across site.

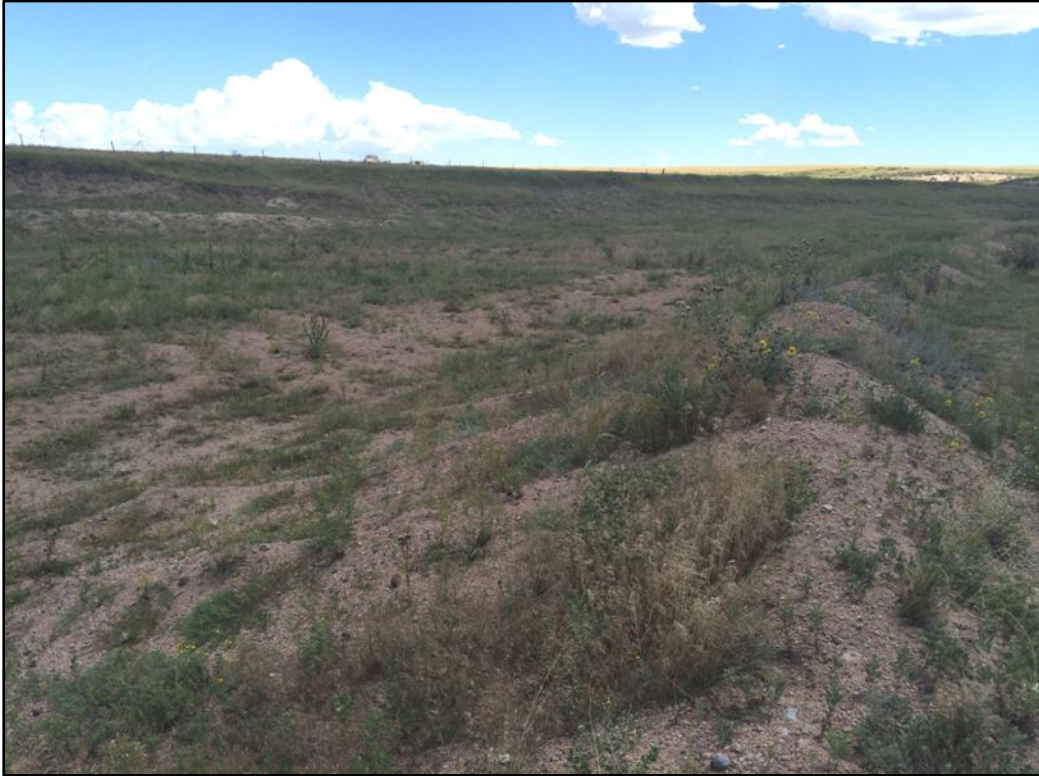
Photo 7. View looking northeast across riverbed from eastern portion of site, showing native grasses and forbs volunteering across site.

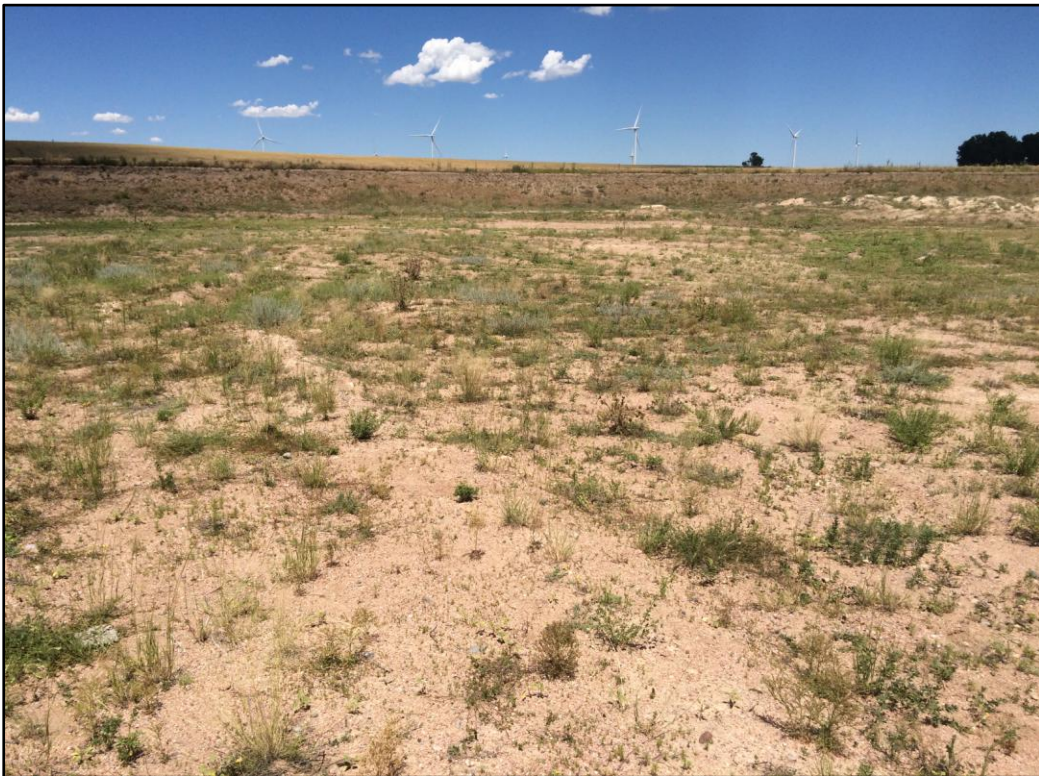
Photo 8. View looking north across riverbed from central portion of site, showing native grasses and forbs volunteering across site.

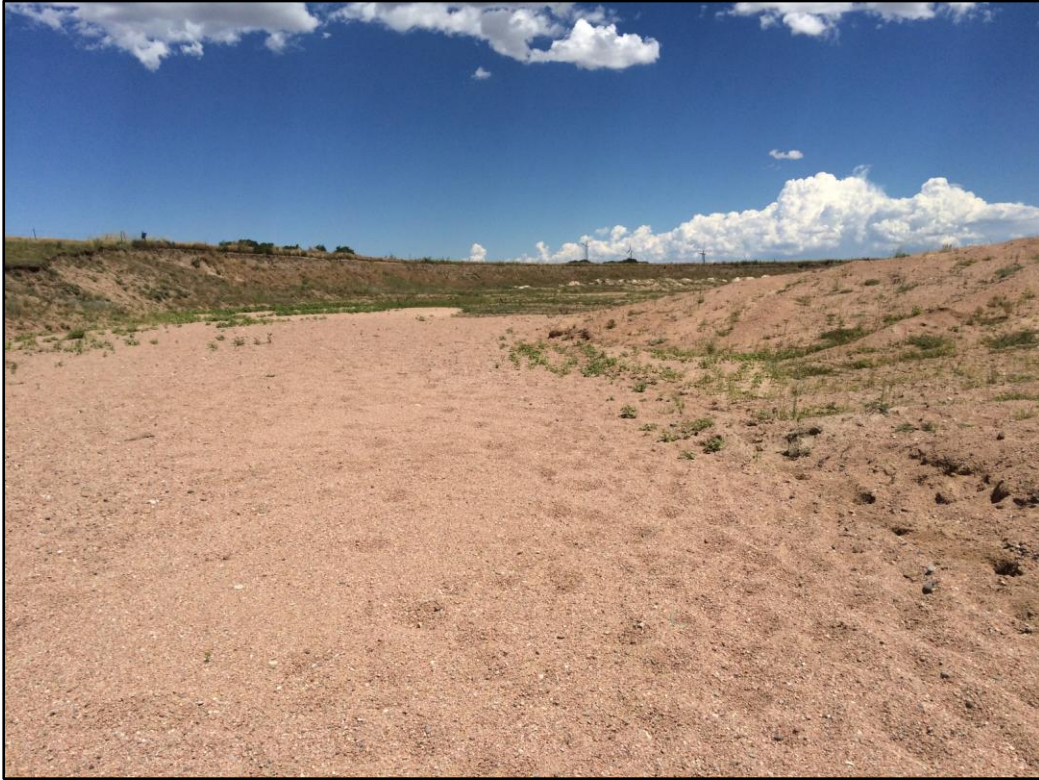
Photo 9. View looking northeast (downstream) from western edge of site, showing riverbed and banks appear to be stable inside permit area.

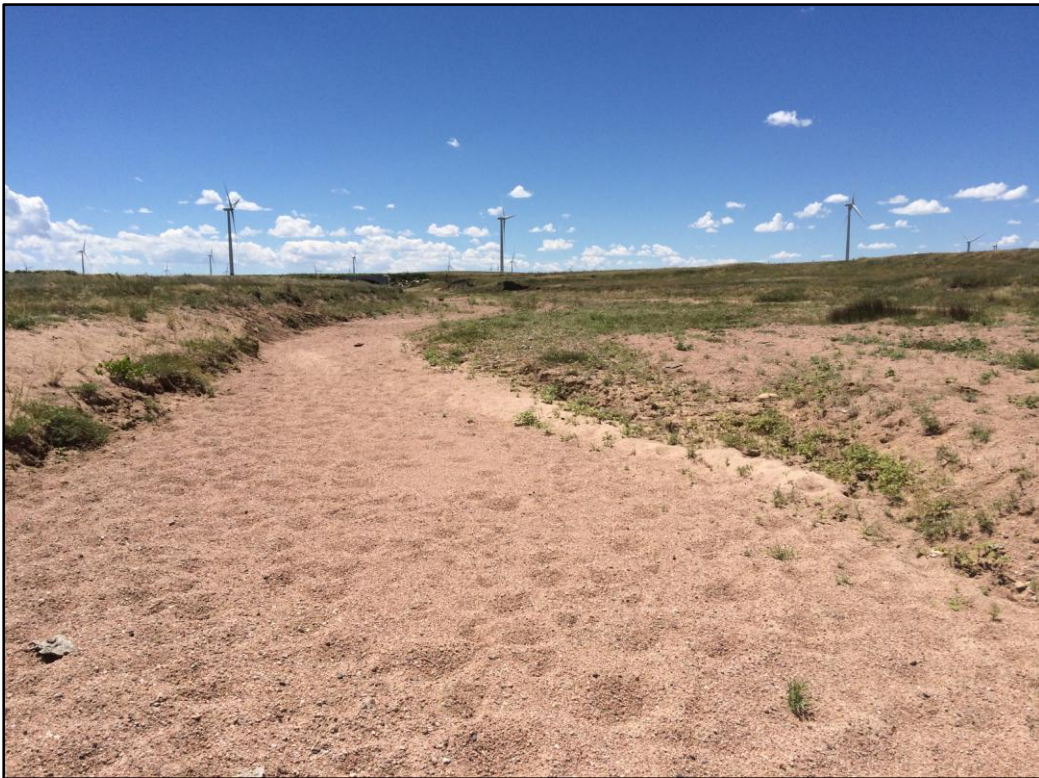
Photo 10. View looking south (upstream) from western edge of site, showing riverbed and banks appear to be stable outside of permit area.
