COLORADO DIVISION OF RECLAMATION, MINING AND SAFETY
MINERALS PROGRAM INSPECTION REPORT
PHONE: (303) 866-3567

MINE NAME: Newsom Pit	MINE/PROSPECTING ID#: M-2010-083	MINERAL: Sand and gravel	COUNTY: Lincoln
INSPECTION TYPE: Monitoring	INSPECTOR(S): Amy Eschberger	INSP. DATE: July 23, 2015	INSP. TIME: 12:45
OPERATOR: Lincoln County	OPERATOR REPRESENTATIVE: John DeWitt	TYPE OF OPERATION: 110c - Construction Limited Impact

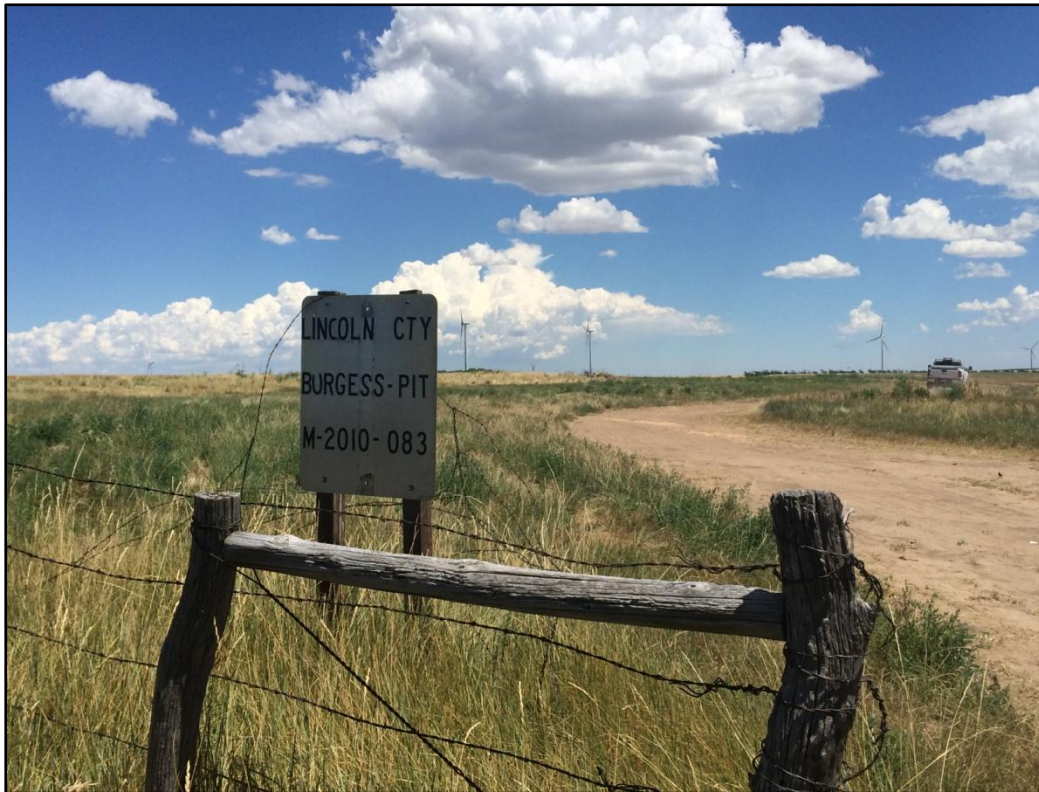
At the time of the inspection, the weather was clear, warm and sunny. A permit sign was posted at the main entrance to the site off of Co Rd 24 (**Photo 1**). The permit boundary was clearly delineated with metal stakes (**Photo 2**). The site was not active during the inspection, and no equipment was stored on site. However, the county extracts and/or hauls material off site every year, which is in compliance with its intermittent status. The river was dry during the inspection (**Photo 3**). However, some water was pooled in the southern edge of the pit from a recent storm event (**Photo 4**). A material stockpile was stored west of the active pit and appeared to be stable (**Photo 5**). A smaller gravel stockpile was stored south of the larger stockpile (**Photo 6**). This stockpile may remain after reclamation for use by the landowner. A topsoil stockpile was stored along the northern edge of the active pit, and appeared to be stable with vegetative cover (**Photo 7**). The pit had an average depth of approximately 5 feet, with slopes of mainly 3H:1V or flatter (**Photos 8-10**), except for the southern wall, which had slopes of approximately 2H:1V (shown in **Photos 4 and 9**). Native grasses and forbs have volunteered across most of the site. The area located just east of the pit (**Photo 11**) and the northern portion of the permit area (located north of the river; **Photo 12**) appeared to be undisturbed by this operation. The riverbed and banks appeared to be stable. No problems with state-listed noxious weed species were observed.

Photo 1. View of permit sign posted at main site entrance off of Co Rd 24.

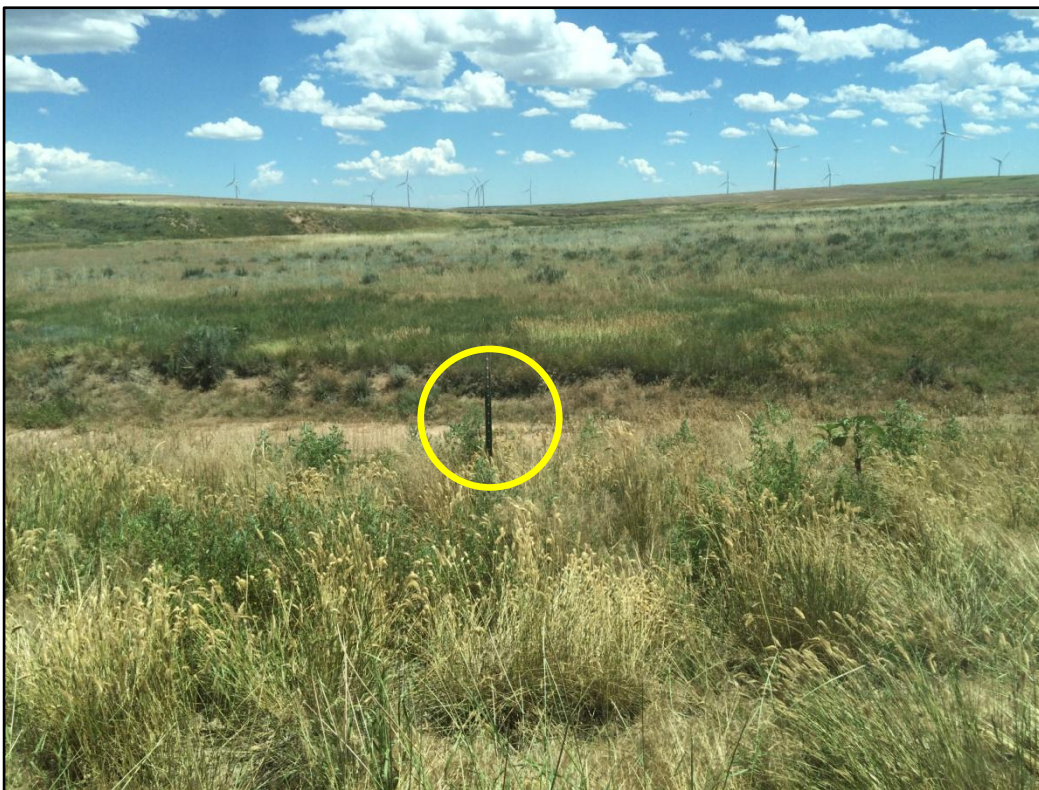
Photo 2. View looking west, showing northwestern permit boundary marker (circled).

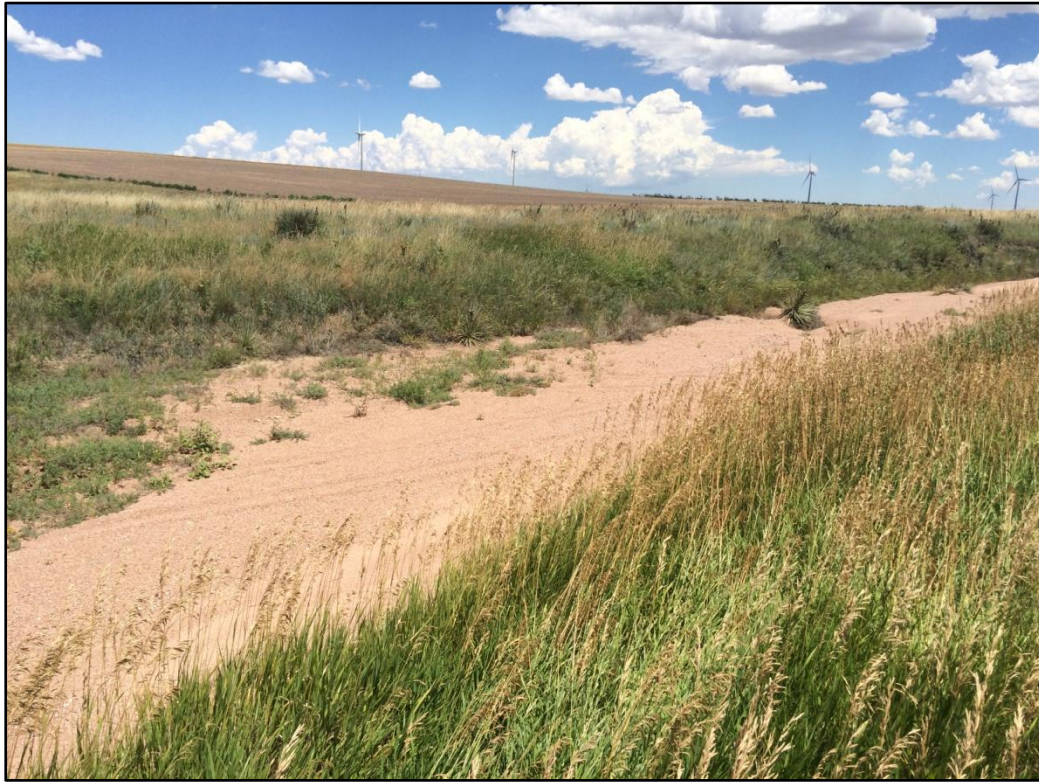
Photo 3. View looking northeast, showing river was dry during inspection.

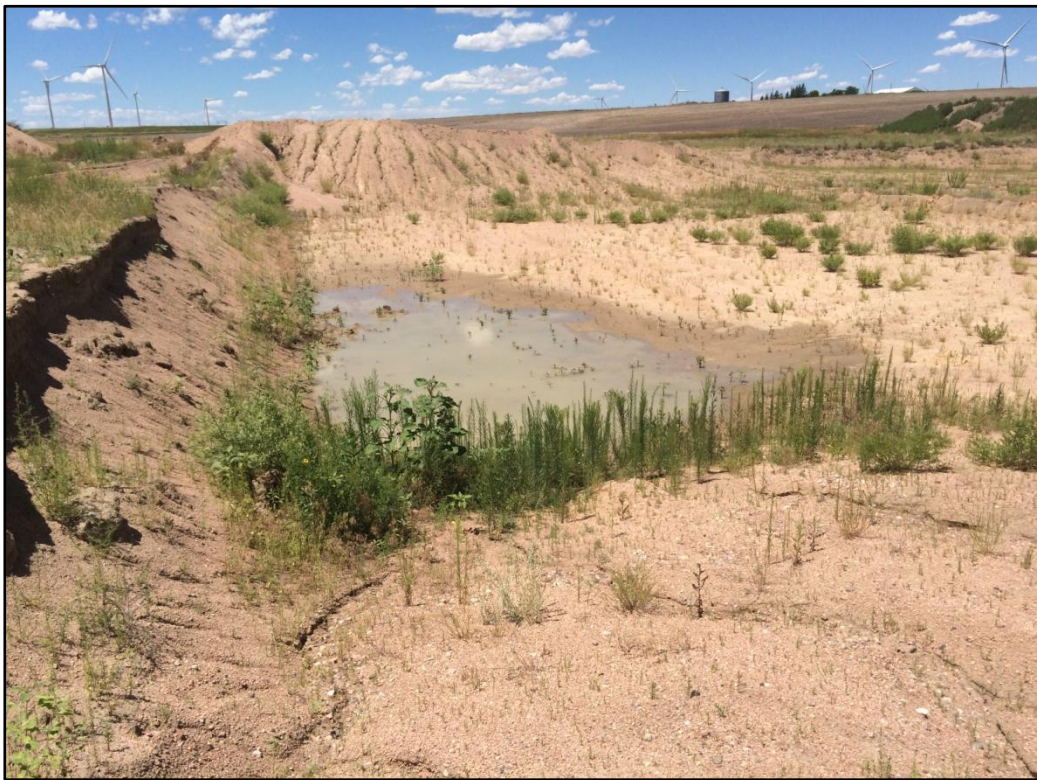
Photo 4. View looking west from southeastern edge of pit, showing some water pooled on pit floor from recent rain event. Note southern pit wall has 2H:1V slope.

The approved reclamation plan for this site includes removing all stockpiles (except the small one that may remain for use by the landowner), grading all slopes to 3H:1V or flatter, replacing any existing overburden in the pit, replacing a minimum depth of 6 inches of topsoil on disturbed areas, and revegetating the site using a rangeland seed mixture recommended by the Natural Resources Conservation Service.

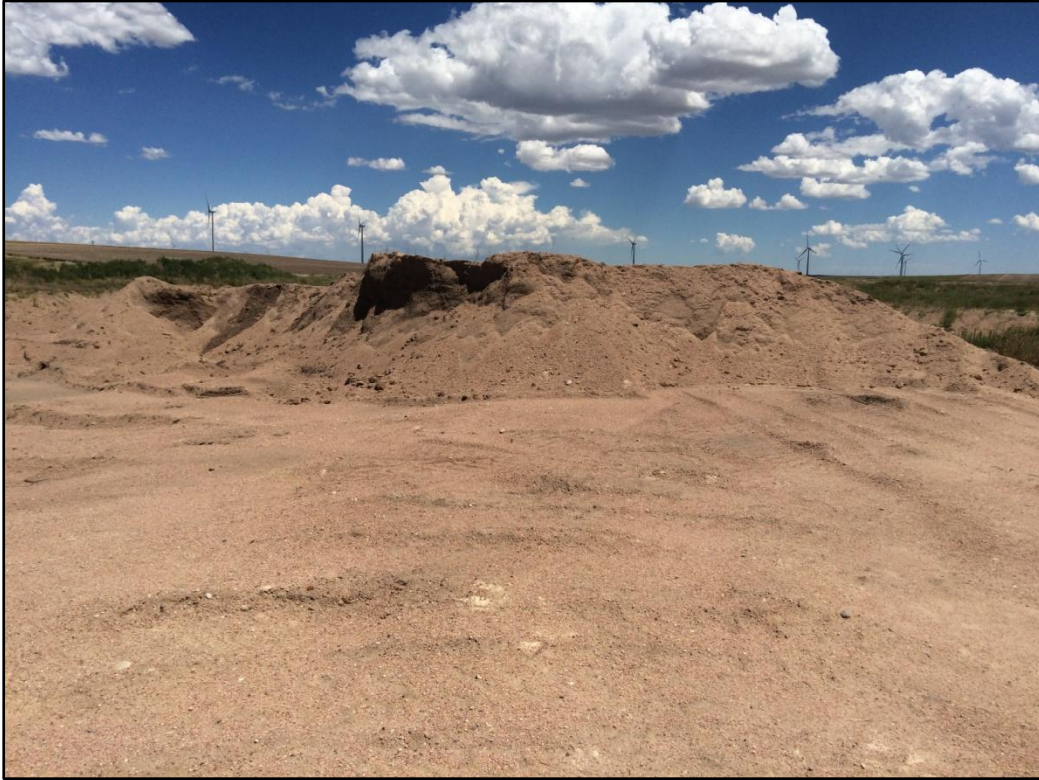
Photo 5. View of material stockpile stored at southwestern edge of pit.

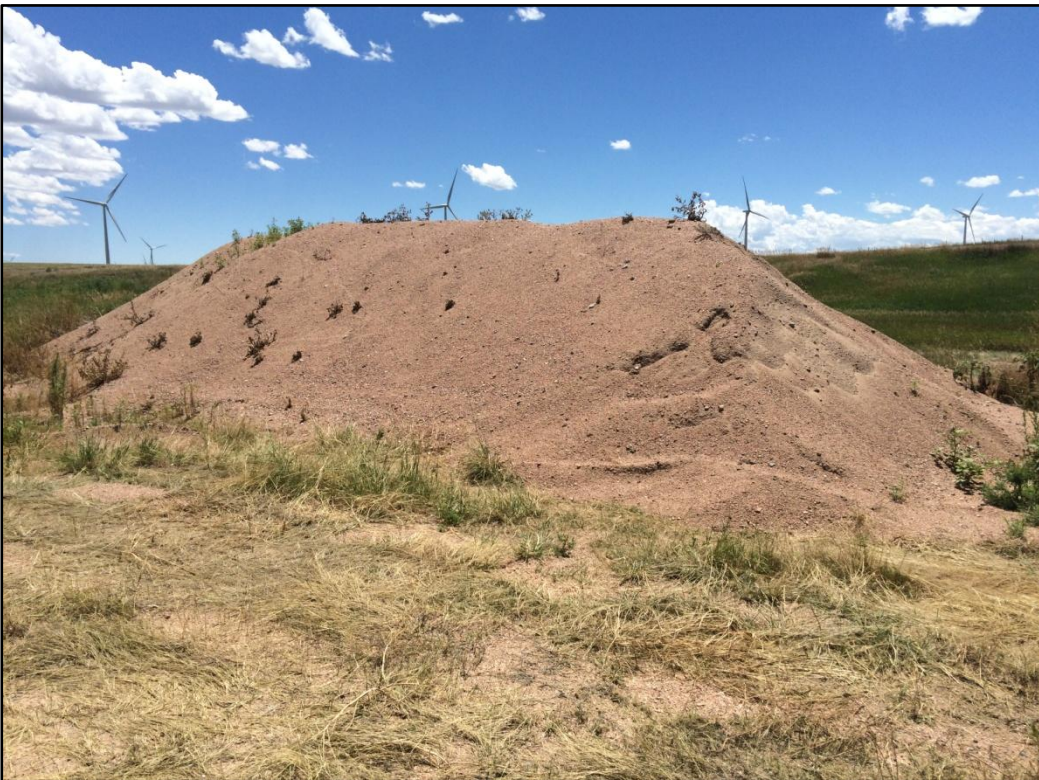
Photo 6. View of small gravel stockpile that may remain after reclamation for use by landowner.

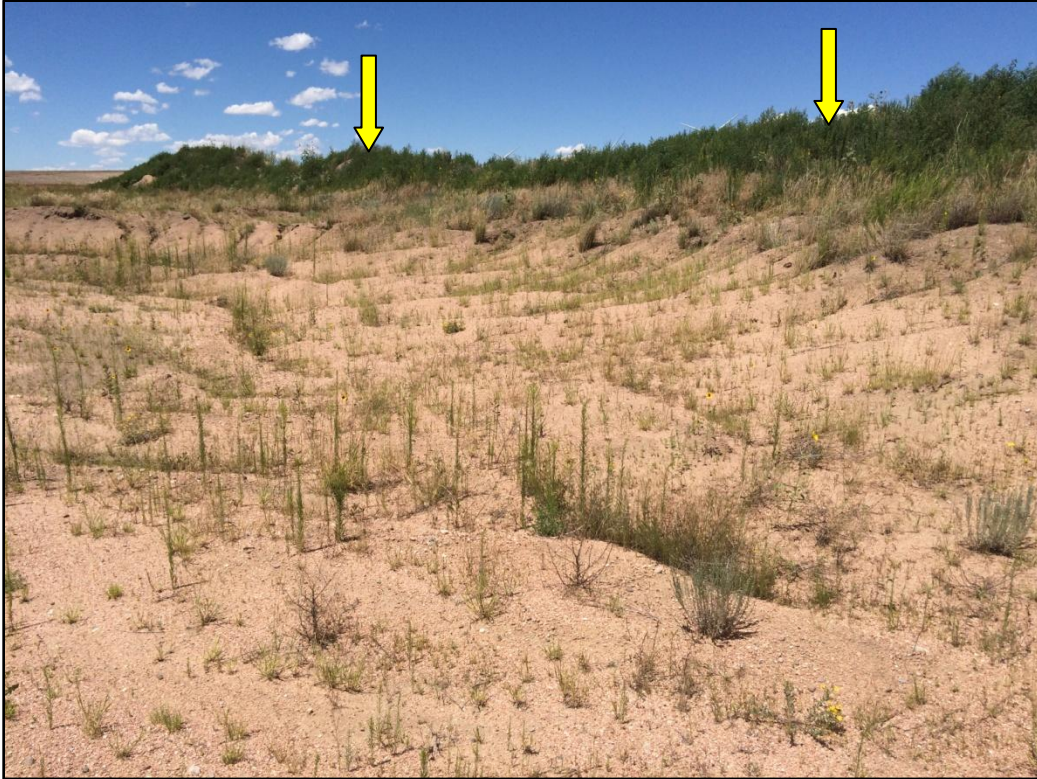
Photo 7. View of topsoil stockpile stored along northern edge of pit (indicated), stable with vegetative cover.

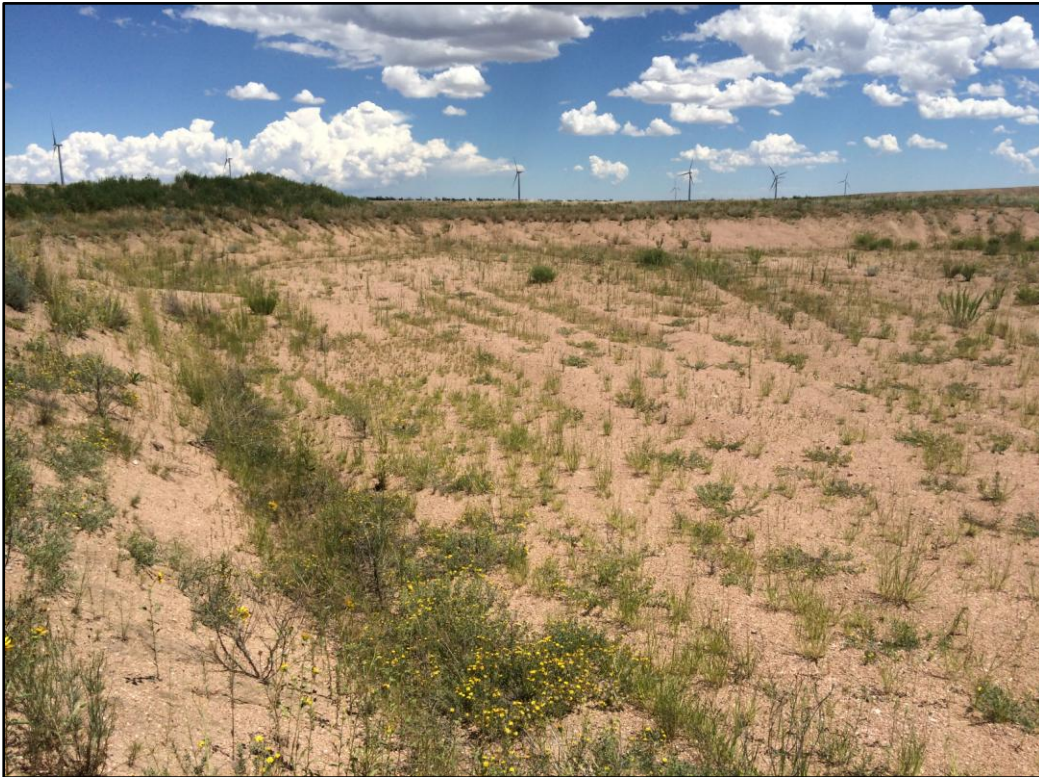
Photo 8. View looking northeast across pit, showing mined walls with slopes of 3H:1V or flatter. Note native grasses and forbs volunteering across site.

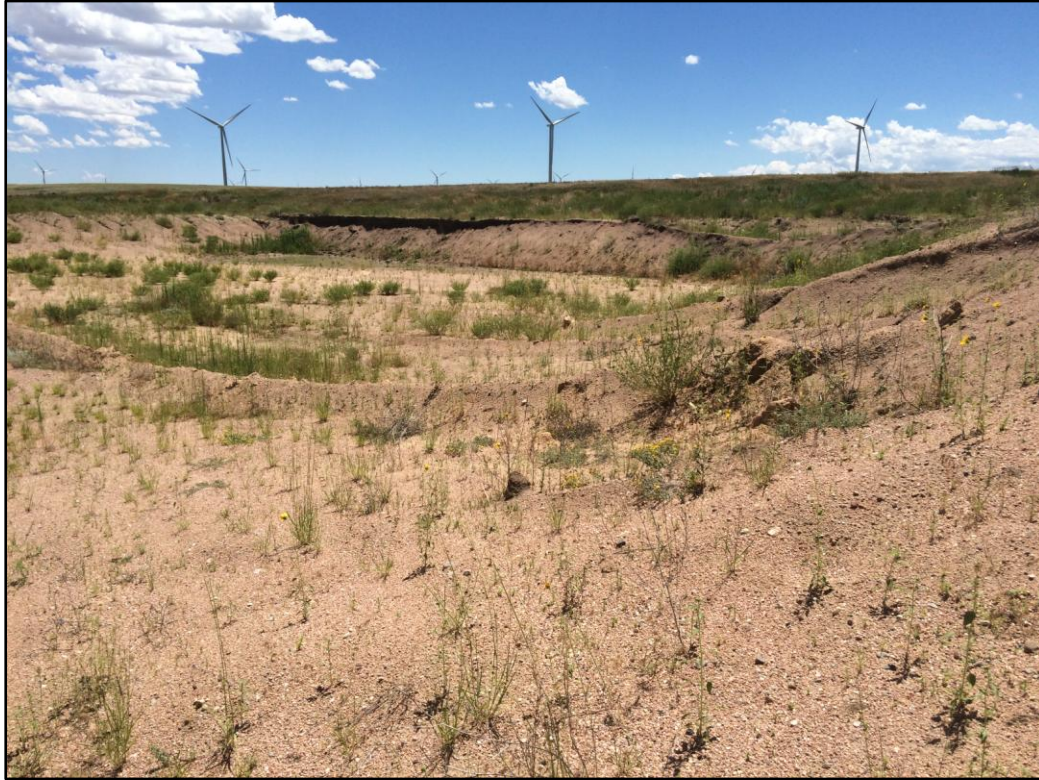
Photo 9. View looking southeast across pit, showing mined walls with slopes of 3H:1V or flatter, except southern wall (in background) with 2H:1V slope. Note native grasses and forbs volunteering across site.

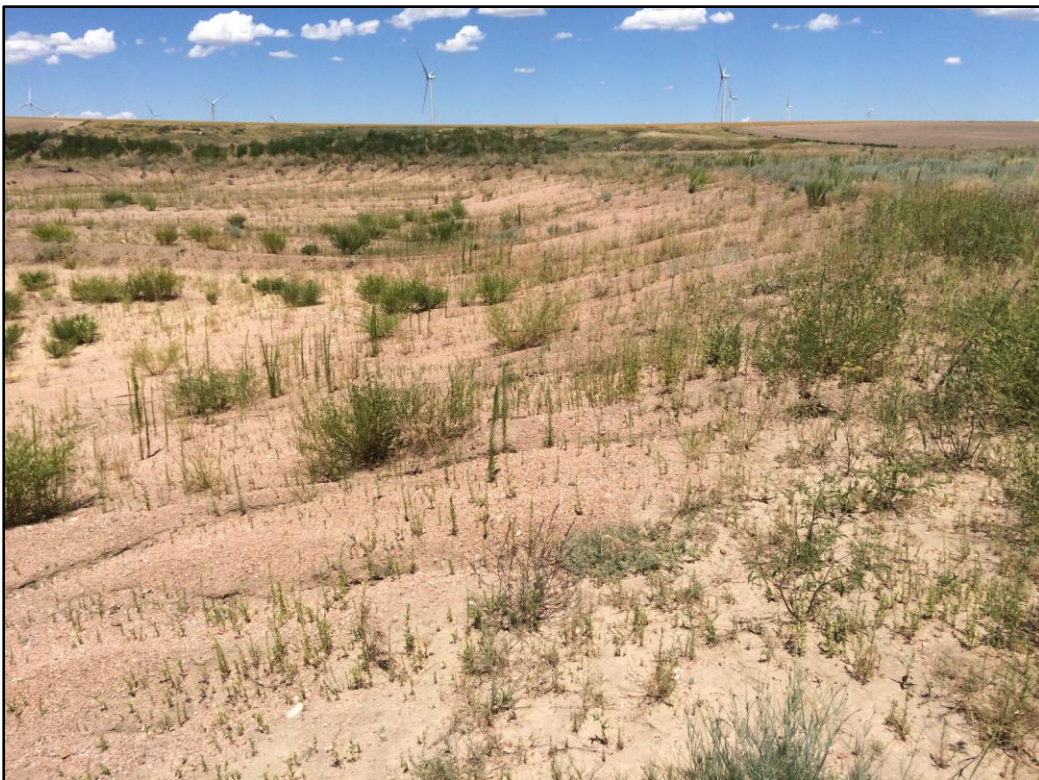
Photo 10. View looking north across eastern pit wall, showing slopes of 3H:1V or flatter. Note native grasses and forbs volunteering across site.

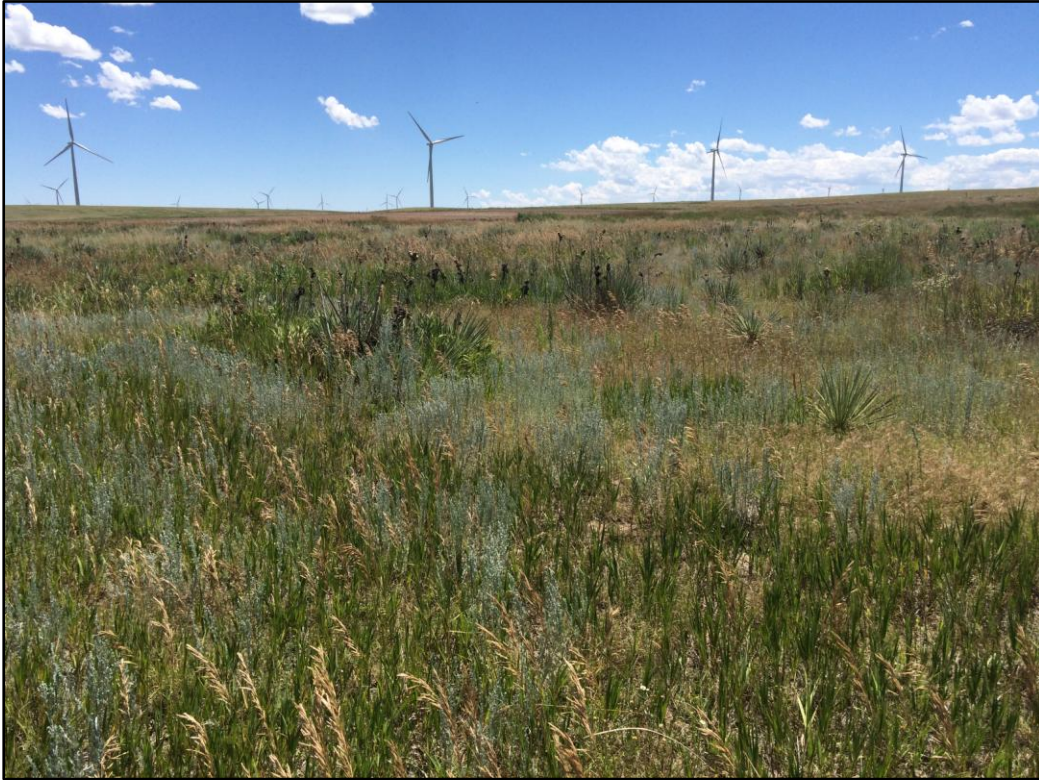
Photo 11. View looking southeast across undisturbed area just east of active pit.

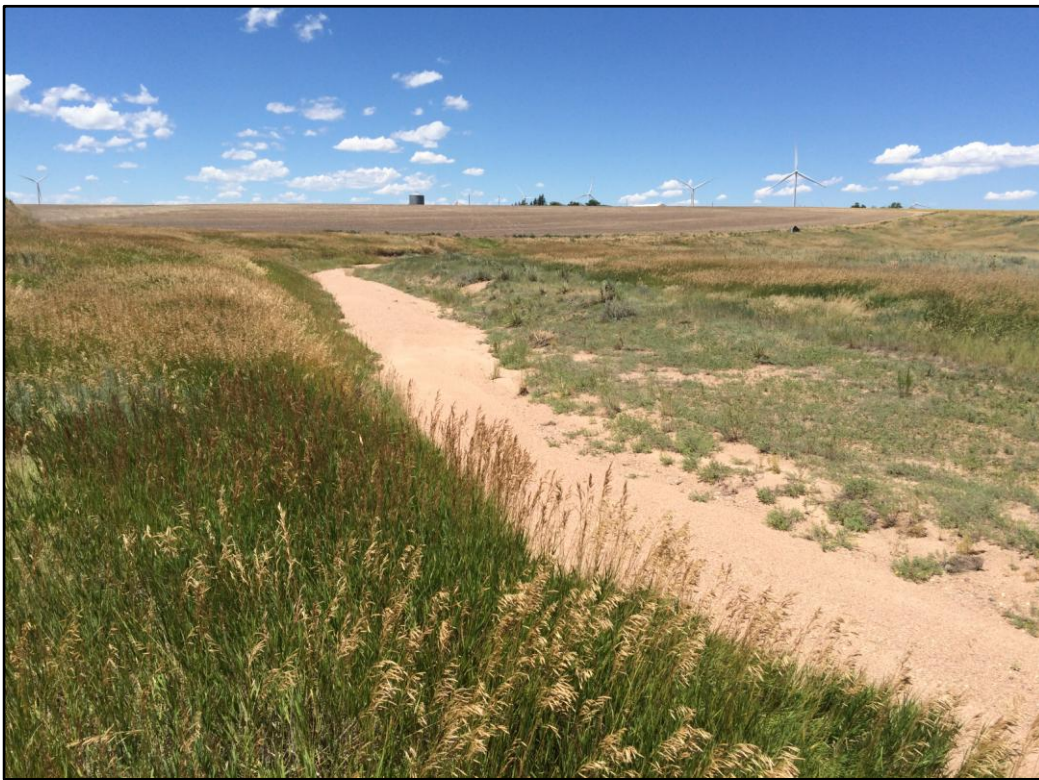
Photo 12. View looking northwest from north of active pit, showing part of undisturbed area in northern portion of permit area (north of river).
