COLORADO DIVISION OF RECLAMATION, MINING AND SAFETY
MINERALS PROGRAM INSPECTION REPORT
PHONE: (303) 866-3567

MINE NAME: Mantle Pit #3	MINE/PROSPECTING ID#: M-1998-047	MINERAL: Sand and gravel	COUNTY: Moffat
INSPECTION TYPE: Monitoring	INSPECTOR(S): Amy C. Yeldell	INSP. DATE: August 5, 2015	INSP. TIME: 12:40
OPERATOR: Moffat County	OPERATOR REPRESENTATIVE: Billy Mack	TYPE OF OPERATION: 112c - Construction Regular Operation

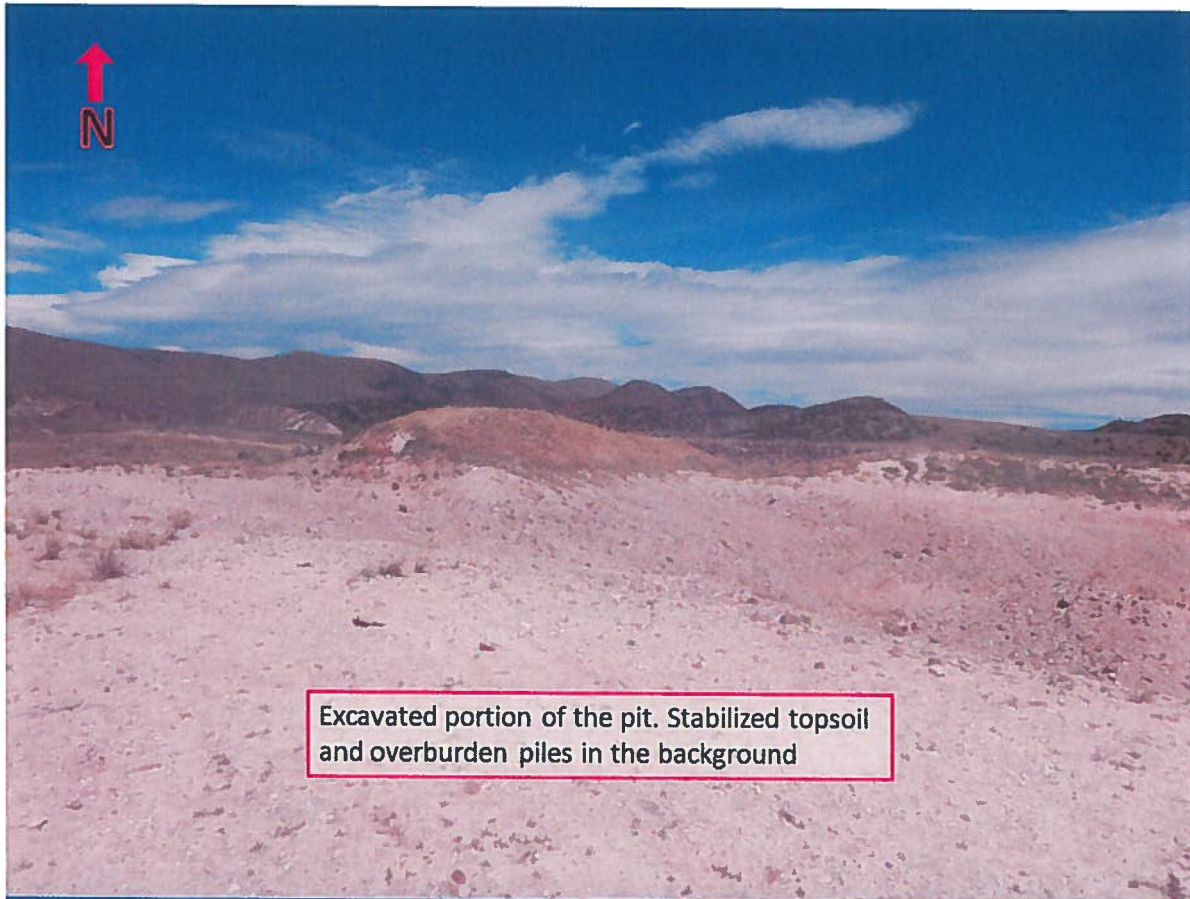
Excavated portion of the pit. Stabilized topsoil and overburden piles in the background

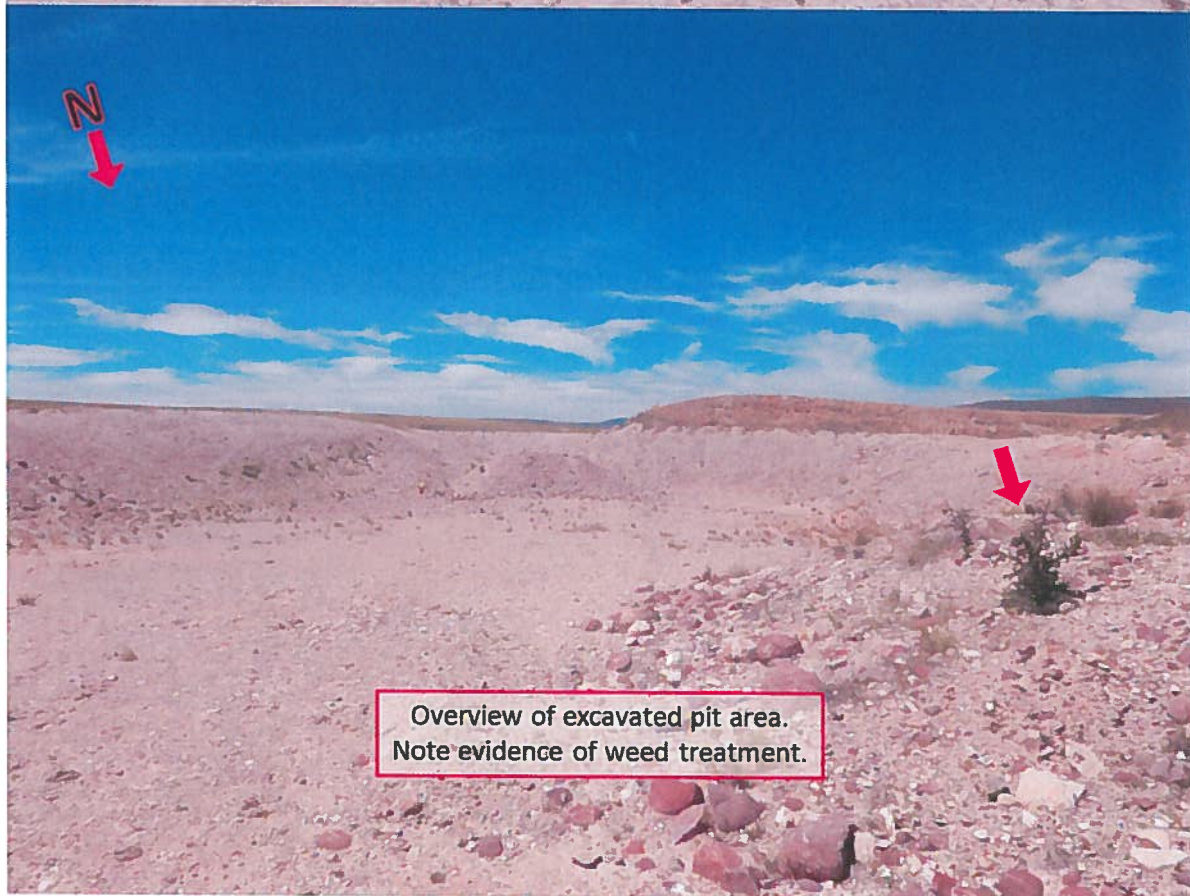
Overview of excavated pit area.
Note evidence of weed treatment.

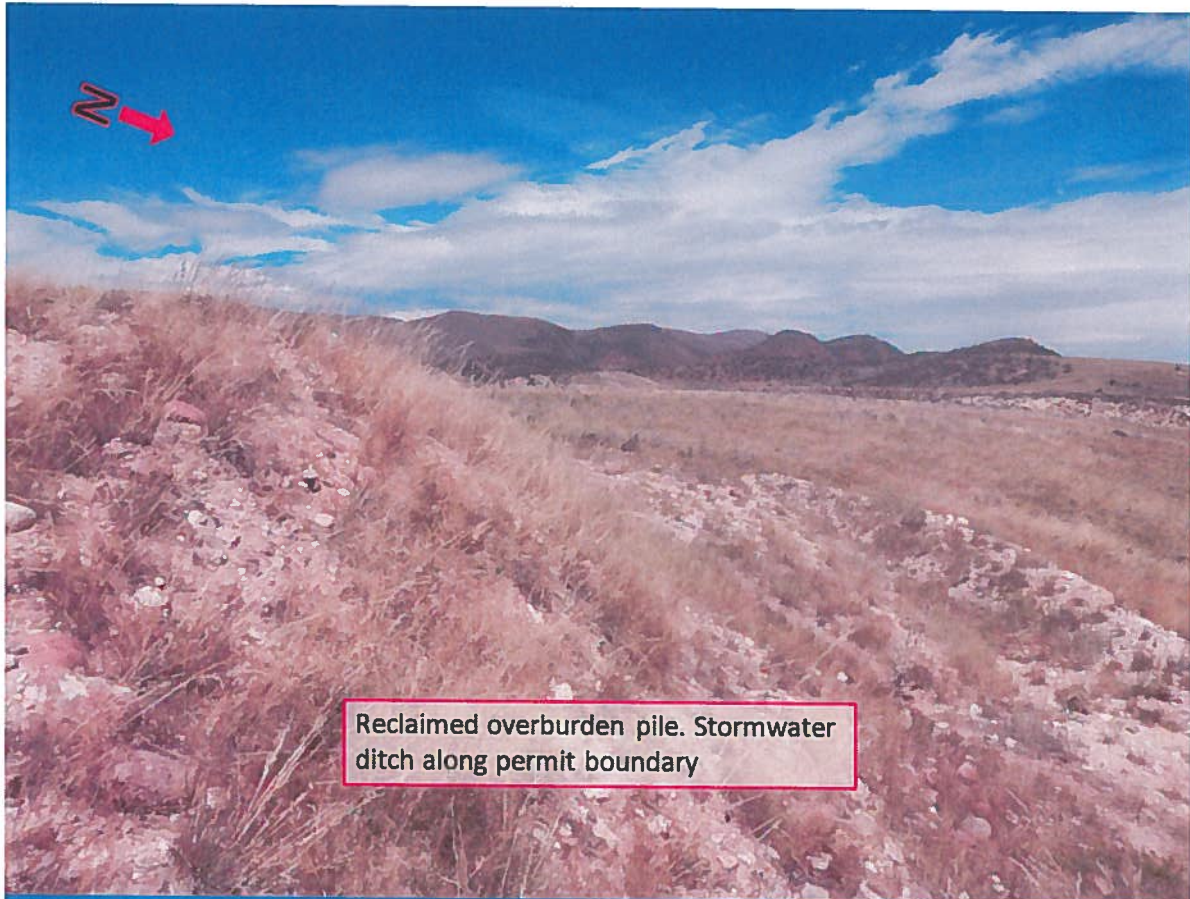
Reclaimed overburden pile. Stormwater ditch along permit boundary

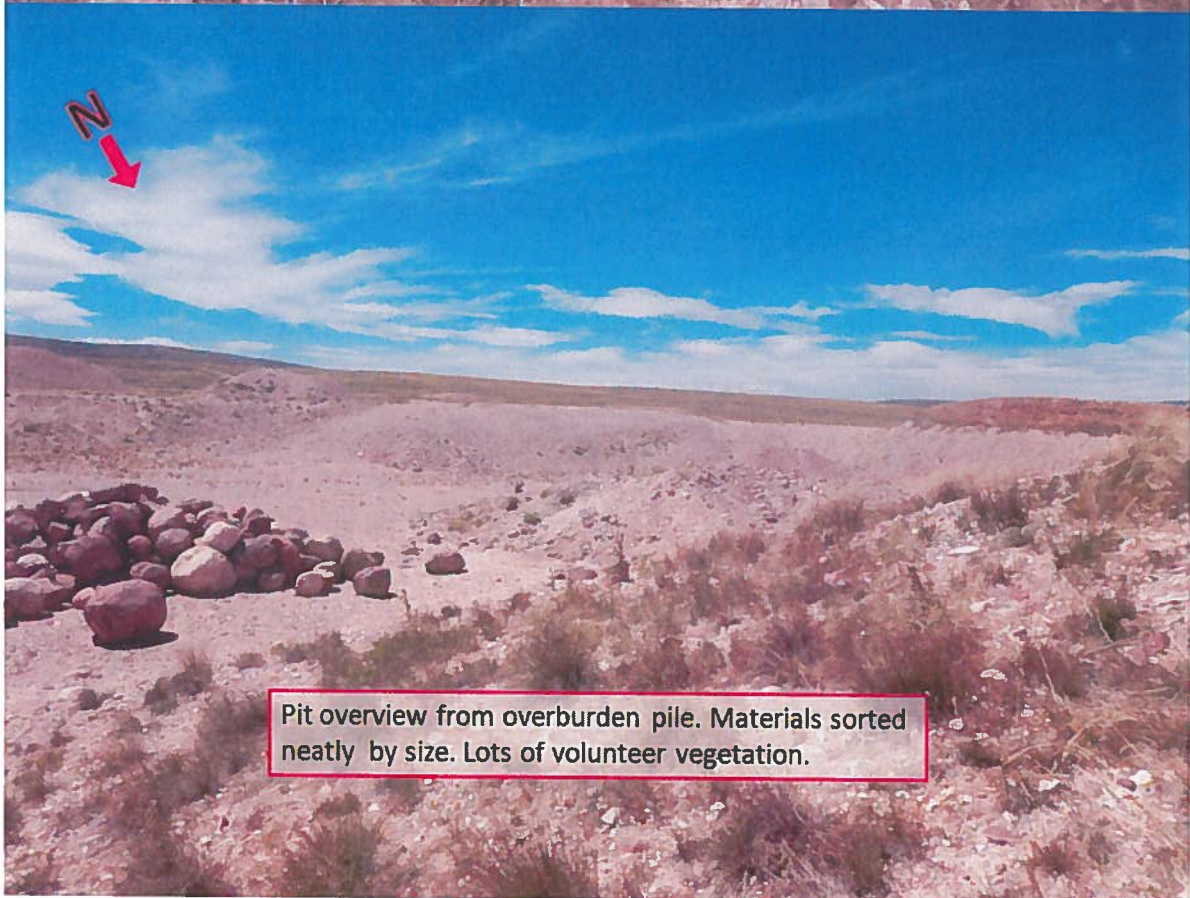
Pit overview from overburden pile. Materials sorted neatly by size. Lots of volunteer vegetation.
