COLORADO DIVISION OF RECLAMATION, MINING AND SAFETY
MINERALS PROGRAM INSPECTION REPORT
PHONE: (303) 866-3567

MINE NAME: J & J Pit	MINE/PROSPECTING ID#: M-1985-001	MINERAL: Sand and gravel	COUNTY: La Plata
INSPECTION TYPE: Monitoring	INSPECTOR(S): Lucas J. West	INSP. DATE: August 10, 2015	INSP. TIME: 12:45
OPERATOR: Glacier Gravel Products	OPERATOR REPRESENTATIVE: Landowner and Operating Company	TYPE OF OPERATION: 110c - Construction Limited Impact	
REASON FOR INSPECTION: Normal I&E Program	BOND CALCULATION TYPE: Separate Cover	BOND AMOUNT: \$8,457.58	
DATE OF COMPLAINT: NA	POST INSP. CONTACTS: None	JOINT INSP. AGENCY: None	
WEATHER: Clear	INSPECTOR'S SIGNATURE:

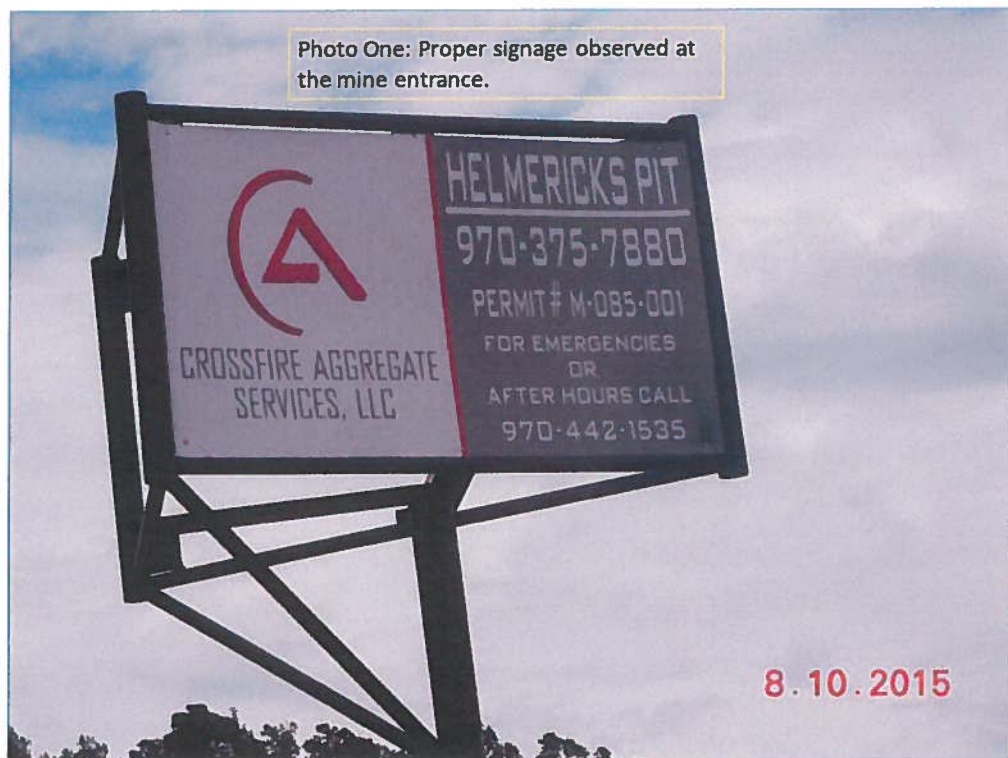
Proper signage was observed at the entrance to the site, as seen in Photo One. Permit boundary markers were not observed as required however. Due to inadequate and vague mapping during the original permitting and in the subsequent annual reports the actual permit boundaries are unclear. According to original maps and legal description in the permit application, when compared to the included maps prepared by the Division, the permit acreage totals approximately 5.6 acres. The permit boundaries as it was described to the Division by the permit holder during this inspection totals approximately 10.7 acres. The original permit was approved for 9.00 acres but is not to exceed ten acres in size according to Title 34 Article 32.5 Section 110 of the Colorado Land Reclamation Act for the Extraction of Construction Materials. No revisions or amendments to the original permit have occurred, making the original permit boundaries and maximum allowed disturbance of 9 acres still applicable. This discrepancy must be addressed by the permit holder to avoid potential violations and board enforcement.

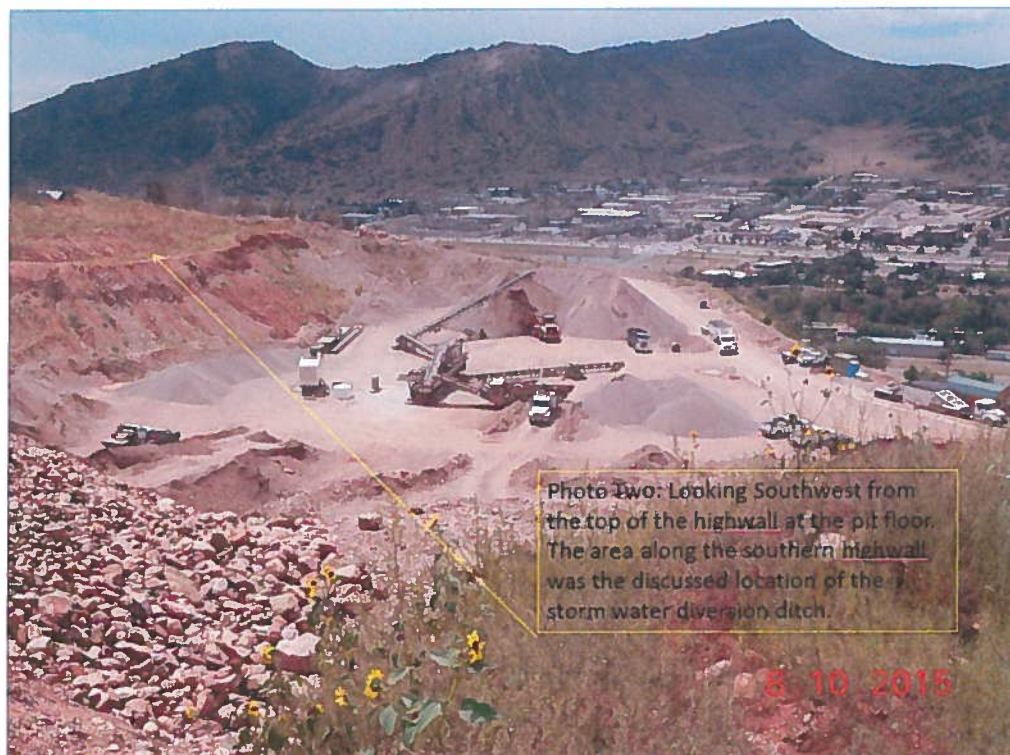
The site exhibits positive drainage with no significant erosion features. One area along the southern bench of the highwall was showing signs of slight erosion as noted in Photo 2. The Division and the contractor discussed the possibility of installing a storm water diversion ditch along the bench to divert water away from the highwall. The diversion ditch is encouraged as such structures are included in site maintenance and do not require a Technical Revision.

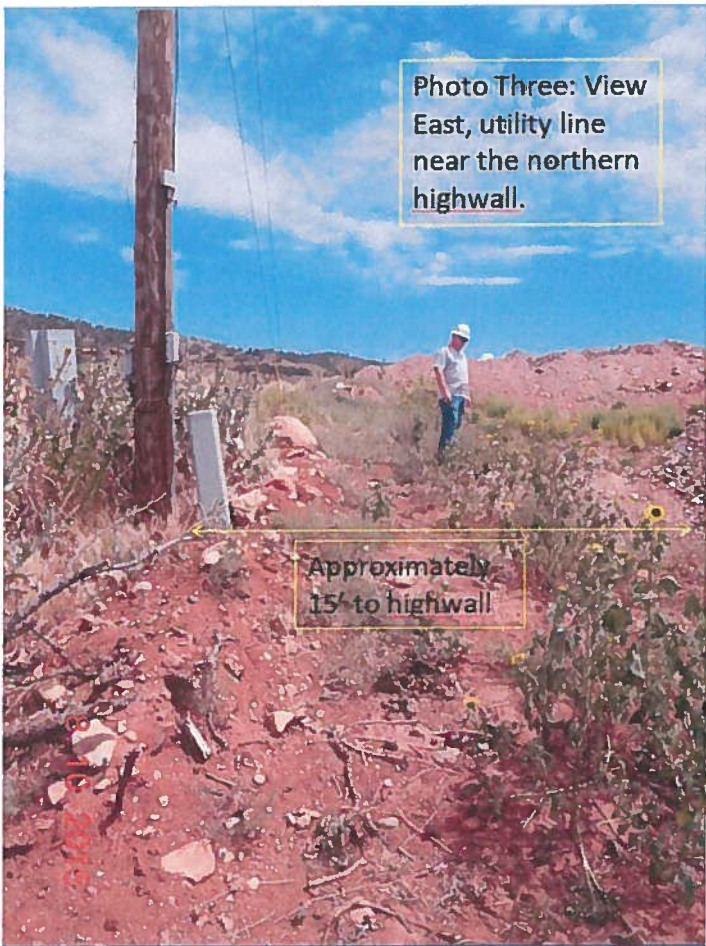
advancing towards a utility line and its related two power poles owned by La Plata County Electric Association. The highwall is currently approximately 15 feet from the base of the power poles, as seen in Photos Three and Four. The contractor on site has raised concerns about the lack of a right of way agreement with The Plata County Electric Association as well as stability and safety concerns from mining to close to the poles. The permit holder disagrees. Due to the unclear permit boundary issue and no markers there is also concern that the area is in fact not included in the approved permit boundaries. If the area is outside the permit boundaries any mining activity would be a violation of the permit. **It is strongly recommended that neither the permit holder nor the contractor advance the Northern highwall further until the required surveying mentioned above is completed and accepted by the Division to ensure the area is within the permit boundaries and proper evaluation of the impacts from excavations to nearby power poles are addressed.**

If the utility lines are found to be inside the permit boundaries the permit holder will be required to submit a Technical Revision which demonstrates compliance with Rule 6.3.12- Exhibit L- Permanent Man Made structures prior to any further excavations in this area. The permit holder assumes all liability and responsibilities if the Divisions recommendation of no further excavations in this area is not followed.

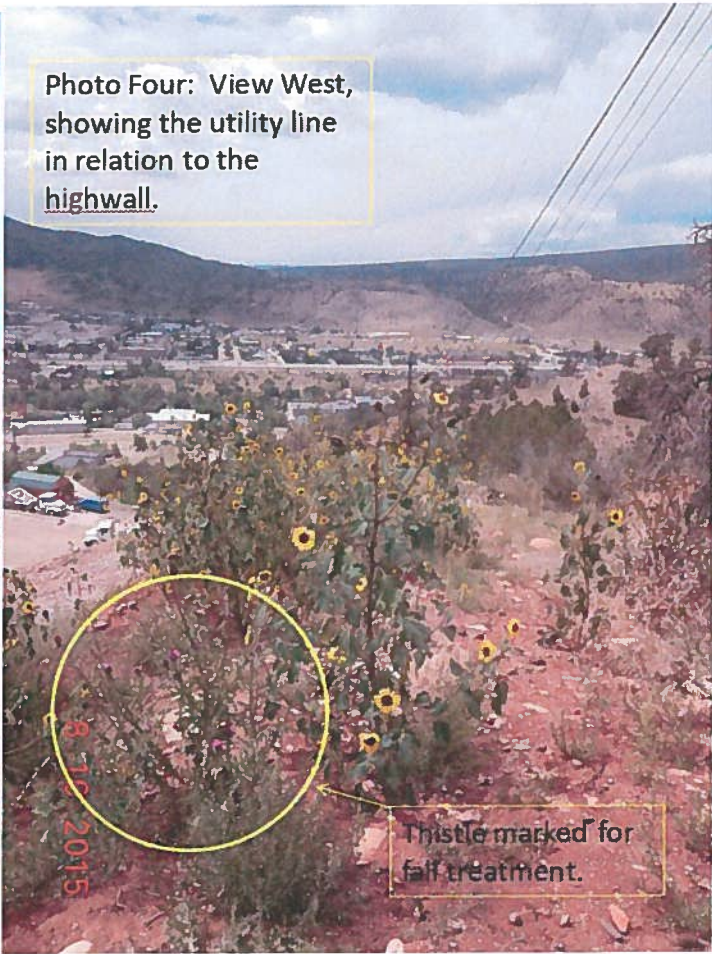
Overall the footprint of the site was in good condition, with no visible excess trash and debris associated with the mine. Scotch thistle was observed along the northern boundary, as seen in Photos Four and Five. The area is considered a sink for these weeds not a source as the entire region is being heavily infested this year. The weeds were marked for fall treatment by the contractor and no other state listed noxious weeds were observed on site.

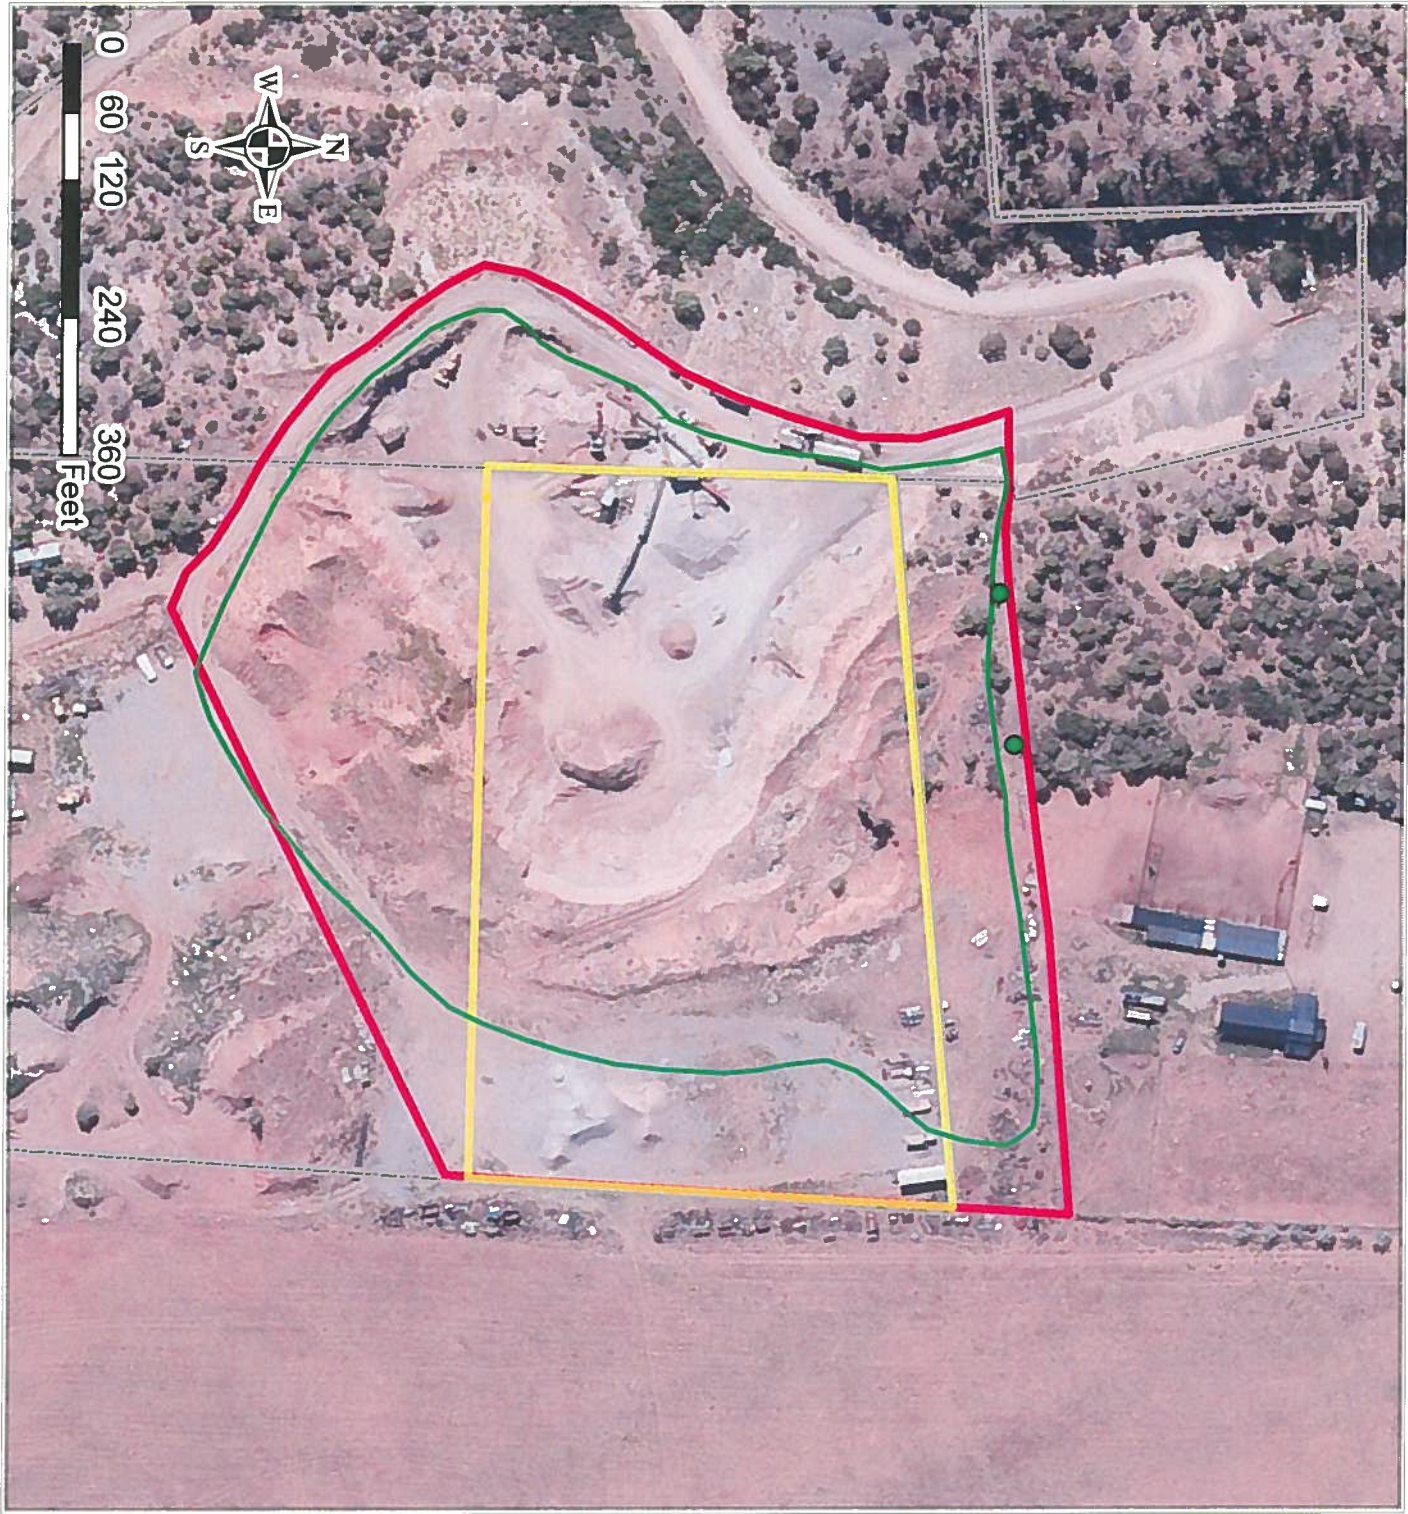
M-1985-001 J&J (Helmricks) Pit

The current actual disturbance measured by the Division is just over 8 acres. The permit boundaries and lack of markers is noted as a problem. The corrective action to the problem is: The permit holder is required to submit to the Division a site survey and map in compliance with the requirements outlined in Rule 6.2.1 (2)(a-e) to reflect the current actual disturbance. The surveyed areas will provide an accurate quantification of the disturbed acreage and delineate the approved permit boundaries of 9 acres. Appropriate boundary markers shall be installed to clearly define the surveyed boundaries. **Failure to provide accurate boundary markers and maps is being cited as a problem with a compliance date of November 09, 2015.**
