COLORADO DIVISION OF RECLAMATION, MINING AND SAFETY
MINERALS PROGRAM INSPECTION REPORT
PHONE: (303) 866-3567

MINE NAME: Gardner Gravel Pit	MINE/PROSPECTING ID#: M-1979-034	MINERAL: Sand and gravel	COUNTY: Routt
INSPECTION TYPE: Monitoring	INSPECTOR(S): Amy C. Yeldell	INSP. DATE: August 6, 2015	INSP. TIME: 09:20
OPERATOR: General Operating Company	OPERATOR REPRESENTATIVE: Mike Gomez	TYPE OF OPERATION: 112c - Construction Regular Operation

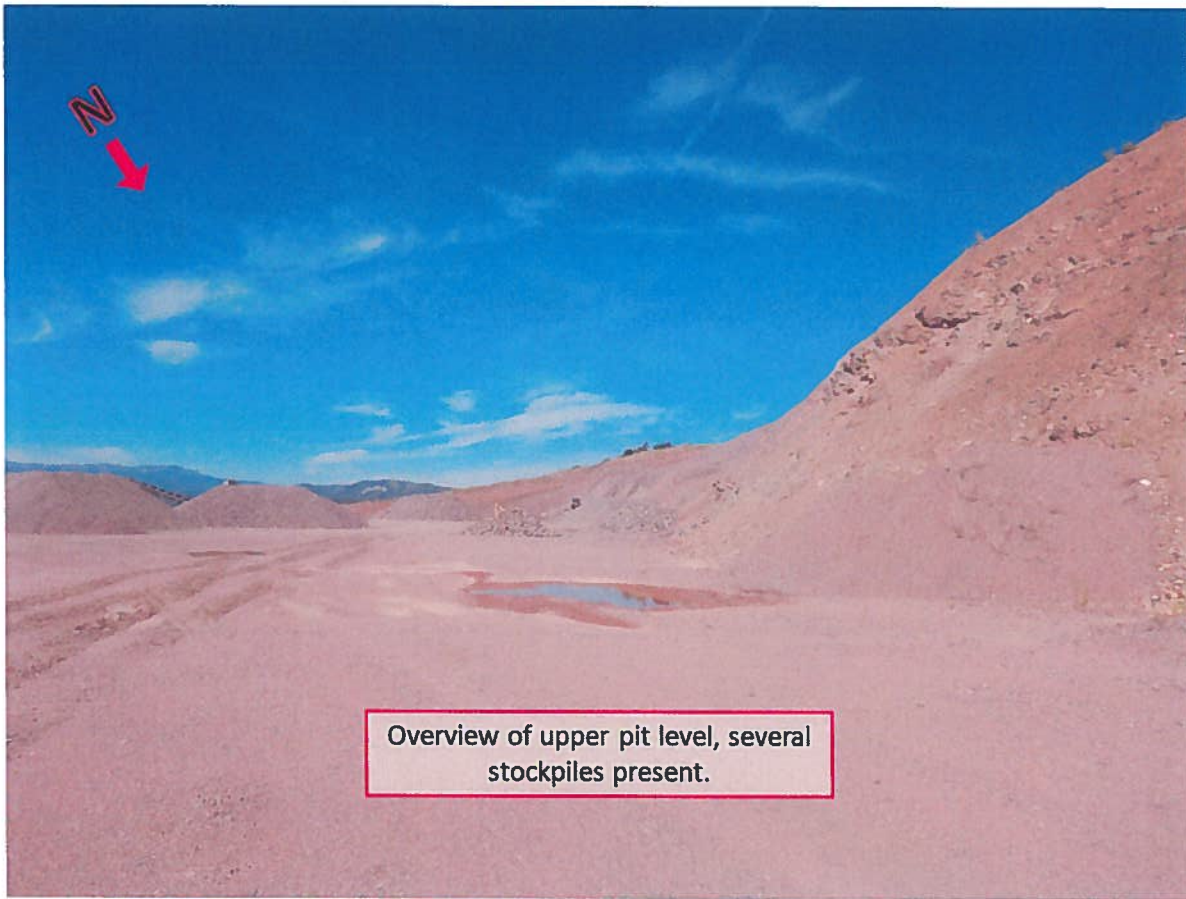
Overview of upper pit level, several stockpiles present.

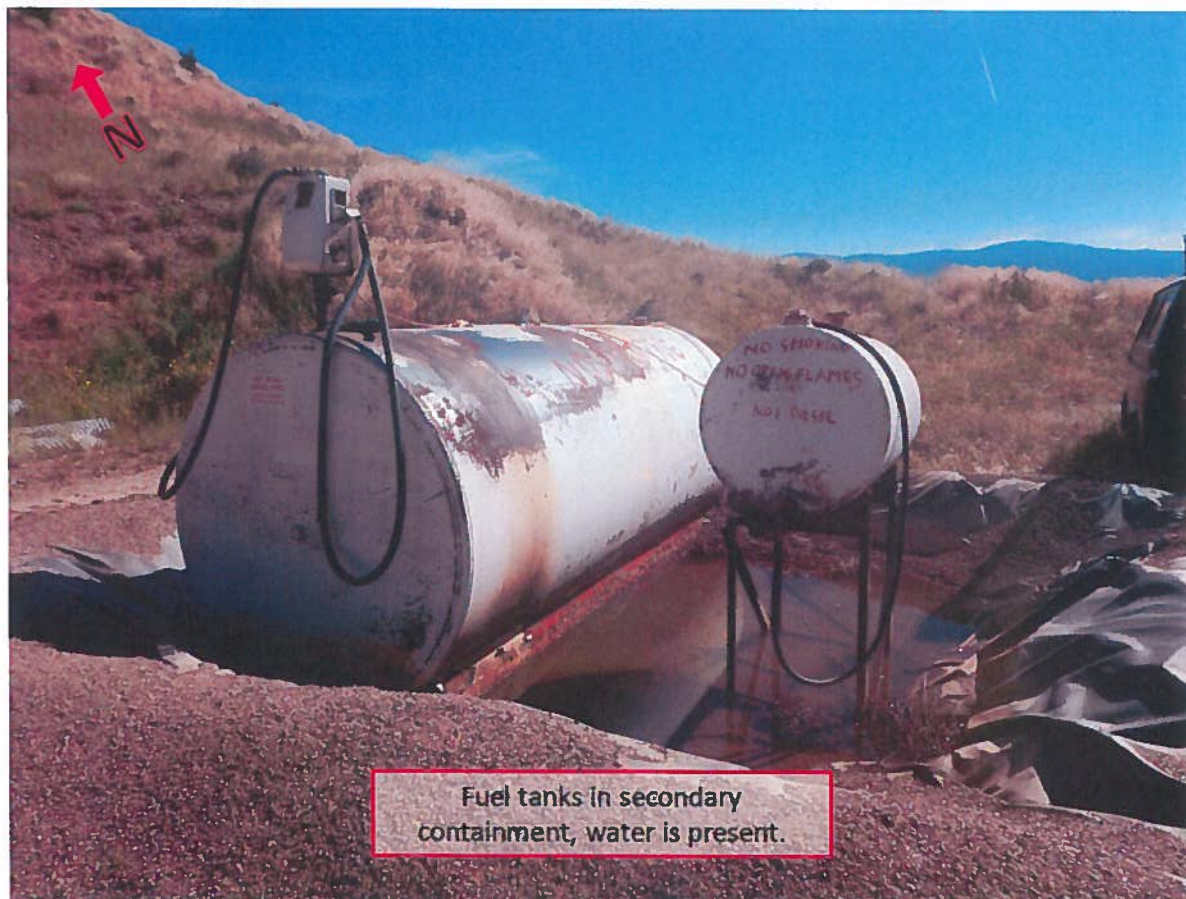
Two fuel tanks are stored in a secondary containment. Stormwater was observed in the containment. It is recommended that that water be hauled off for disposal to ensure the secondary containment has adequate capacity.

Fuel tanks in secondary containment, water is present.
