RE: Request for Bond Release, Purple Hill, Permit P-2012-004

Reclamation Report

Name of Operation: Purple Hill

Prospecting Notice of Intent: P-2012-004

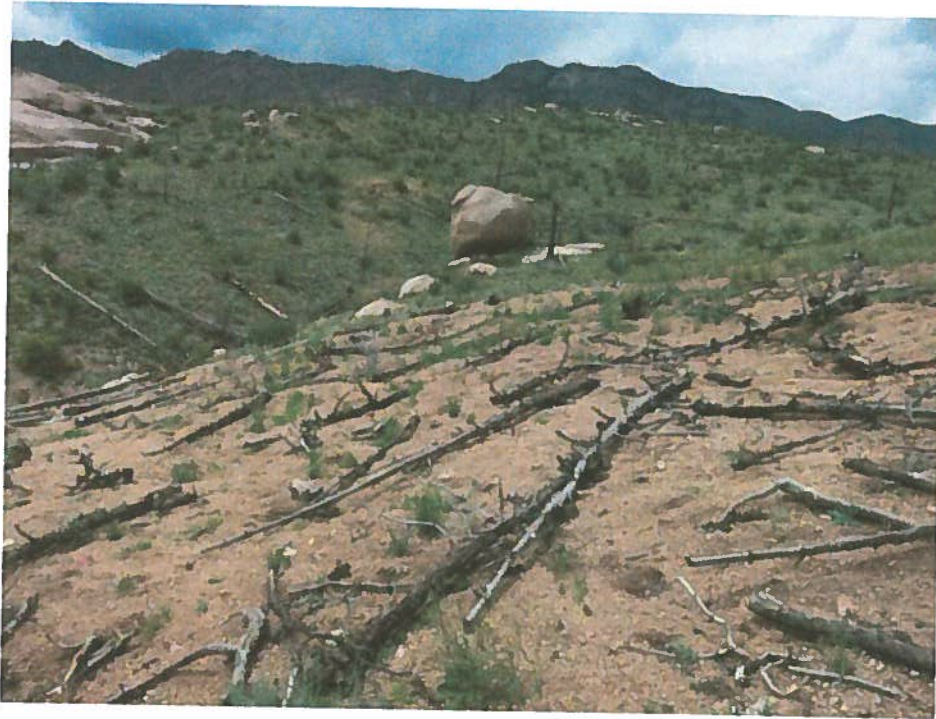
First seeds germinated in July 2013 and vegetation started to establish throughout the fall of 2013 aided by regular and above average precipitation. Growth continued and vegetation started to establish after ample snow fall winter 2013/2014. Fig. 1 shows site condition in July 2014.

Figure 1: Site conditions as of July 2014, looking north across the project site. First vegetation established.

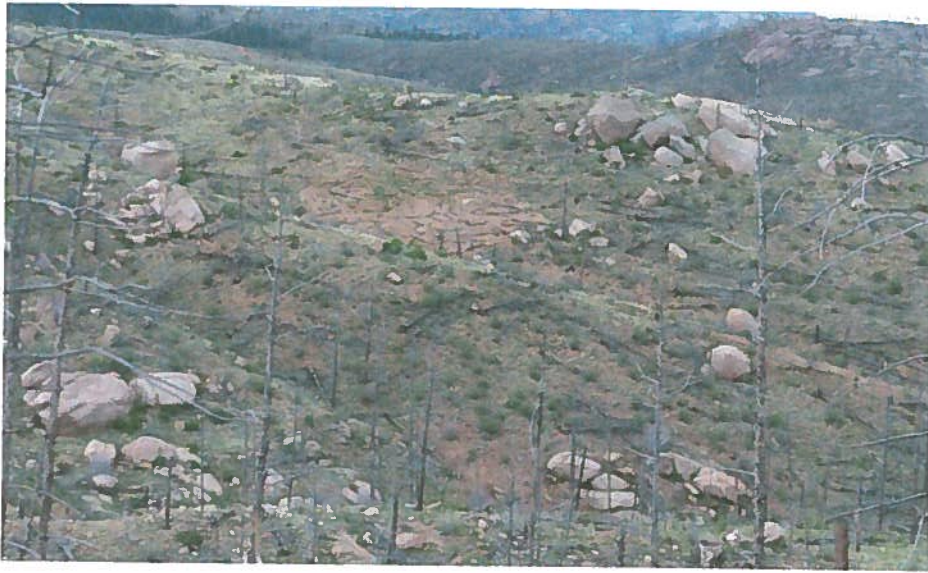
Growth and further expansion of vegetation through seeds spread naturally from undisturbed surrounding continued through Spring. Fig. 2 shows site conditions mid May 2015 as photographed from across the Matukat road to the south. The site started to blend into the surrounding. Dense vegetation on top and sparser on slope, is comparable to surrounding, with distinctly sparser vegetation on SW facing slopes being typical.

Figure 2: Site conditions mid May 2015, photographed from Matukat road looking north across Molly Gulch.

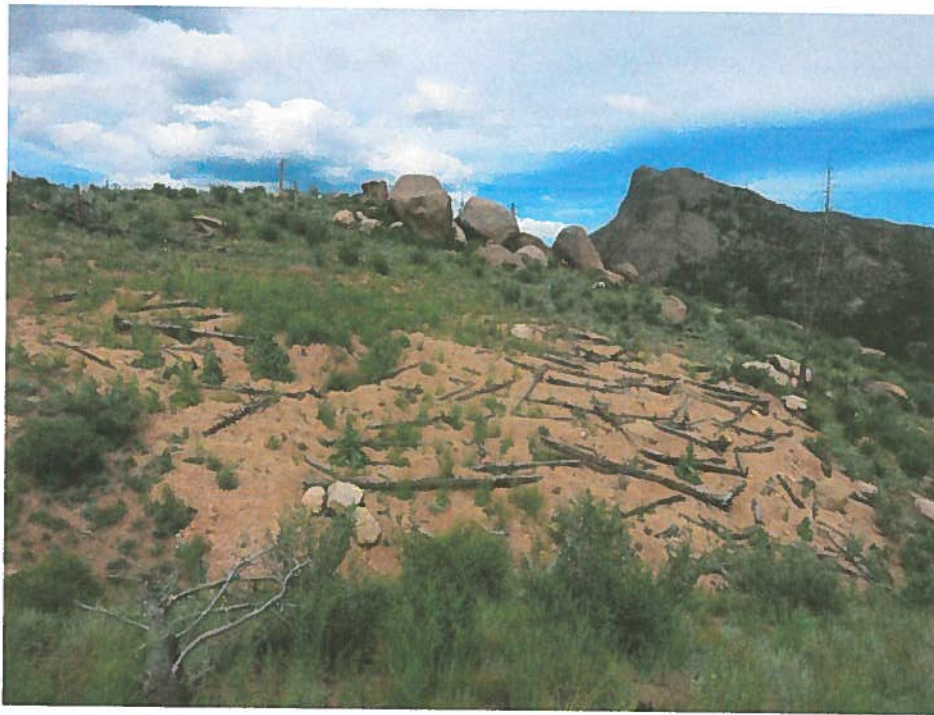
Ample rainfall through summer 2015 supported further growth and spread of vegetation. Fig. 3 shows site conditions as of July 2015. The reclaimed area is barely distinguishable from its surrounding.

Figure 3: Site conditions as of July 2015. Looking east across draw from west of the project area.
