COLORADO DIVISION OF RECLAMATION, MINING AND SAFETY
MINERALS PROGRAM INSPECTION REPORT
PHONE: (303) 866-3567

MINE NAME: Skold Pit	MINE/PROSPECTING ID#: M-1998-032	MINERAL: Gravel	COUNTY: Sedgwick
INSPECTION TYPE: Monitoring	INSPECTOR(S): Elliott R. Russell	INSP. DATE: April 16, 2015	INSP. TIME: 09:45
OPERATOR: Sedgwick County	OPERATOR REPRESENTATIVE: Randy Renquist	TYPE OF OPERATION: 110c - Construction Limited Impact

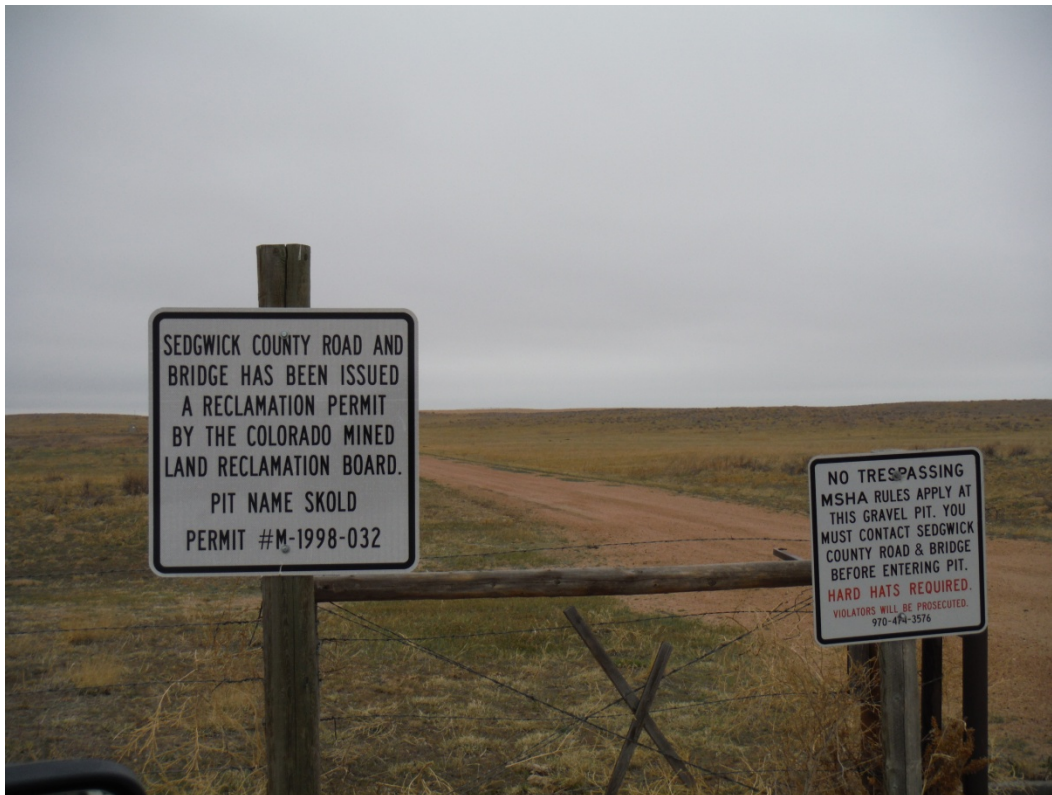
Site identification sign posted at the site entrance; looking north.

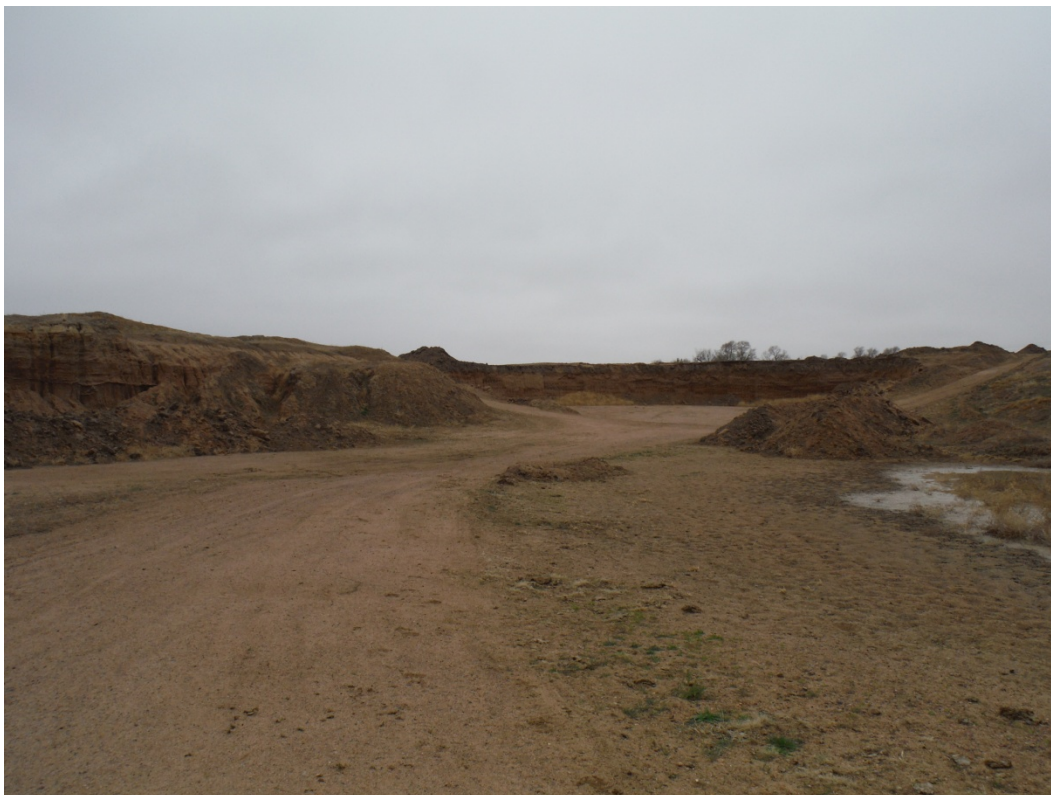
Pit overview; looking south.

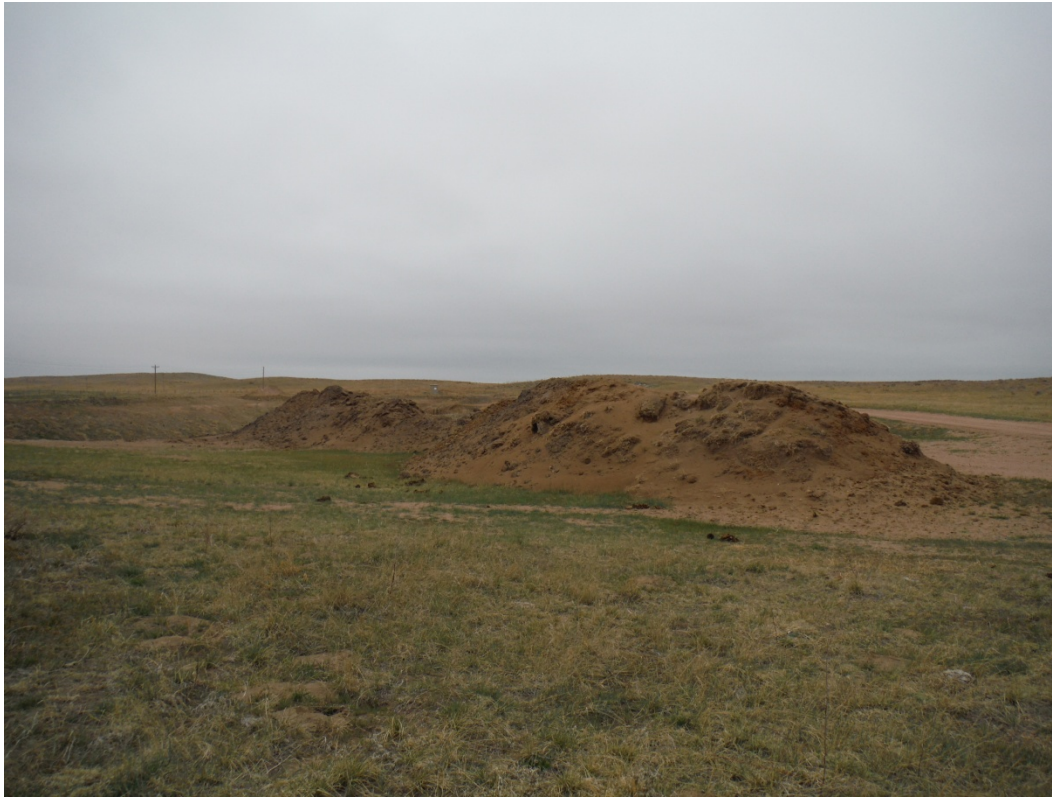
Topsoil stockpiled southeast of the pit; looking north.

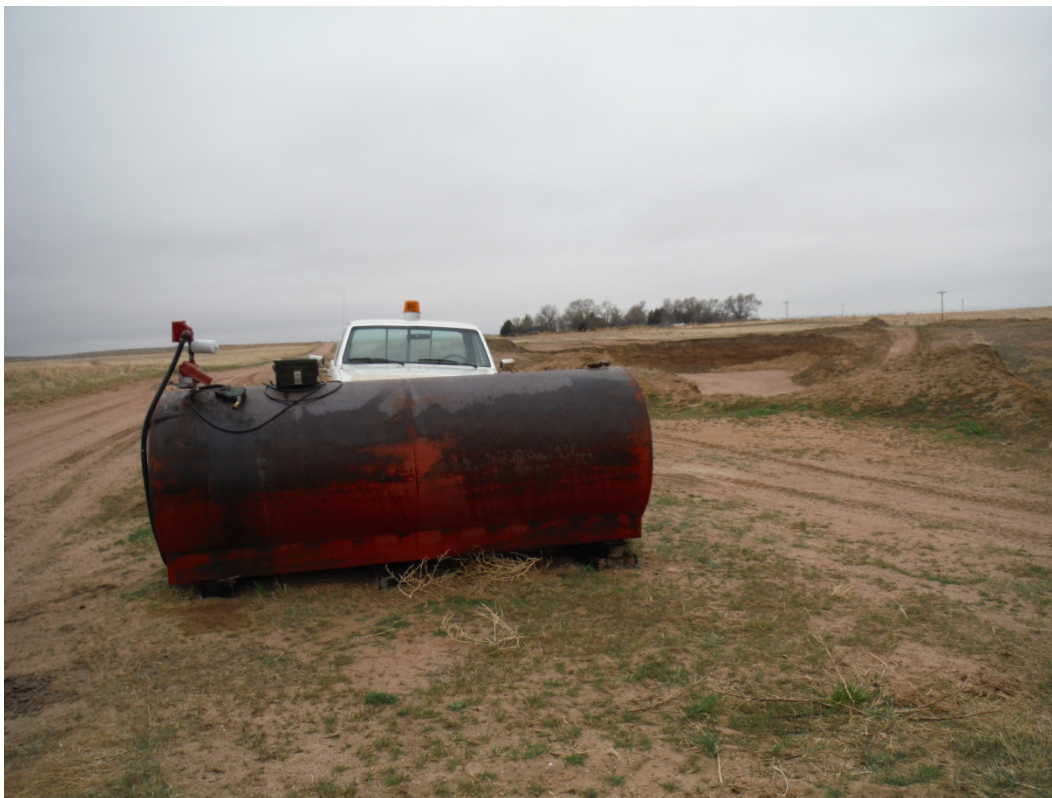
PROBLEM/POSSIBLE VIOLATION: Problem: Improper storage and containment of fuels and/or other hazardous materials was present on site.

The Division observed a fuel tank on-site, located near the northeast corner of the pit. There was no secondary containment structure around this tank and it was unknown if it was a double-walled tank. This has been cited as a problem requiring corrective action, please see page 2 of this report for more information.

Fuel tank located northeast of the pit; looking south.

CORRECTIVE ACTIONS: All storage tanks, petroleum and any hazardous materials on site for any period of time shall have appropriate secondary containment. The site will also have to comply with all applicable SPCC requirements. Please supply photo documentation that any fuel or hazardous materials containers are stored properly - including applicable secondary containment structures by the corrective action date. Note that secondary containment structures shall consist of an impermeable containment which could contain all contents of the tanks and various containers (when full) plus 10% of the total capacity. The operator may also provide photo documentation that all containers have been removed from the site on or before the corrective action date.

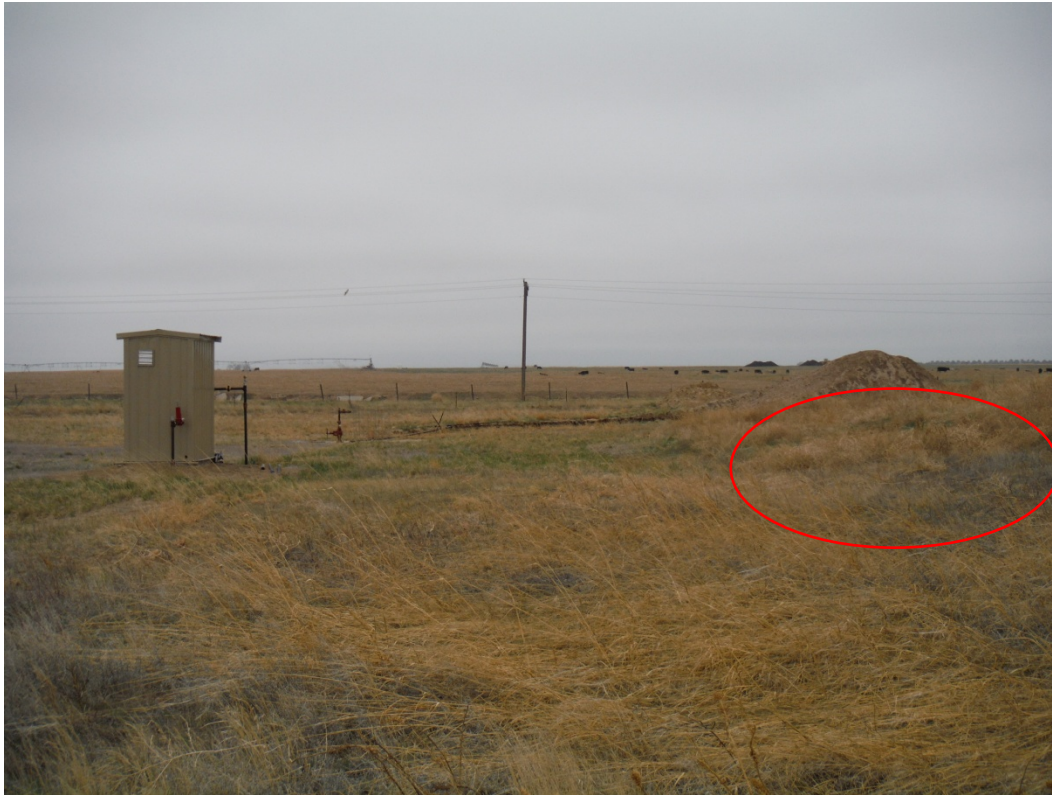
PROBLEM/POSSIBLE VIOLATION: Problem: There are structures within 200' of the permit boundary which do not have structure agreements within the approved permit. This is a failure to comply with section 6.4.19 of the Rule.

The Division also observed a new oil/gas facility between the pit excavation and the northern permit boundary (the vegetated topsoil stockpile is located just to the north of this facility). The facility consists of shed, pipeline, and a small excavated overflow pit. After reviewing the permit documents, the Division was unable to locate any associated structure agreements regarding this facility, most likely because the facility appears to have been installed within the last couple of years. This has been cited as a problem requiring corrective action; please see page 2 of this report for further detail on this problem. Rule 6.3.12 states:

Oil and gas facility just north of the pit, a portion of the northern topsoil pile is circled in red; looking west.

CORRECTIVE ACTIONS: The Operator shall submit a notarized agreement between the Operator and the persons having interest in the oil/gas facility, which the Operator is to provide compensation for any damage to the structure; or submit other documentation in accordance with Rule 6.3.12.
