COLORADO DIVISION OF RECLAMATION, MINING AND SAFETY
MINERALS PROGRAM INSPECTION REPORT
PHONE: (303) 866-3567

MINE NAME: State Land-Jensen Pit	MINE/PROSPECTING ID#: M-1983-050	MINERAL: Sand and gravel	COUNTY: Sedgwick
INSPECTION TYPE: Monitoring	INSPECTOR(S): Elliott R. Russell	INSP. DATE: April 16, 2015	INSP. TIME: 10:25
OPERATOR: Phillips County	OPERATOR REPRESENTATIVE: None	TYPE OF OPERATION: 110c - Construction Limited Impact

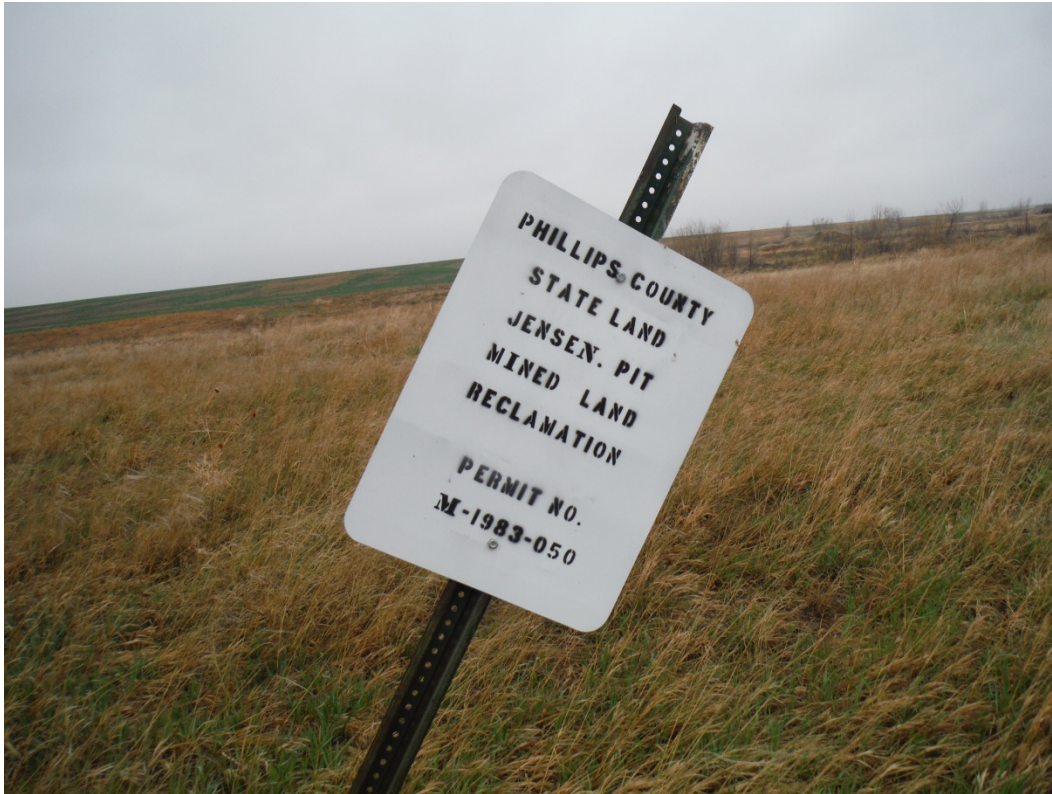
Site identification sign posted at the site entrance; looking east.

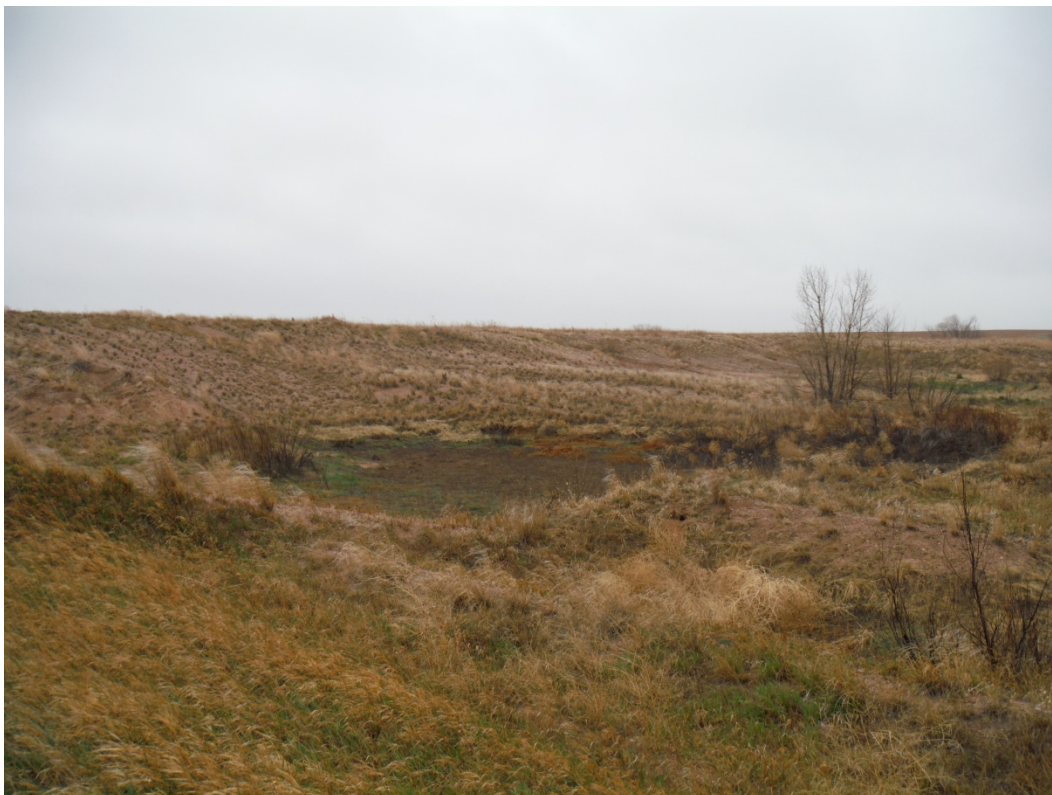
Site overview; looking northwest.

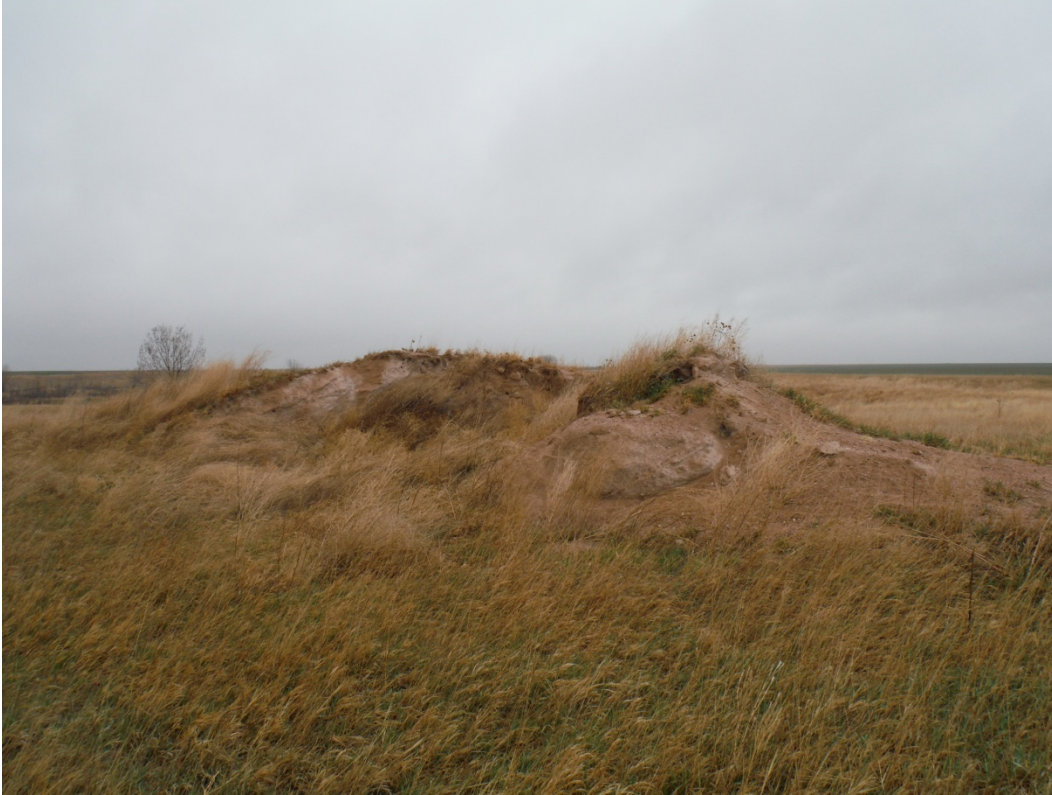
Product stockpile; looking east.

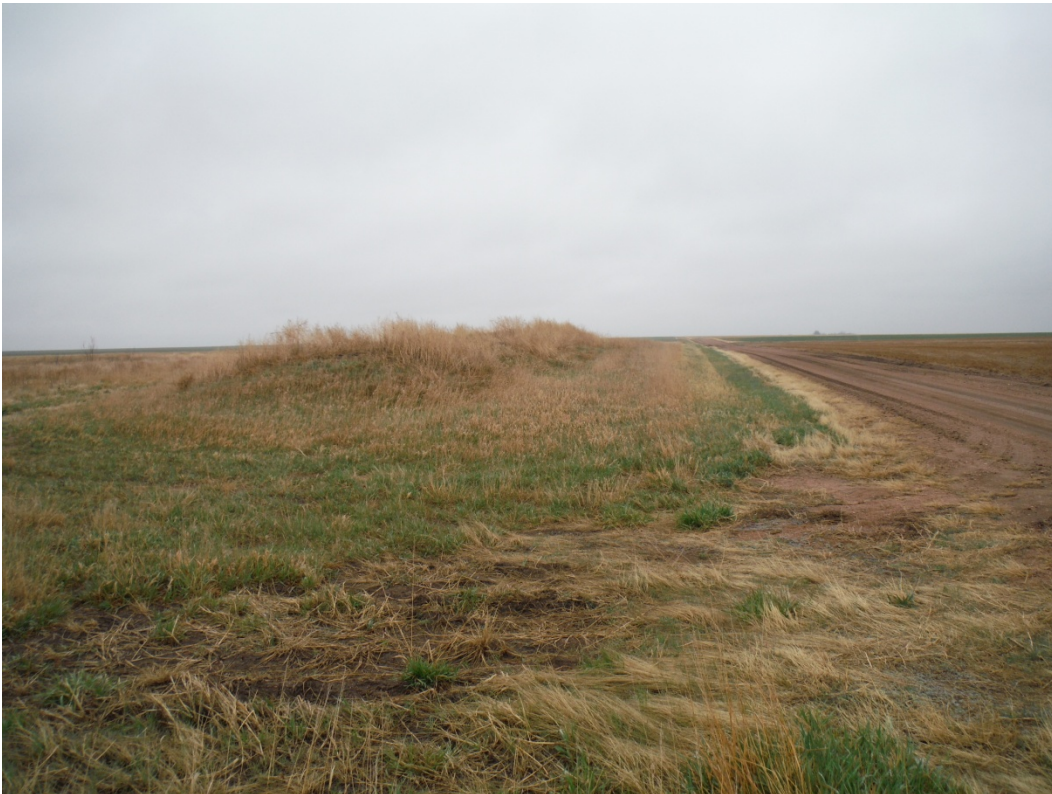
Toposil stockpile along the western boundary; looking south.

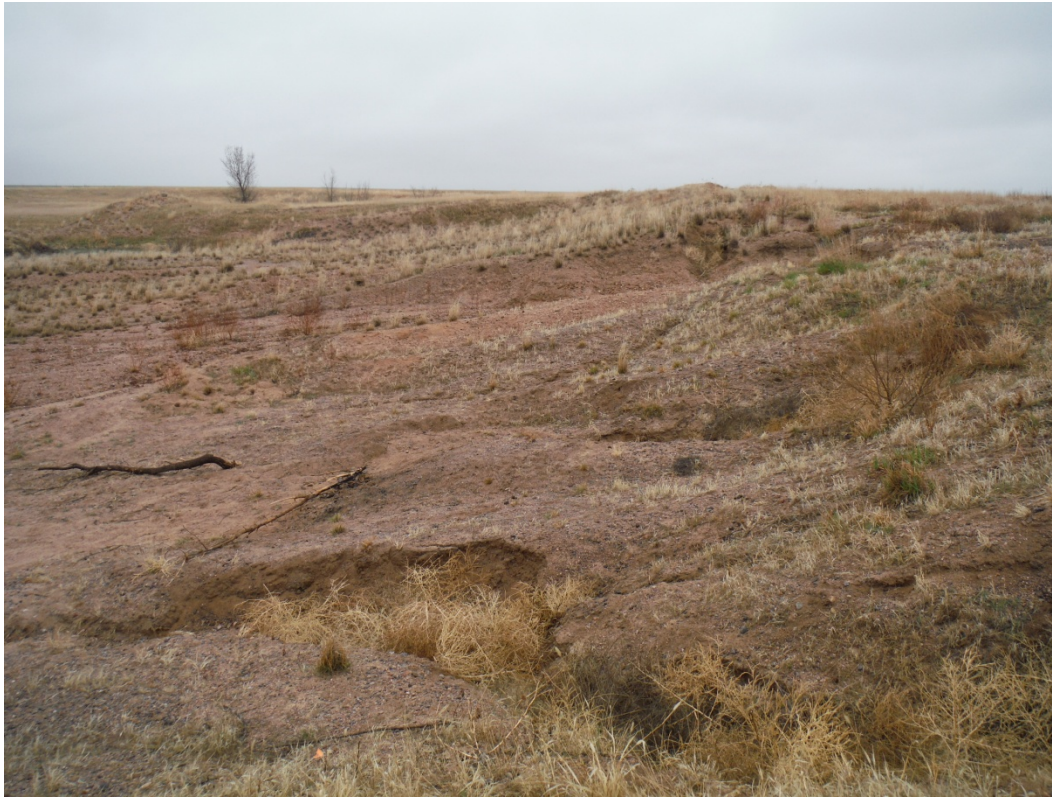
Excavated area, signs of erosion present; looking south.
