COLORADO DIVISION OF RECLAMATION, MINING AND SAFETY
MINERALS PROGRAM INSPECTION REPORT
PHONE: (303) 866-3567

MINE NAME: Kinnie Gravel Pit	MINE/PROSPECTING ID#: M-1997-061	MINERAL: Gravel	COUNTY: Sedgwick
INSPECTION TYPE: Monitoring	INSPECTOR(S): Elliott R. Russell	INSP. DATE: April 16, 2015	INSP. TIME: 10:50
OPERATOR: Sedgwick County	OPERATOR REPRESENTATIVE: Randy Renquist	TYPE OF OPERATION: 110c - Construction Limited Impact

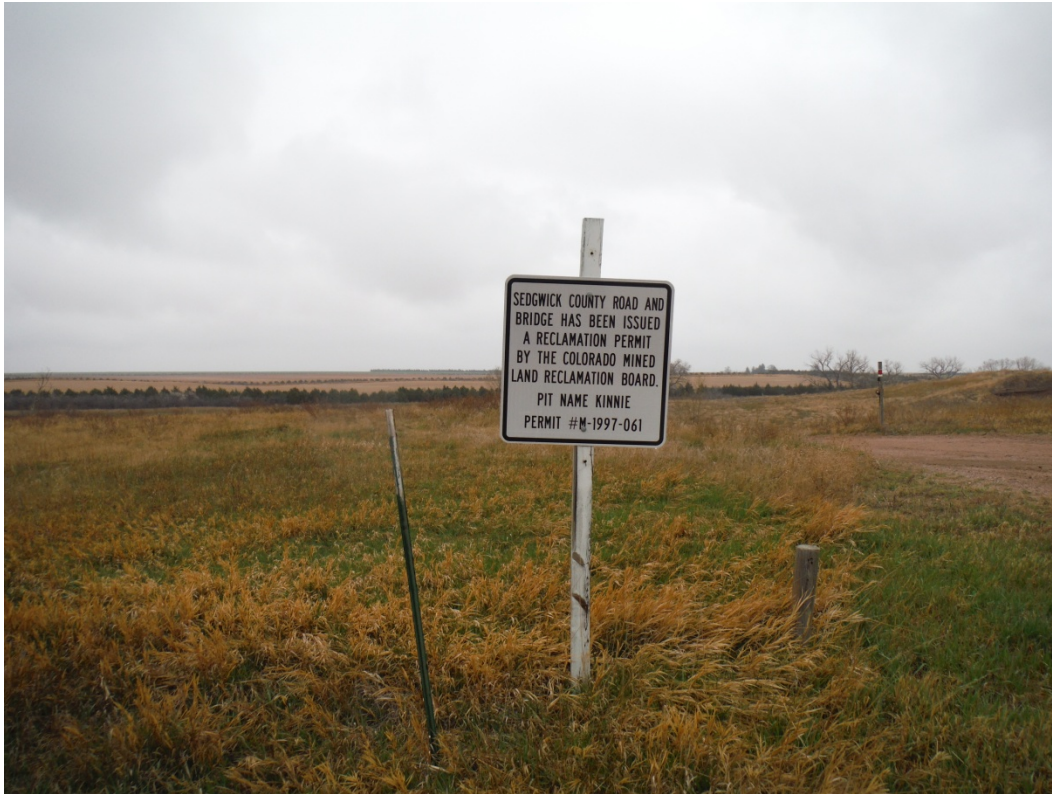
Site identification sign posted at the site entrance; looking north.

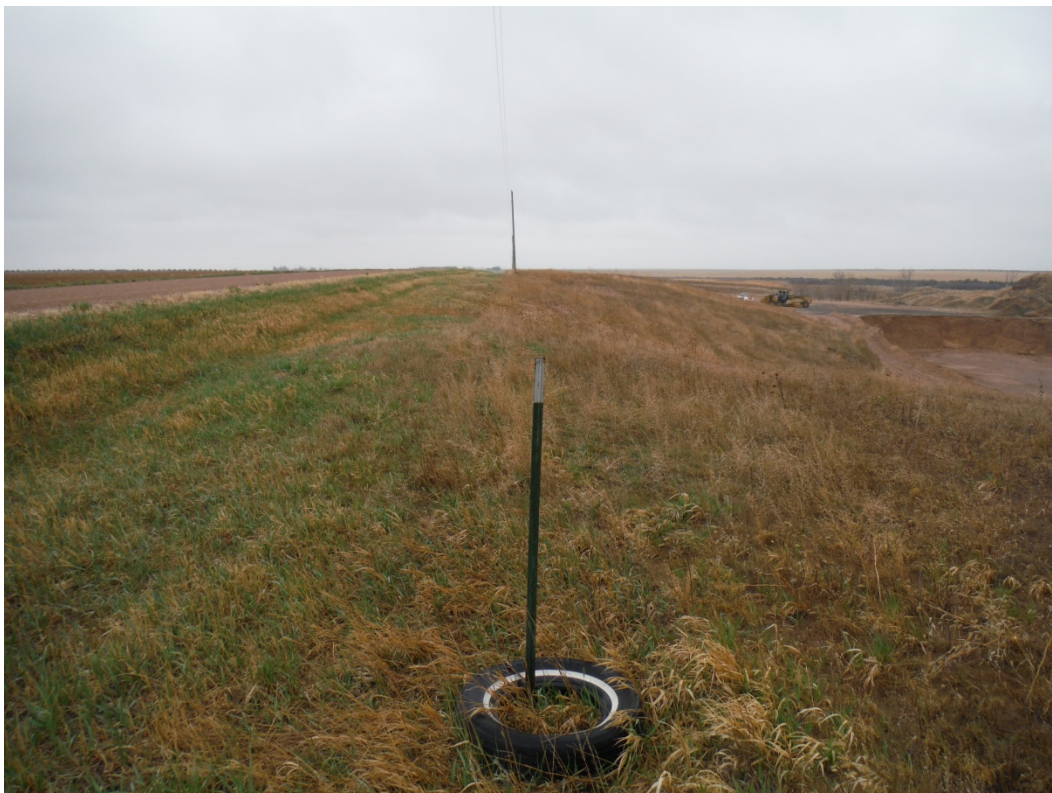
Southeast boundary marker; looking west.

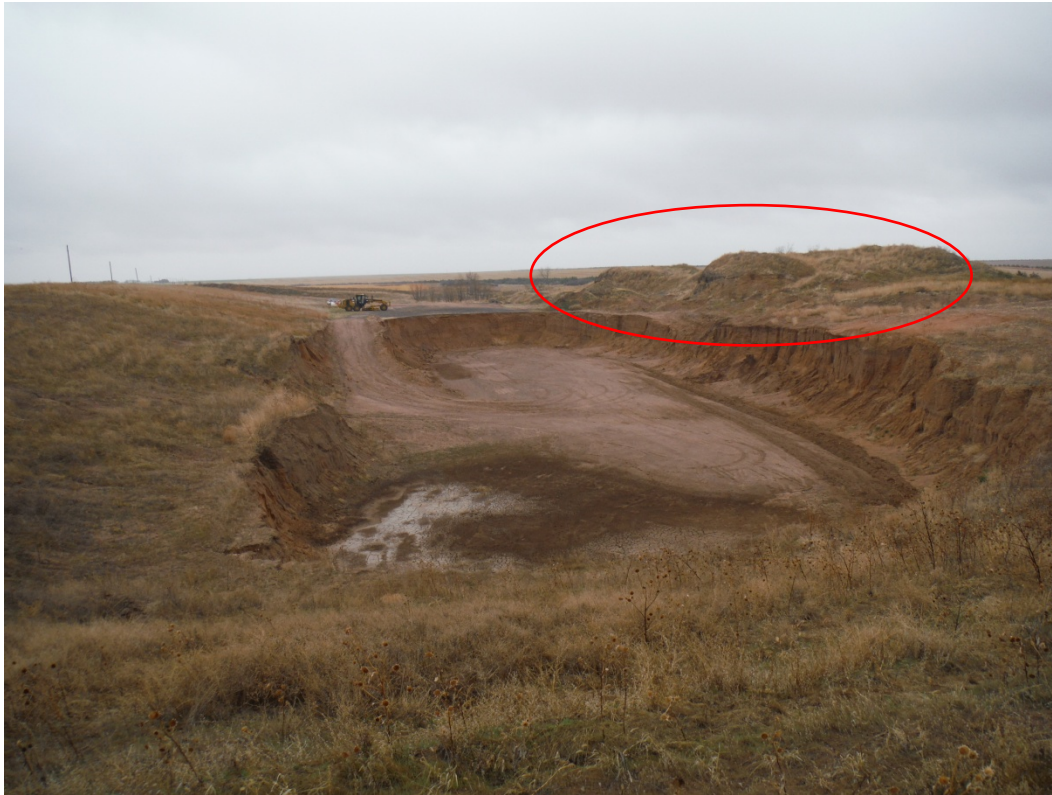
The site consists of a single excavated area being worked in two lifts; the majority of the permit area was mined 10-15 feet deep and now the active face is another 15 feet below. The first lift's southern and eastern slopes have been graded and vegetated while the second lift contains vertical highwalls. Topsoil and overburden has been stripped and piled along the northern portion of the site

Pit overview, overburden and topsoil stockpiles circled in red; looking west.

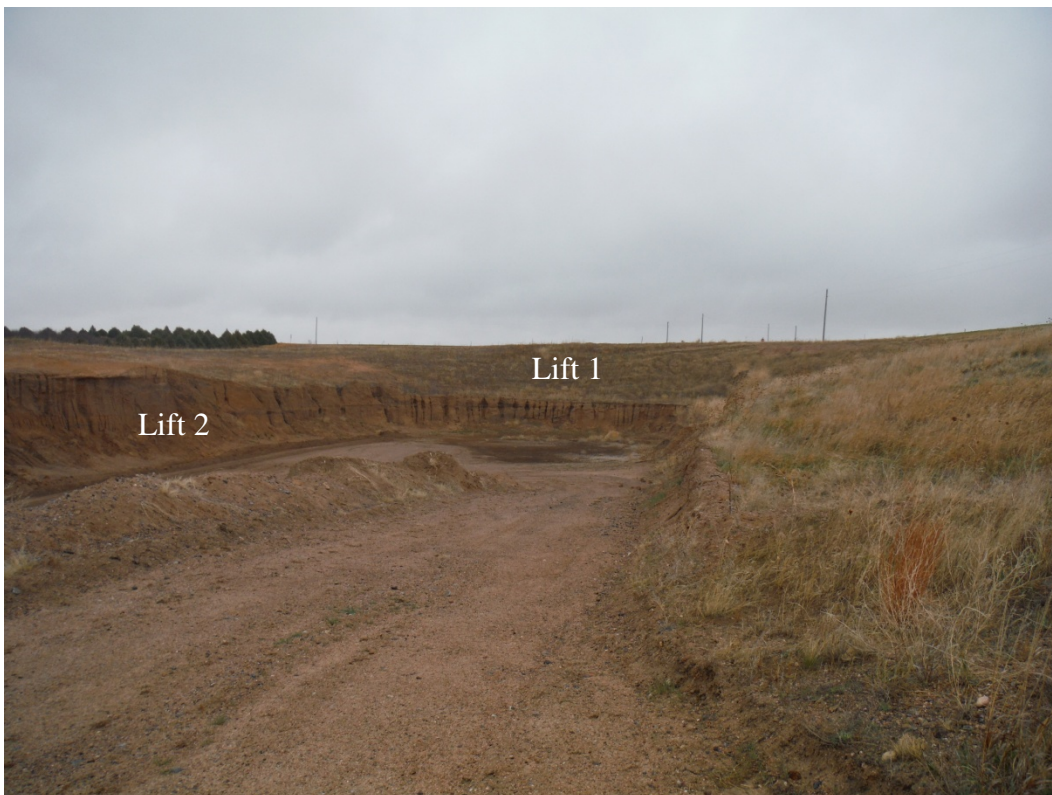
Pit overview; looking east.

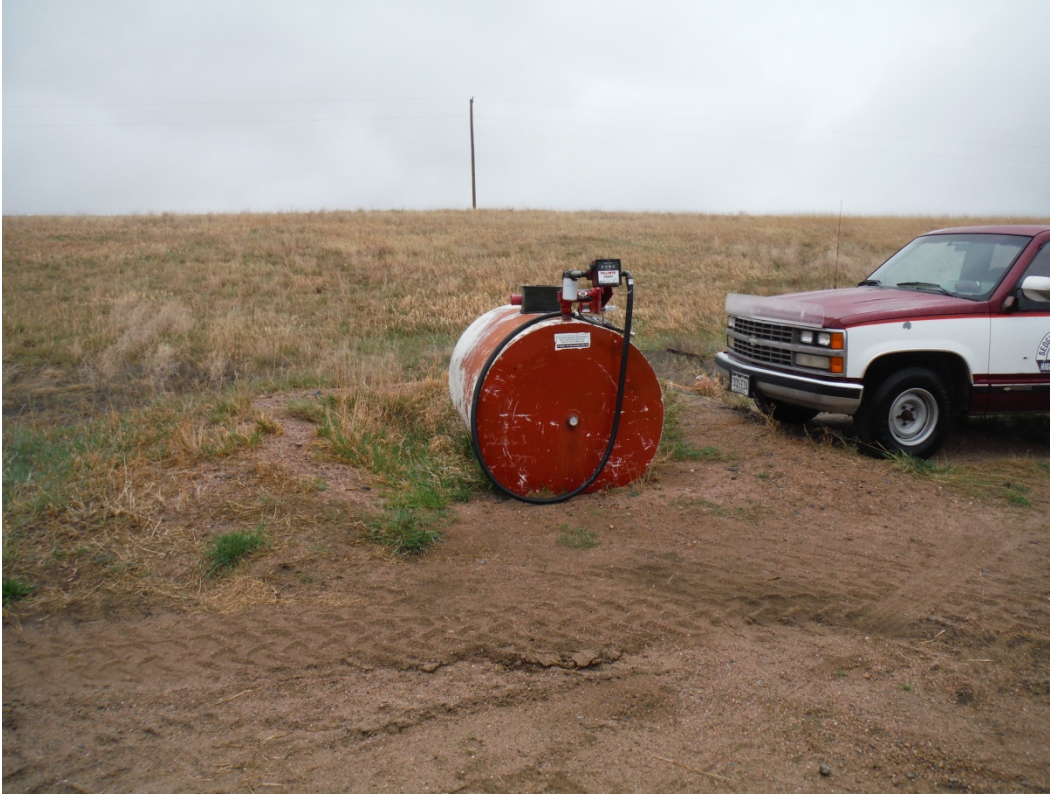
PROBLEM/POSSIBLE VIOLATION: Problem: Improper storage and containment of fuels and/or other hazardous materials was present on site.

The Division observed a fuel tank on-site, near the access road leading down into the pit. There was no secondary containment structure around this tank and it was unknown if it was a double-walled tank. This has been cited as a problem requiring corrective action; please see above for further detail on this problem.

Fuel tank located on site; looking south.

CORRECTIVE ACTIONS: All storage tanks, petroleum and any hazardous materials on site for any period of time shall have appropriate secondary containment. The site will also have to comply with all applicable SPCC requirements. Please supply photo documentation that any fuel or hazardous materials containers are stored properly - including applicable secondary containment structures by the corrective action date. Note that secondary containment structures shall consist of an impermeable containment which could contain all contents of the tanks and various containers (when full) plus 10% of the total capacity. The operator may also provide photo documentation that all containers have been removed from the site on or before the corrective action date.

CORRECTIVE ACTION DUE DATE: 8/30/15
