**COLORADO DIVISION OF RECLAMATION, MINING AND SAFETY**  
**MINERALS PROGRAM INSPECTION REPORT**  
**PHONE: (303) 866-3567**

<b>MINE NAME:</b> Dolezal Gravel Pit	<b>MINE/PROSPECTING ID#:</b> M-1996-073	<b>MINERAL:</b> Gravel	<b>COUNTY:</b> Sedgwick
<b>INSPECTION TYPE:</b> Monitoring	<b>INSPECTOR(S):</b> Elliott R. Russell	<b>INSP. DATE:</b> April 16, 2015	<b>INSP. TIME:</b> 11:45
<b>OPERATOR:</b> Sedgwick County	<b>OPERATOR REPRESENTATIVE:</b> Randy Renquist	<b>TYPE OF OPERATION:</b> 110c - Construction Limited Impact

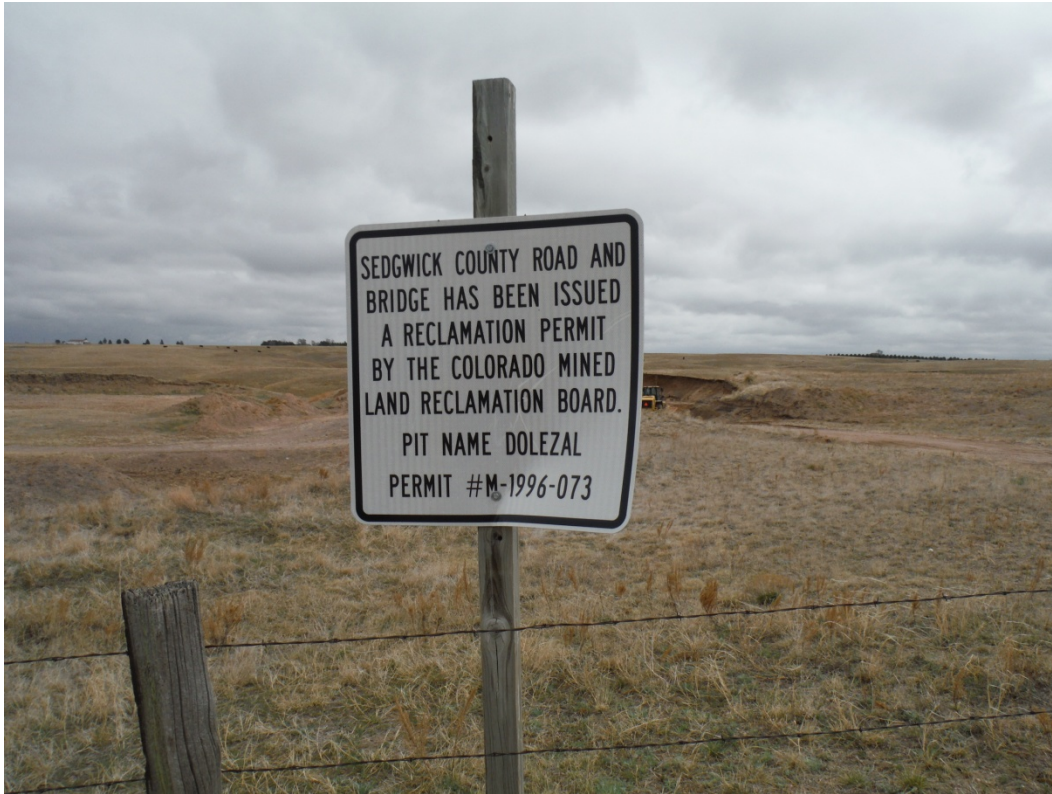
Site identification sign posted at the site entrance; looking east.

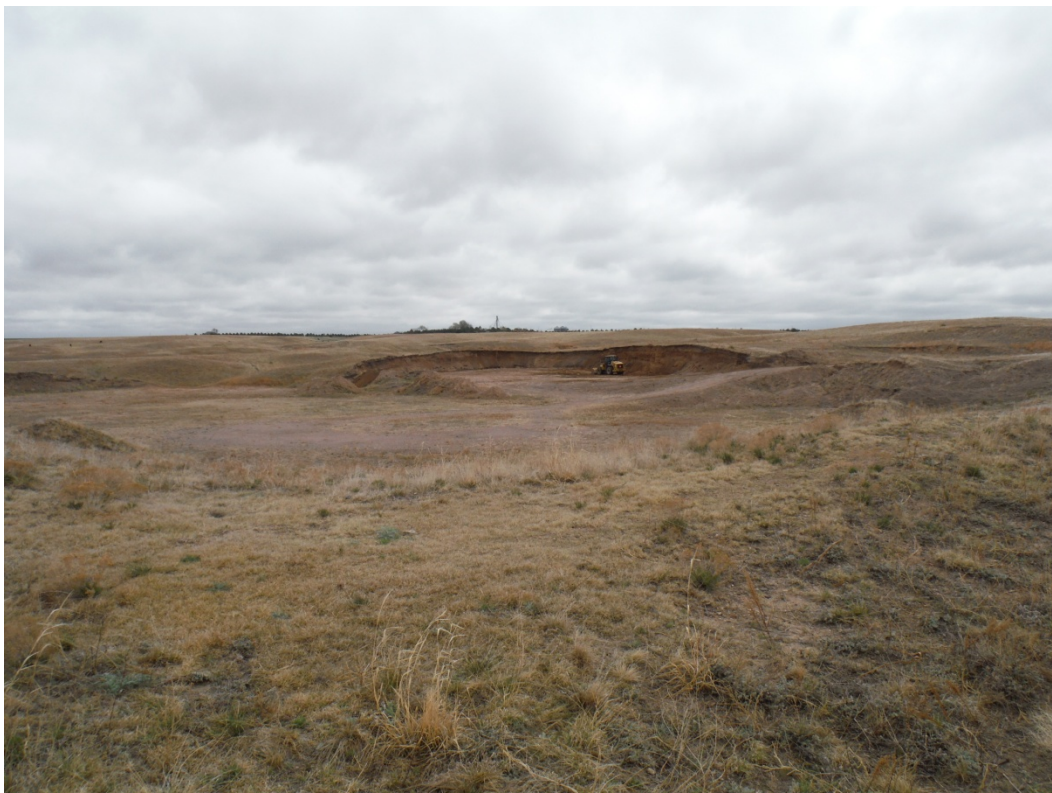
Site overview; looking southeast from the northwest boundary corner.

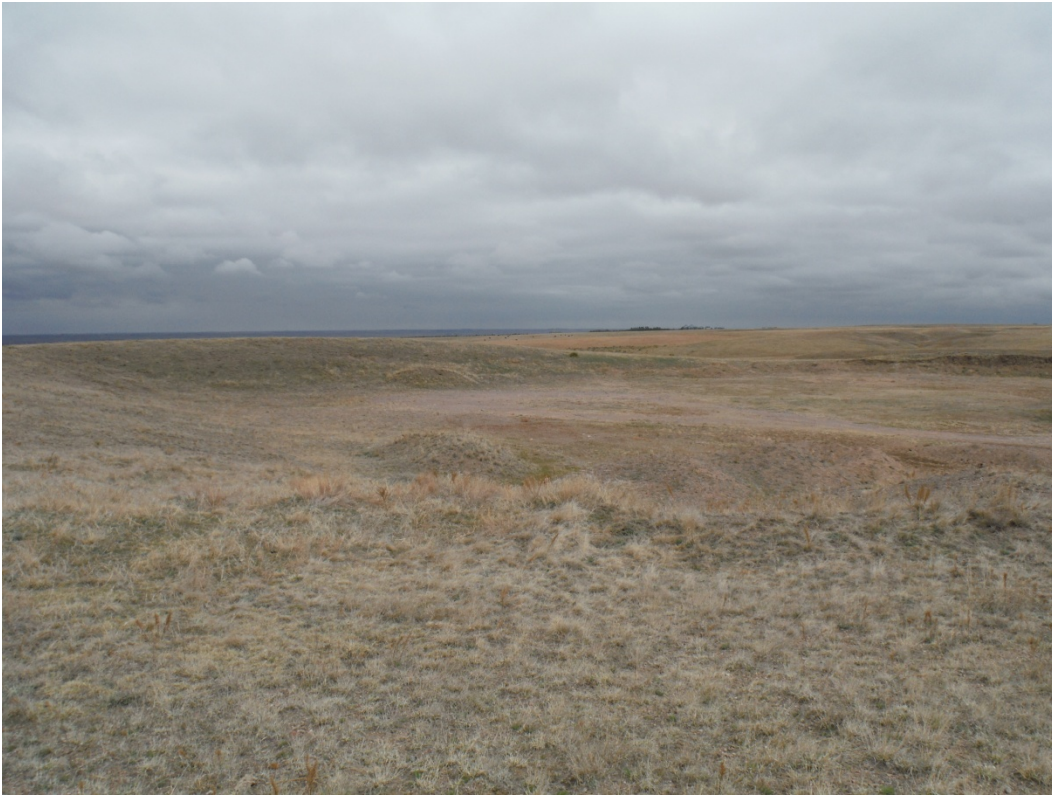
The mining operation started in the northern portion of the site and is currently in the central portion, almost to the permit area which reduces in width. The majority of the northwestern portion of the site has been sloped and seeded and only two small stockpiles remain. Topsoil has been piled along the northeastern boundary as well as just north of the active area on the pit floor. The current mining face is approximately 15 feet tall and it appeared that topsoil was not stripped at the face; the Operator was reminded that topsoil will need to be salvaged prior to advancing the current digging area.

Northwestern portion of the site; looking northeast.

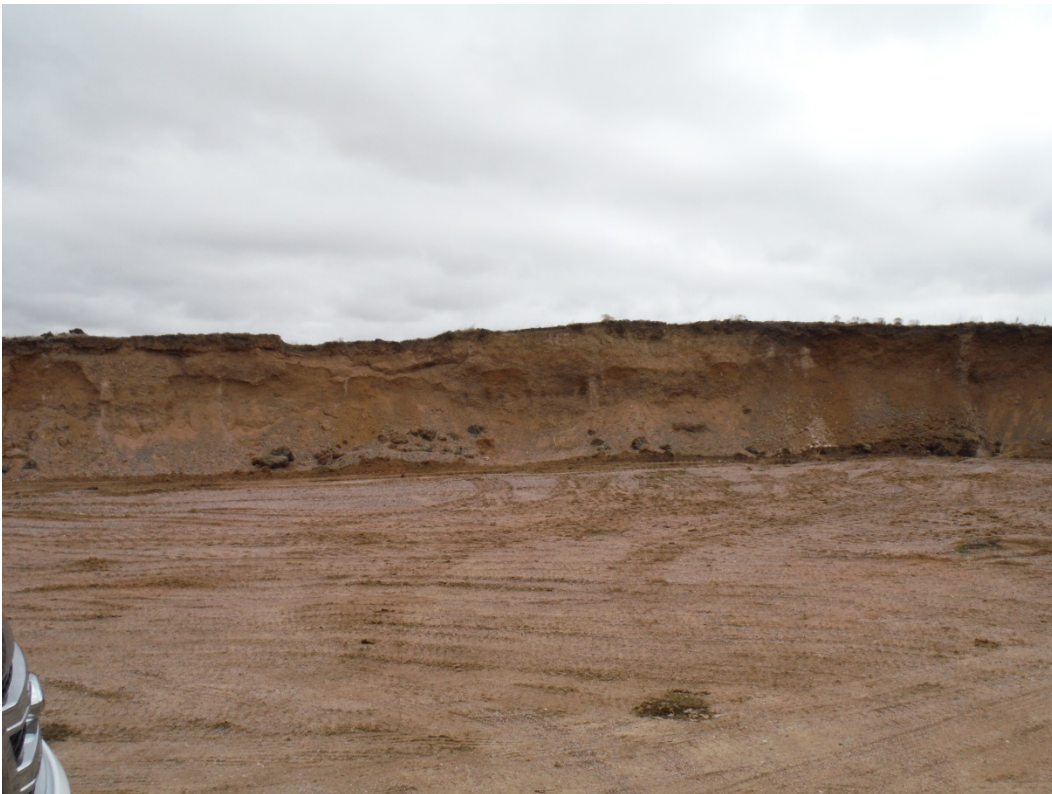
Pit active mining face (note: darker organic “topsoil” sloughing off due to not being stripped); looking south.

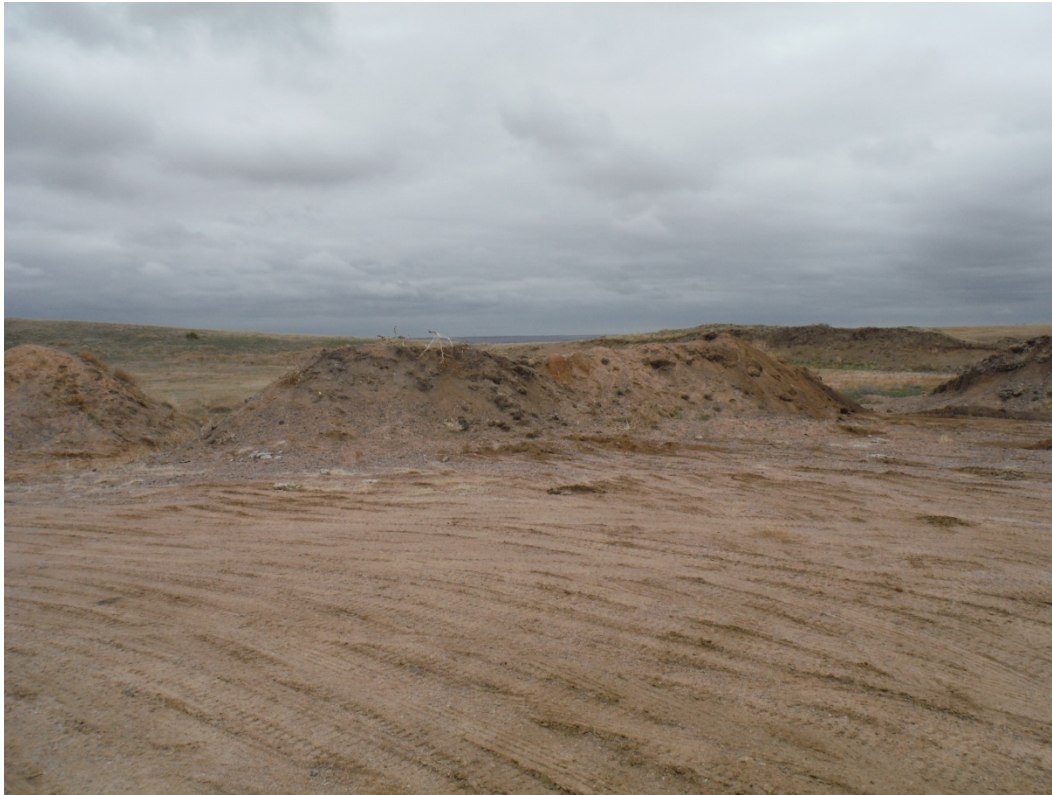
New topsoil stockpile on pit floor, older pile in the back right of the photo; looking north.
