COLORADO DIVISION OF RECLAMATION, MINING AND SAFETY
MINERALS PROGRAM INSPECTION REPORT
PHONE: (303) 866-3567

MINE NAME: Cresson Project	MINE/PROSPECTING ID#: M-1980-244	MINERAL: Gold	COUNTY: Teller
INSPECTION TYPE: Aerial Inspection	INSPECTOR(S): Timothy A. Cazier	INSP. DATE: August 28, 2015	INSP. TIME: 09:05
OPERATOR: Cripple Creek & Victor Gold Mining Company	OPERATOR REPRESENTATIVE: None	TYPE OF OPERATION: 112d-3 - Designated Mining Operation	
REASON FOR INSPECTION: Normal I&E Program	BOND CALCULATION TYPE: None	BOND AMOUNT: \$136,475,000.00	
DATE OF COMPLAINT: NA	POST INSP. CONTACTS: None	JOINT INSP. AGENCY: None	
WEATHER: Clear	INSPECTOR'S SIGNATURE:

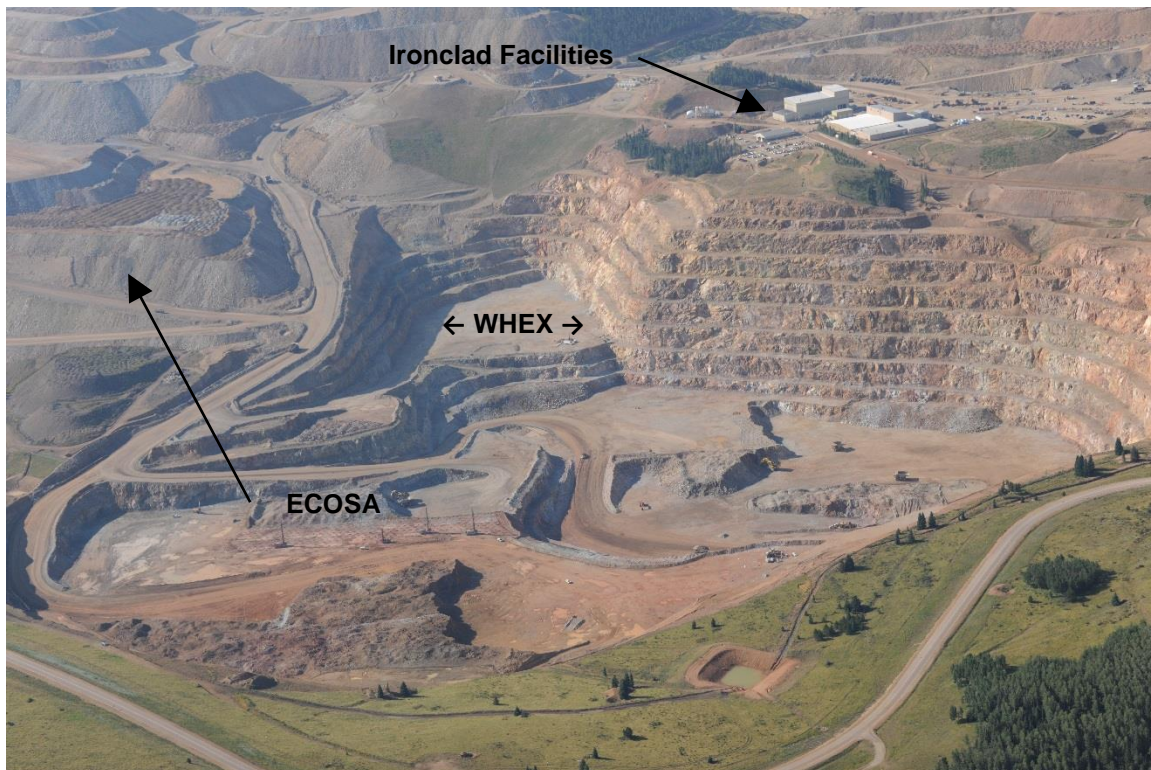
Photo 1. Wildhorse Extension Pit (looking south).

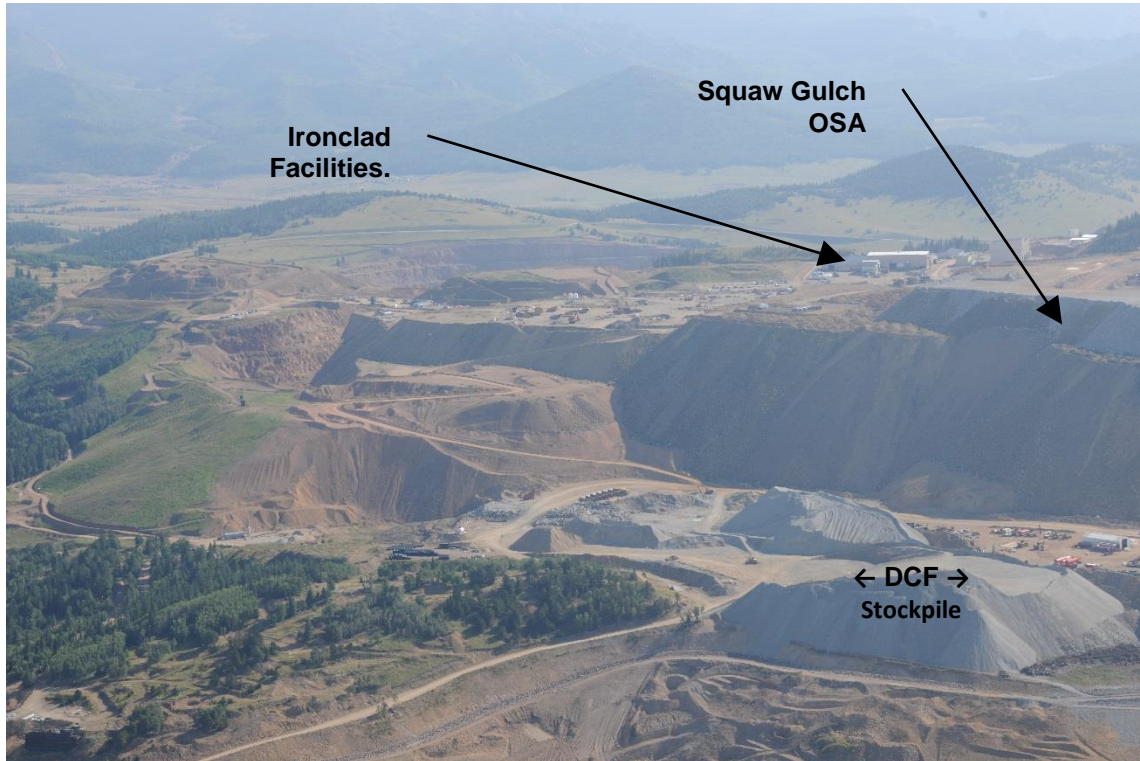
Photo 2. Drain Cover Fill stockpile (looking NE).

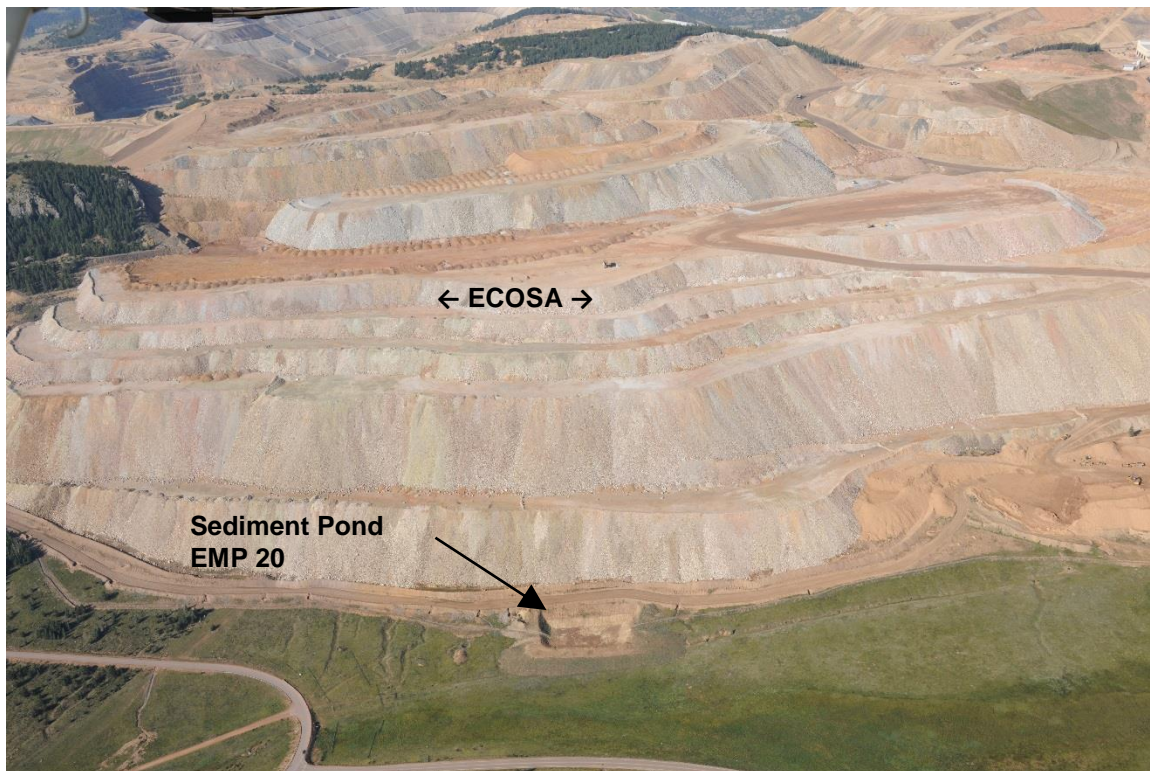
Photo 3. East Cresson OSA (looking SW).

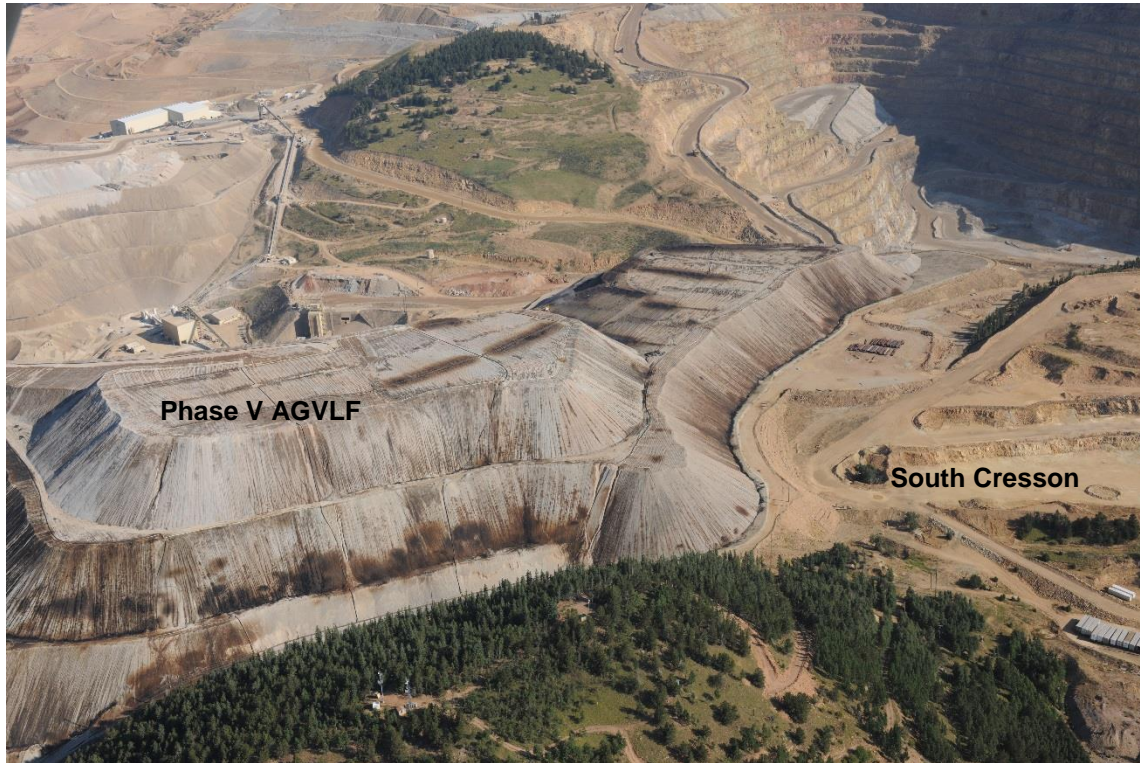
Photo 4. South Cresson & Phase V AGVLF (looking NE).

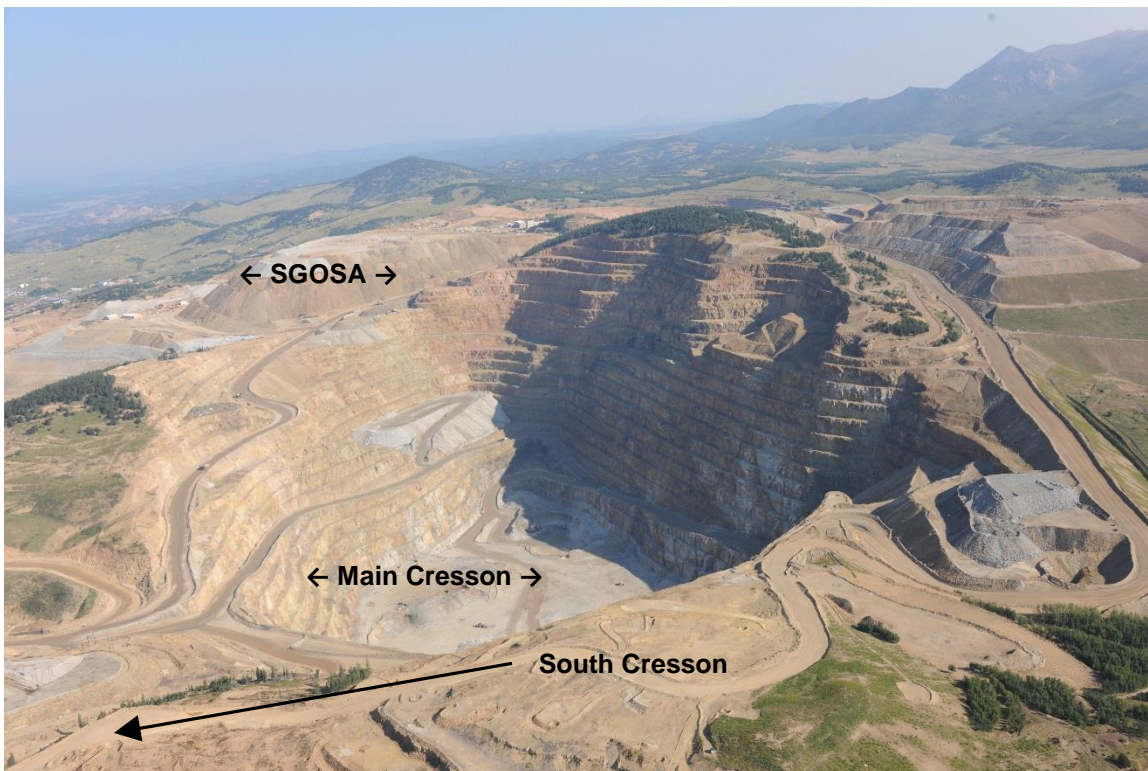
Photo 5. Main Cresson Pit (Looking north).

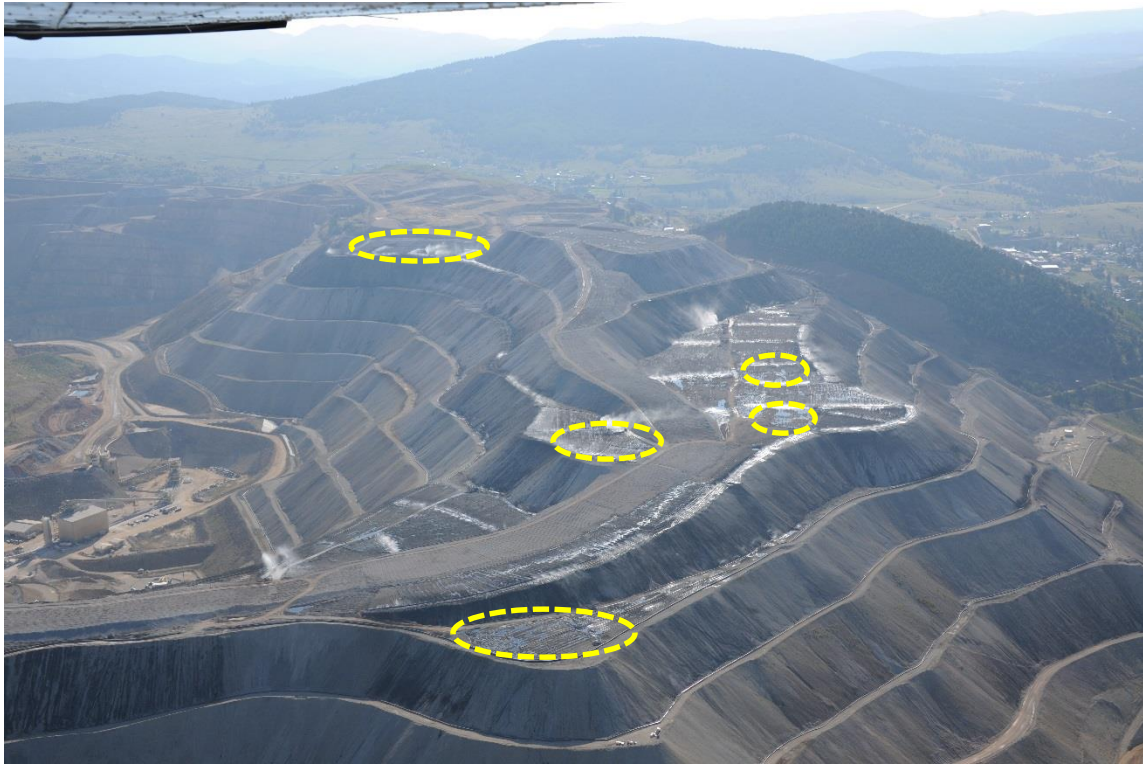
PROBLEM/POSSIBLE VIOLATION: Problem: A significant amount of water, exceeding the allowed 3' x 3' area under section II.B of the Wildlife Protection Plan was observed on the AGVLF.

PROBLEM/POSSIBLE VIOLATION: Problem: The observed ponded water on the AGVLF surface appears to have saturated the surface and may pose geotechnical slope instability problems.

The significant amount of water observed on the AGVLF surface (see **Photo 6**) appears to be out of compliance with section II.B of the approved Wildlife Protection Plan. The Division also has concerns as to what, if any effect the ponded water may have on the geotechnical slope stability of the AGVLF. These issues are cited as problems on p. 1 of this report.

Photo 6. Arequa Gulch VLF (Looking SE) [*Larger areas of ponded water are circled*].

CORRECTIVE ACTIONS: Provide an explanation of the situation and a proposed means to address/mitigate the problem by the Corrective Action due date.

CORRECTIVE ACTIONS: Provide a geotechnical slope stability analysis assuming saturated material exits to the appropriate depth to assess the impact on the factors of safety presented in the MLE2/Amendment 10 slope stability exhibit.

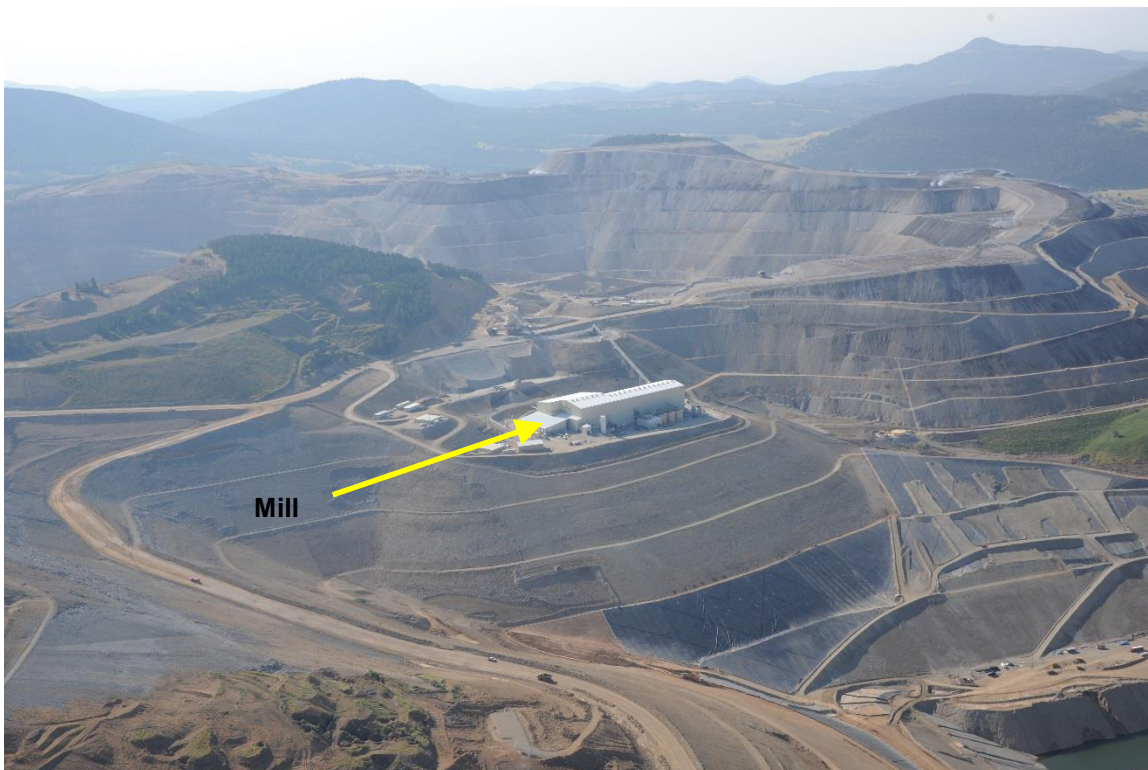
Photo 7. New Mill (Looking south).

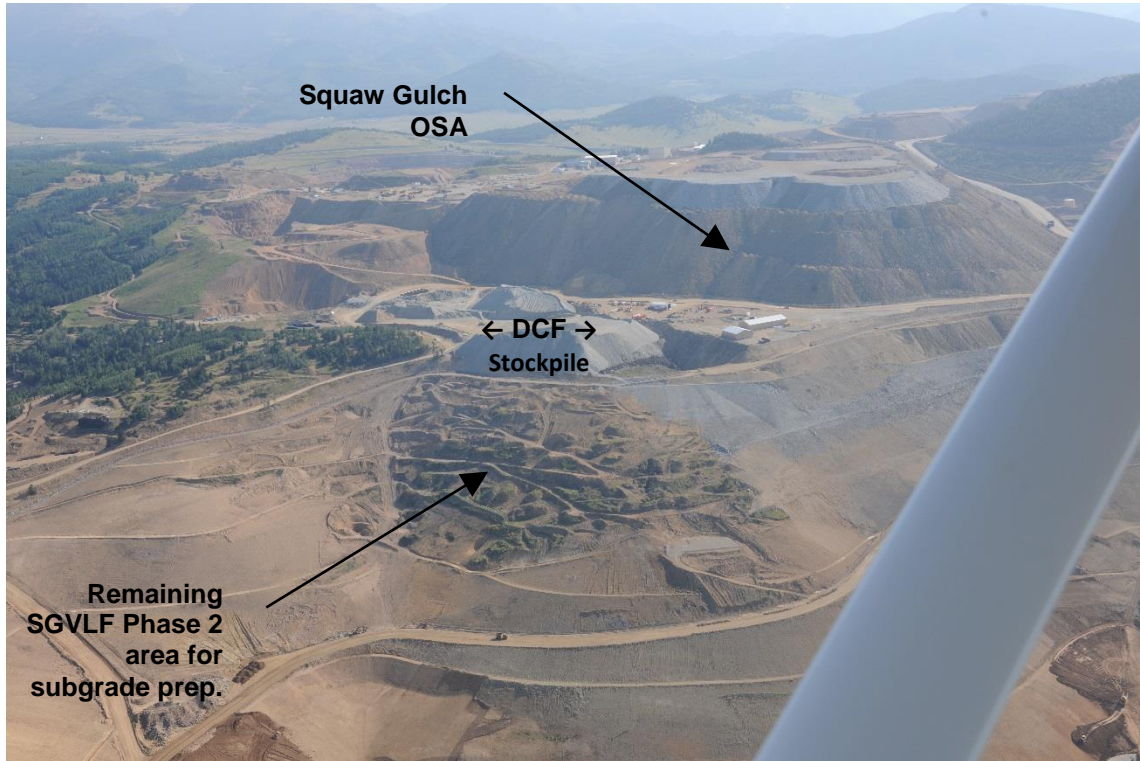
Photo 8. Squaw Gulch OSA (looking east).

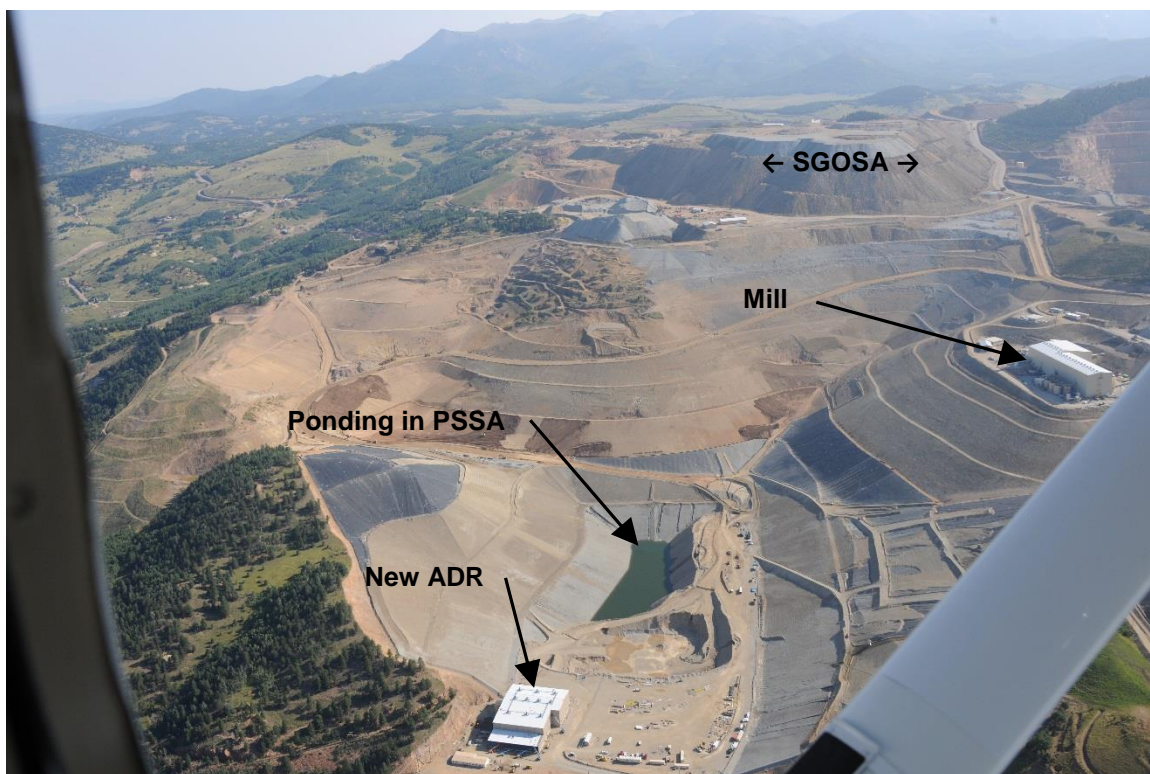
PROBLEM/POSSIBLE VIOLATION: Problem: A significant amount of potentially impacted water was observed in the SGVLF PSSA. This is a potential wildlife attractant.

PROBLEM/POSSIBLE VIOLATION: Problem: The observed ponded water in the SGVLF PSSA may pose geotechnical slope instability problems that may lead to sloughing on the certified and approved PSSA liner.

Ponded water was also observed in the PSSA area of the SGVLF (see **Photo 9**). The Division had not expected this amount of potentially impacted water (*potentially impacted as the Division understands impacted water from the new mill area is routed to the PSSA*) being exposed during the construction of the SGVLF. Further, we

could not find any discussion in the approved permit about this condition, but it appears to be a potential wildlife attractant. This ponded condition may also have geotechnical implications on the stability of the DCF covered liner in the PSSA. The saturated toe of the covered liner may lead to slope instability, causing the DCF to slide and potentially damage the certified, approved geomembrane liner in the PSSA. These issues are also cited as problems on p. 1 of this report.

Photo 9. Squaw Gulch VLF (Looking NE) [Note significant ponding in PSSA].

CORRECTIVE ACTIONS: Provide an estimate as to how long this condition may persist and a proposed means to address/mitigate the problem by the Corrective Action due date.

CORRECTIVE ACTIONS: Provide a geotechnical slope stability analysis assuming saturated material exits at the toe of the DCF covered liner to assess the impact on the factors of safety presented in the MLE2/Amendment 10 slope stability exhibit.

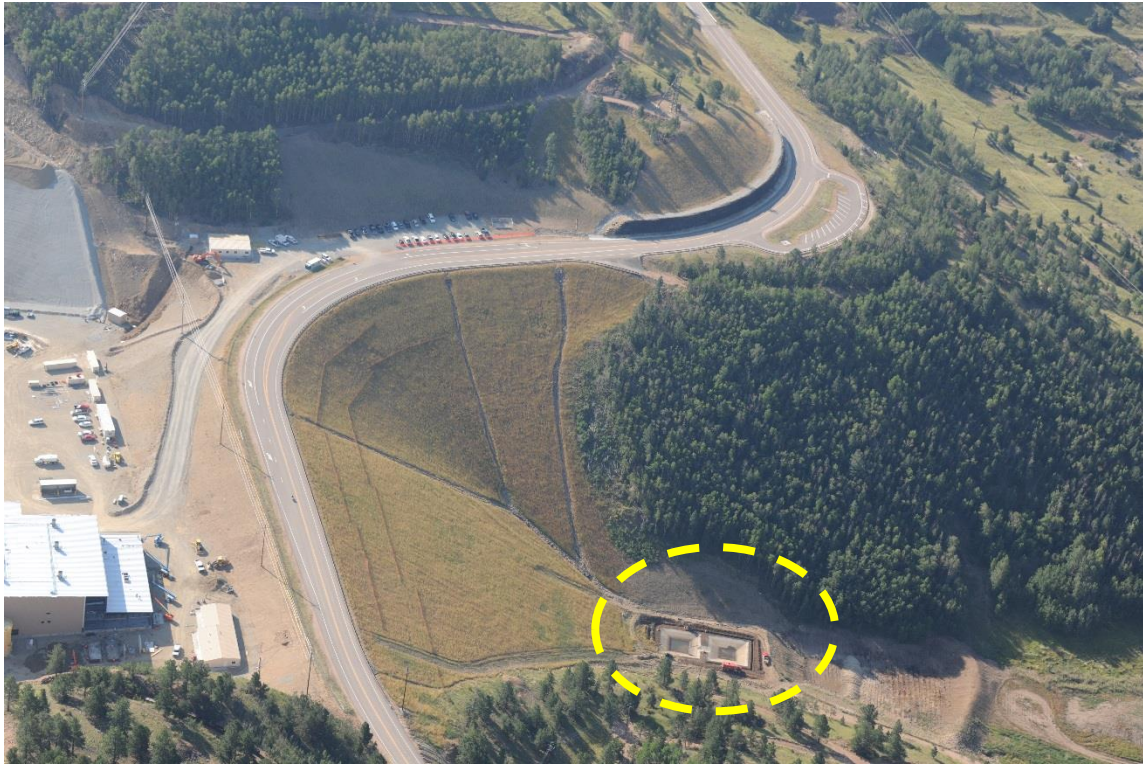
Photo 10. SGVLF underdrain Ponds (Looking south) [*Note well vegetated slope to left*].
