COLORADO DIVISION OF RECLAMATION, MINING AND SAFETY
MINERALS PROGRAM INSPECTION REPORT
PHONE: (303) 866-3567

MINE NAME: Hindmarsh Sandstone	MINE/PROSPECTING ID#: M-2006-009	MINERAL: Sandstone (silica, stone quartzite)	COUNTY: Montezuma
INSPECTION TYPE: Monitoring	INSPECTOR(S): Lucas J. West	INSP. DATE: August 12, 2015	INSP. TIME: 09:00
OPERATOR: Mesa Sandstone, LLC	OPERATOR REPRESENTATIVE: William and Kay Goode	TYPE OF OPERATION: 112c - Construction Regular Operation

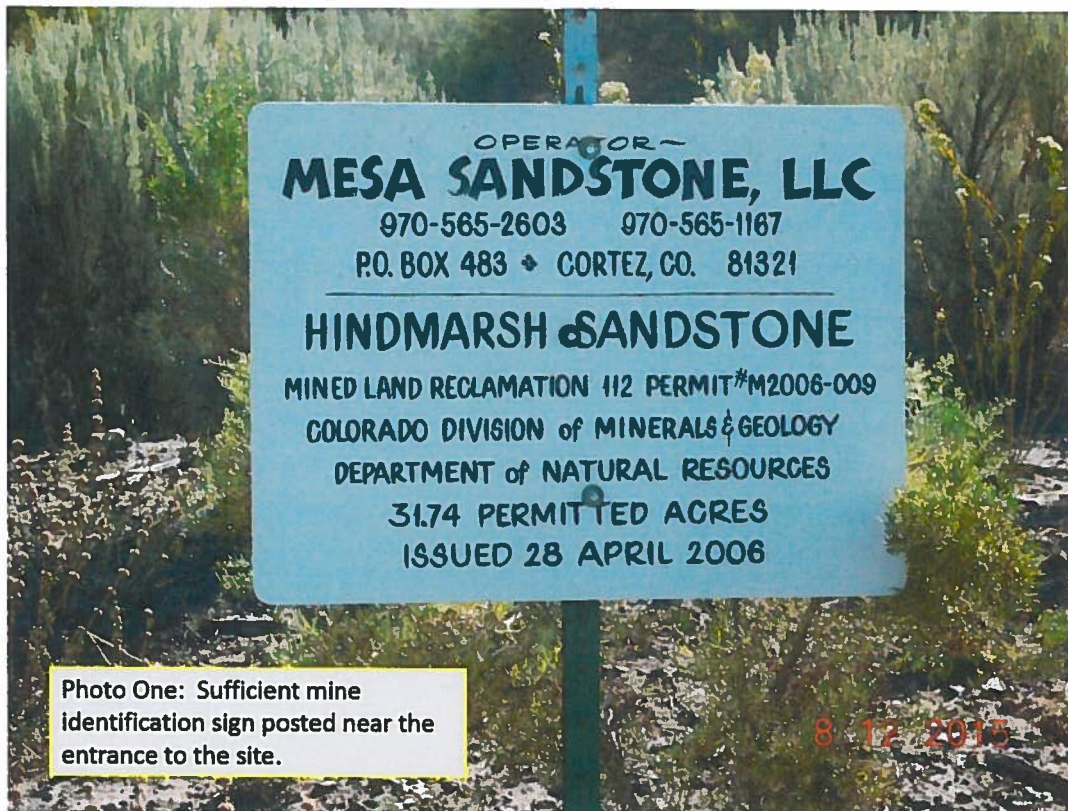
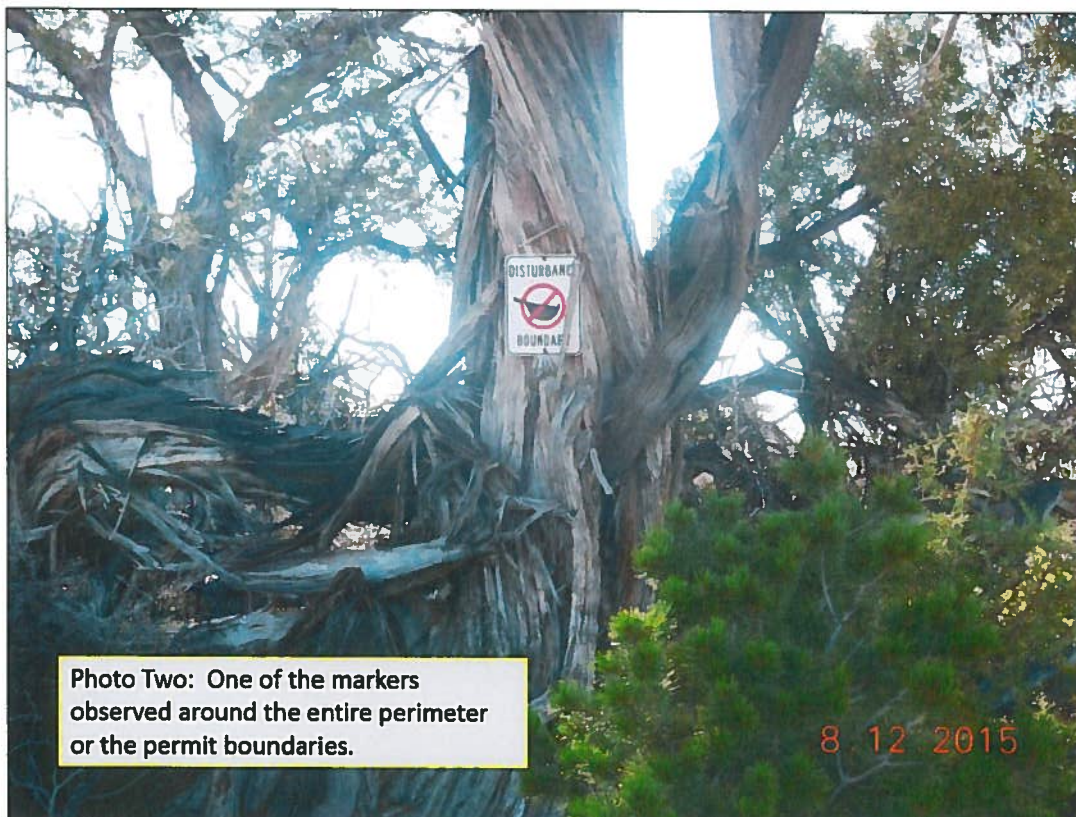
As seen in Photos One and Two, mine identification signs and permit boundary markers were observed. Site conditions were consistent with the descriptions contained within the annual report. The operator is the surface and subsurface property owner. Mining is being conducted by the use of blasting, crushing and screening material. Equipment, including a crusher, loader and conveyors were observed onsite as seen in Photos Three and Four. The site was not active during this inspection. No explosives are stored onsite, as the operator only blasts as new material is needed. Stockpiled material was observed on the pit floor, and appeared to be stable. The site consists of two main areas, an upper portion where the highwalls and some material stockpiles are located as seen in Photo Four, and a lower area. Protective safety berms were observed around all highwalls located in the upper area. The lower area is used for crushing and screening material as well as loading trucks. A scale and scale house is located adjacent to the access road at the entrance to the lower area.

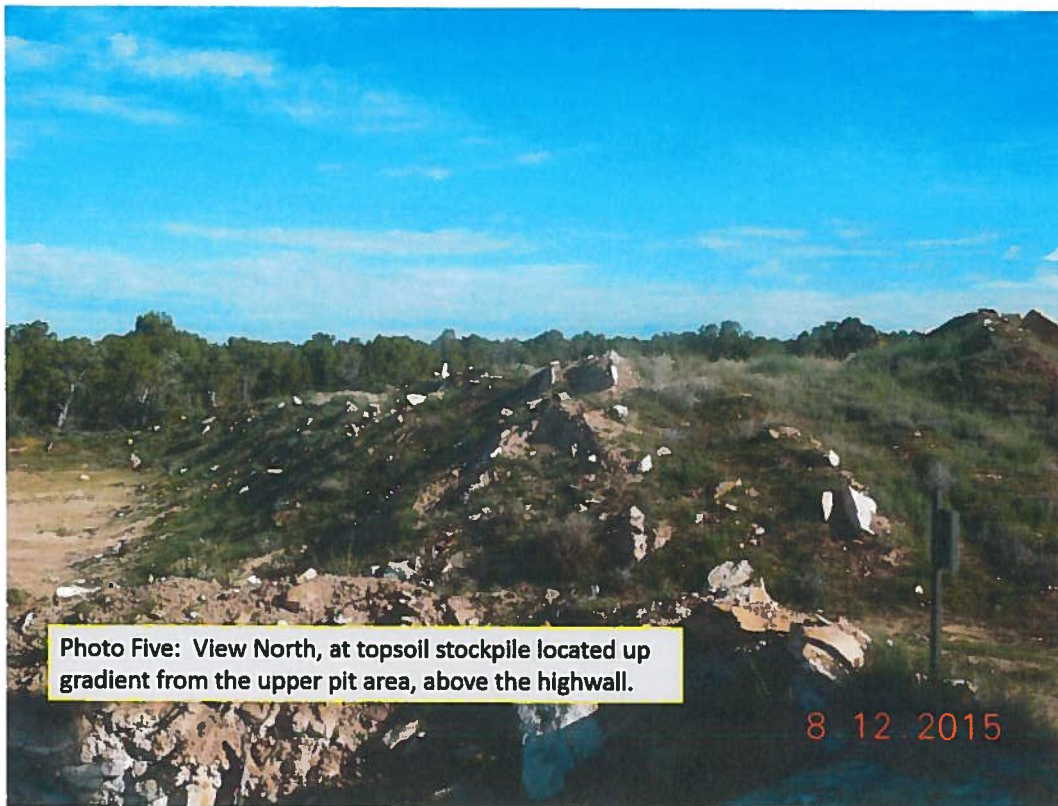
Topsoil and over burden stockpiles were observed up gradient from the highwall located in the upper pit area, a sufficient distance away from the highwall to allow safe access. The topsoil stockpile was well vegetated and appeared to be stable as seen in Photo Five. No noxious weeds were observed onsite, and the Operator has a continuously active weed management plan.
