COLORADO DIVISION OF RECLAMATION, MINING AND SAFETY
MINERALS PROGRAM INSPECTION REPORT
PHONE: (303) 866-3567

MINE NAME: Cortez Pit	MINE/PROSPECTING ID#: M-1976-059	MINERAL: Sandstone (silica, st quartzite)	COUNTY: Montezuma
INSPECTION TYPE: Monitoring	INSPECTOR(S): Lucas J. West	INSP. DATE: August 12, 2015	INSP. TIME: 10:30
OPERATOR: Skanska USA Civil West	OPERATOR REPRESENTATIVE: Todd Schieffer,	TYPE OF OPERATION: 112c - Construction Regular Operation

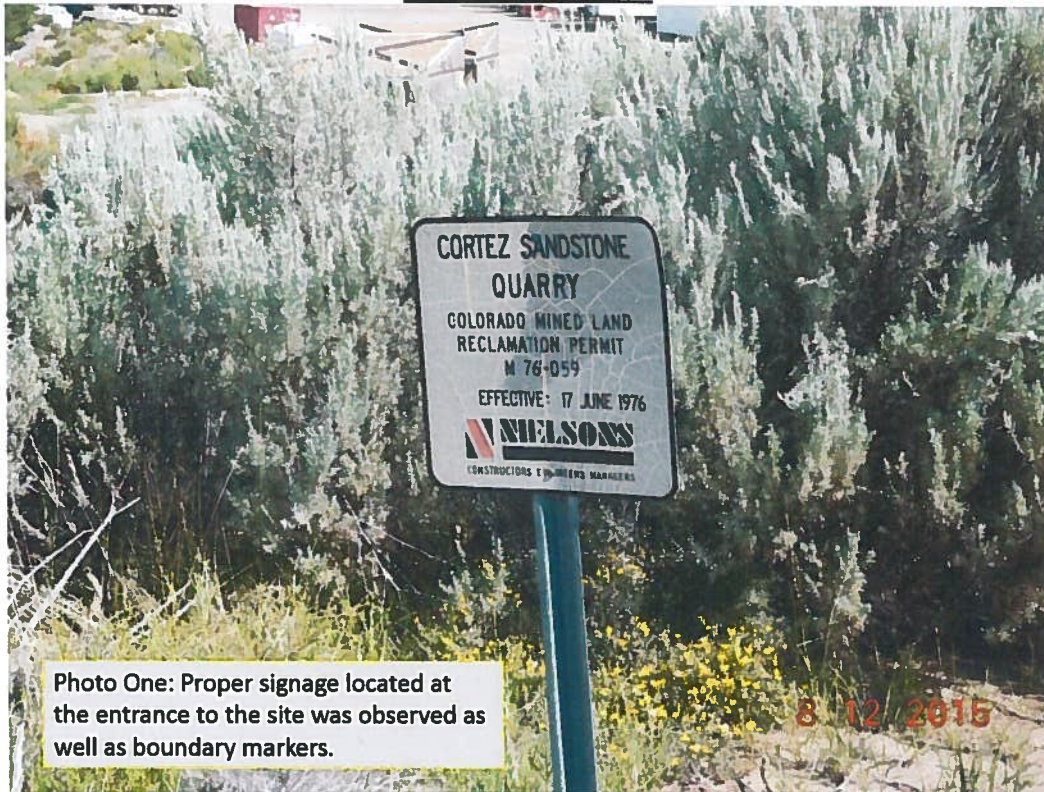
The site has been approved for intermittent operations and according to the annual reports provided by the Operator, the last date of excavation was in 2012. Proper signage and markers along the permit boundaries were observed during the inspection as seen in Photo One. As identified by the Operator the site was approved for intermittent status but is currently being used as a lay down yard for some mining related and other non-mining related equipment. As seen in Photos Two-Four the equipment located onsite includes but is not limited to trailers, conveyors, and Grizzly Screen. All equipment stored within the permitted area was done so in a neat and orderly fashion, the overall footprint of the site was in good condition and free of trash and debris.

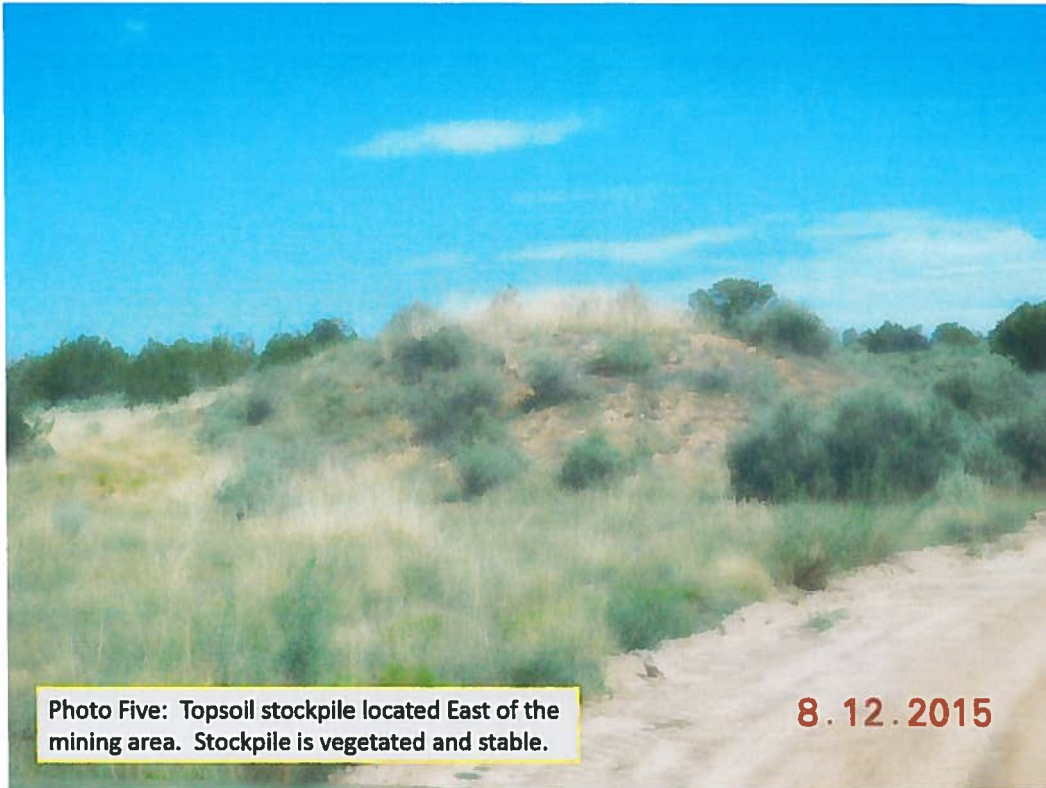
Photo Five: Topsoil stockpile located East of the mining area. Stockpile is vegetated and stable.
