COLORADO DIVISION OF RECLAMATION, MINING AND SAFETY
MINERALS PROGRAM INSPECTION REPORT
PHONE: (303) 866-3567

MINE NAME: Windy Ridge Pit	MINE/PROSPECTING ID#: M-2003-052	MINERAL: Sand and gravel	COUNTY: Prowers
INSPECTION TYPE: Monitoring	INSPECTOR(S): Amy Eschberger	INSP. DATE: April 9, 2015	INSP. TIME: 15:00
OPERATOR: Carder, Inc.	OPERATOR REPRESENTATIVE: Ron Peterson	TYPE OF OPERATION: 112c - Construction Regular Operation

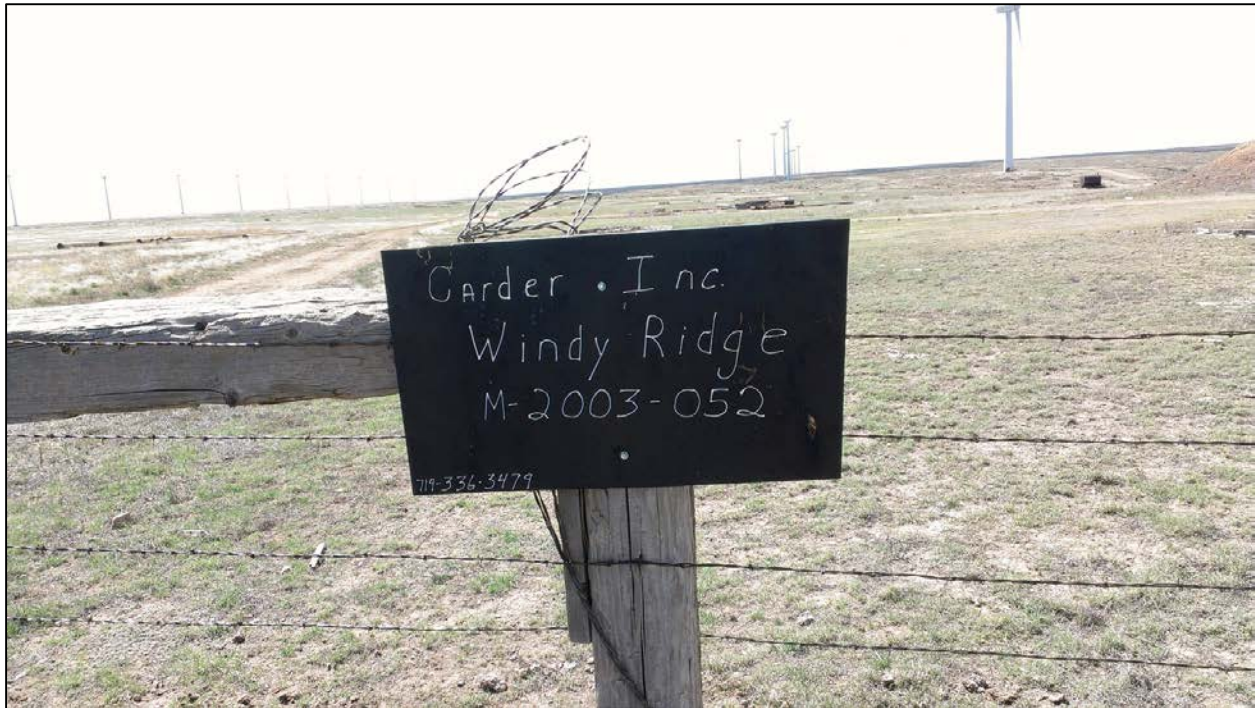
At the time of the inspection, the weather was partly cloudy, cool and windy, and the ground was dry. A permit identification sign was posted at the gated entrance to the site (**Photo 1**). The permit boundary was adequately delineated. The mine was not active during the inspection. However, a small dozer and a screener were stored on site. A few small material stockpiles were stored on the pit floor. Although this pit has not been mined since 2012, Mr. Peterson indicated that some hauling off from stockpiled material occurs every year. The operator should be aware that if mining activities (e.g., extracting, processing and/or hauling off mined material) do not occur every year, the operator is required to either begin final reclamation of the site, or file for temporary cessation. If mining is expected to continue in the future, then filing for temporary cessation would allow for a 5-year period of inactivity.

Photo 1. View of permit identification sign posted at gated entrance to site.

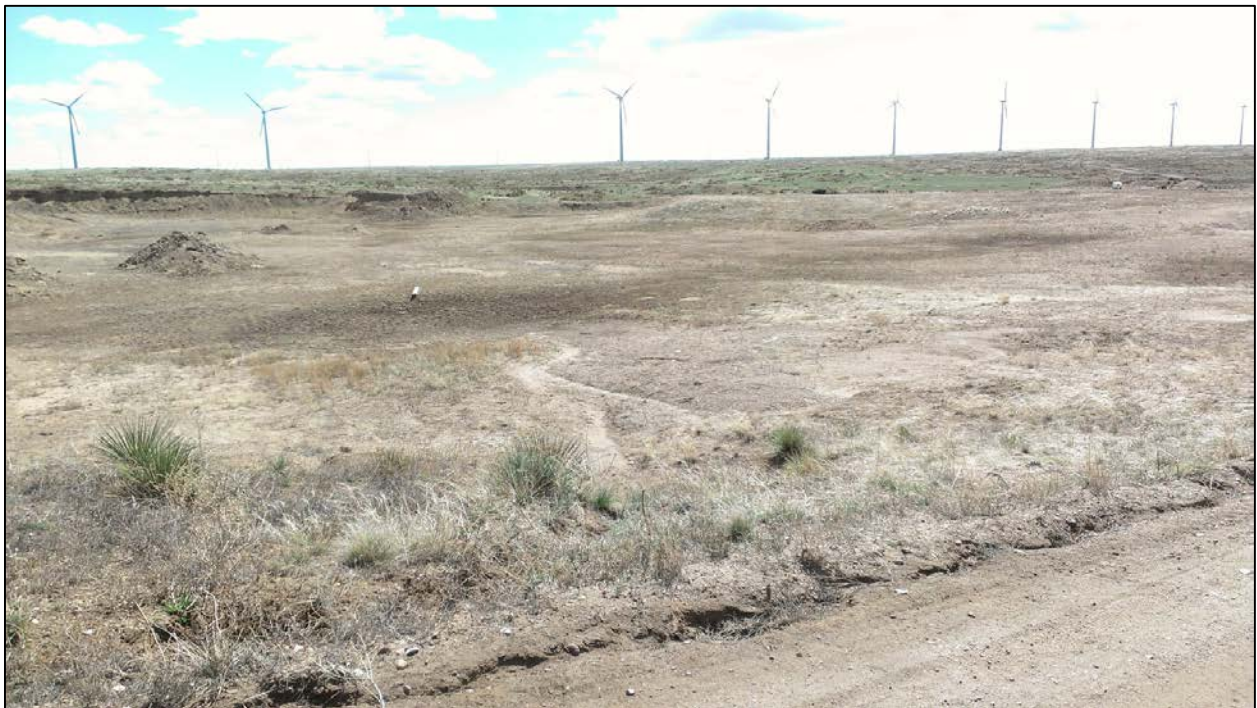
Currently, only a small portion of the permit area near the eastern boundary has been disturbed. The Division estimates this disturbance to be approximately 12 acres in size (see enclosed Google Earth image), which is well within the maximum allowed 20 acres. The disturbed area includes a pit (**Photo 2**) with a west-facing highwall that is approximately 10 feet in height and 600 feet in length with slope gradients of near vertical (**Photo 3**), a mined wall along the northeastern edge of the pit which has been graded to slopes of approximately 4H:1V (**Photo 4**), a few material stockpiles on the pit floor (**Photo 5**), and topsoil berms stored above the pit, east of the disturbance (**Photo 6**). The topsoil stockpiles appeared to be stable with vegetative cover. Native grasses and yucca are volunteering across much of the disturbed area. Very few weeds were observed in the permit area. The approved reclamation plan calls for grading all mined slopes to 3H:1V or flatter, replacing topsoil on disturbed areas at a minimum depth of four inches, and revegetating the site to rangeland. There are a few existing ranch roads traversing the site which are being used or will be used at some point by the operation. At a minimum, the primary ranch road that runs east-west across the northern edge of the site will remain after reclamation.

Photo 2. View looking southwest across pit floor from access road. Wind turbines shown in distance are located south of permit area.

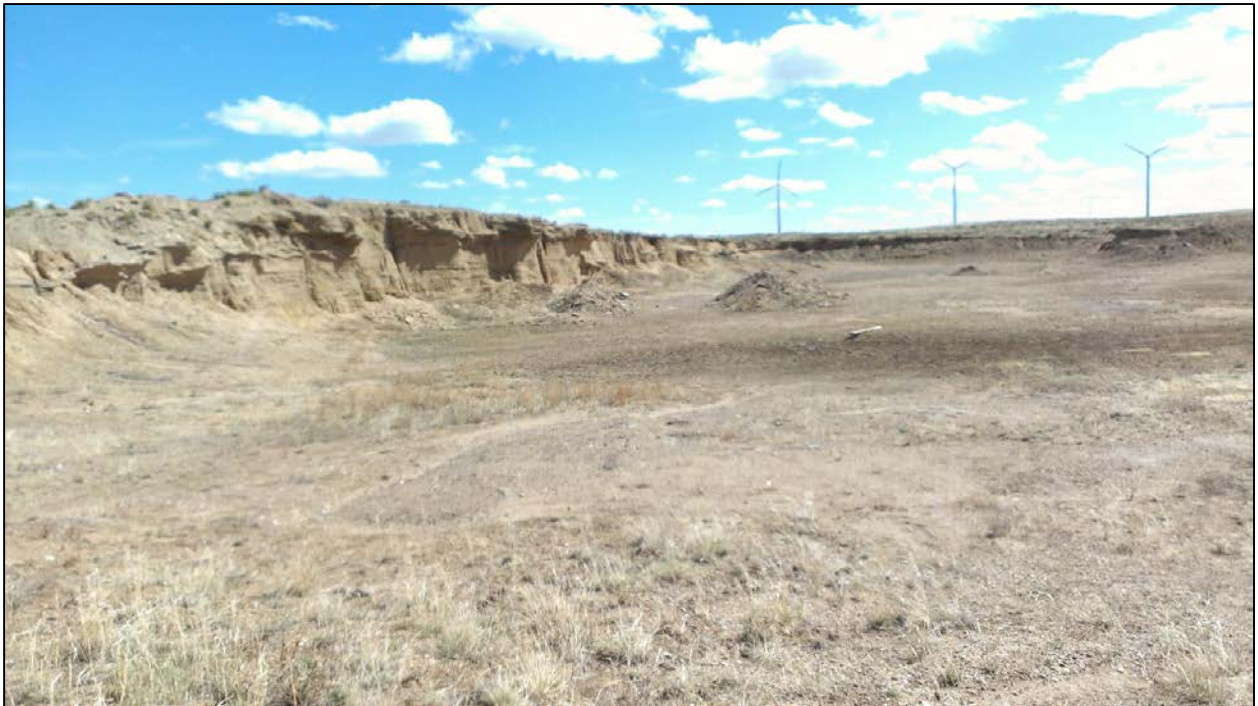
Photo 3. View looking southeast from access road at pit highwall with slope gradients of near vertical.

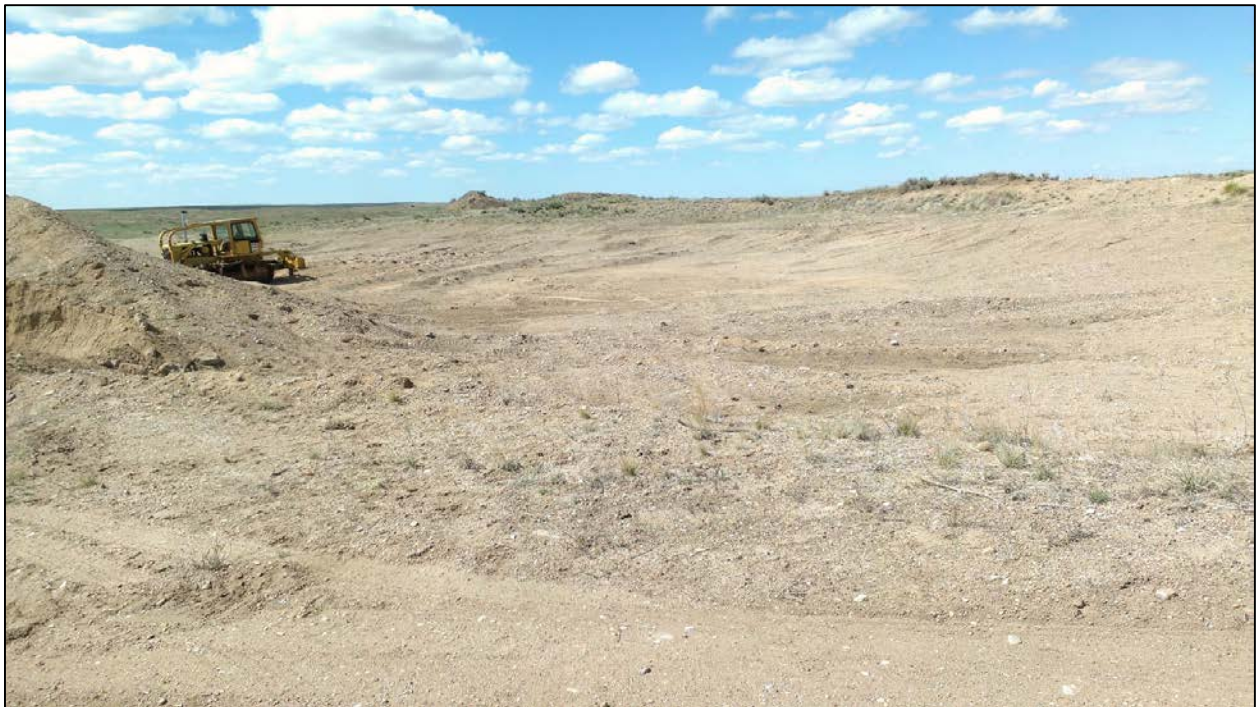
Photo 4. View looking north from access road at mined slope along northeastern edge of pit that was graded to approximately 4H:1V.

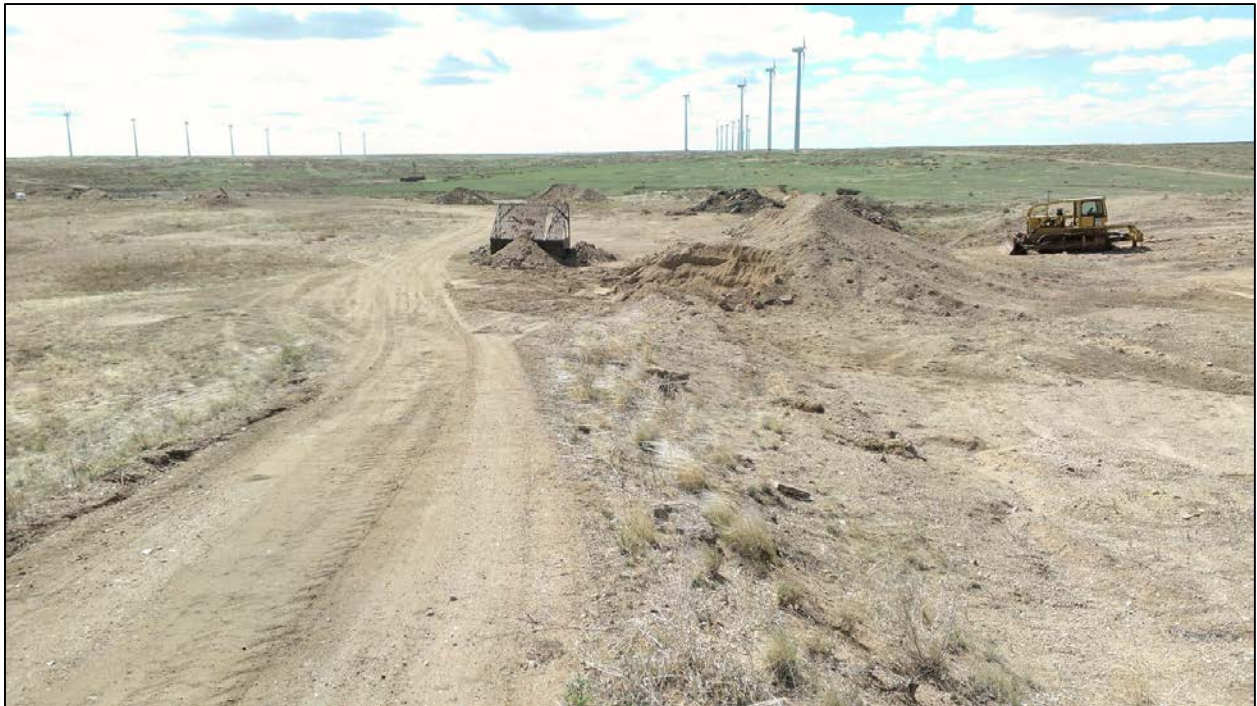
Photo 5. View looking west from access road, showing a few of the small material stockpiles stored on the pit floor. Also note presence of small dozer and screener.

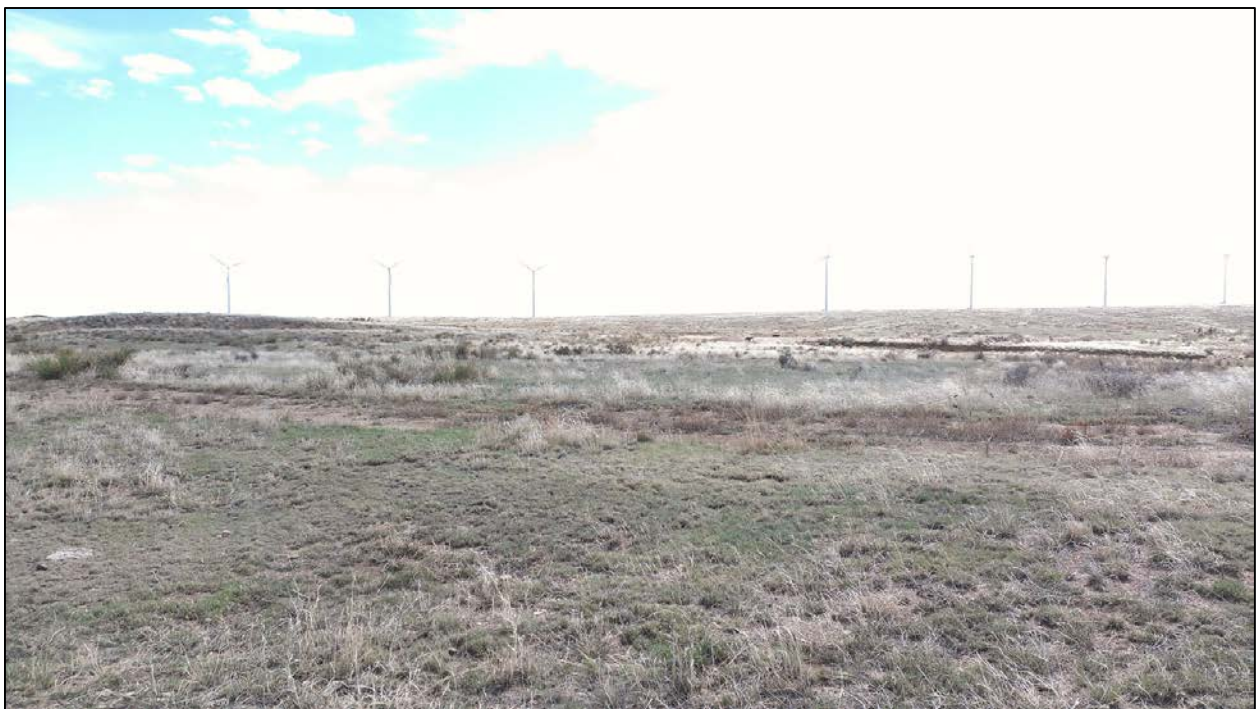
Photo 6. View looking southwest from east of pit, showing topsoil berm (indicated) stable with vegetative cover.

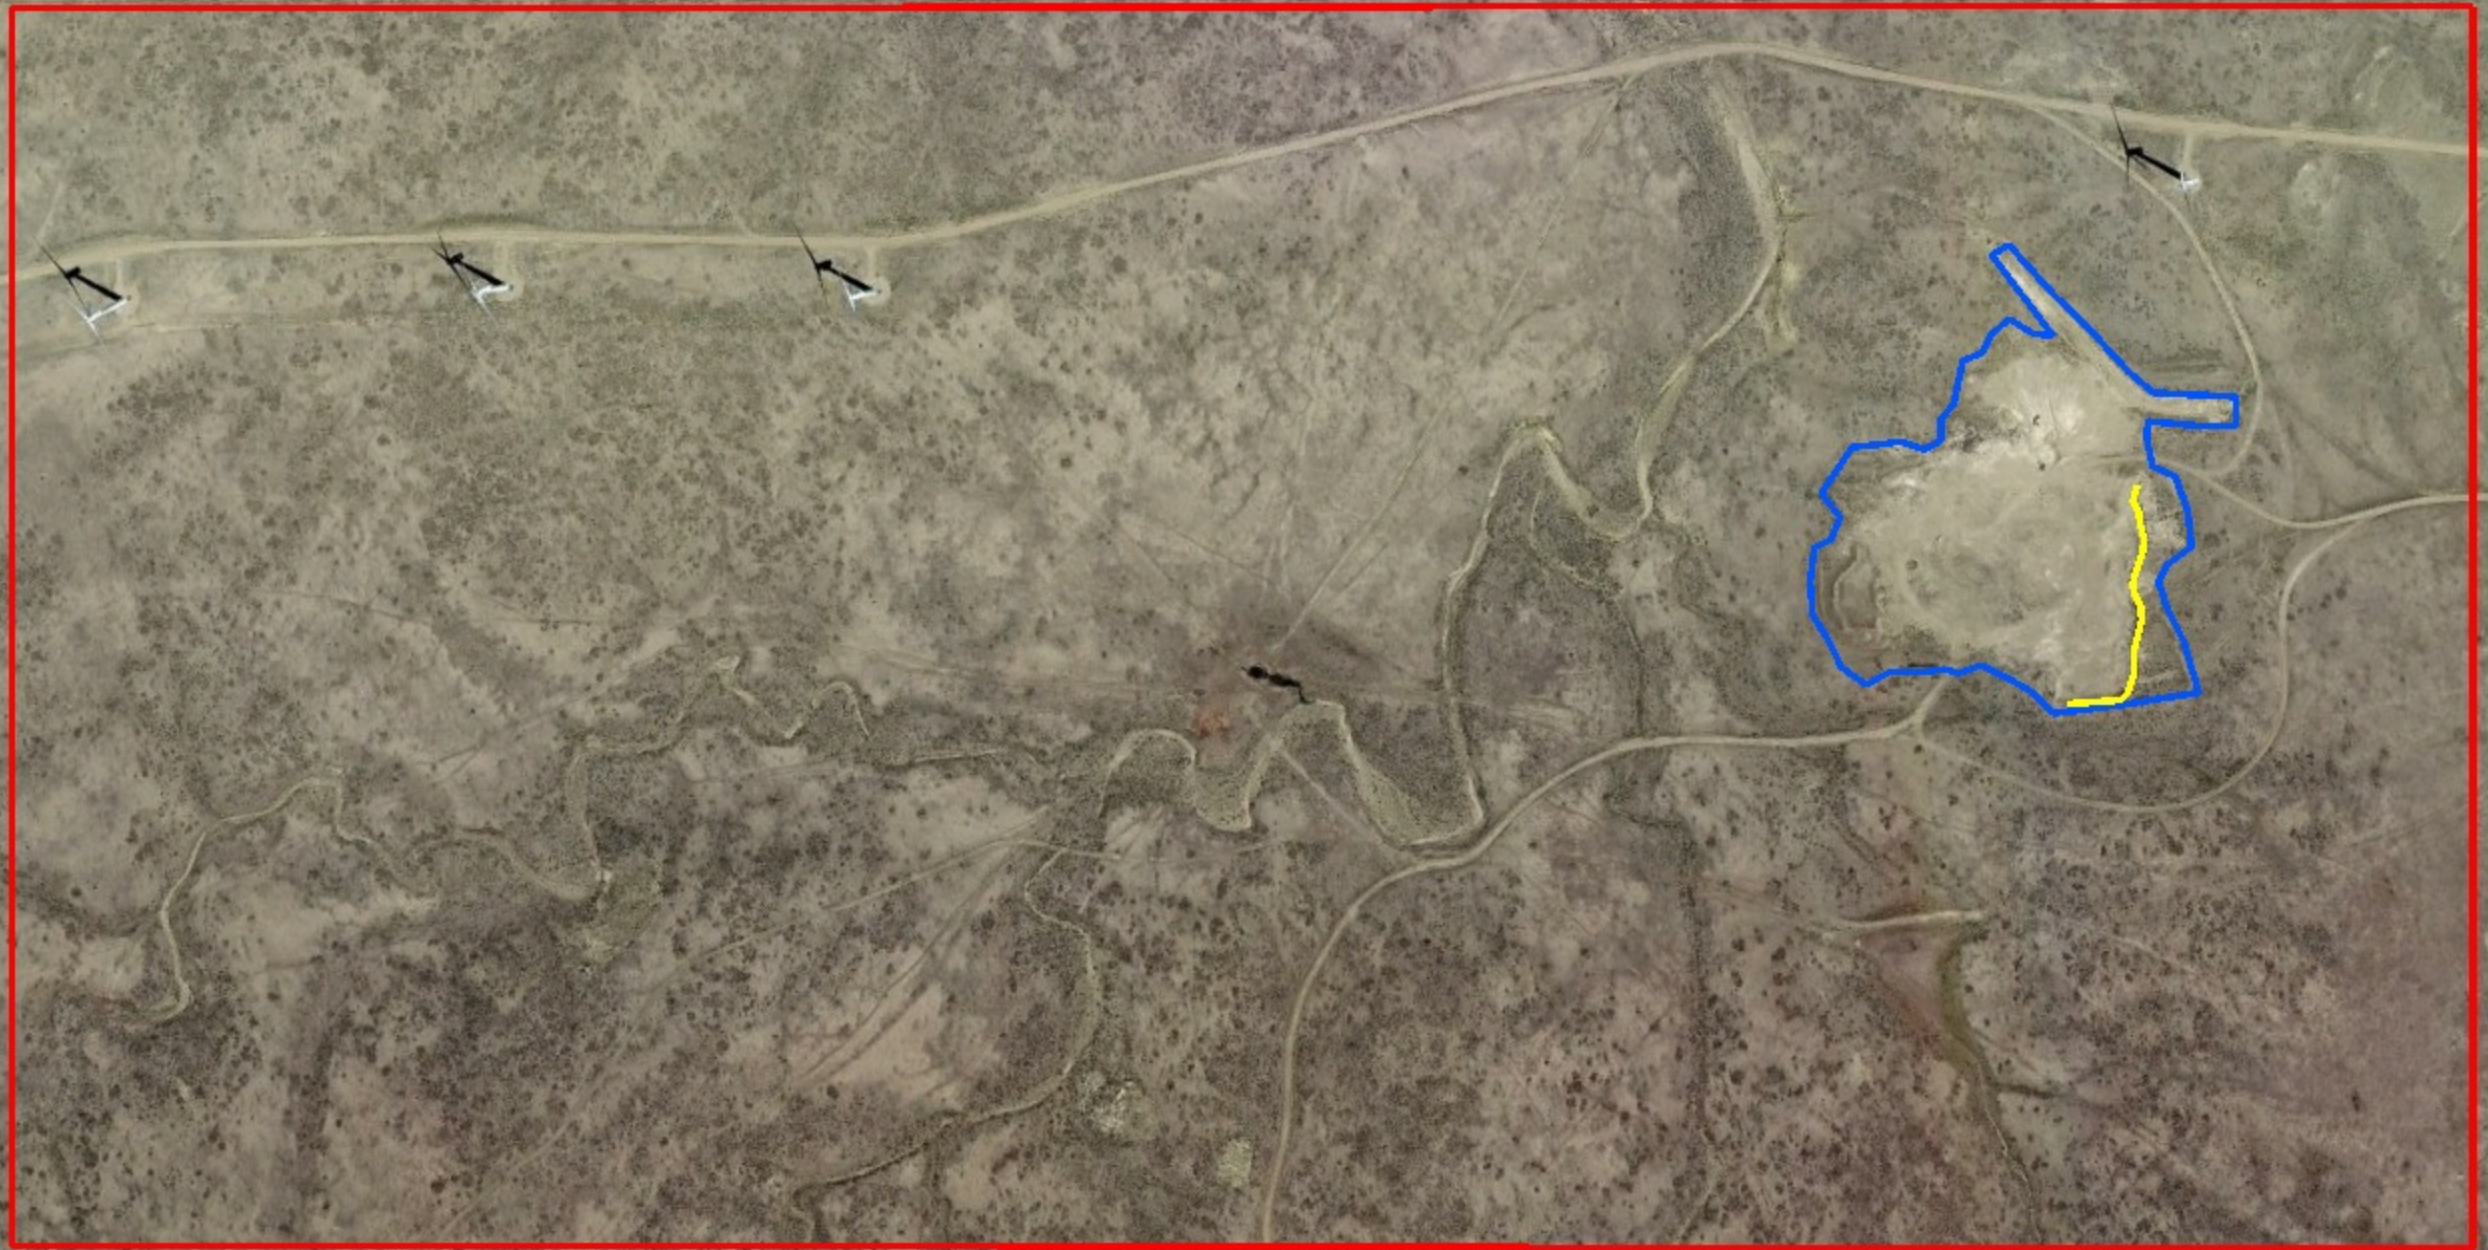
M-2003-052 / Windy Ridge Pit / Carder, Inc.

Blue Line = 11.6 acres = Disturbed Area (as of 4/9/2015 inspection)

Yellow Line = 600 ft = Approximate Length of Highwall
