**COLORADO DIVISION OF RECLAMATION, MINING AND SAFETY**  
**MINERALS PROGRAM INSPECTION REPORT**  
**PHONE: (303) 866-3567**

<b>MINE NAME:</b> Indian Springs Park Pit	<b>MINE/PROSPECTING ID#:</b> M-2001-087	<b>MINERAL:</b> Gravel	<b>COUNTY:</b> Fremont
<b>INSPECTION TYPE:</b> Monitoring	<b>INSPECTOR(S):</b> Timothy A. Cazier	<b>INSP. DATE:</b> August 6, 2014	<b>INSP. TIME:</b> 11:15
<b>OPERATOR:</b> Fremont County	<b>OPERATOR REPRESENTATIVE:</b> Sterling Rife	<b>TYPE OF OPERATION:</b> 112c - Construction Regular Operation

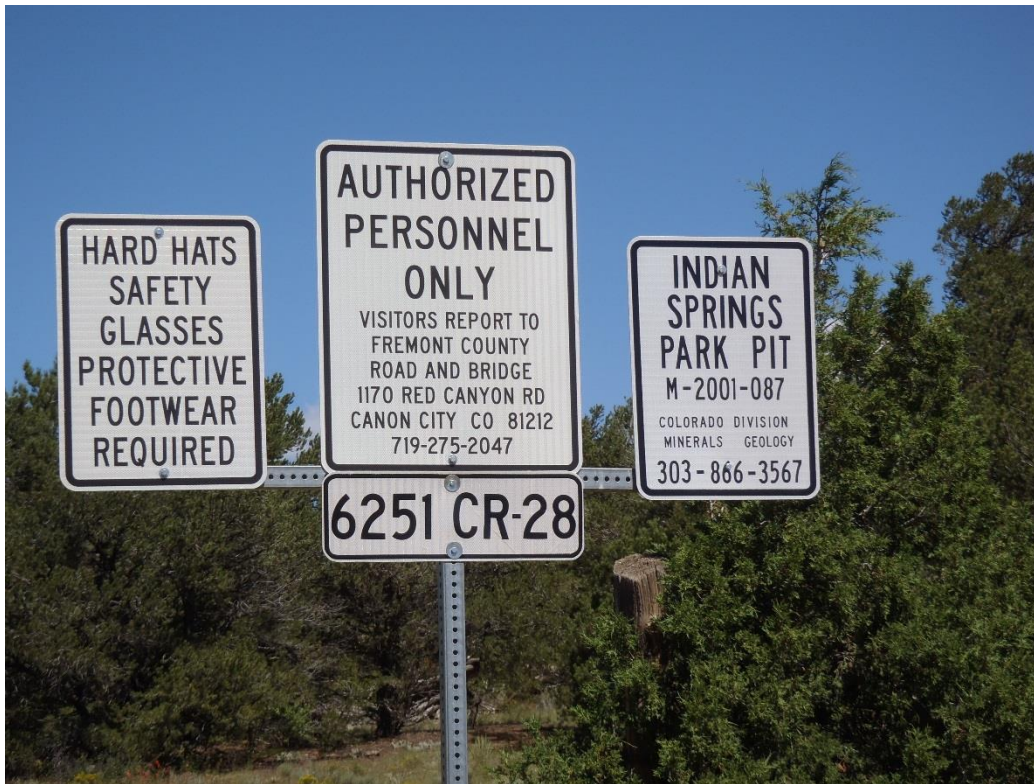
**Markers & Boundary** – A permit sign was displayed at the site entrance (see **Photo 1**). The Operator has marked the permit boundary with T-posts (see **Photo 2**).

Photo 1. Permit identification sign.

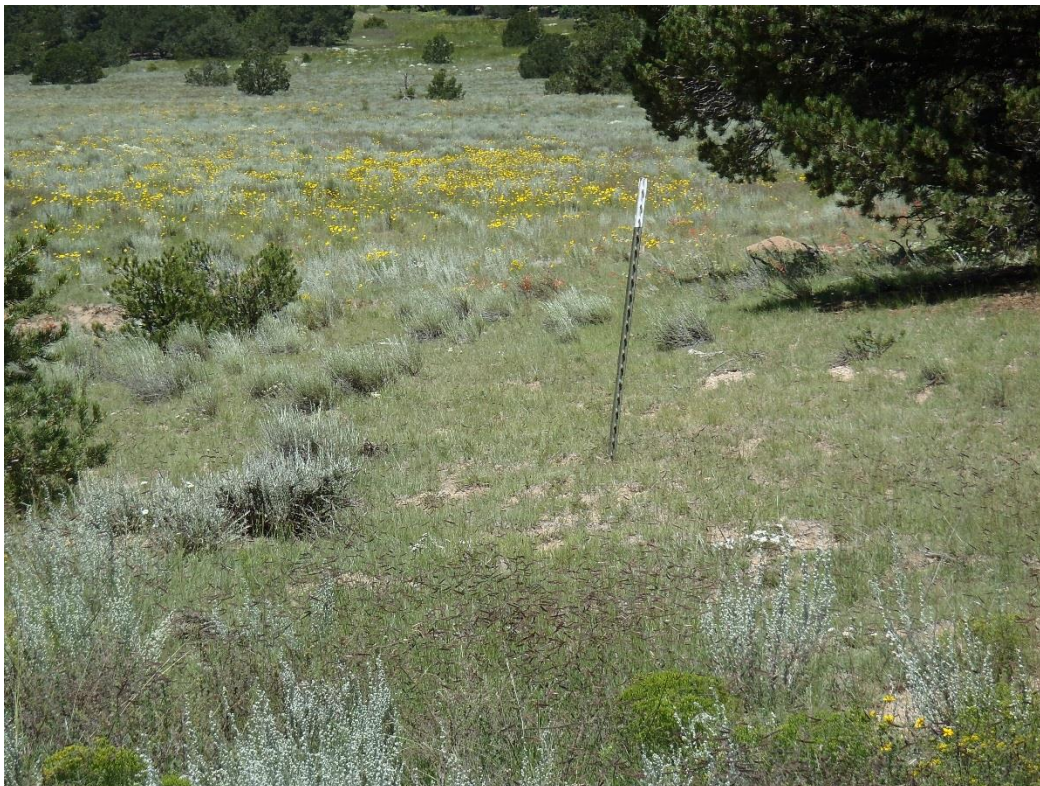
Photo 2. Typical permit boundary marker (west side).

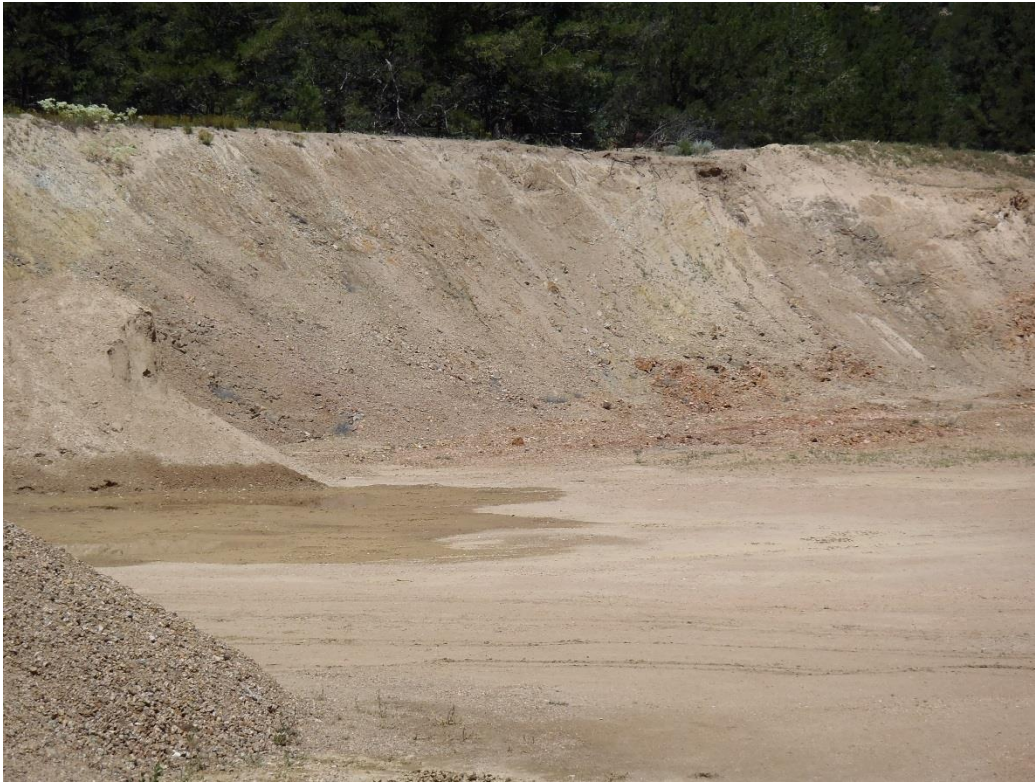
**Mining Plan** – Highwalls were observed to be steeper than 3H:1V (see **Photo 3**), but appeared stable. Mr. Rife explained the material is rippable and that blasting is not currently necessary. This inspector reminded Mr. Rife that the permit has a stipulation requiring a geotechnical stability exhibit be submitted and approved by the Division prior to initiating any blasting activity. Several material stockpiles were also observed on the pit floor (see **Photo 4**).

Photo 3. Pit highwall – *note stable but >3H:1V slope* (looking NW).

1. No problems or concerns were observed during the inspection.
2. The Operator is reminded that should blasting be required in the future at this pit, Stipulation #2 requires the submittal of a Geotechnical Stability Exhibit in accordance with Rule 6.5(4) of the Construction Materials Rules and Regulations of the Colorado Mined Land Reclamation Board.

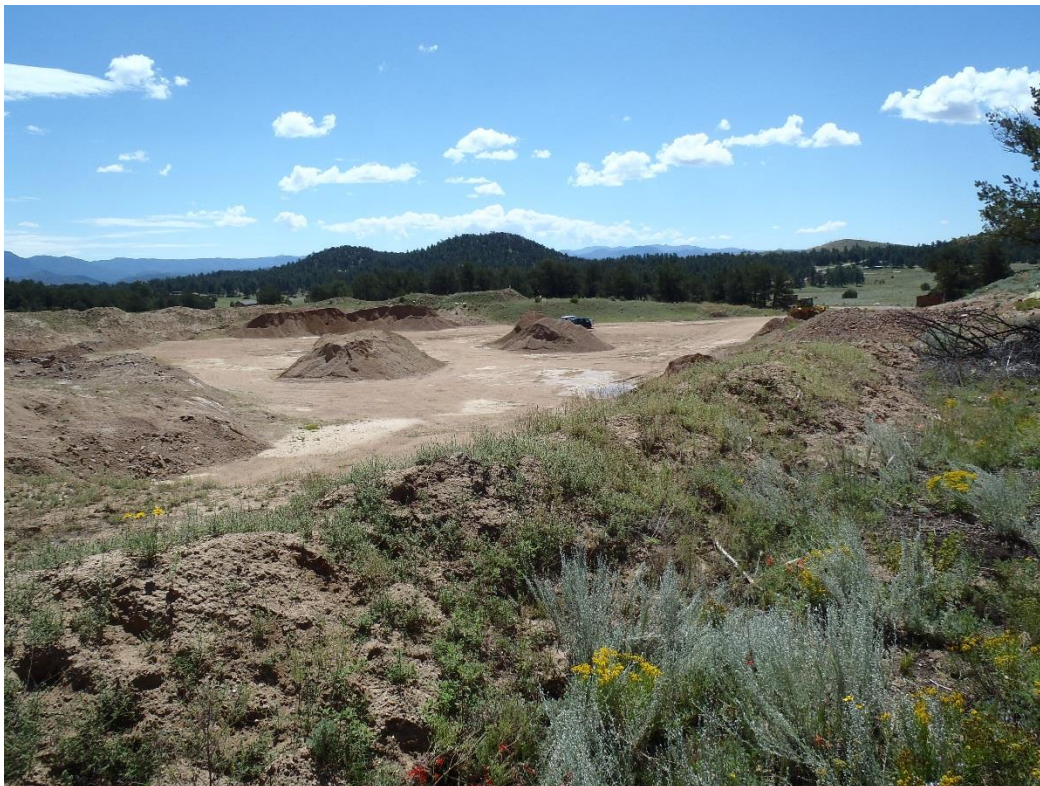
Photo 4. Material stockpiles observed on the pit floor (looking SE).

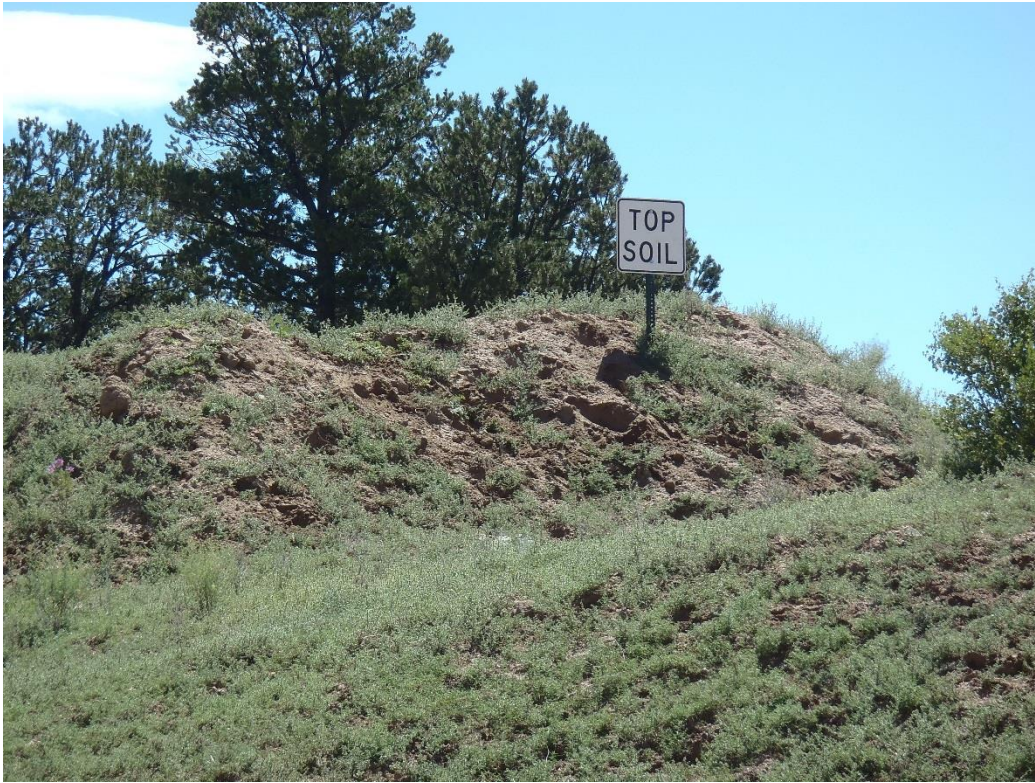
**Reclamation** – No reclamation had been initiated. Topsoil stockpiles were placed near the permit boundary and labeled in typical Fremont Co. manner (see **Photo 5**). Backfill material for reclamation was stockpiled offset 15 to 20 feet from the crest of the highwall (see **Photo 6**).

Photo 5. Topsoil stockpile sign.

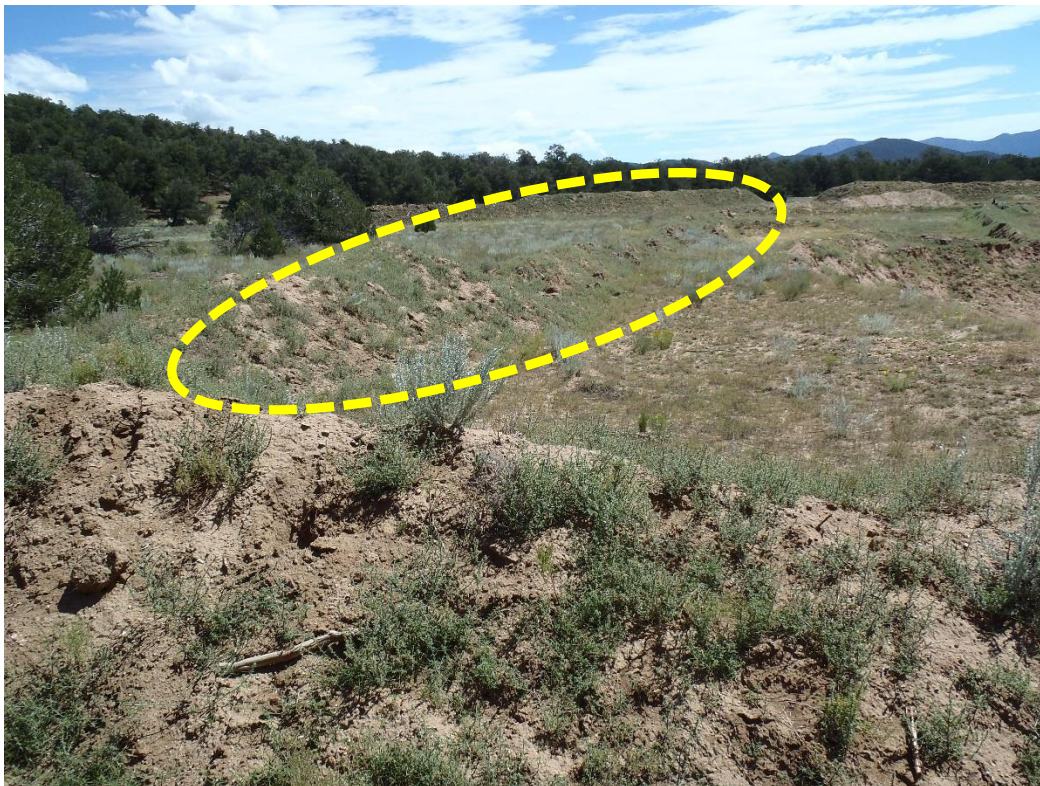
Photo 6. Backfill material offset from highwall.

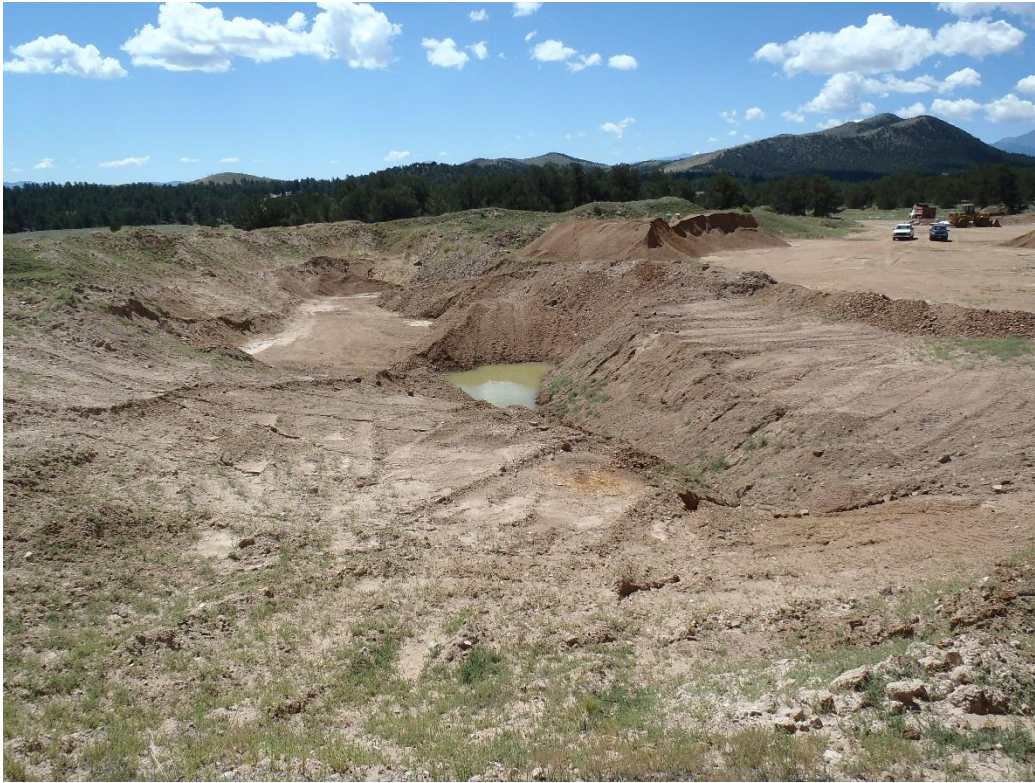
**Environmental** – No problems with contaminant spills, erosion/sedimentation or noxious weeds were observed. Some standing water was observed in the deeper east pit. Mr. Rife explained that water was runoff from recent heavy rains (see **Photo 7**).

Photo 7. Standing water observed in deeper east pit (looking south).
