COLORADO DIVISION OF RECLAMATION, MINING AND SAFETY
MINERALS PROGRAM INSPECTION REPORT
PHONE: (303) 866-3567

MINE NAME: Wagner Pit	MINE/PROSPECTING ID#: M-2010-002	MINERAL: Sand and gravel	COUNTY: Moffat
INSPECTION TYPE: Monitoring	INSPECTOR(S): Amy C. Yeldell	INSP. DATE: September 9, 2015	INSP. TIME: 10:30
OPERATOR: Wagner Rock LLC	OPERATOR REPRESENTATIVE: None	TYPE OF OPERATION: 110c - Construction Limited Impact

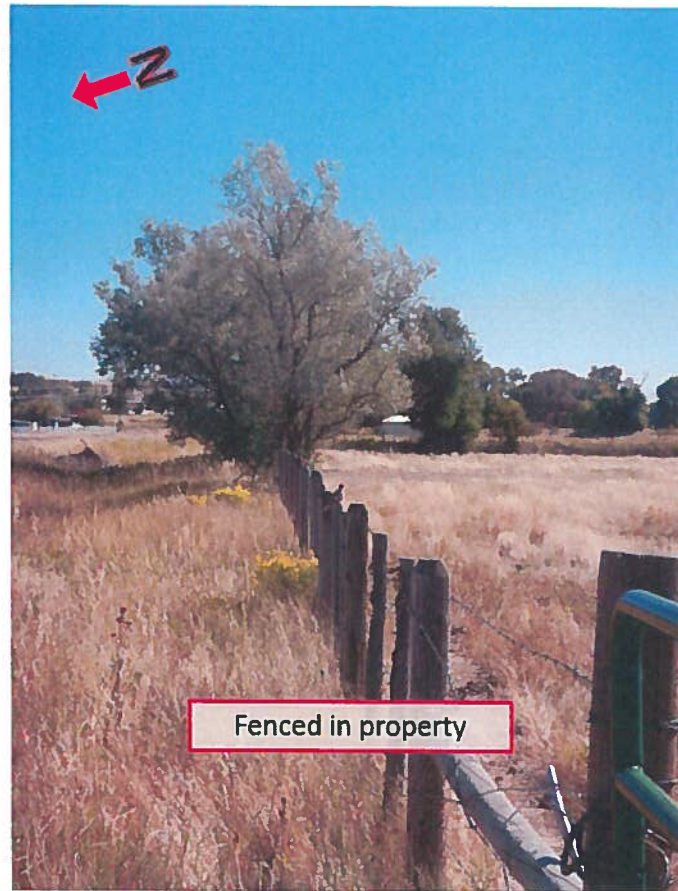
The mine identification sign and affected area boundary markers are in place and in compliance with Rule 3.1.12. The sign is located at the entrance and the entire permit boundary is fenced in.

Fenced in property

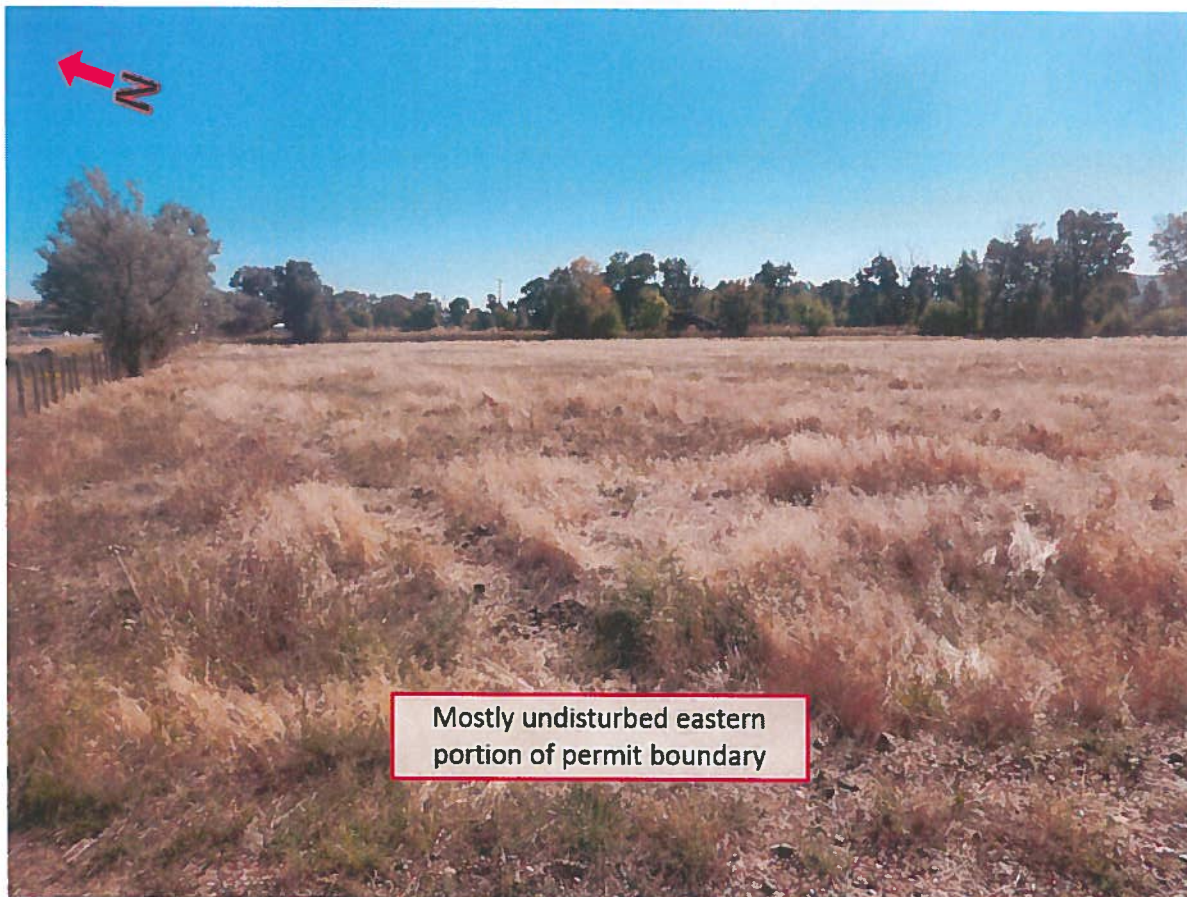
Mostly undisturbed eastern
portion of permit boundary

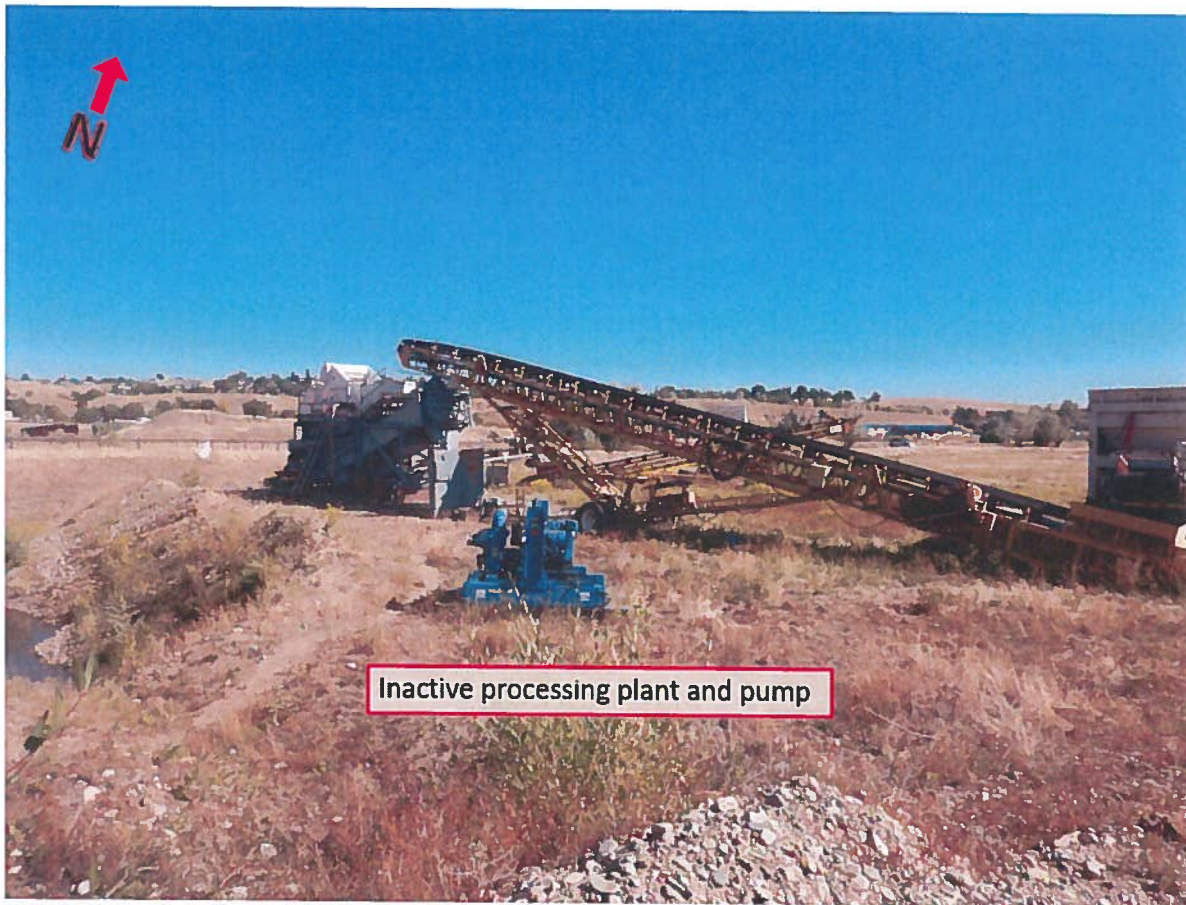
The site is currently inactive. In discussion with the operator after the inspection he noted that periodically material is excavated from the eastern pit and hauled to his other permitted pit, Wagner Rock M-1999-018 for processing. Mining is moving from west to east and two-thirds of the site is undisturbed. A mobile processing plant was on site however it did not appear to have been operational in quite some time based on how the vegetation had taken over.

Inactive processing plant and pump

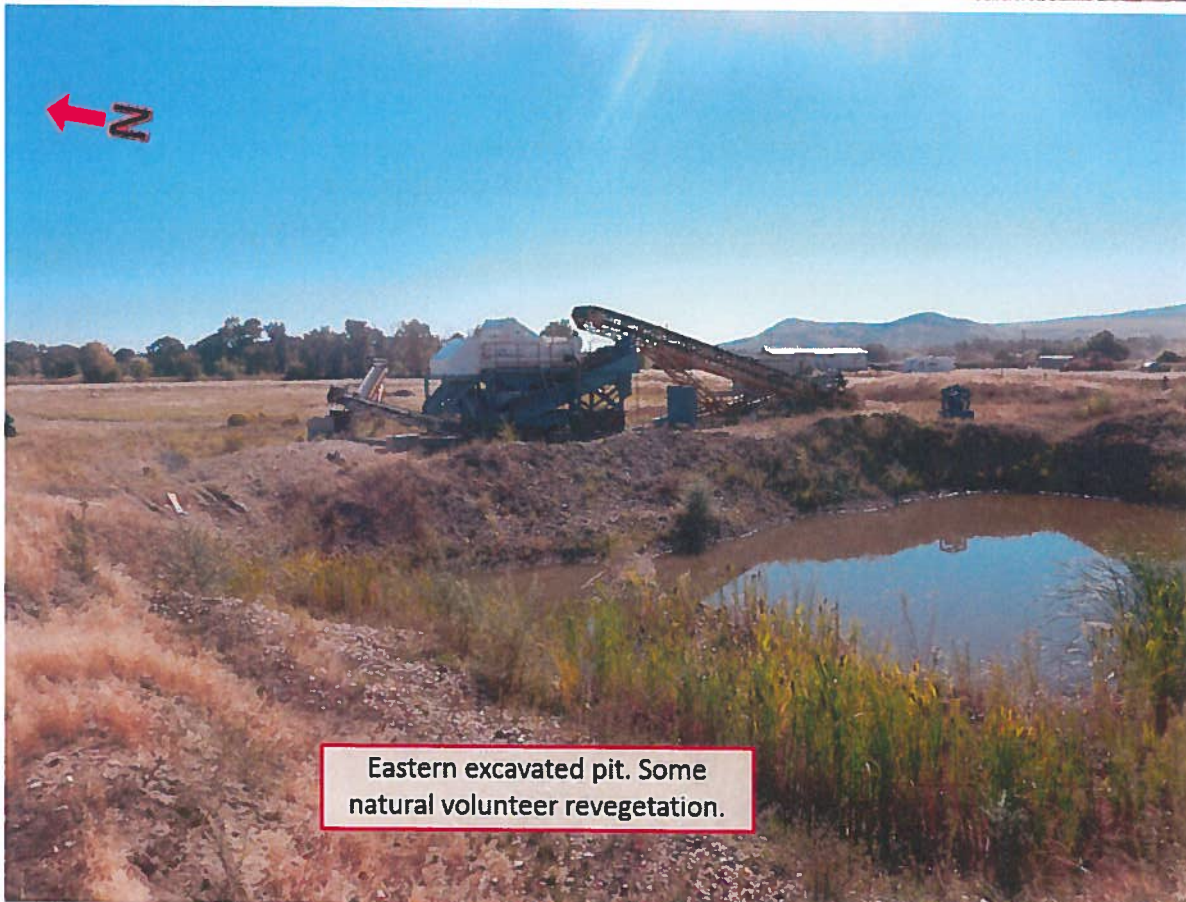
Eastern excavated pit. Some natural volunteer revegetation.
