**COLORADO DIVISION OF RECLAMATION, MINING AND SAFETY**  
**MINERALS PROGRAM INSPECTION REPORT**  
**PHONE: (303) 866-3567**

<b>MINE NAME:</b> Bunn Ranch Pit	<b>MINE/PROSPECTING ID#:</b> M-1980-131	<b>MINERAL:</b> Sand and gravel	<b>COUNTY:</b> Moffat
<b>INSPECTION TYPE:</b> Monitoring	<b>INSPECTOR(S):</b> Amy C. Yeldell	<b>INSP. DATE:</b> September 9, 2015	<b>INSP. TIME:</b> 13:00
<b>OPERATOR:</b> Elam Construction, Inc.	<b>OPERATOR REPRESENTATIVE:</b> Jon Muller	<b>TYPE OF OPERATION:</b> 112c - Construction Regular Operation

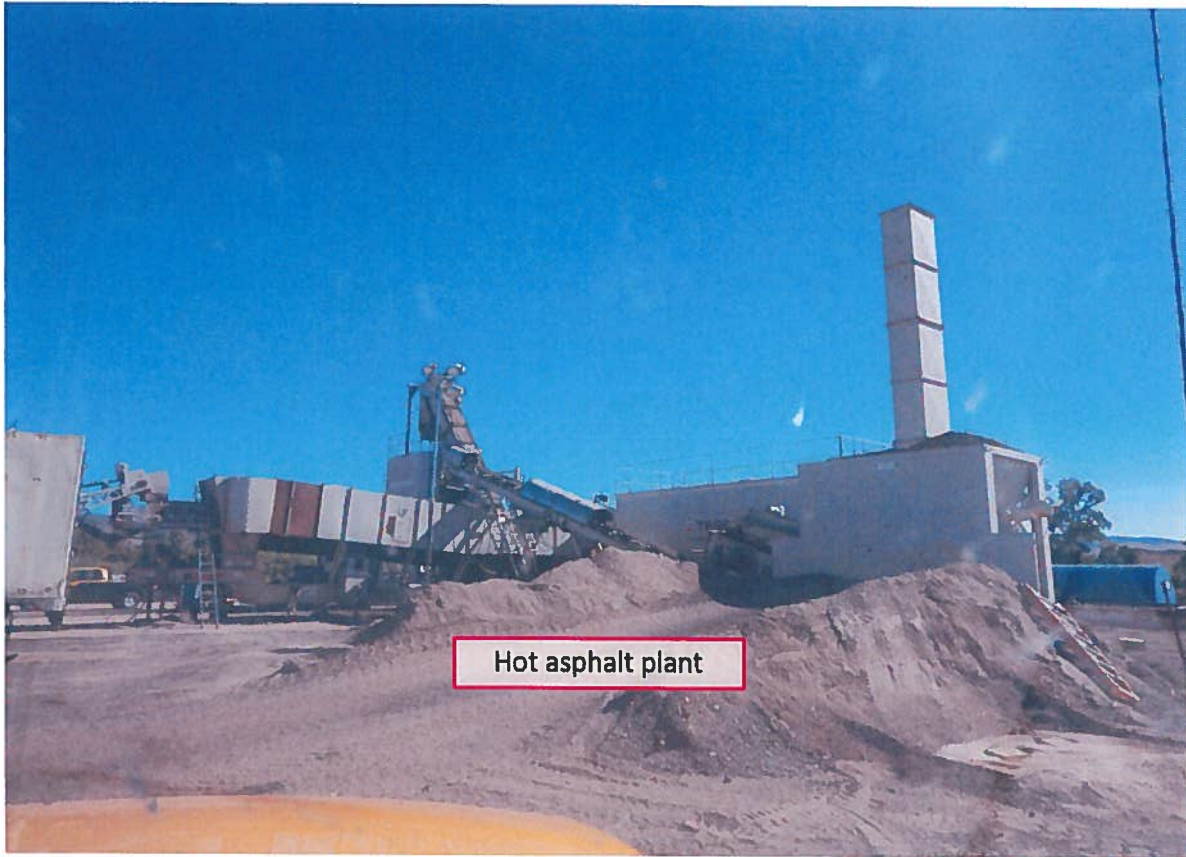
Hot asphalt plant

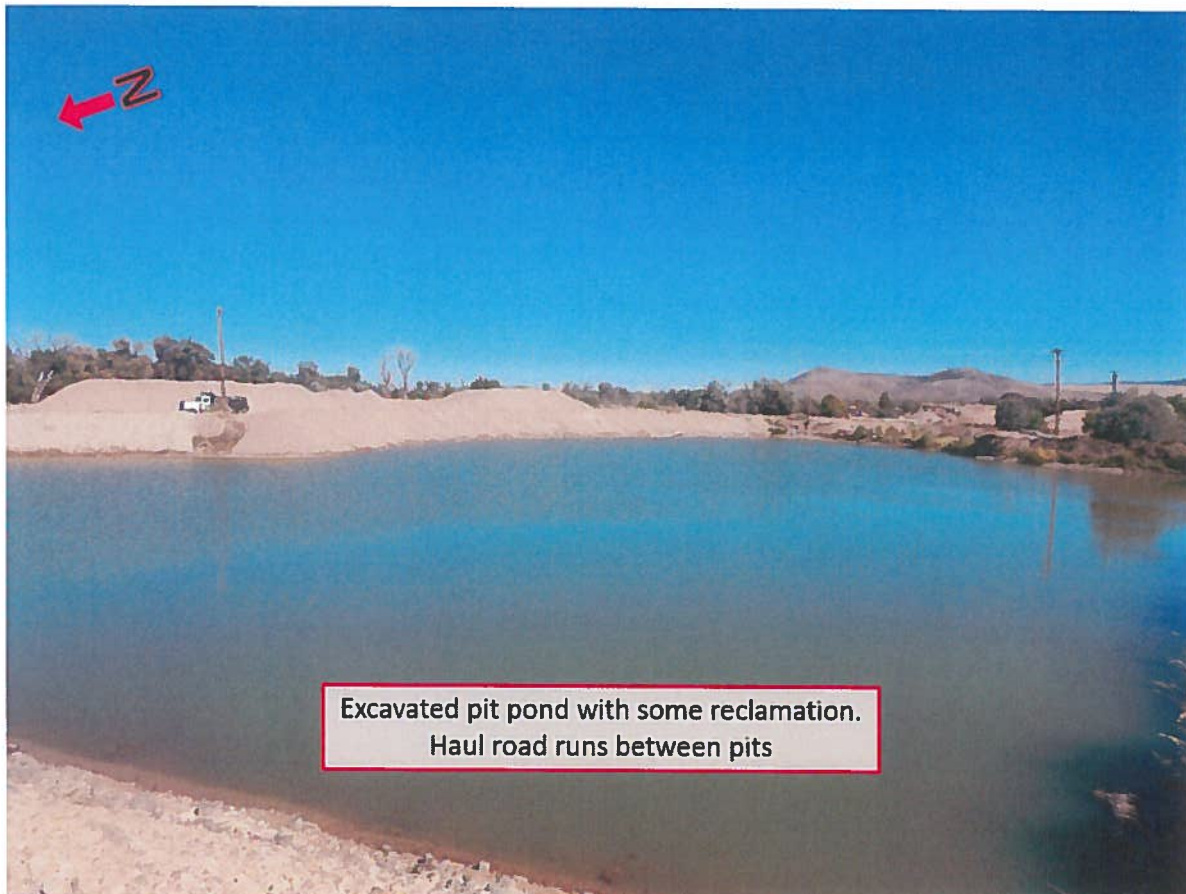
Excavated pit pond with some reclamation.  
Haul road runs between pits
