COLORADO DIVISION OF RECLAMATION, MINING AND SAFETY MINERALS PROGRAM INSPECTION REPORT

MINE NAME:	MINE/PROSPECTING ID#:	MINERAL:	COUNTY:
Norwood Pit	M-1981-154	Sand and gravel	San Miguel
INSPECTION TYPE:	INSPECTOR(S):	INSP. DATE:	INSP. TIME:
Multi Person Inspection	Lucas J. West, Russ Means	August 19, 2015	13:00
OPERATOR:	OPERATOR REPRESENTATIVE:	TYPE OF OPERATION:	
San Miguel County	Bill Wilson	112c - Construction Regular Operation

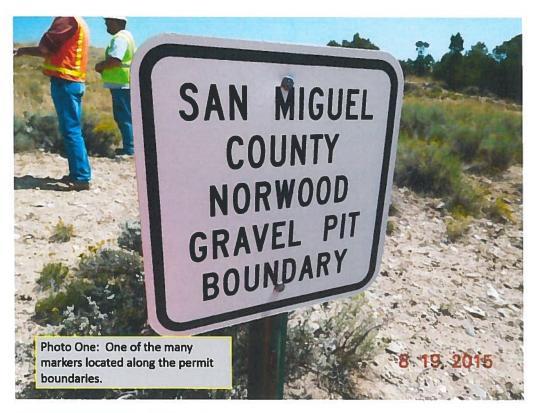
The site was not active at the time of the inspection and no mining related equipment was located on the site. The permit boundaries were well marked on the East, South and West sides with T-posts and signs that were observed as seen in Photo One. The site shares a permit boundary with the United Companies United/Norwood pit along the northern edge of the permitted area. Various stockpiles were observed on site and appeared to be stable. Hauling and processing of materials takes place on an as needed basis and is in compliance with Rule 1.13. As seen as in Photo Two there is a large depression on the pit floor that has collected storm water, the Operator has clarified it dries up seasonally and is only filled in response to precipitation events.

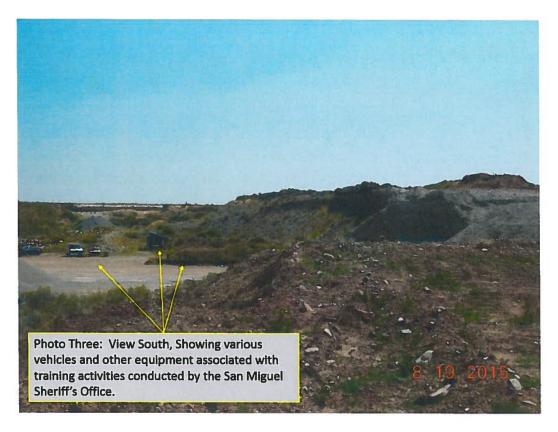
The pit floor is occasionally used by the San Miguel Sheriff's Department as a shooting range. Various vehicles and other debris associated with tactical training activities are located on site as seen in Photo Three. Various other debris and equipment not associated with mining activities was observed, but kept in an organized and orderly fashion. San Miguel County also uses a small area of the pit for the burning of weed cuttings in a contained and sealed fire box. The Operator expressed that weed burning activities haven't taken place for a while but the fire box and propane tanks are still located on the site.
