COLORADO DIVISION OF RECLAMATION, MINING AND SAFETY
MINERALS PROGRAM INSPECTION REPORT
PHONE: (303) 866-3567

MINE NAME: United/Norwood Pit	MINE/PROSPECTING ID#: M-1988-037	MINERAL: Gravel	COUNTY: Montrose
INSPECTION TYPE: Multi Person Inspection	INSPECTOR(S): Lucas J. West, Russ Means	INSP. DATE: August 19, 2015	INSP. TIME: 11:00
OPERATOR: Oldcastle SW Group, Inc. dba United Compas County	OPERATOR REPRESENTATIVE: Tim Ricks	TYPE OF OPERATION: 112c - Construction Regular Operation

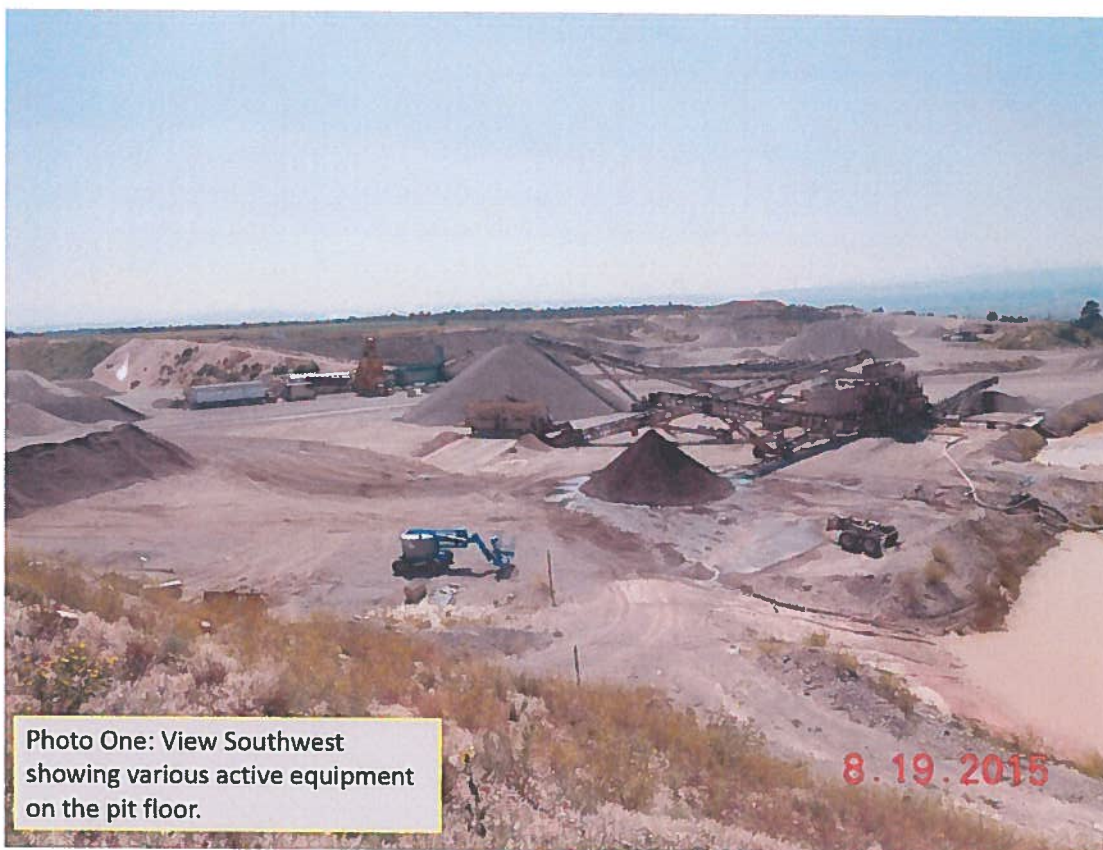
The site was active at the time of the inspection. Front end loaders, crusher, a hot plant, wash plant and conveyors were observed as seen in Photo One. Proper mine identification sign and permit boundary markers or berms delineating the boundaries were observed during the inspection. Numerous stockpiles were observed on the pit floor with adequate separation to allow for vehicle and equipment traffic to maneuver around them. Active dust mitigation was observed at the time of the inspection. All stockpiles appear to be stable and show no signs of erosion at the time.

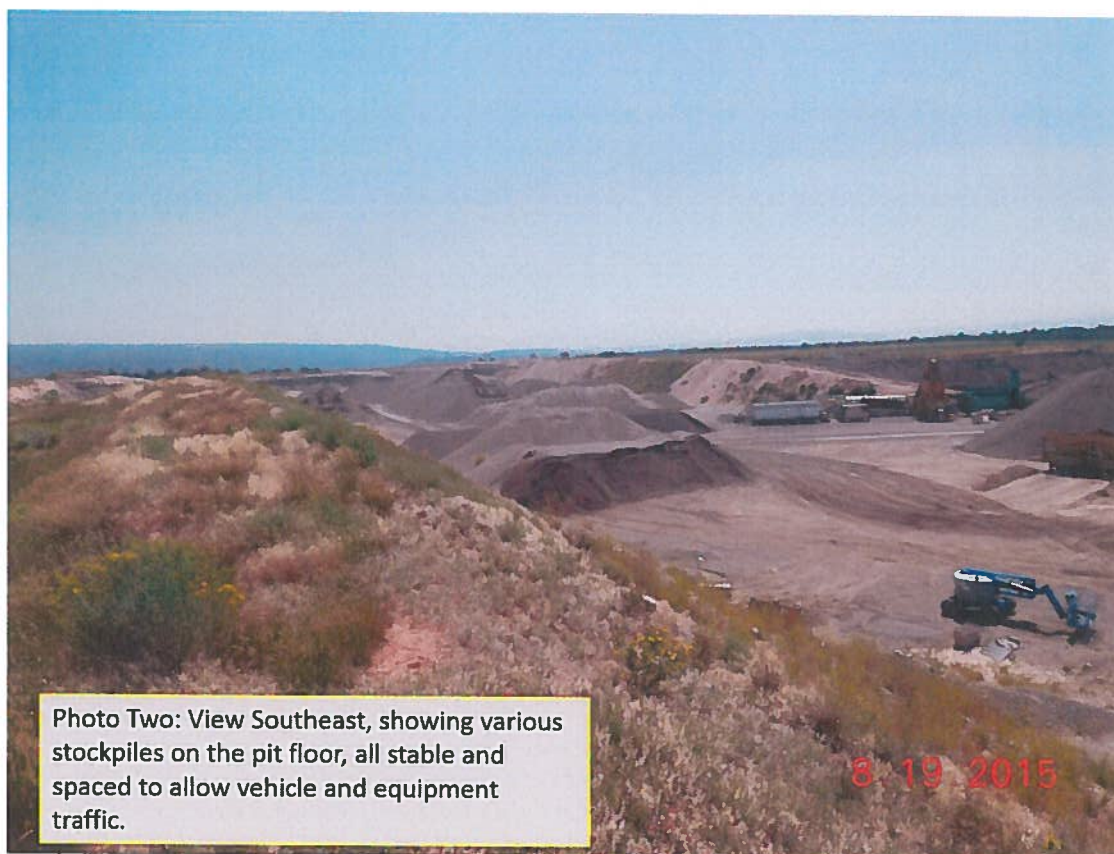
As seen in Photo Two, the topsoil stockpile was observed and appears stable with adequate vegetative cover to prevent erosion. All sloping leading down to the pit wall, with the exception of the East face which is an active 1H: 1V highwall, are approximately 3H: 1V, stable and well vegetated. Evidence of chemical weed treatment was observed. Some new growth of Canadian Thistle was noted, however the Operator explained that the site is due for another round of treatment soon.

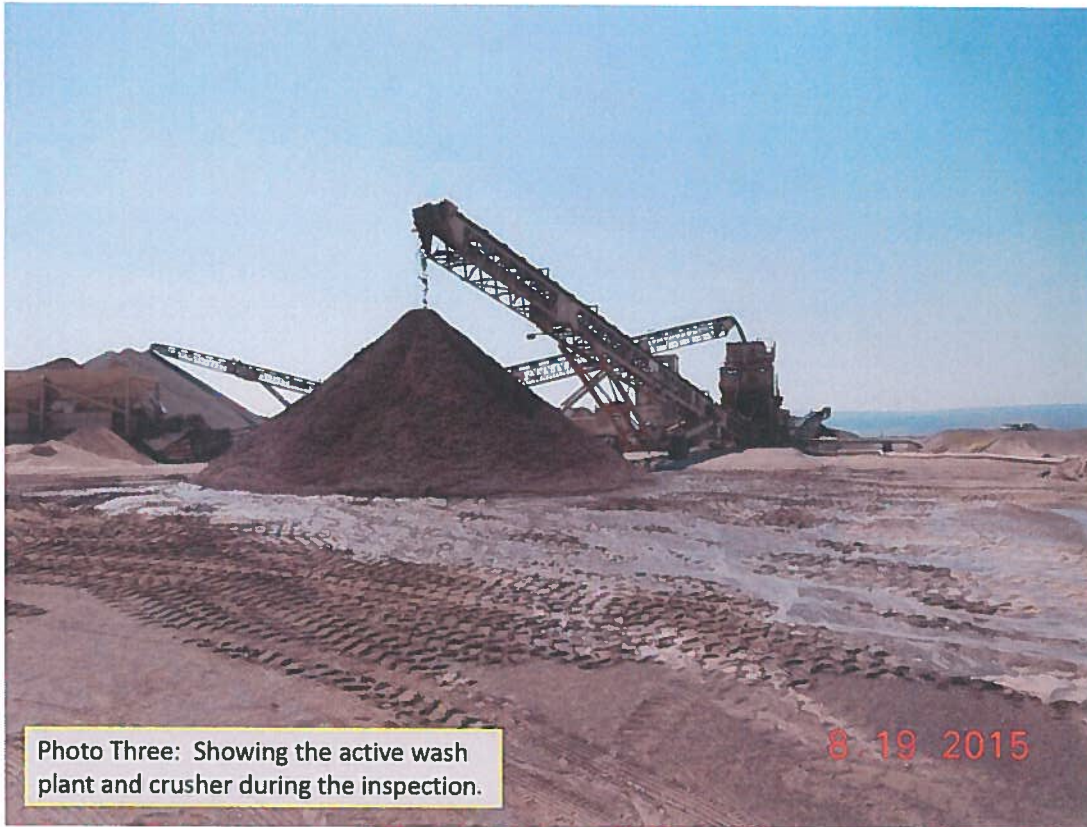
The crusher and wash plant were active at the time of the inspection as seen in Photo Three. The wash plant operates on a closed loop system with four settling ponds where the sediment is deposited before the water is recirculated. Photo Four shows the layout of the wash plant and settling ponds.

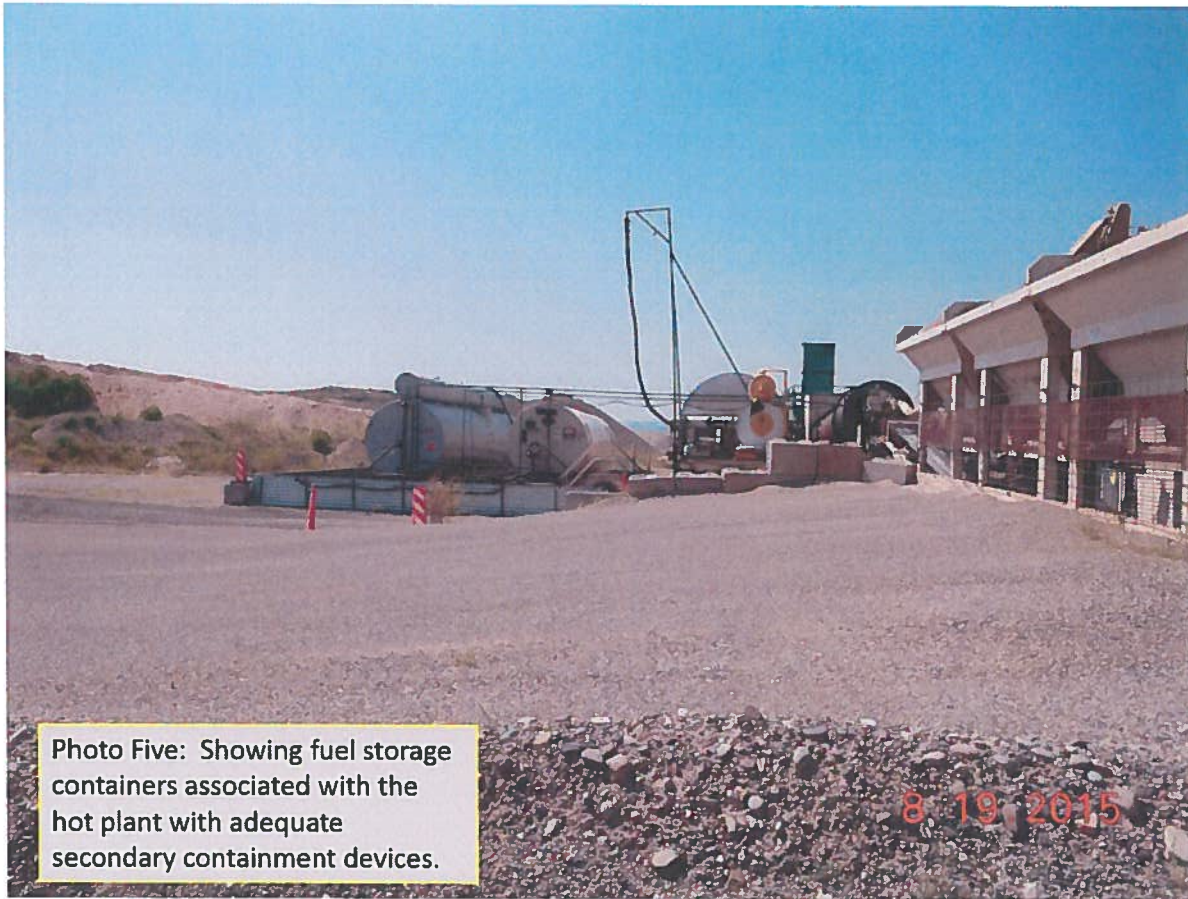
The hot plant was not active during the time of the inspection, but appears to be well kept and in good working order. As seen in Photo Five, all fuel containers associated with the hot plant have adequate secondary containment devices that show no evidence of spills. One other fuel container was observed on site, and it too had adequate secondary containment with no evidence of spills or potential hazards.

Photo Five: Showing fuel storage containers associated with the hot plant with adequate secondary containment devices.
