COLORADO DIVISION OF RECLAMATION, MINING AND SAFETY
MINERALS PROGRAM INSPECTION REPORT
PHONE: (303) 866-3567

MINE NAME: Dougherty Pit	MINE/PROSPECTING ID#: M-1978-079	MINERAL: Sand and gravel	COUNTY: Lincoln
INSPECTION TYPE: Monitoring	INSPECTOR(S): Amy Eschberger	INSP. DATE: August 27, 2015	INSP. TIME: 11:20
OPERATOR: Lincoln County	OPERATOR REPRESENTATIVE: John DeWitt and Rick Ashcraft	TYPE OF OPERATION: 110c - Construction Limited Impact

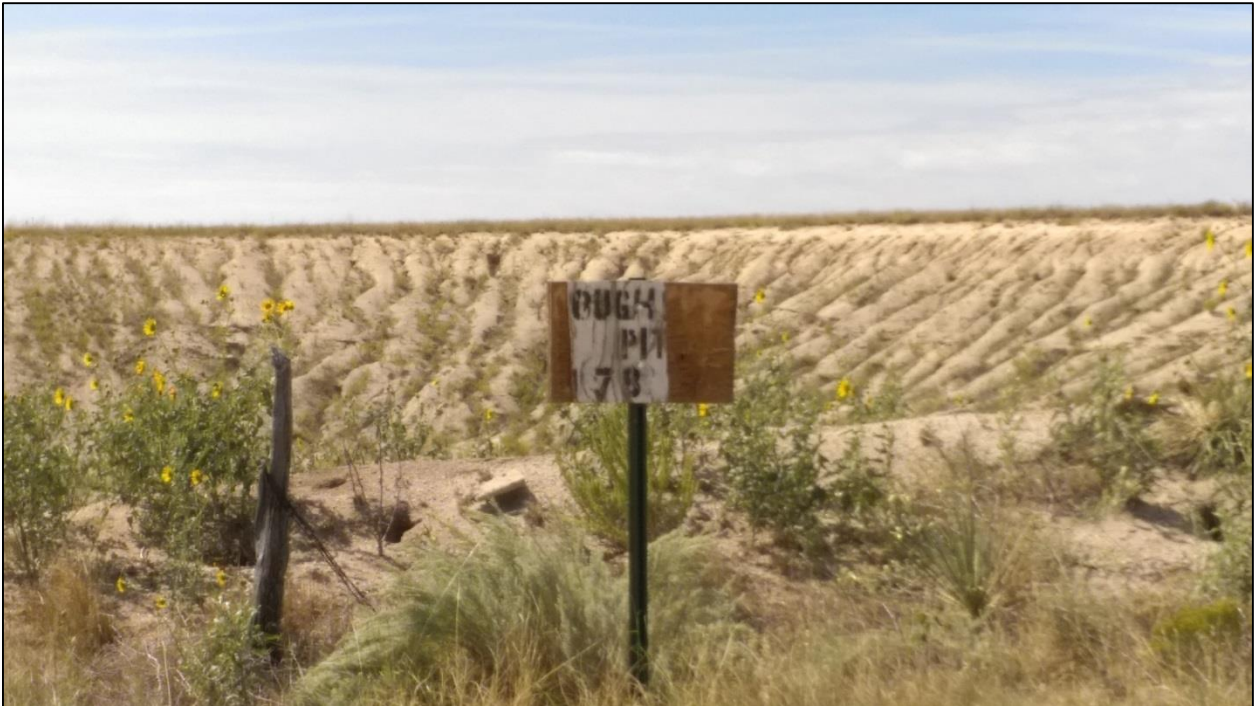
At the time of the inspection, the weather was clear, warm and sunny, and the ground was dry. A permit identification sign was posted at the main site entrance off of Co Rd J (**Photo 1**). However, some of the text had worn off the sign. The Division recommends the operator replace the permit sign, including at a minimum, the information required by Rule 3.1.12(1): the name of the operator, a statement that the permit was issued by the Colorado Mined Land Reclamation Board (MLRB), and the permit number. The permit boundary was adequately delineated with metal posts (**Photo 2**). The mine was not active during the inspection; however, a small dozer and screen were stored on site. The county extracts, processes, and/or hauls off material from this site every year, which is in compliance with its intermittent status.

Photo 1. View of permit sign posted at main site entrance off of Co Rd J. This sign needs to be replaced as it is no longer readable.

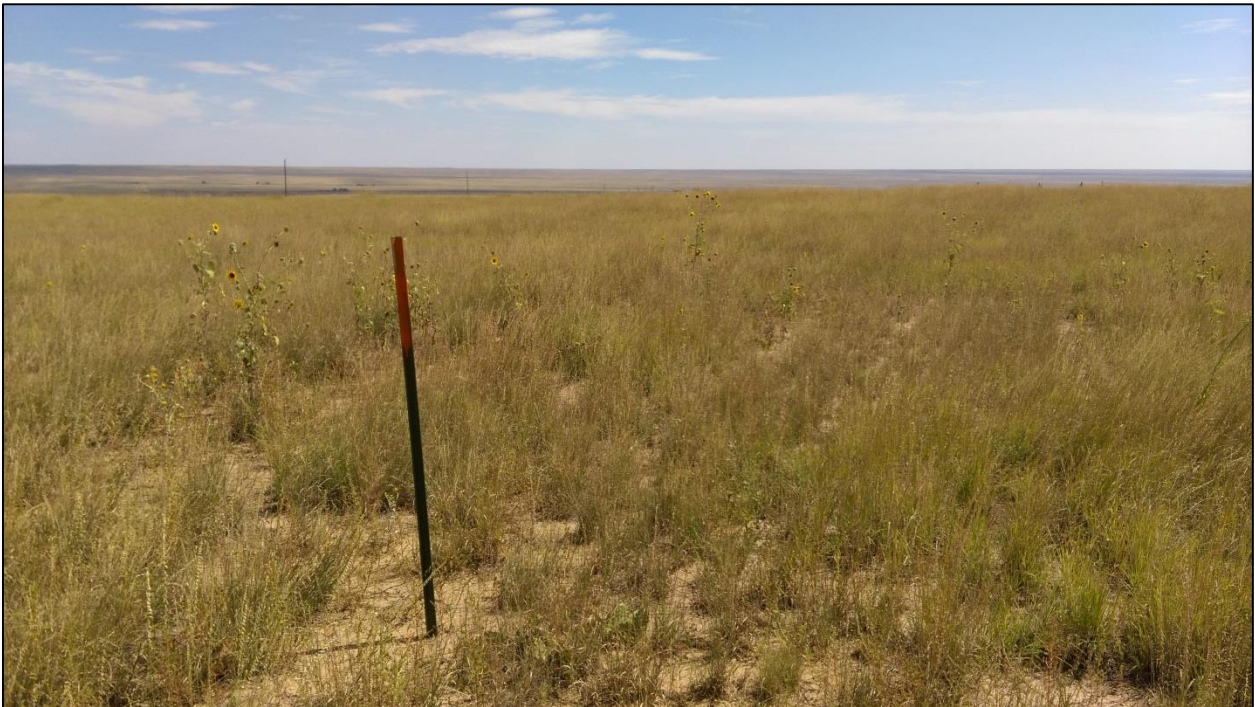
Photo 2. View looking west, showing metal post marking southwestern corner of permit boundary.

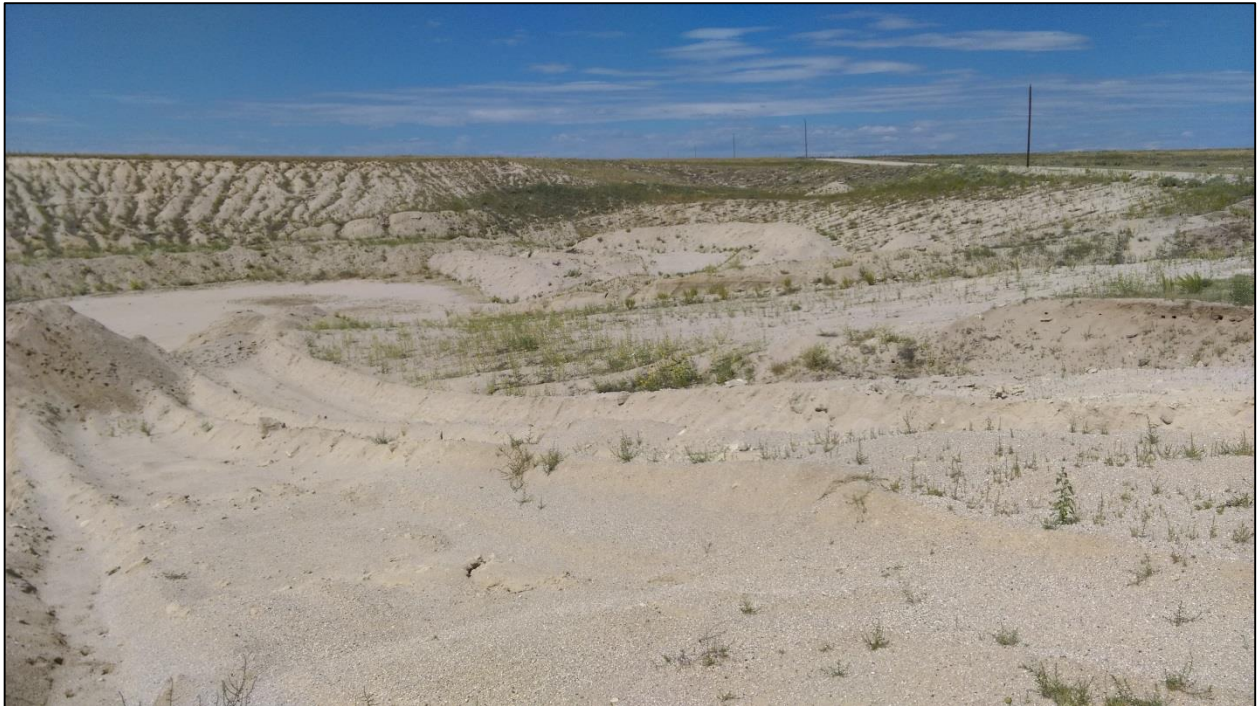
Photo 3. View looking northwest across pit from eastern edge, showing slopes graded mainly to 3H:1V or flatter.

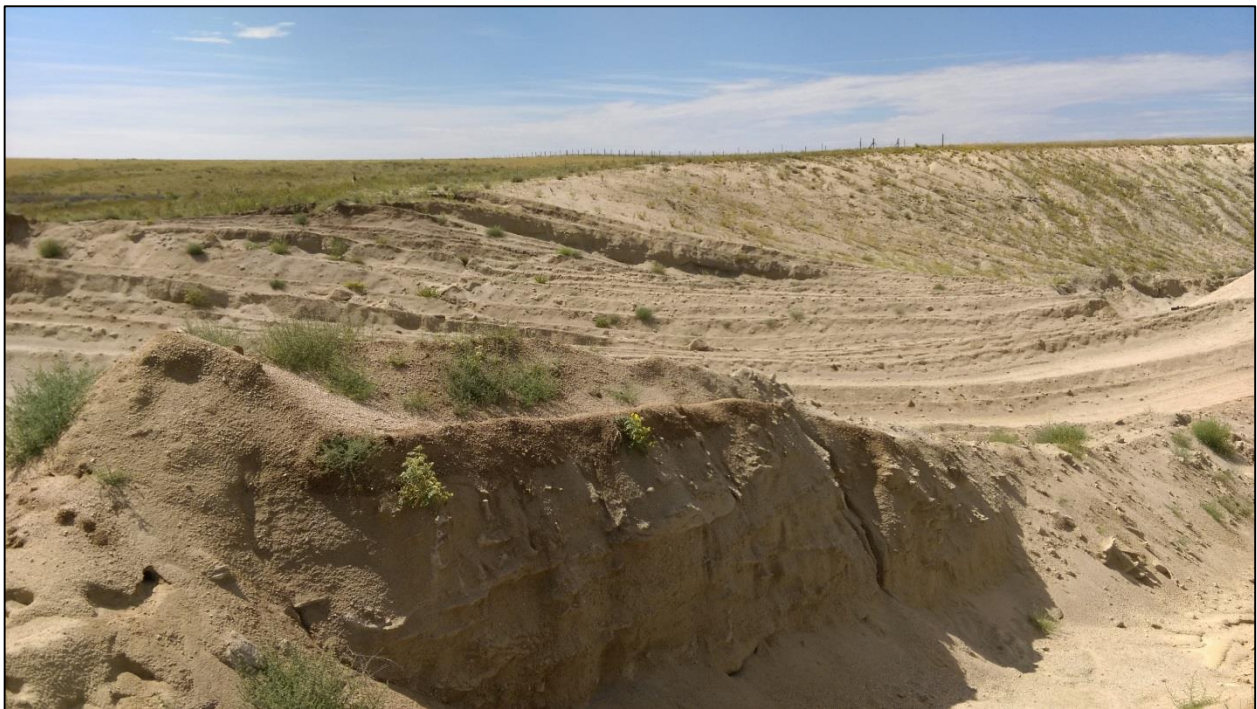
Photo 4. View looking south across most recently mined eastern pit wall, showing slopes graded mainly to 3H:1V or flatter.

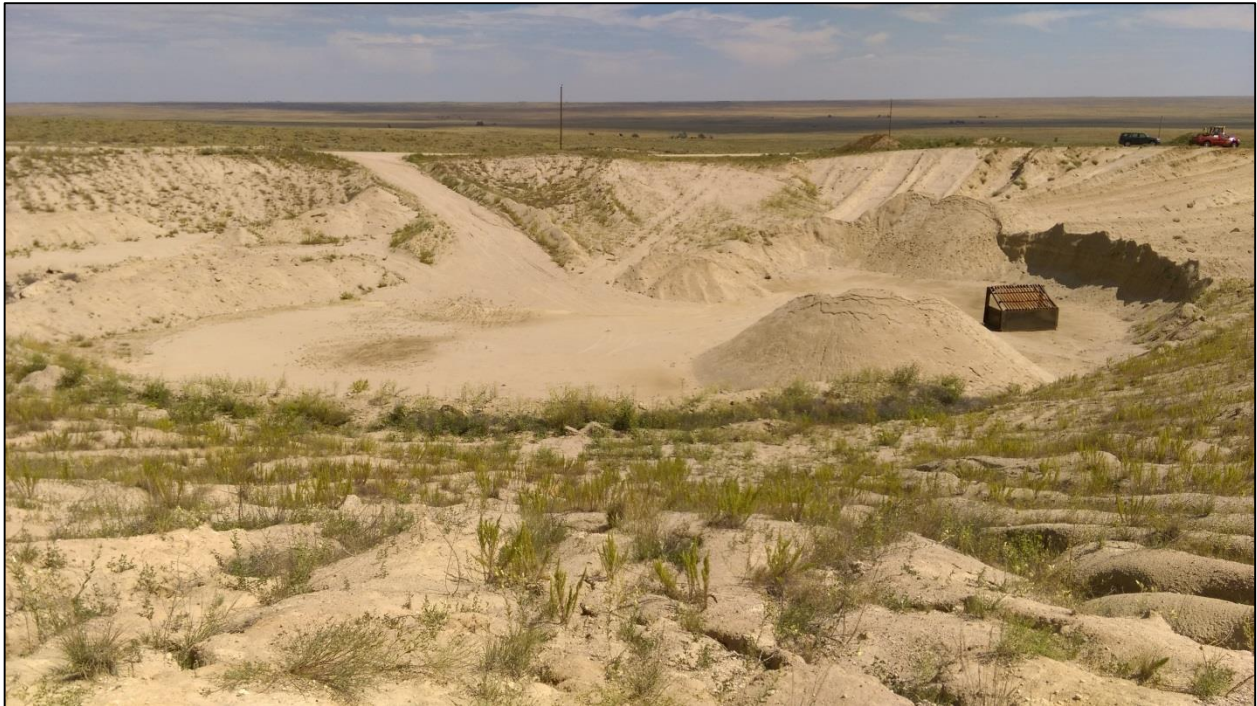
Photo 5. View looking east across pit from western edge, showing slopes graded mainly to 3H:1V or flatter. Note the few small material stockpiles stored on pit floor.

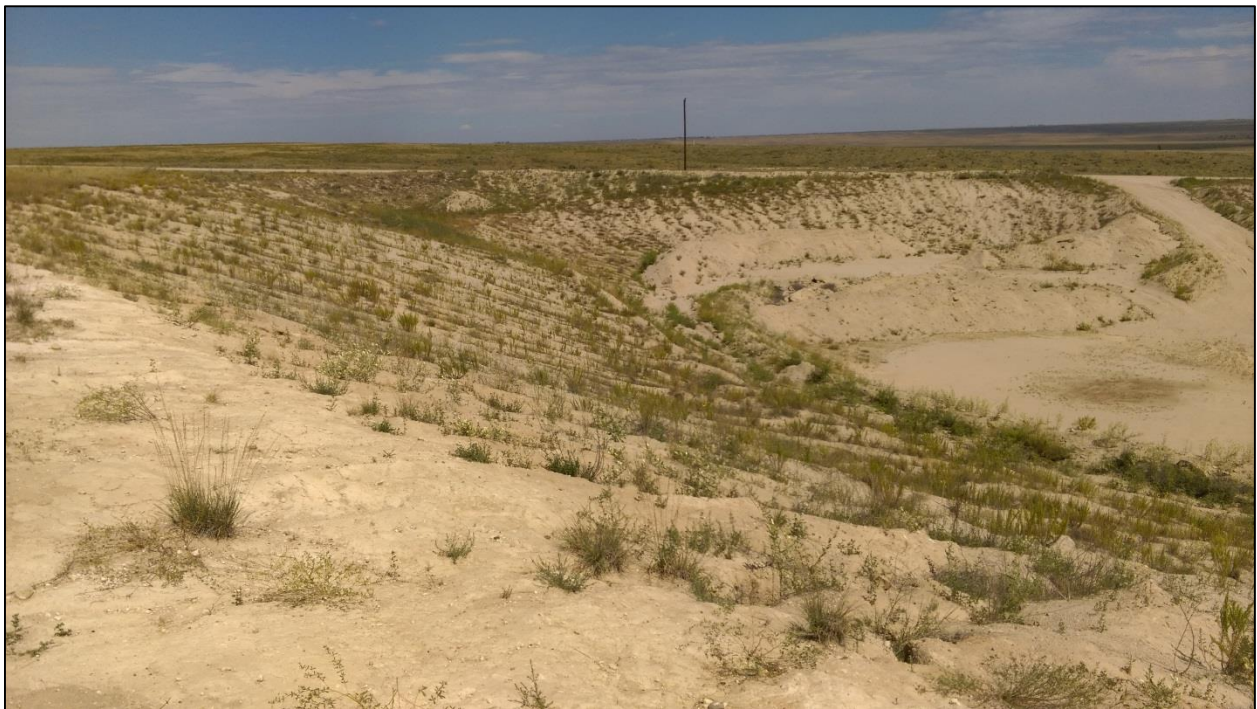
Photo 6. View looking north across western mined wall, showing slopes graded mainly to 3H:1V or flatter.

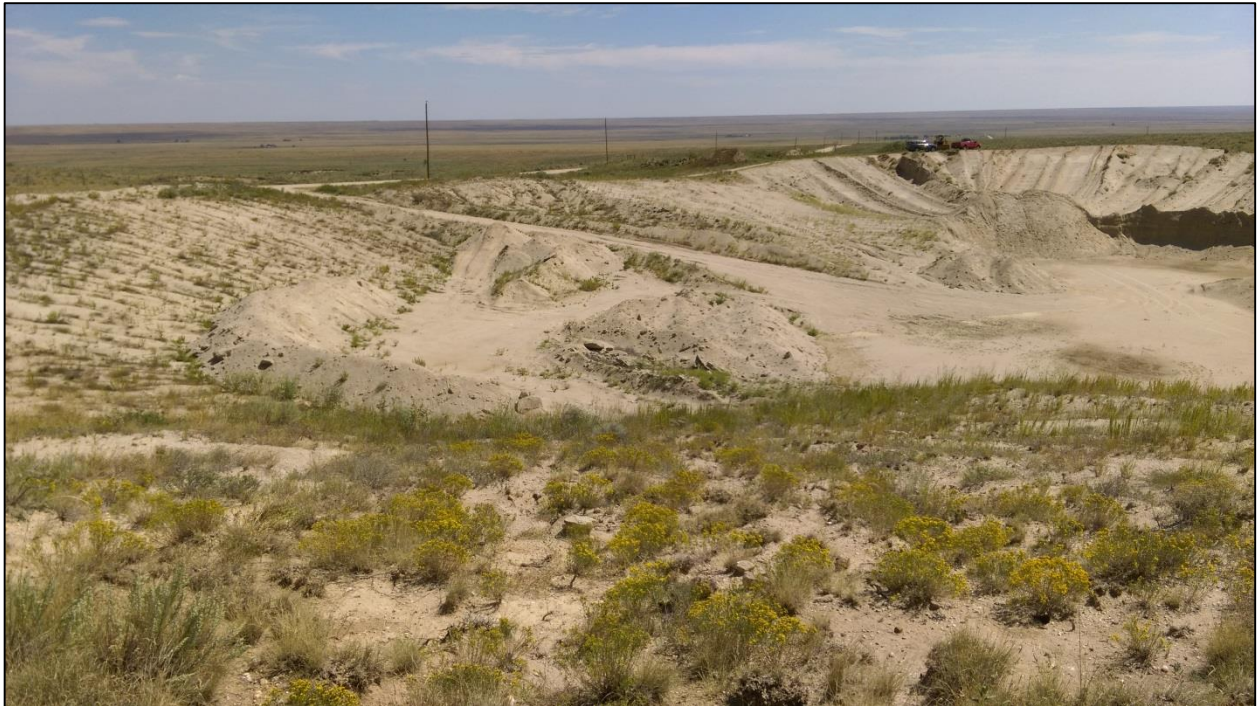
Photo 7. View looking northeast across (earlier mined) northwestern portion of pit, showing slopes graded closer to 4H:1V.

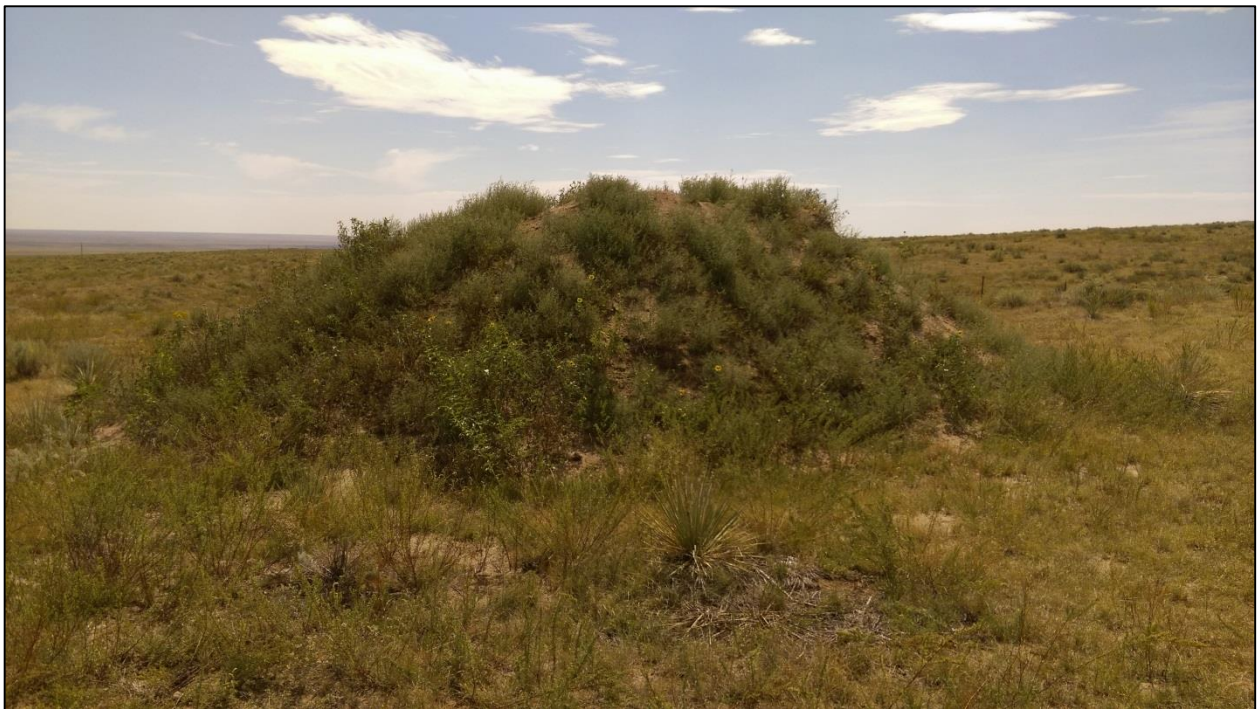
Photo 8. View of small topsoil stockpile stored east of pit, stable with vegetative cover.

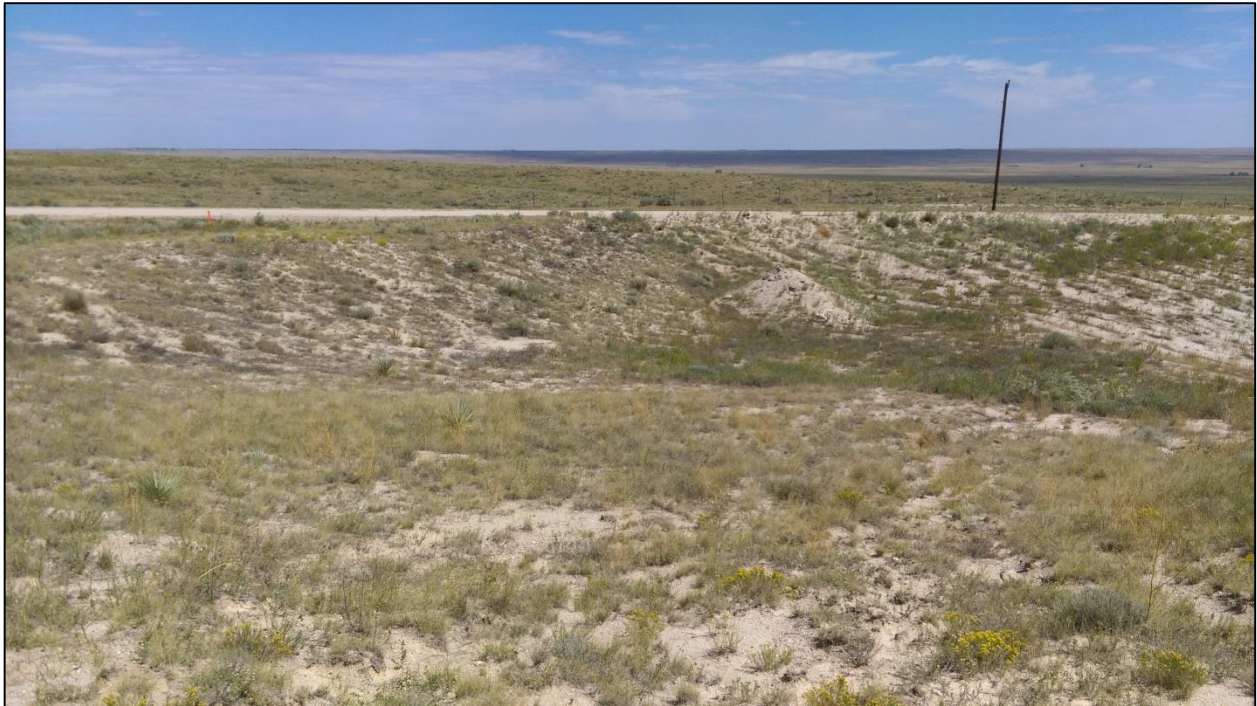
Photo 9. View looking north across (earlier mined) northwestern portion of site, showing slopes graded to 4H:1V or flatter. Note slightly more vegetative cover here than in other disturbed areas.

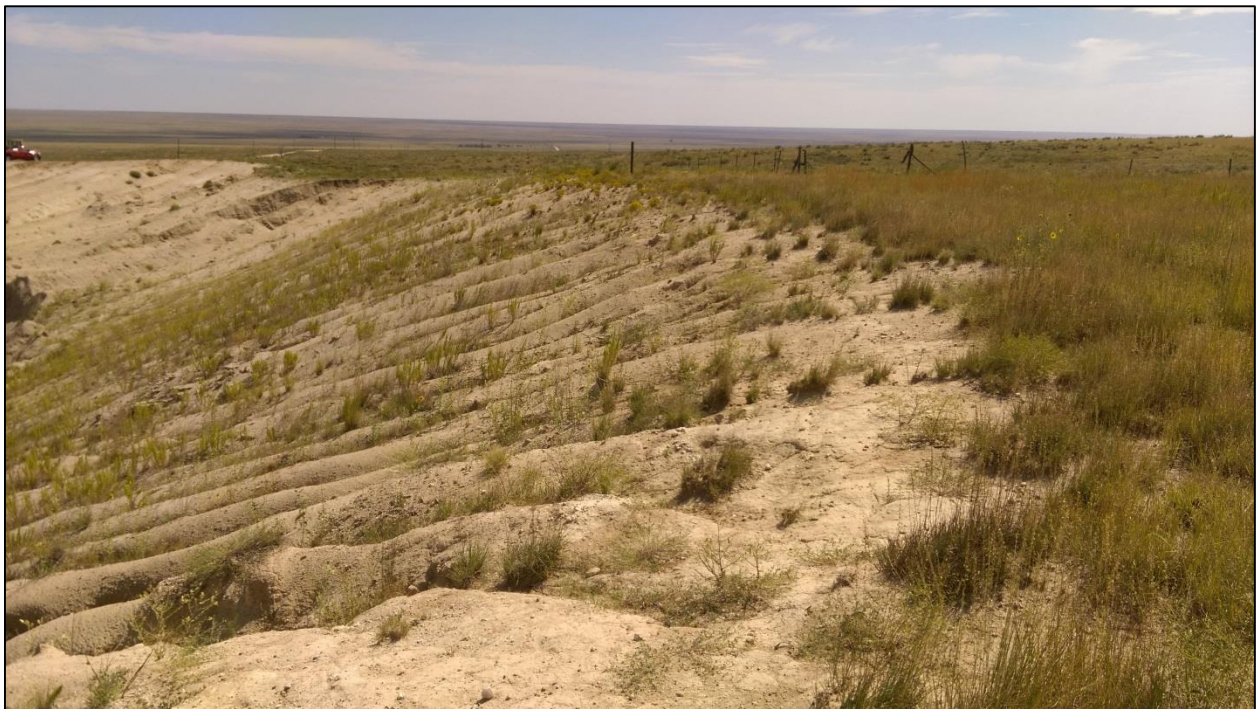
The operation was most recently working the eastern pit wall. It should be noted that portions of the southern pit wall are very close to the southern permit boundary (**Photo 10**; also see enclosed Google Earth image of site). The southern pit wall has been backfilled and graded to approximately 3H:1V or flatter, as required by the approved reclamation plan. It appears that additional disturbance of this slope is not anticipated. However, as the pit is expanded eastward, the operator should be careful not to disturb land outside of the permit boundary, as only 200 feet or less remains between the edge of the pit and the eastern boundary.

Photo 10. View looking east across southern mined wall (graded to 3H:1V). Portions of this disturbance are within only 10-20 feet of the southern permit boundary.
