**COLORADO DIVISION OF RECLAMATION, MINING AND SAFETY**  
**MINERALS PROGRAM INSPECTION REPORT**  
**PHONE: (303) 866-3567**

| <b>MINE NAME:</b><br>Harold Eichman Gravel Pit | <b>MINE/PROSPECTING ID#:</b><br>M-1985-105 | <b>MINERAL:</b><br>Sand and gravel | <b>COUNTY:</b><br>Lincoln |
| <b>INSPECTION TYPE:</b><br>Monitoring | <b>INSPECTOR(S):</b><br>Amy Eschberger | <b>INSP. DATE:</b><br>August 27, 2015 | <b>INSP. TIME:</b><br>13:00 |

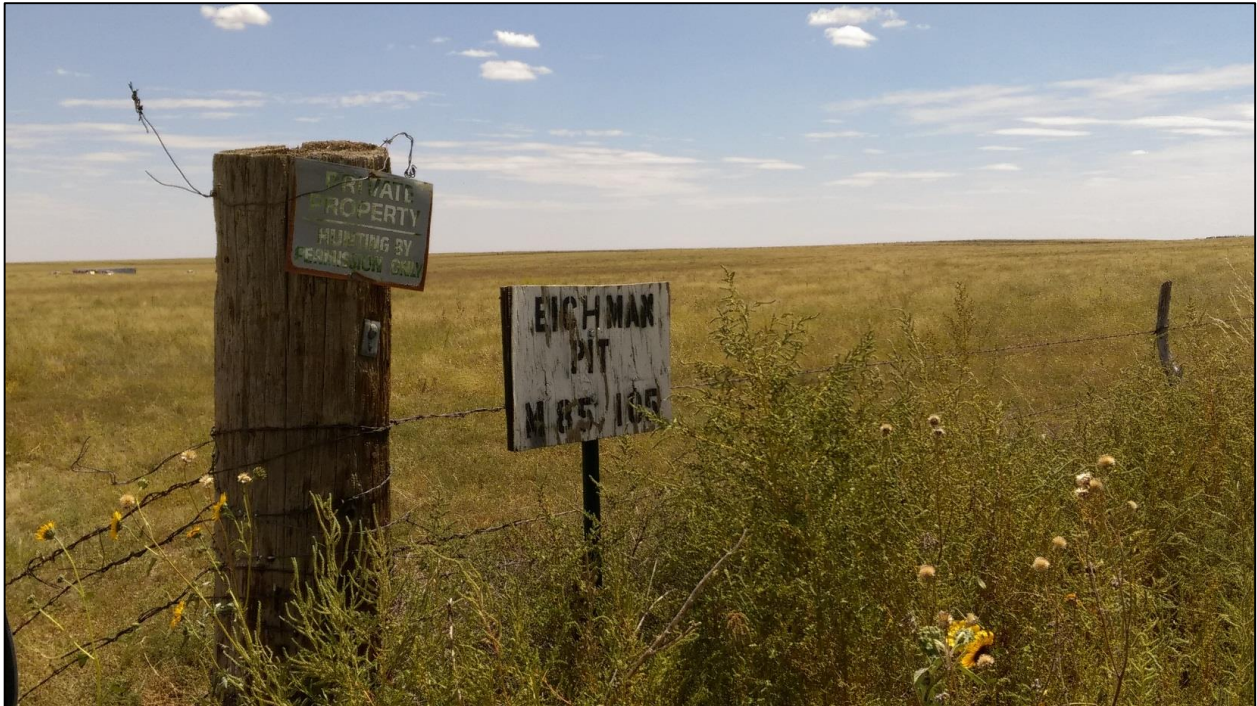
At the time of the inspection, the weather was partly cloudy and warm. A permit sign was posted at the main site entrance off of Co Rd M (**Photo 1**). This sign includes the permit number as required; however, Rule 3.1.12(1) requires the sign to also include the name of the operator, and a statement that the permit was issued by the Colorado Mined Land Reclamation Board (MLRB). The Division recommends the operator replace this sign, including all required information. The permit boundary was adequately delineated with metal posts. The mine was not active during the inspection, and no equipment was stored on site. The county extracts, processes, and/or hauls off material from this site every year, which is in compliance with its intermittent status.

**Photo 1.** View of permit sign posted at main site entrance off of Co Rd M. This sign should also include the name of the operator, and a statement that the permit was issued by the CO MLRB.

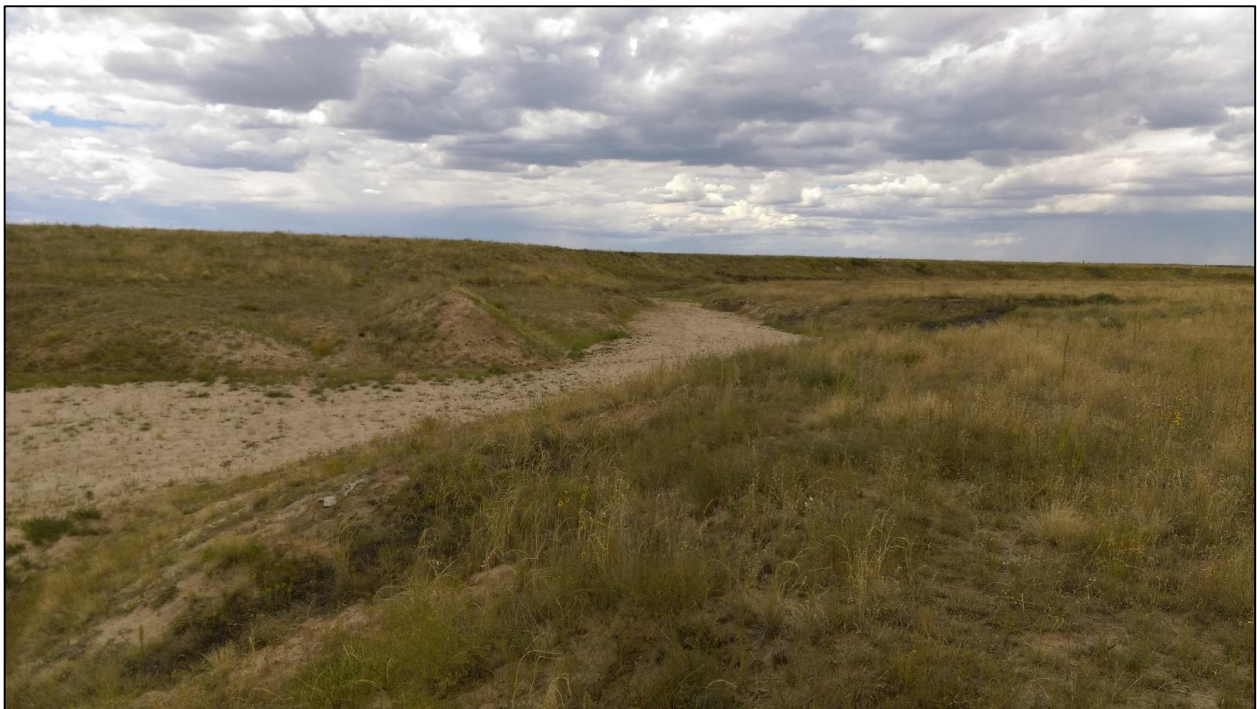
**Photo 2.** View looking upstream from western edge of permit area, showing creek bed dry at the time of the inspection.

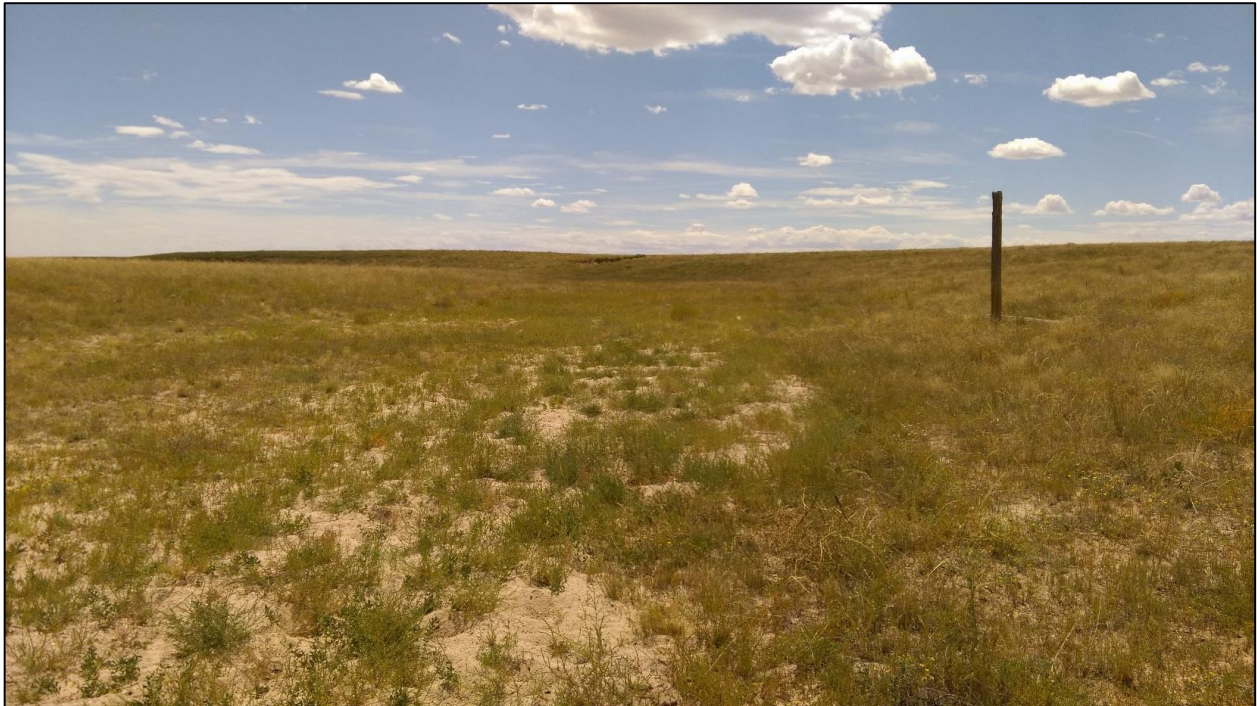
**Photo 3.** View looking downstream from southeastern edge of permit area, showing creek bed dry at the time of the inspection. Note creek bed is relatively level with surrounding topography just downstream of pit.

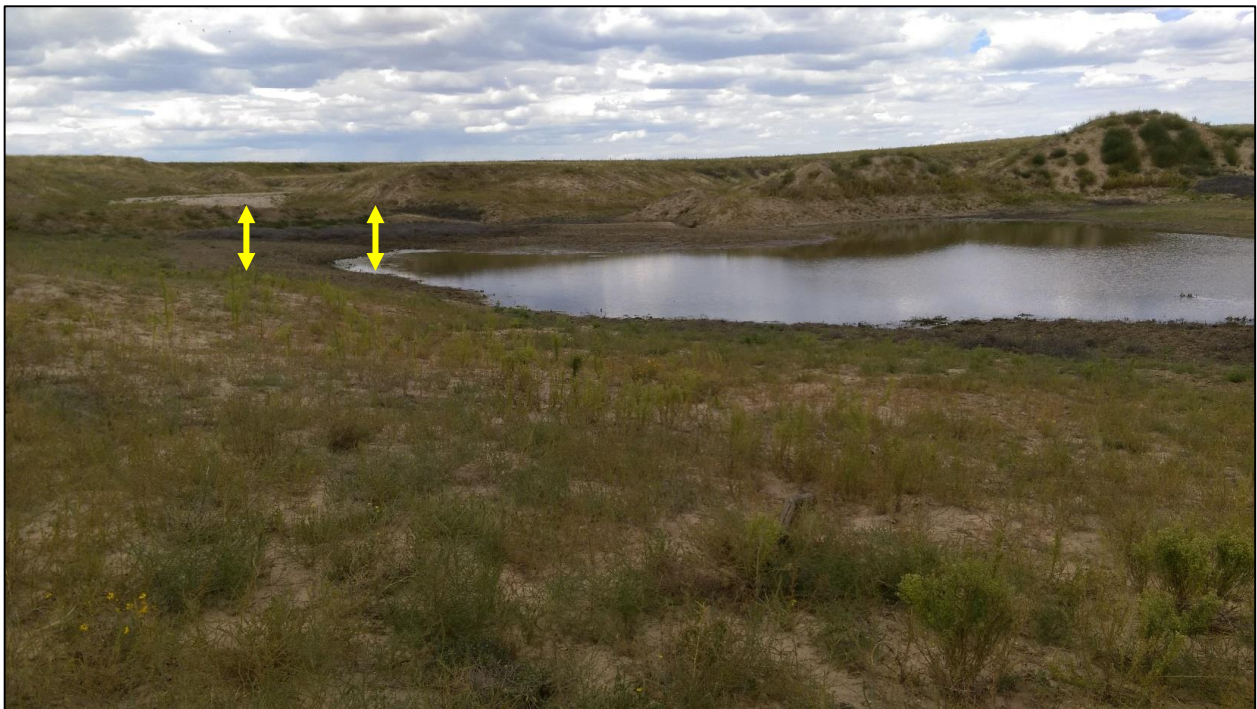
During the inspection, the creek bed was dry upstream (**Photo 2**) and downstream (**Photo 3**) of the site. However, up to approximately 1-2 feet of standing water was present in the pit (**Photos 4-8**), with a surface area of approximately 1.5 acres. According to Mr. DeWitt and Mr. Ashcraft, they have had issues with standing water in this pit after heavy storm events, especially the ones that occurred in this area last summer. The creek experienced uncommon heavy flows that damaged the southern portion of the small earthen dam on the upstream side of the pit (**Photo 9**). Judging by the erosion line around the bottom edges of the pit and stockpiles, the water level may have been approximately 4 feet deep in the pit at one time. Two potential drainages exist on the eastern and southeastern edges of the pit. However, the pit floor is approximately 5 feet below the creek bed that is upstream from the pit (**Photo 10**; also see **Photo 4**), and approximately 10 feet below the creek bed that is downstream from the pit (**Photos 11 and 12**). Therefore, stormwater is not able to naturally drain from the pit. The operator has been unable to get equipment into the pit due to the standing water. If the operator anticipates pumping water from the pit, the Division recommends first contacting the Water Quality Control Division of the Colorado Department of Public Health and Environment to determine whether a stormwater discharge permit is required for ephemeral creeks. With the lack of positive drainage, no sediment appears to be leaving the site.

**Photo 4.** View looking northwest from southern pond bank, showing standing water in pit. Note pit floor is approximately 5 feet below upstream creek bed elevation (indicated).

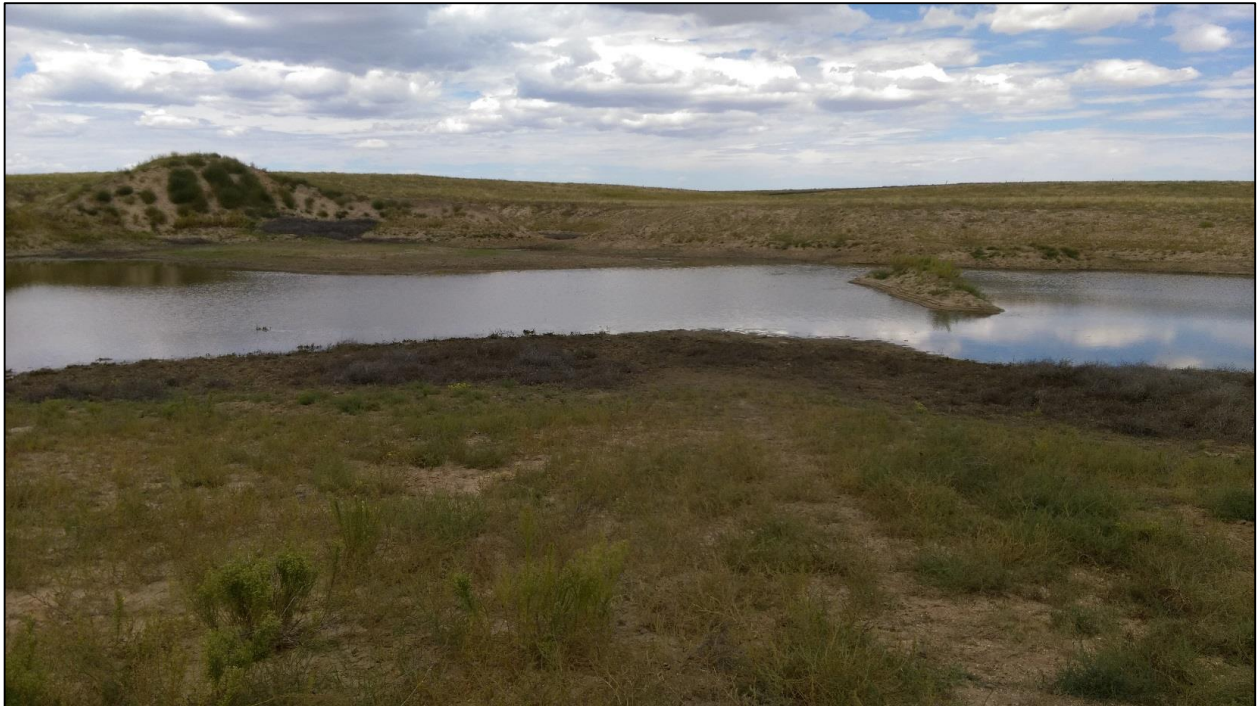
**Photo 5.** View looking north from southern pond bank, showing standing water in pit. Note material stockpile stored on pit floor (at left).

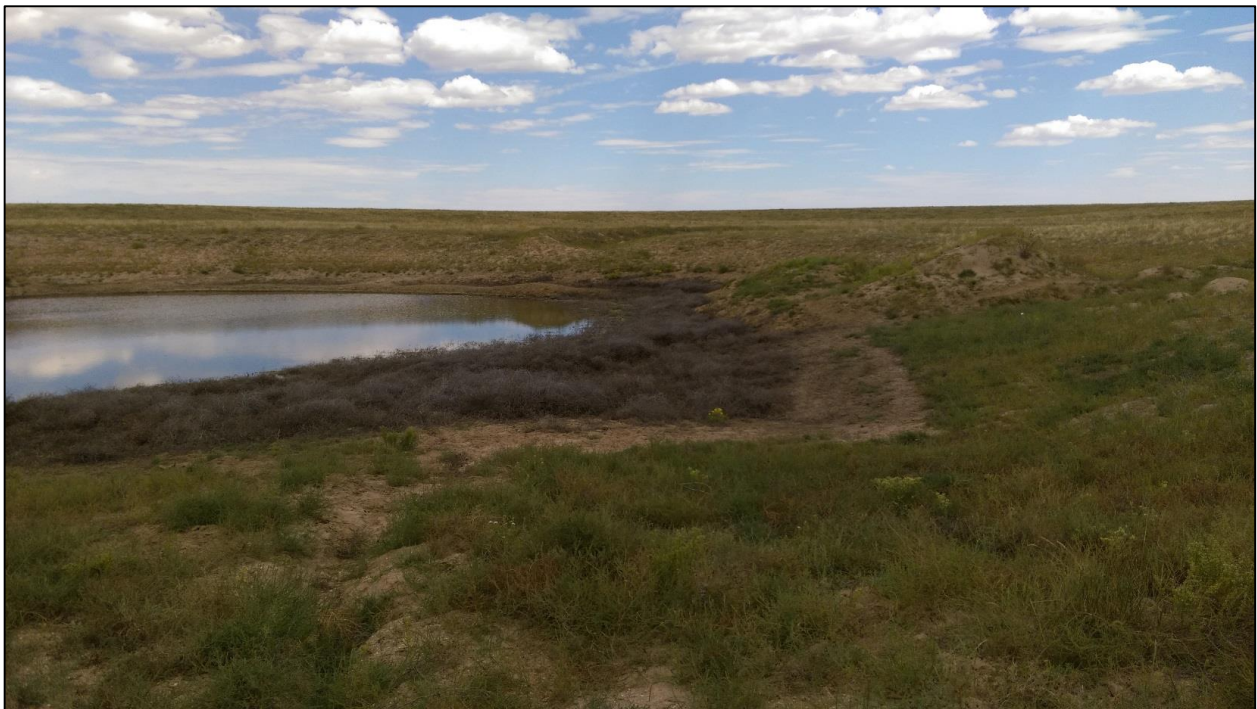
**Photo 6.** View looking northeast from southern pond bank, showing standing water in pit.

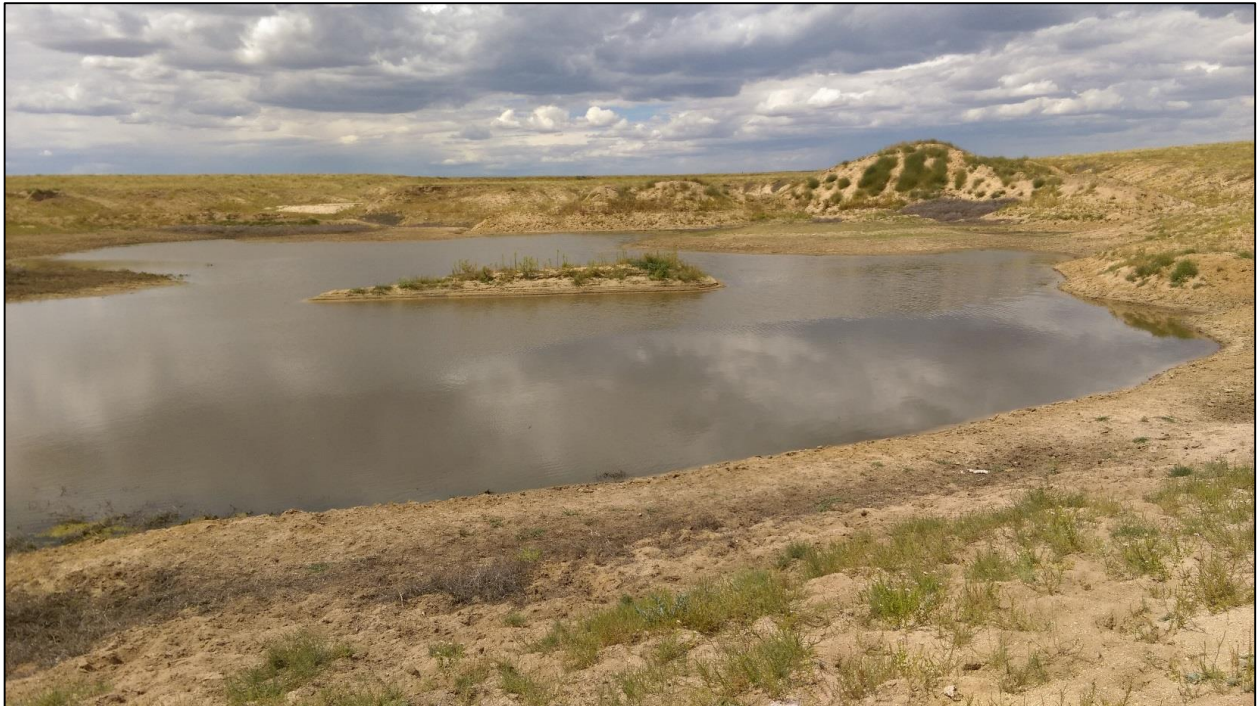
**Photo 7.** View looking southwest from northern pond bank, showing standing water in pit. Note material stockpile stored on pit floor (at right).

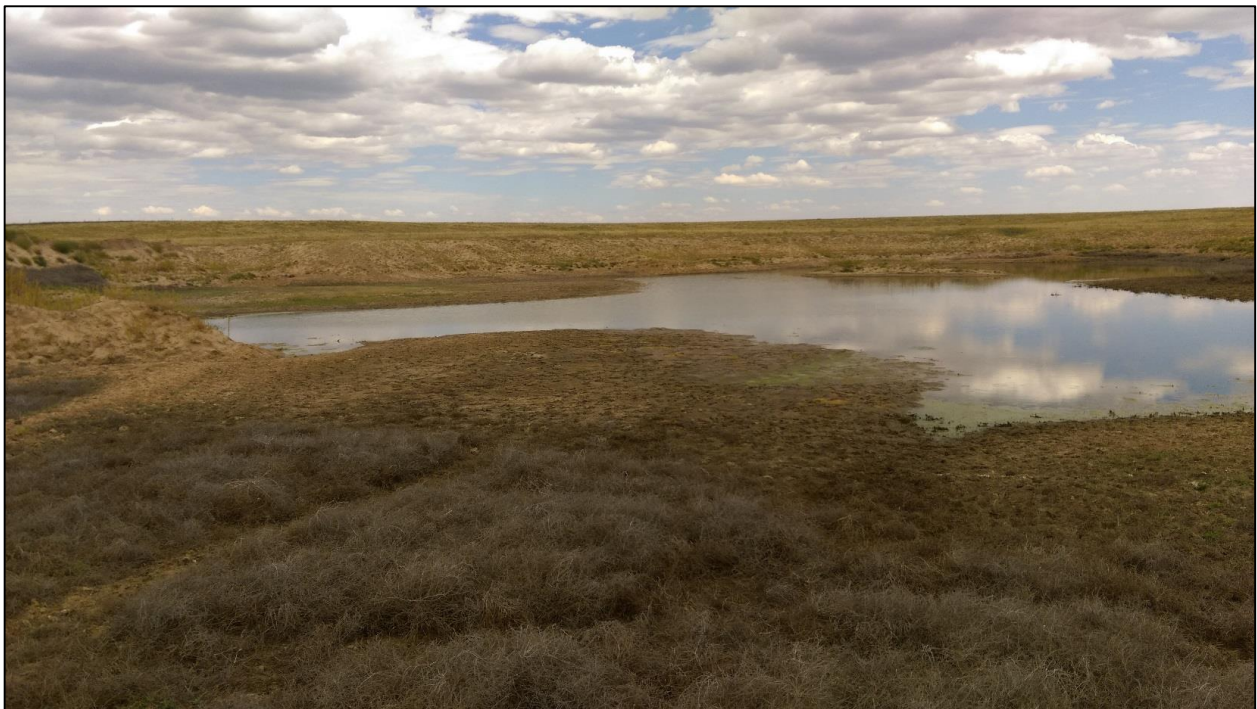
**Photo 8.** View looking east from earthen berm located at western edge of permit area, showing standing water in pit.

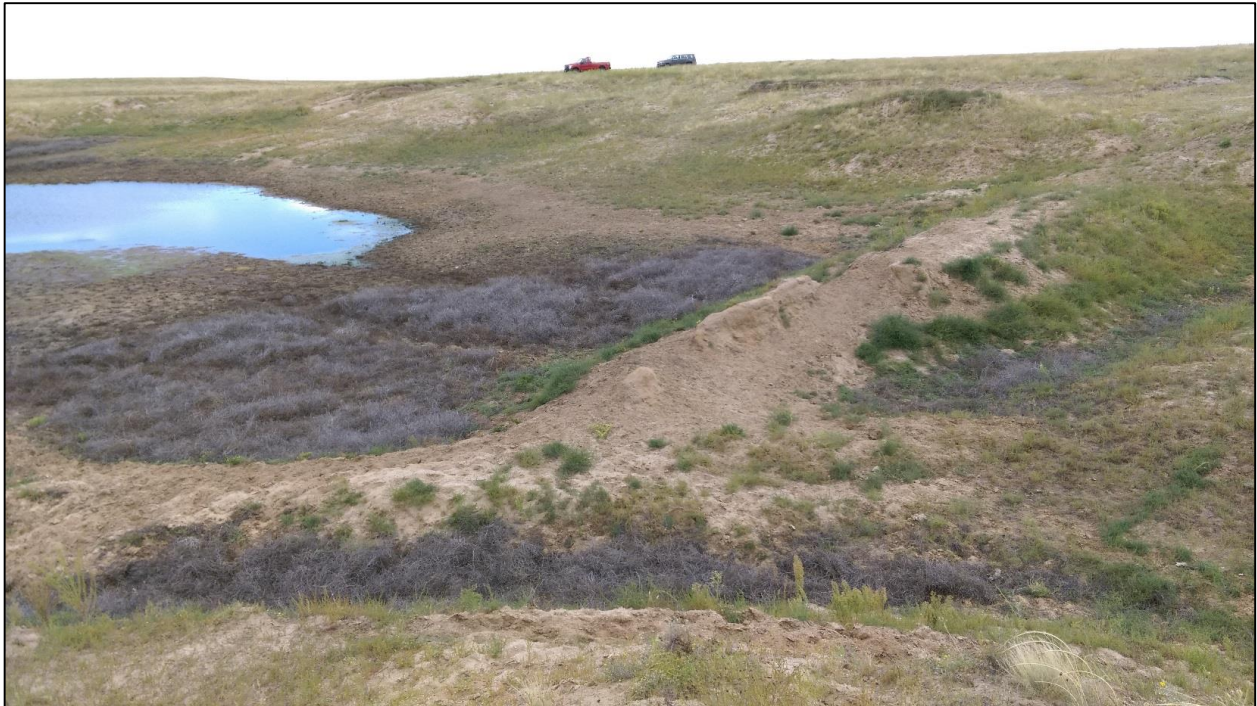
**Photo 9.** View looking southeast, showing damage to earthen berm caused by high flow event(s) in the creek

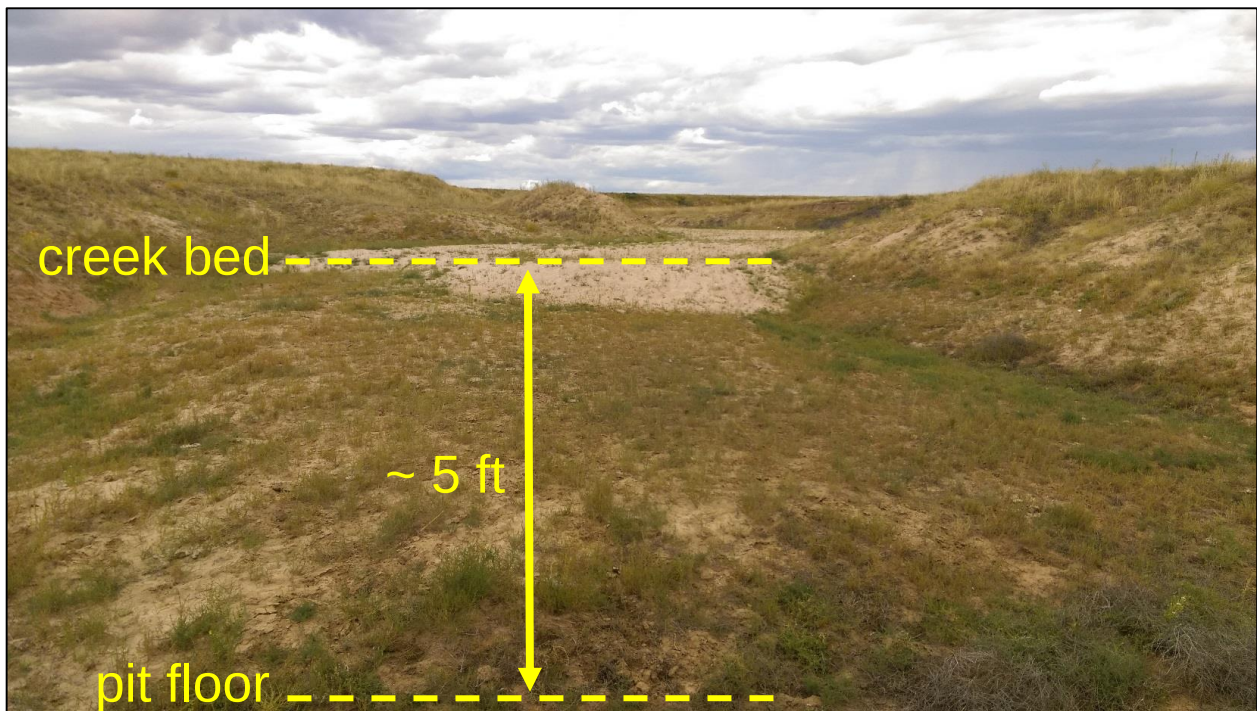
**Photo 10.** View looking upstream from elevation slightly above pit floor, showing elevation of creek bed upstream from site approximately 5 feet higher in elevation than pit floor (indicated). *Note indication is approximate as actual pit floor (behind photographer) is slightly lower than pit floor elevation indicated on photo.*

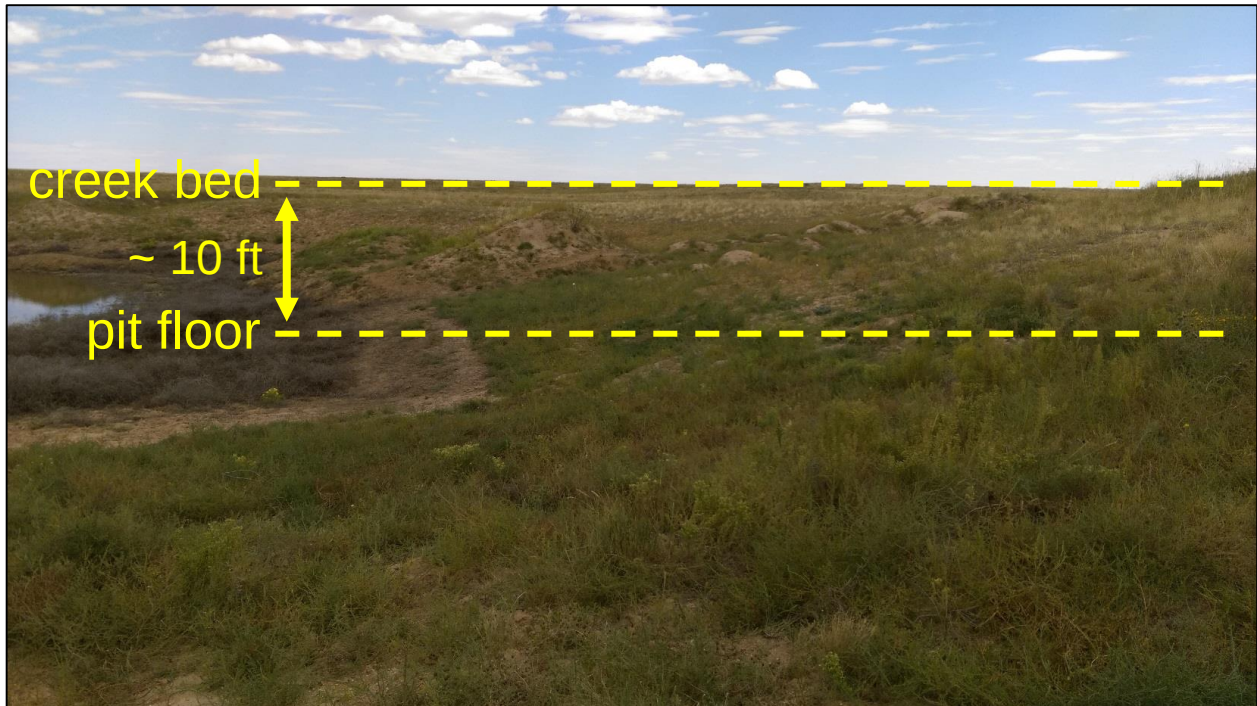
**Photo 11.** View looking east from southern pond bank, showing elevation of creek bed downstream of site approximately 10 feet higher in elevation than pit floor (indicated).

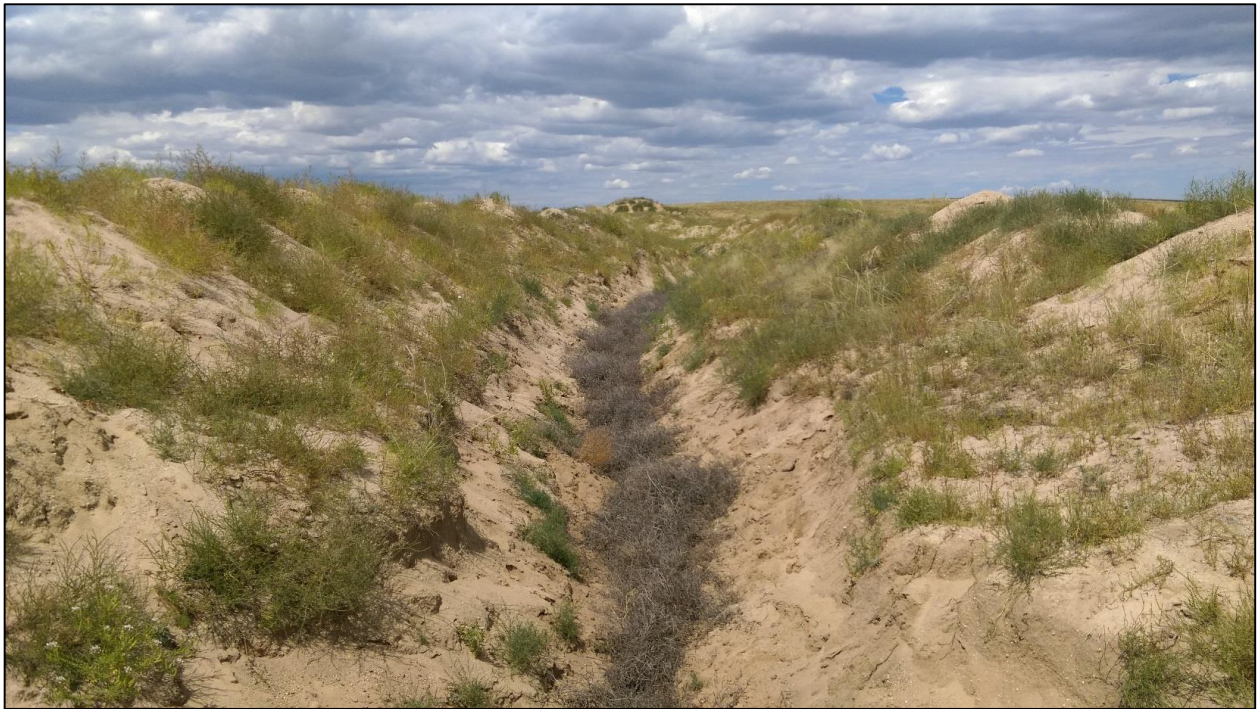
**Photo 12.** View looking upgradient at portion of drainage downstream of pit, located at southeastern edge of permit area. Note upward slope which does not allow for positive drainage of the pit.

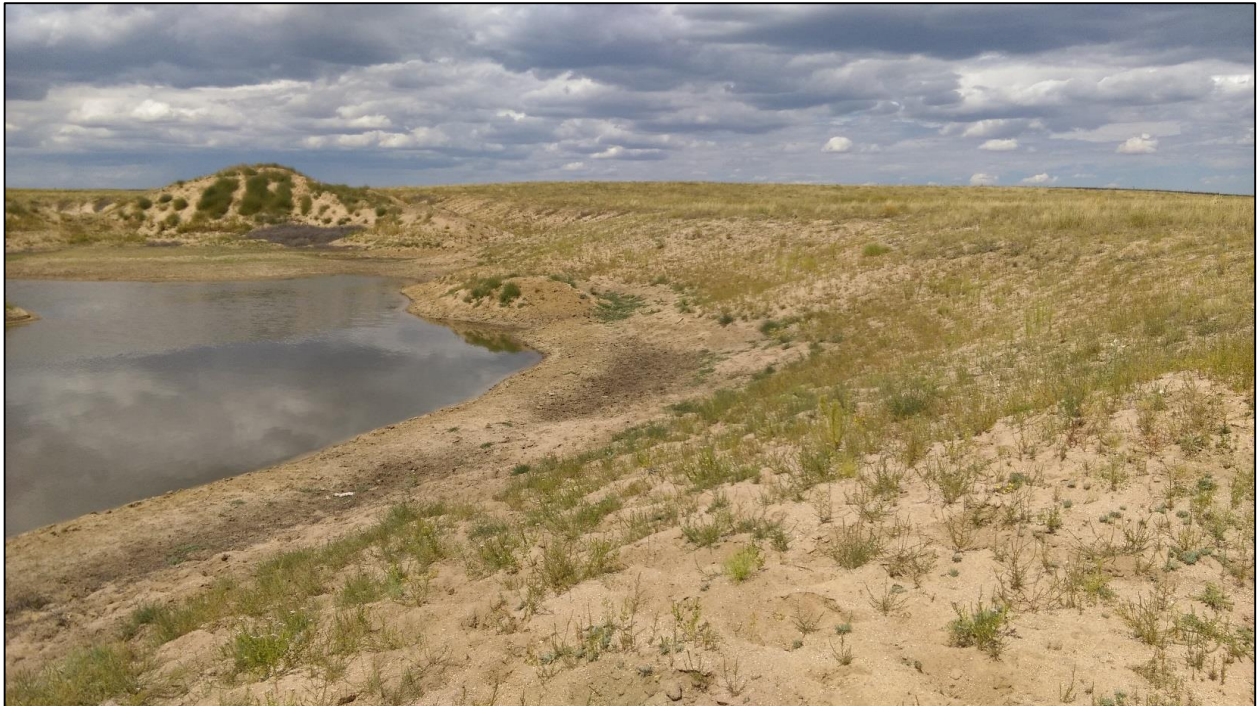
The Division estimates that approximately 6.34 acres have been disturbed by the operation (see enclosed Google Earth image of site). The northern pond bank has been mined to a maximum depth of approximately 10-15 feet. This northern mined wall has been graded to slopes of 3H:1V or flatter (**Photos 13 and 14**). The southern pond bank has slope gradients of mainly 3H:1V, with some slightly steeper portions (**Photo 15**). Mined material is stockpiled on the pit floor, north of the creek (**Photo 16**). No topsoil is stored on site. According to the permit Amendment that was approved by the Division on 02/07/2000 (Revision No. AM-01),

**Photo 13.** View looking west across northern mined bank, showing slopes graded to 3H:1V or flatter.

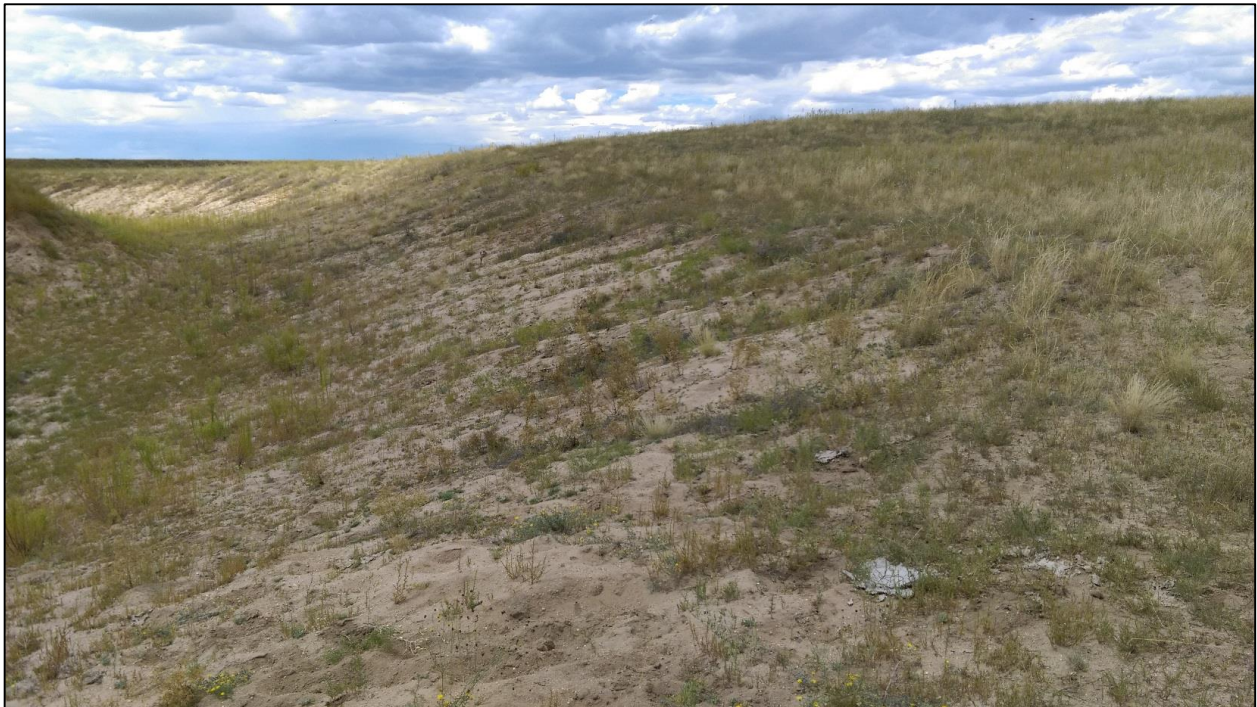
**Photo 14.** View looking southwest across northern mined bank (behind material stockpile), showing slopes graded to 3H:1V or flatter.

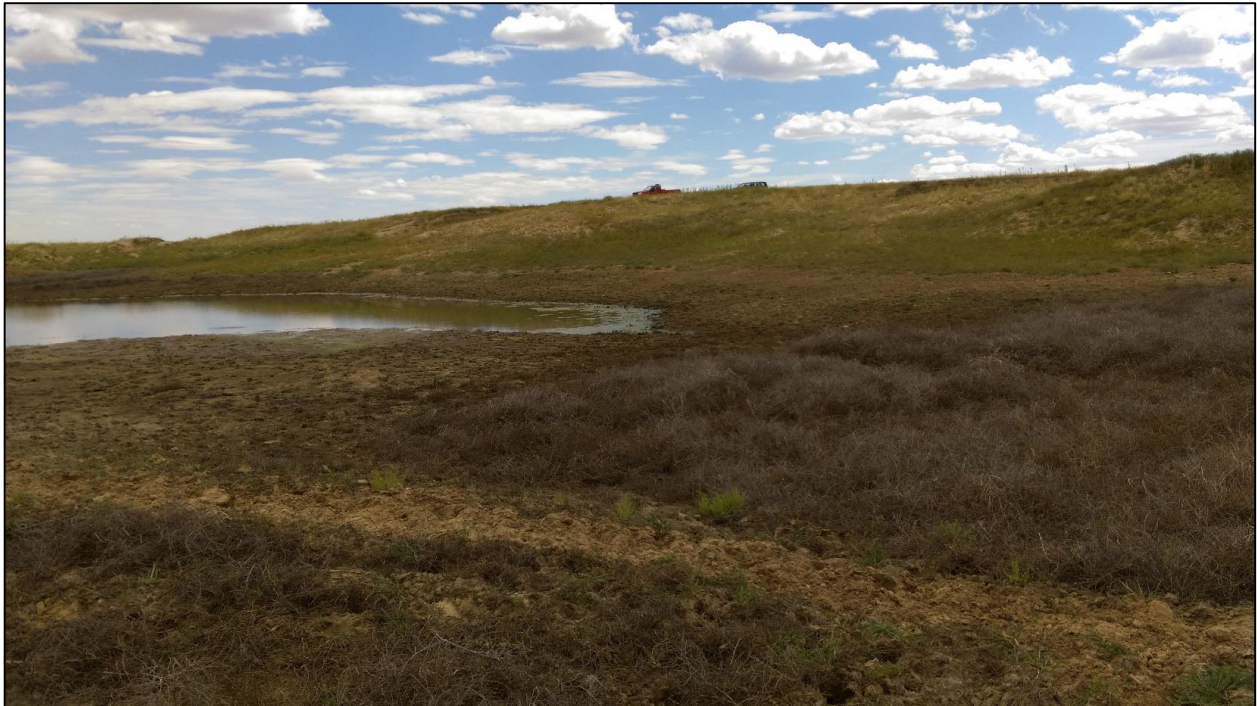
**Photo 15.** View looking southeast across southern pond bank, showing slopes graded mainly to 3H:1V or flatter, with some slightly steeper portions.

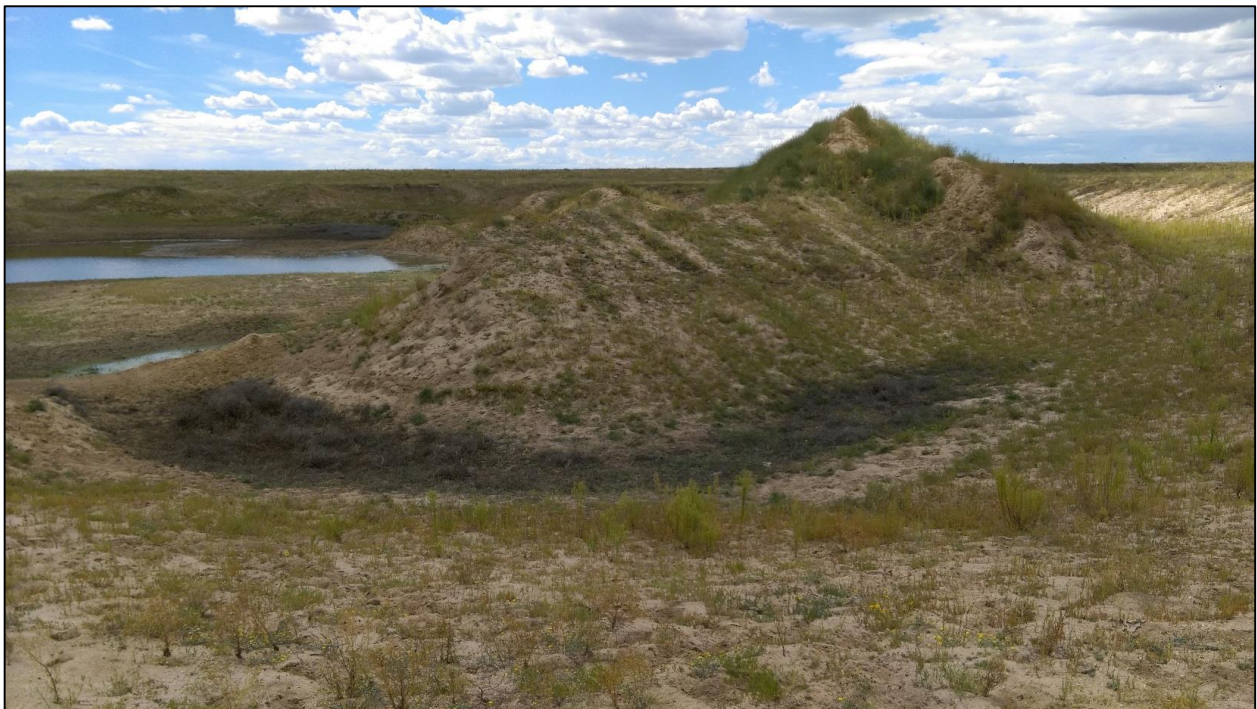
**Photo 16.** View of material stockpile stored on pit floor at northwestern edge of pit.
