COLORADO DIVISION OF RECLAMATION, MINING AND SAFETY
MINERALS PROGRAM INSPECTION REPORT
PHONE: (303) 866-3567

MINE NAME: Willow Creek Mine	MINE/PROSPECTING ID#: M-1983-011	MINERAL: Gold	COUNTY: Lake
INSPECTION TYPE: Monitoring	INSPECTOR(S): Dustin M. Czapla	INSP. DATE: September 2, 2015	INSP. TIME: 13:30
OPERATOR: Mt. Elbert Mining Co., L.L.C.	OPERATOR REPRESENTATIVE:	TYPE OF OPERATION: 112 - Hard Rock Regular Operation

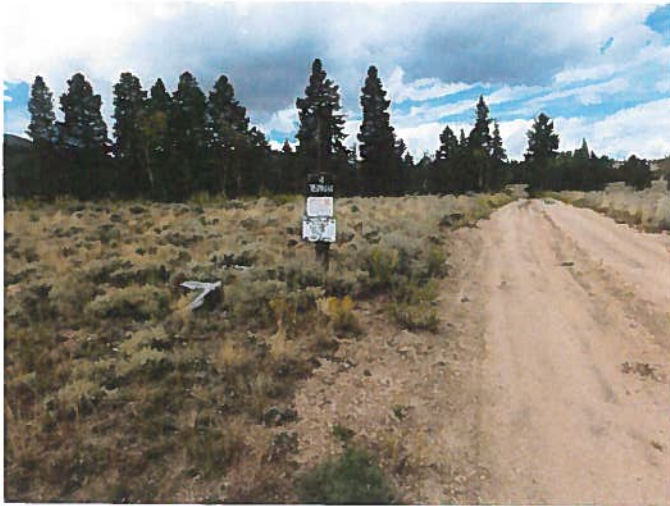
Adequate mine identification signage was noted at the entrance to the site.

Figure 1: Mine entrance

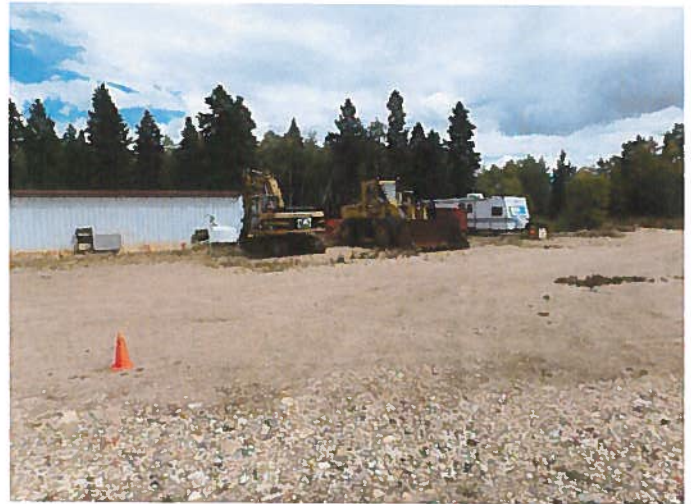
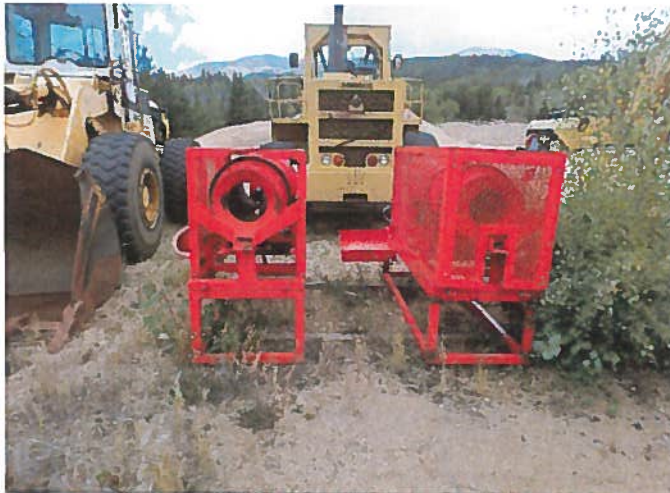
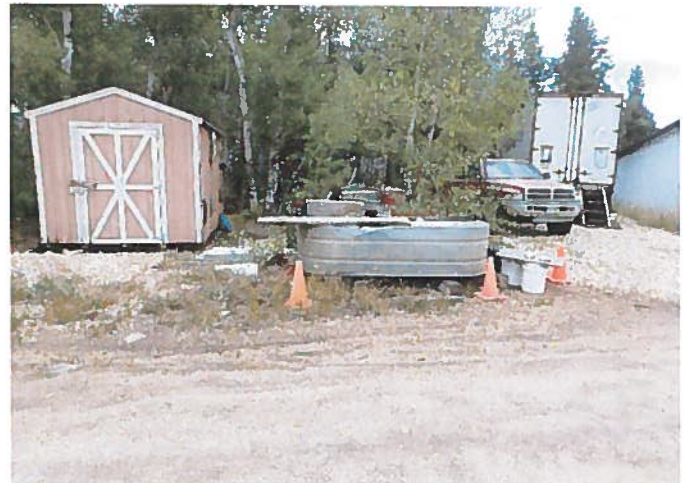
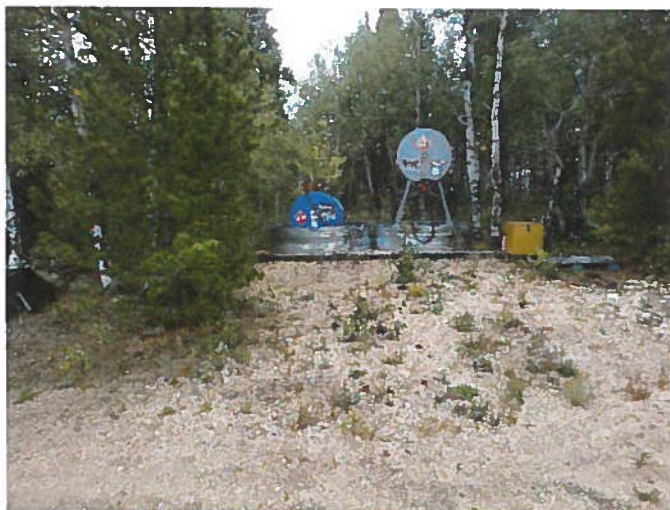
The shop building and shed were locked and appeared secure. No signs of vandalism were evident. An excavator, loaders, camp trailer and other various equipment were parked around the shop area. No equipment leaks were noted. The fuel tanks were placed inside adequate secondary containment. The processing equipment was secure. The generator was locked and the shed was boarded up.

Figure 2: Shop area

Figure 3: Shop area

Figure 4: Shop area

Figure 5: Shop area

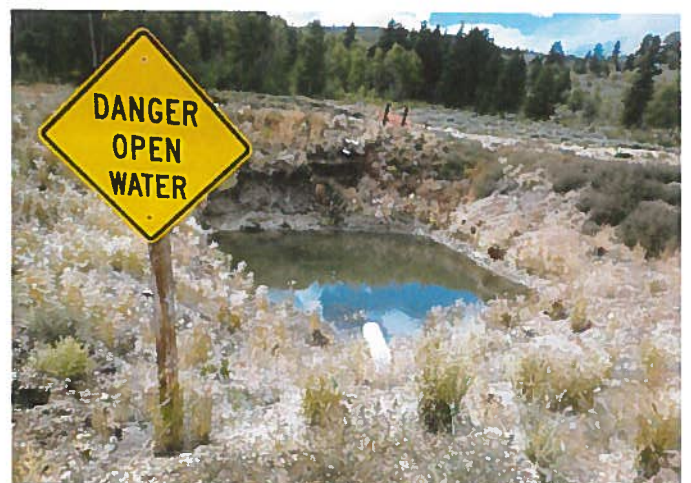
The process ponds contained several feet of water. Seepage from the impoundments was not noted.

Figure 6: Upper pond, on south side of road

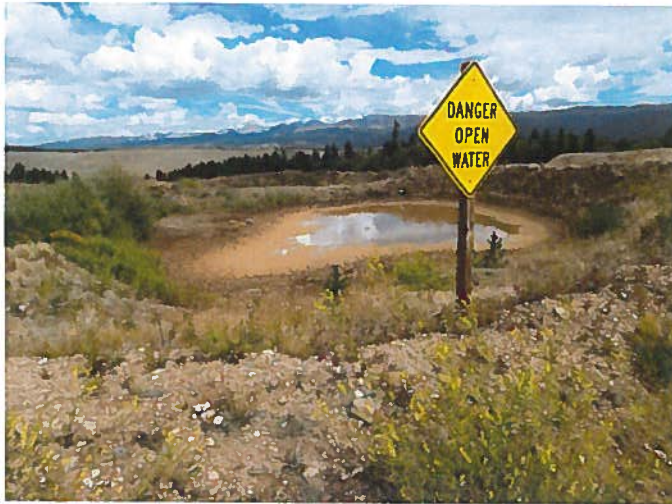
Figure 7: Pond on north side of road

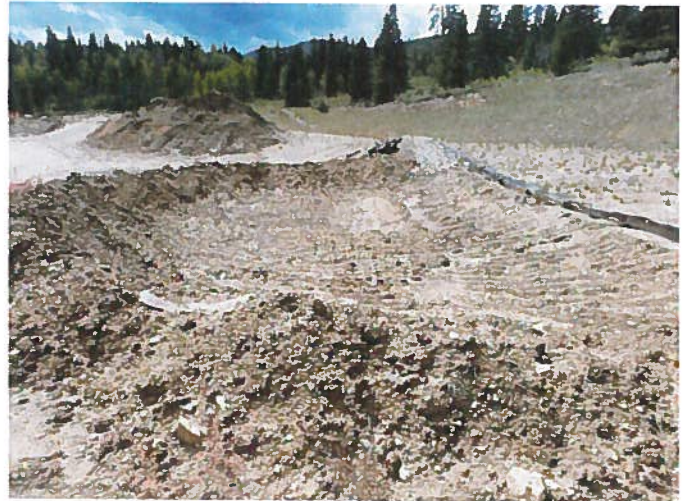
Stormwater control structures have been installed along the USFS boundary. A rip-rap channel and detention pond have been constructed on the north and south sides of the USFS area.

Figure 8: South retention pond at base of USFS slope

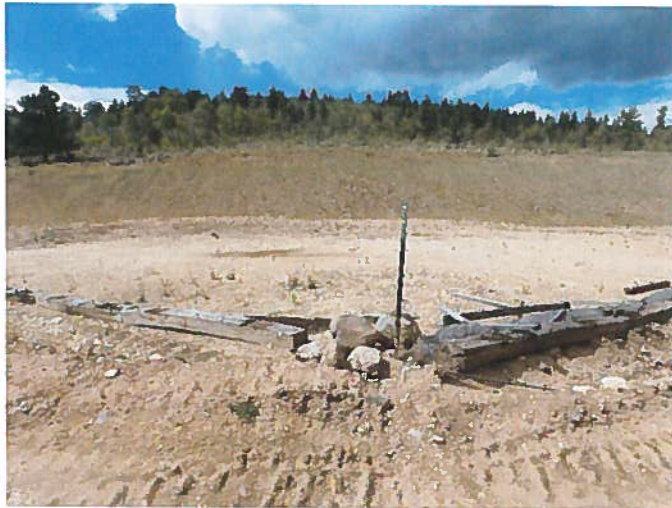
Vegetation is becoming well established on the USFS slope on the west side of the permit area. The USFS area at the base of the slope still requires topsoil and seeding.

Figure 9: Reclaimed USFS slope

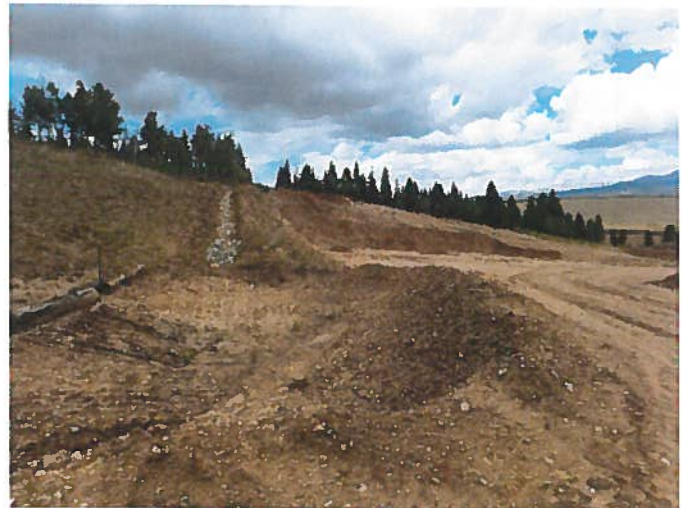
Figure 10: North retention pond at base of USFS slope

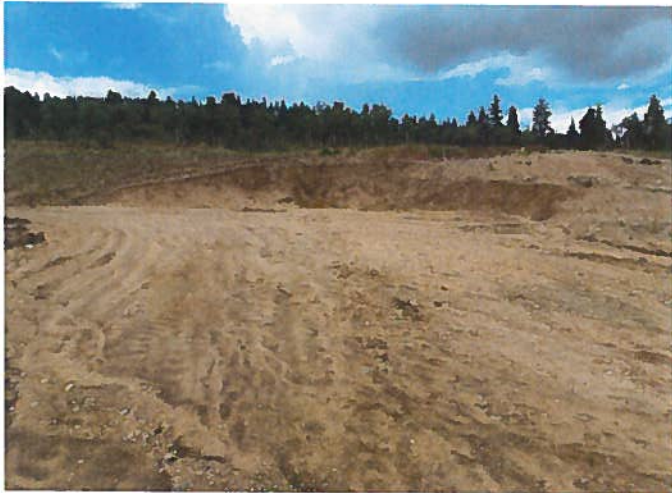
Mining has re-disturbed some of the reclaimed slope on the north side of the USFS area. A highwall approximately 60 feet long by 10 feet high, with a slope approximately 0.5H:1V, has been created. The mining plan requires that all slopes be maintained at 3H:1V or less. If the operator does not comply with this requirement the financial warranty will need to be increased accordingly. A second dig area has been created just north of the process area. The pit slope in this area also exceeds 3H:1V.

Figure 15: Redisturbed slope on north side of USFS slope

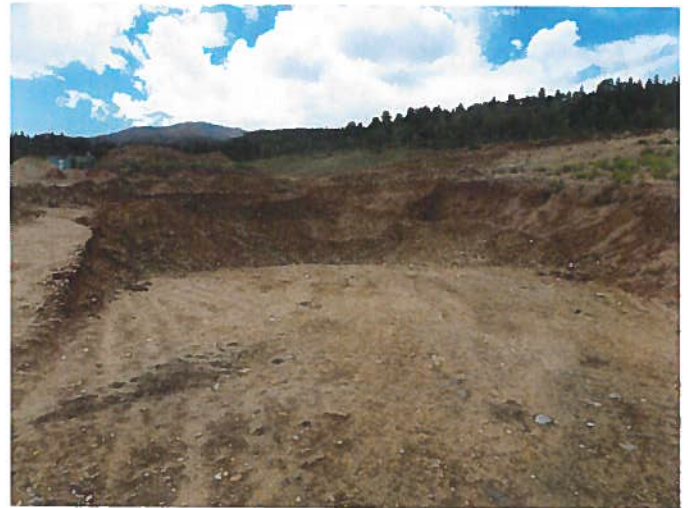
Figure 16: Dig area north of process area

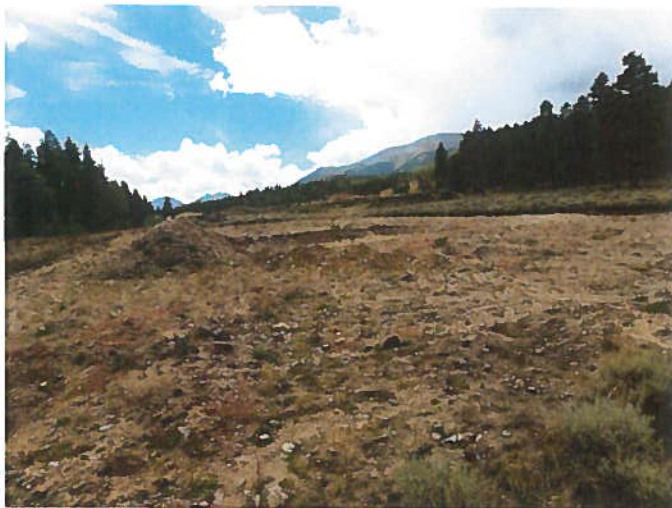
An area of approximately ½ acre in the north part of the permit area has been stripped of topsoil. The topsoil has been stockpiled on the southwest side of this disturbance. The operator should be aware that additional financial warranty will be required prior to mining this area, and prior to opening up any additional mining areas.

Figure 17: North 1/2 acre area stripped of stockpile

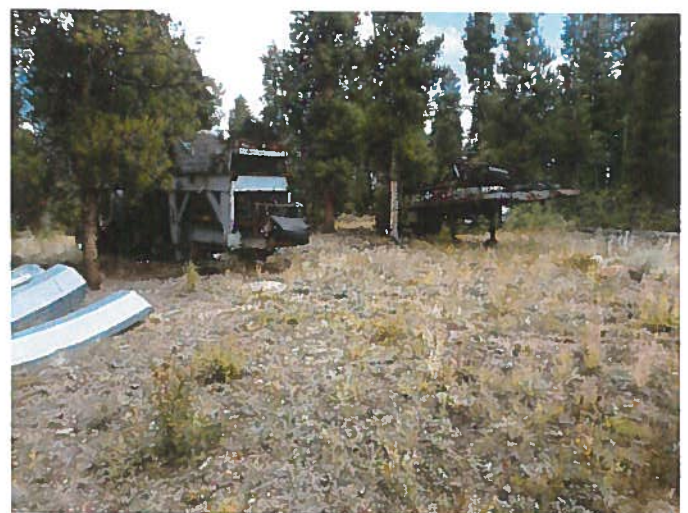
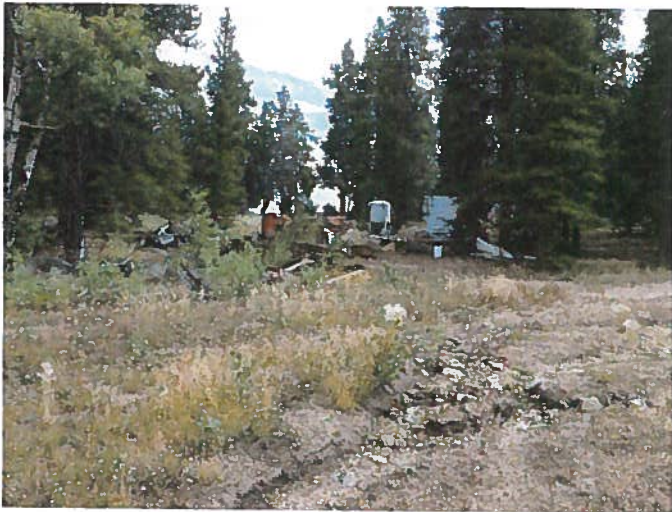
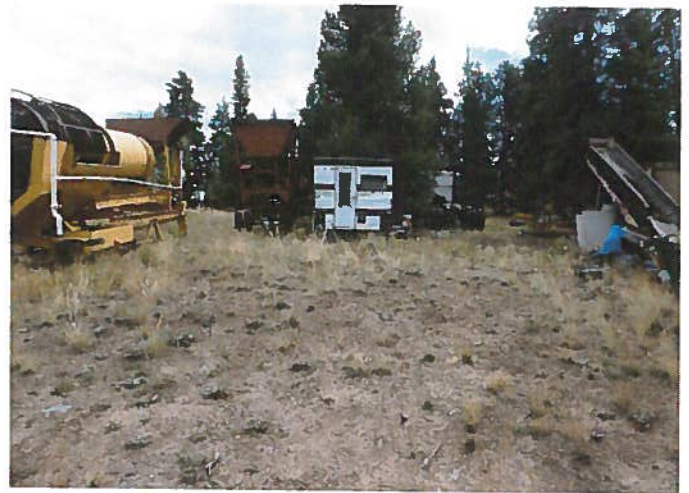
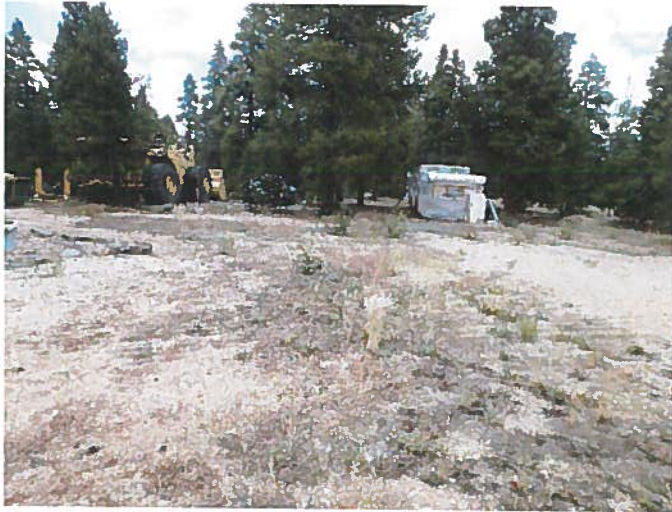
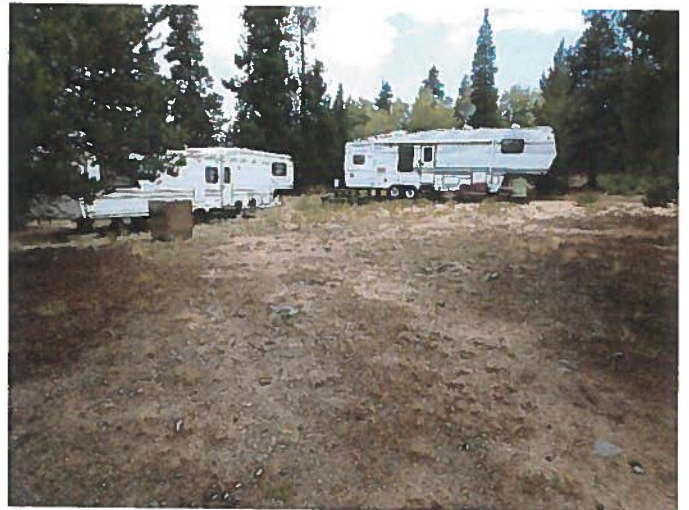
The wooded area on the east side of mining area is still littered with random equipment and junk.

Figure 18: Wooded "junk" area

Figure 19: Wooded "junk" area

Figure 20: Wooded "junk" area

Figure 21: Wooded "junk" area

Figure 22: Wooded "junk" area
