COLORADO DIVISION OF RECLAMATION, MINING AND SAFETY MINERALS PROGRAM INSPECTION REPORT

MINE NAME:	MINE/PROSPECTING ID#:	MINERAL:	COUNTY:
Thank You Lord Claim	M-2013-041	Gemstones	Chaffee
INSPECTION TYPE:	INSPECTOR(S):	INSP. DATE:	INSP. TIME:
Monitoring	Dustin Czapla, Michael Cunningham	September 11, 2015	15:30
OPERATOR:	OPERATOR REPRESENTATIVE:	TYPE OF OPERATION:	
Brian Busse		110(2) - Hard Rock Limited Impact

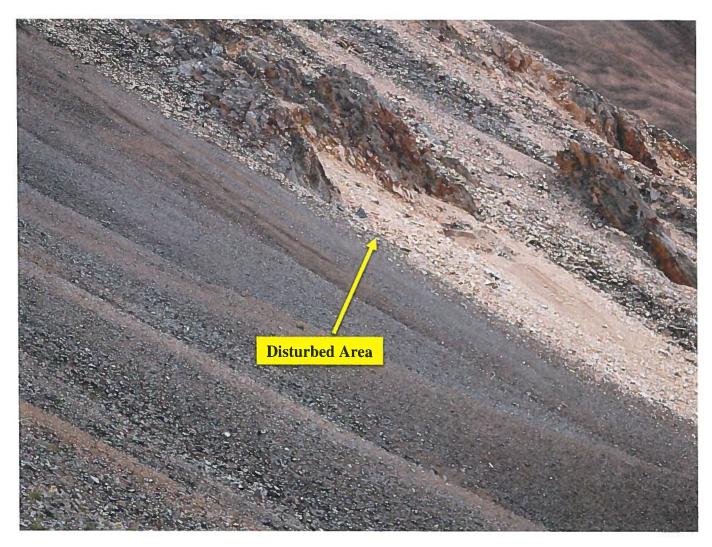
This was a routine monitoring inspection. A representative for the operator was not present. The site was observed from the footpath leading to the site from FR277. The site is located at 38.661536°, -106.263451°, approximately 11.5 miles west of Nathrop at an elevation of 12,300 feet. The site is accessed by foot from FR277. Mining at the site consists of excavating into the talus slope with hand tools. Little to no topsoil or vegetation exists at the site. Less than 0.5 acres appeared to be disturbed. No problems or violations were noted.
