**COLORADO DIVISION OF RECLAMATION, MINING AND SAFETY
MINERALS PROGRAM INSPECTION REPORT**

MINE NAME: Hitch Rack Ranch	MINE/PROSPECTING ID#: P-2014-016	MINERAL: Granite, granite gneiss	COUNTY: El Paso
INSPECTION TYPE: Preoperation Inspection	INSPECTOR(S): Timothy A. Cazier	INSP. DATE: September 18, 2014	INSP. TIME: 15:40
OPERATOR: Transit Mix Concrete Co.	OPERATOR REPRESENTATIVE: Jerald Schnabel	TYPE OF OPERATION: ME - Mineral Exploration

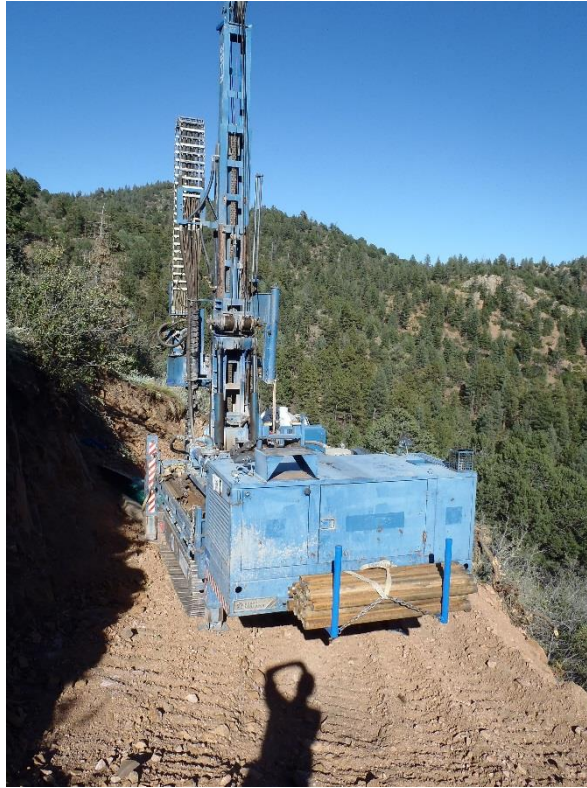
The Division does not require a posted notice for NOIs. A drill rig (see **Photo 1**) was set up at Site B1 at the end of a newly constructed drill road (see **Photo 2**). The drill road was measured (see **Figure 1**). Mr. Schnabel indicated (as stated in the NOI application) that some of the drill roads would be kept for ranch access.

Photo 1. Drill rig at site B1 (looking east).

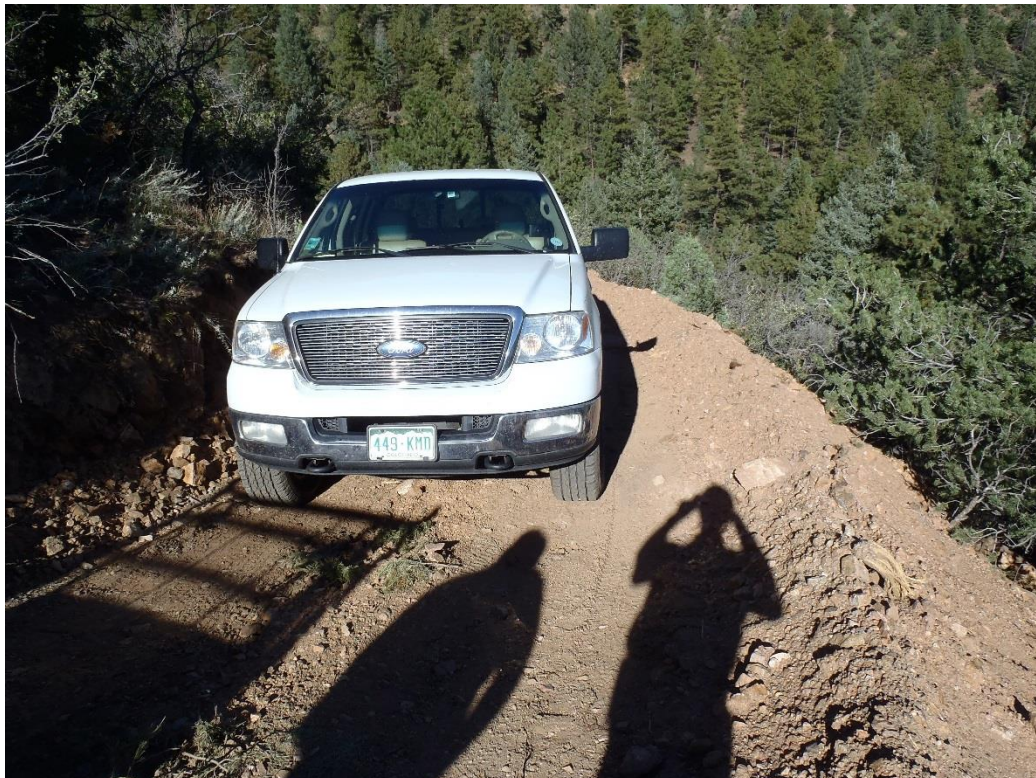
Photo 2. Typical drill road (looking east).
