# COLORADO DIVISION OF RECLAMATION, MINING AND SAFETY MINERALS PROGRAM INSPECTION REPORT

MINE NAME:	MINE/PROSPECTING ID#:	MINERAL:	COUNTY:
Whirlwind Mine	M-2007-044	Uranium and vanadio	Mesa
INSPECTION TYPE:	INSPECTOR(S):	INSP. DATE:	INSP. TIME:
Monitoring	Stephanie J. Mitchell	August 11, 2015	09:00
OPERATOR:	OPERATOR REPRESENTATIVE:	TYPE OF OPERATION:	
Energy Fuels Resources (USA) Inc.	Race Fisher and Todd Eldridge	112d-1 - Designated Mining Operation

PERMIT #: M-2007-044 INSPECTOR'S INITIALS: SJM INSPECTION DATE: August 11, 2015

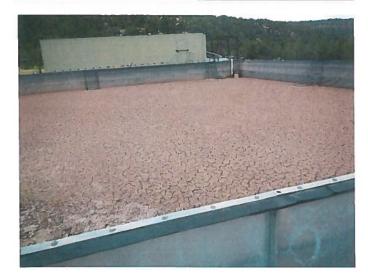
Bench where portal is located

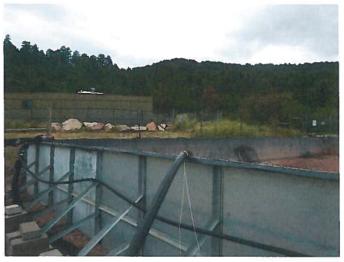
Waste Rock Pile beyond Fence

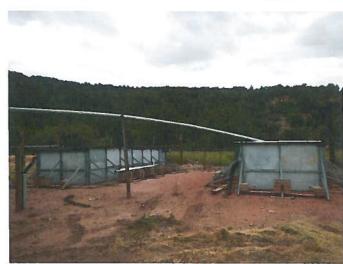
Packrat Portal
