COLORADO DIVISION OF RECLAMATION, MINING AND SAFETY
MINERALS PROGRAM INSPECTION REPORT
PHONE: (303) 866-3567

MINE NAME: Moores Pit	MINE/PROSPECTING ID#: M-1980-178	MINERAL: Sand and gravel	COUNTY: Mesa
INSPECTION TYPE: Monitoring	INSPECTOR(S): Stephanie J. Mitchell	INSP. DATE: August 11, 2015	INSP. TIME: 14:00
OPERATOR: Moores Mining, LLC	OPERATOR REPRESENTATIVE: Leon Moore	TYPE OF OPERATION: 112c - Construction Regular Operation

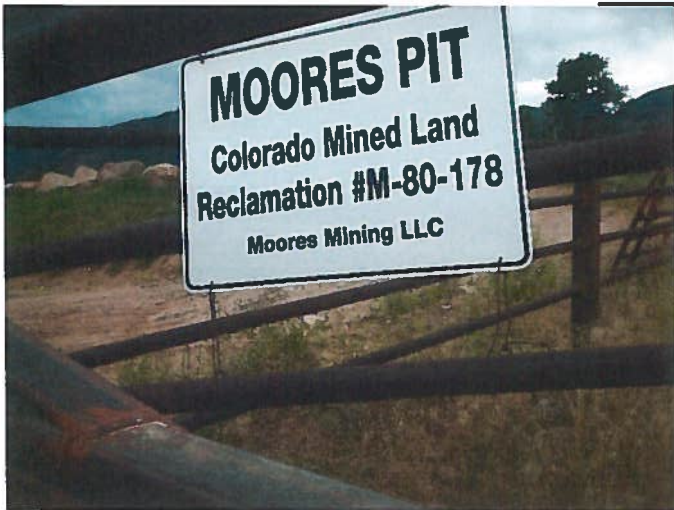
The permit area for this site is designated as 34.2 acres. The Moore's Pit is a 112c gravel pit. The post mine land used designated for this site is Rangeland. The proper mine identification sign was in place, and the entire permit boundary was walked, and all the corners of the permit area were marked with posts and delineated with a fence.

Mine ID Sign

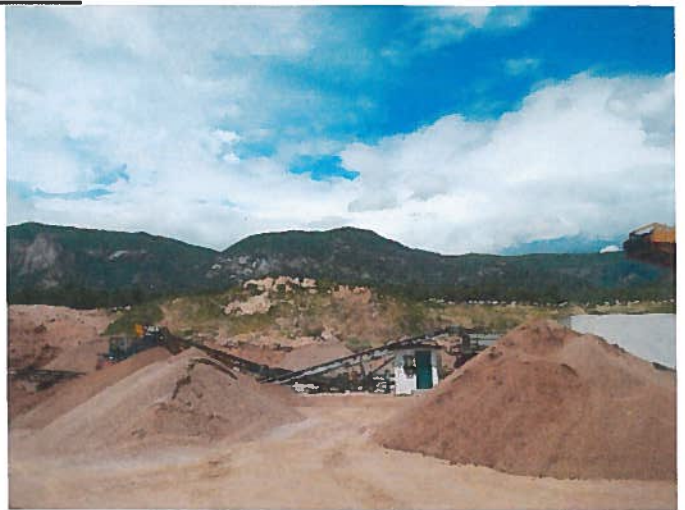
The site is currently active with crushing equipment on site as well as loaders and excavators. Fuel is being stored with adequate secondary containment structures in place. The Highwall is appears to be 50' feet in depth. Overburden stockpile are stable. Mining is moving to the west.

Crushing Equipment

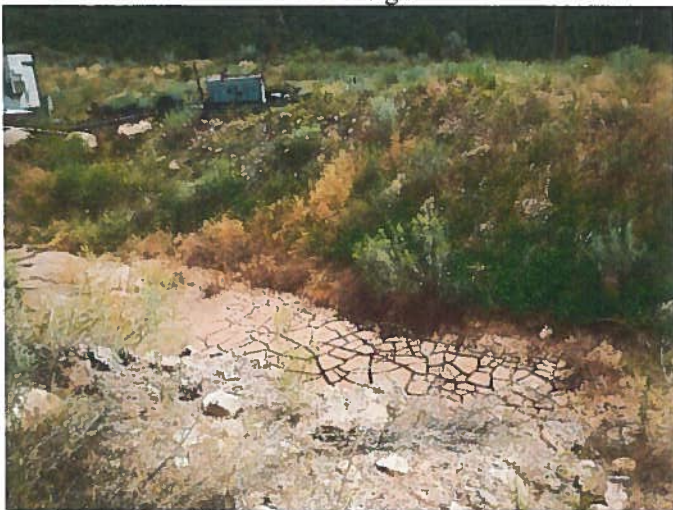
Stormwater Protection- Less than 72 hr retention

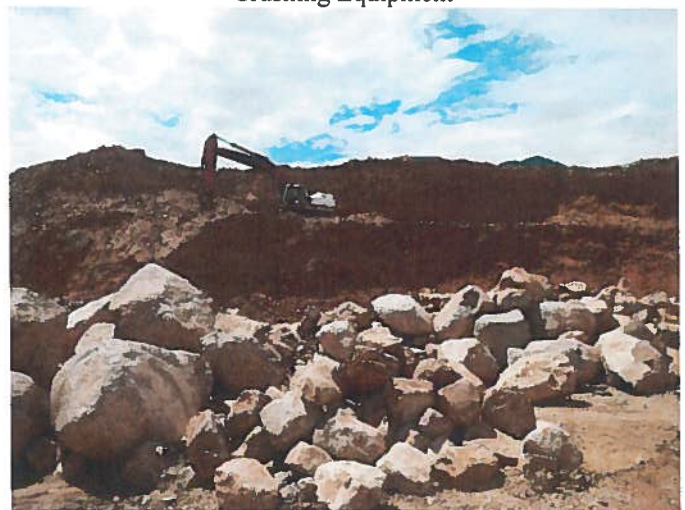
Highwall- Benched

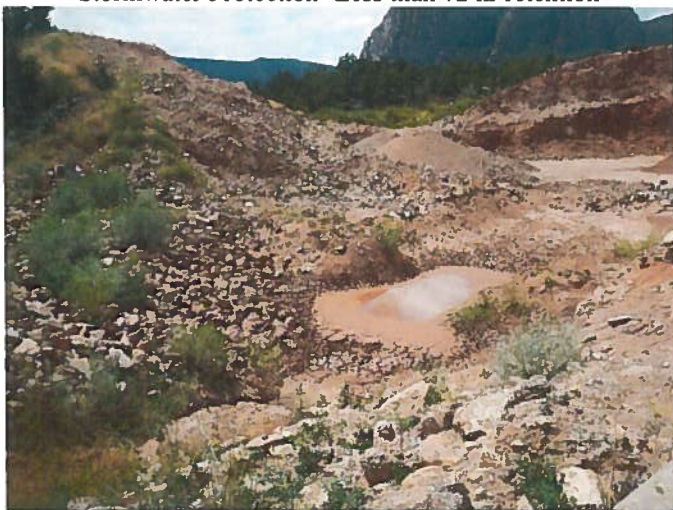
Stormwater Protection- Less than 72 hr retention

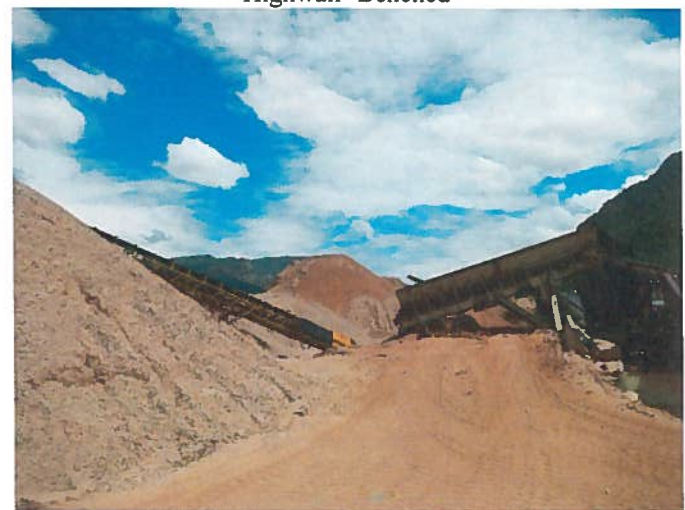
Material Stockpiles

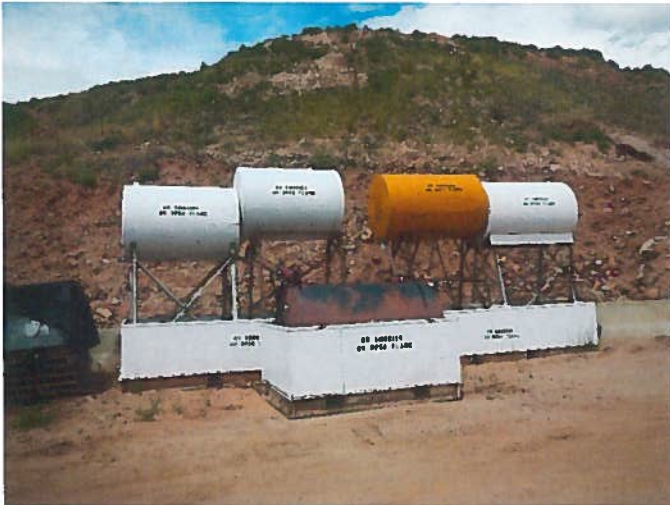
Fuel Storage

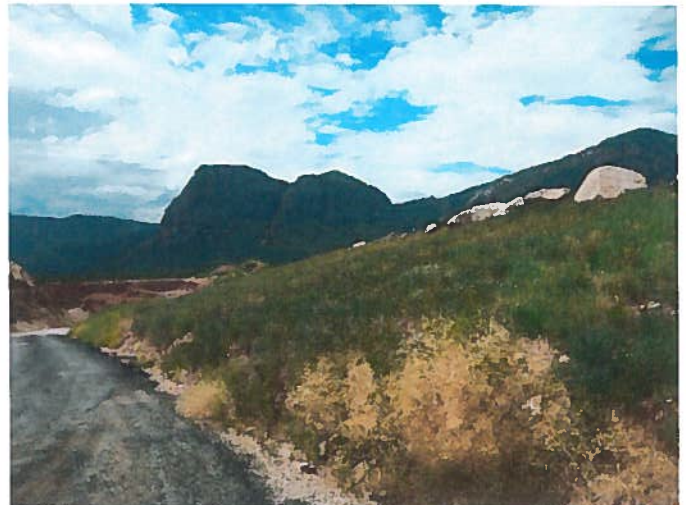
The northeast area of the permit area has been graded to a 3:1 slope and revegetated. Vegetation is becoming well established.

Reclaimed Slope

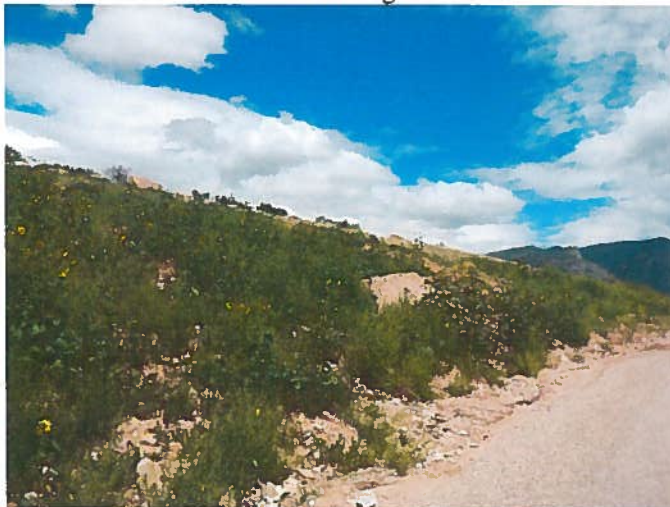
3:1 reclaimed slope- north side of permit area

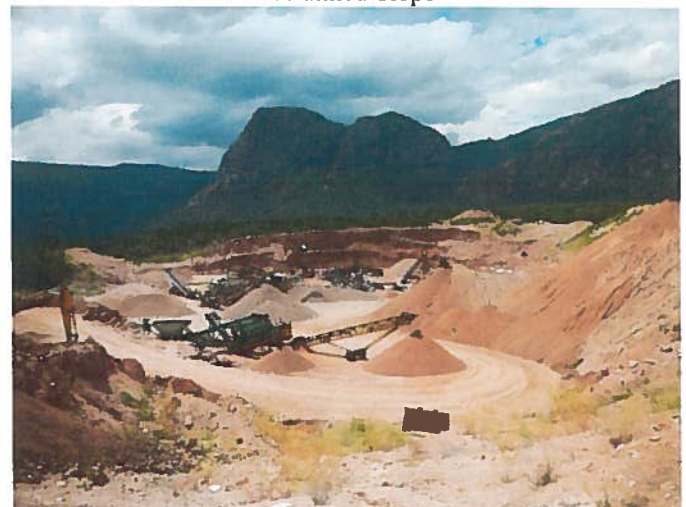
Overall Site
