COLORADO DIVISION OF RECLAMATION, MINING AND SAFETY
MINERALS PROGRAM INSPECTION REPORT
PHONE: (303) 866-3567

MINE NAME: Toltec No 2	MINE/PROSPECTING ID#: M-1984-039	MINERAL: Silver, gold, copper,	COUNTY: San Juan
INSPECTION TYPE: Monitoring	INSPECTOR(S): Lucas J. West	INSP. DATE: September 10, 2015	INSP. TIME: 08:15
OPERATOR: Wilbur F Benham	OPERATOR REPRESENTATIVE: John	TYPE OF OPERATION: 110(2) - Hard Rock Limited Impact	
REASON FOR INSPECTION: Normal I&E Program	BOND CALCULATION TYPE: BC- Complete Bond Calculation	BOND AMOUNT: \$2,500.00	
DATE OF COMPLAINT: NA	POST INSP. CONTACTS: None	JOINT INSP. AGENCY: None	
WEATHER: Clear	INSPECTOR'S SIGNATURE:

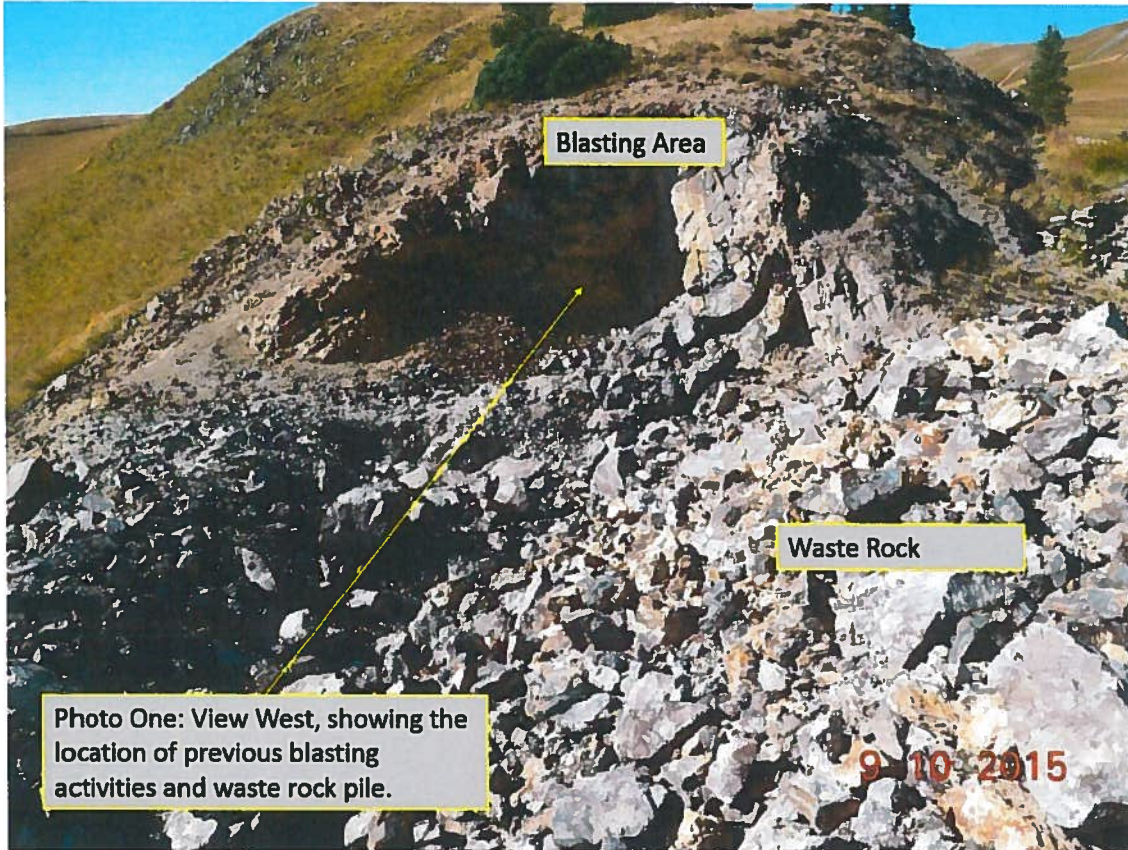
As seen in Photo One, mining is being conducted by blasting the face of an exposed rock outcrop creating a highwall and separating the material into ore, and waste rock piles. Photos Two and Three, show the stockpiles located on site. In Discussions with Mr. Benham, The Operator, he indicated that in the spring of 2015, a significant amount of his ore stockpile had been mistakenly taken and used for road base by a nearby landowner. The site shows no sign of recent activity and was confirmed by the Operator that little activity

had taken place during the 2015 mining season. The overall footprint of the site was in good condition, free from trash and debris. The highwall, approximately 20 Ft. high, as well as the waste rock pile are stable and show no signs of erosion. No noxious weeds were observed at this time.

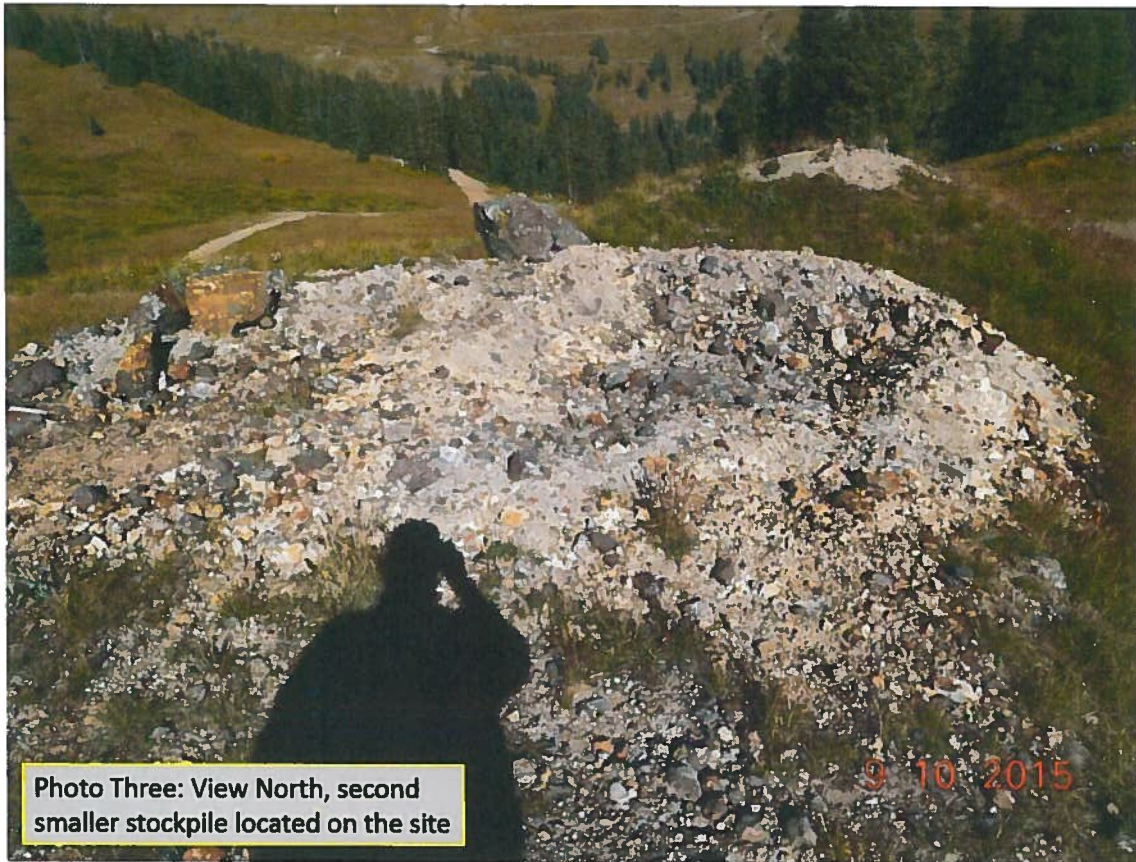
Photo Three: View North, second smaller stockpile located on the site

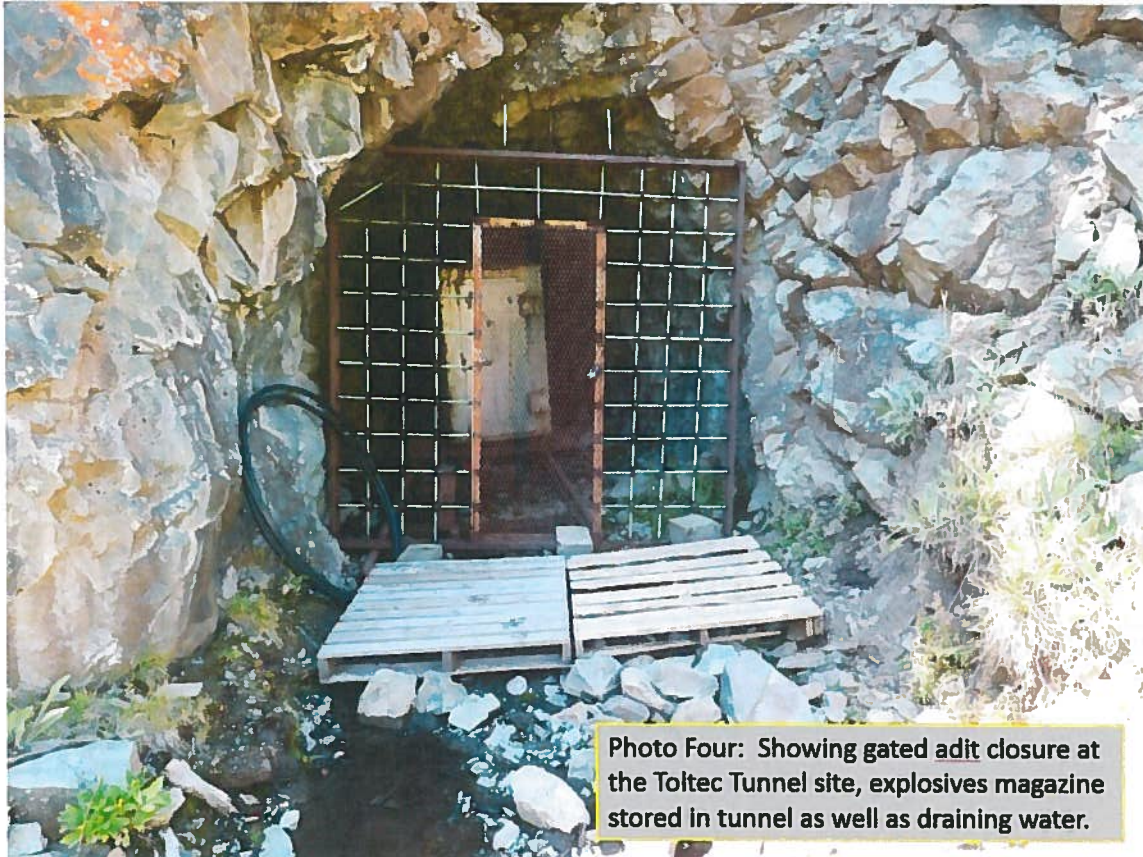
The Operator is using the Toltec Tunnel area, located on County Road 2 at approximately 10,600ft in elevation, as a staging, encampment area and intended processing area. The area contains a fifth-wheel camper, an outhouse, various debris, explosive and detonator magazines which are stored in the tunnel behind a locked gate as seen in Photo Four. Conversations with the Operator, indicated that he had recently acquired the necessary equipment to set up a gravity separation milling process in the area. The equipment, as seen in Photos Five and Six was not active, nor set up at the time of the inspection. Equipment includes various types of crushers, screens and a sluice box approximately 15 Ft. in Length. According to permitting documentation the area is owned by the operator. Also shown in Photo Four is the tunnel, which is a preexisting disturbance and is discharging water at a rate of less than five Gallons per Minute. No milling was identified in any of the permitting documents nor existing revisions to the permit. Given the geochemistry of the area and the nature of the proposed milling operations, according to Rule 1.1 (14) the site would then be considered a Designated Mining Operation and compliance requirements outlined in Rule 7 of the Hard Rock and Metals Mining Rules shall be complied with.

Photo Four: Showing gated adit closure at the Toltec Tunnel site, explosives magazine stored in tunnel as well as draining water.

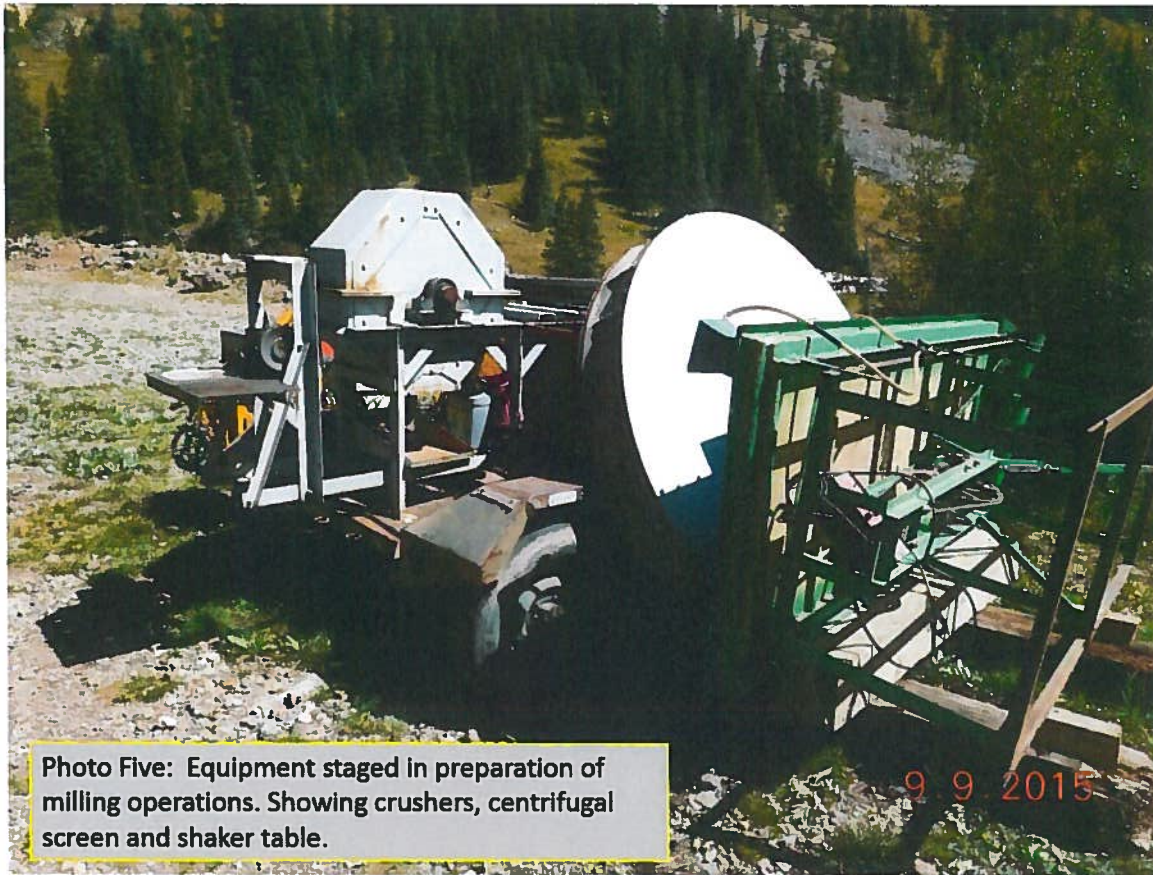
Photo Five: Equipment staged in preparation of milling operations. Showing crushers, centrifugal screen and shaker table.

In order to avoid any future problems or possible violations the operator must submit and receive Division approval of the Amendment to the permit, Environmental Protection Plan and the appropriate financial warranty must be in place prior to the installation and operation of the mill facility.

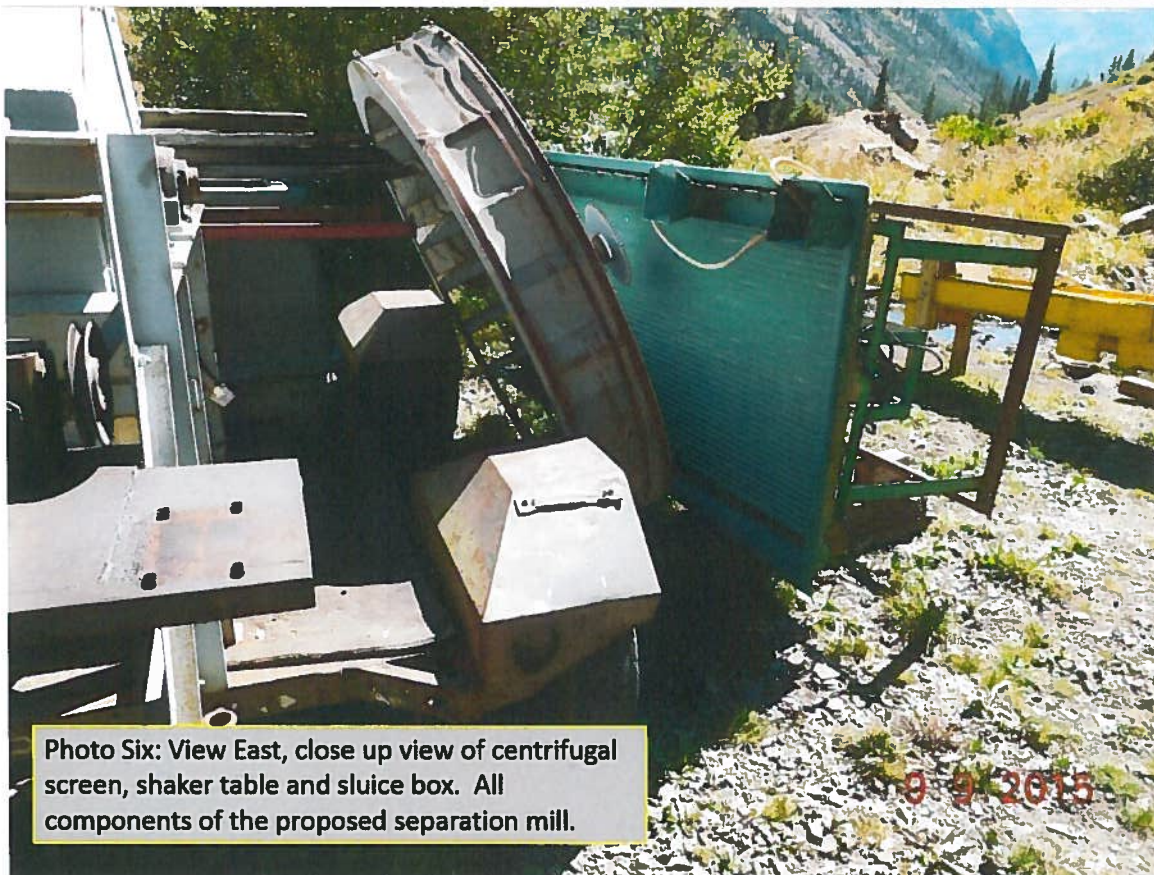
Photo Six: View East, close up view of centrifugal screen, shaker table and sluice box. All components of the proposed separation mill.
