COLORADO DIVISION OF RECLAMATION, MINING AND SAFETY
MINERALS PROGRAM INSPECTION REPORT
PHONE: (303) 866-3567

MINE NAME: Midway Pit	MINE/PROSPECTING ID#: M-1988-018	MINERAL: Sand and gravel	COUNTY: El Paso
INSPECTION TYPE: Monitoring	INSPECTOR(S): Timothy A. Cazier	INSP. DATE: September 25, 2014	INSP. TIME: 09:55
OPERATOR: Midway Aggregates, RLLP	OPERATOR REPRESENTATIVE: Joe Baxter & Leonard Read	TYPE OF OPERATION: 112c - Construction Regular Operation	
REASON FOR INSPECTION: Normal I&E Program	BOND CALCULATION TYPE: Complete Bond	BOND AMOUNT: \$40,000.00	
DATE OF COMPLAINT: NA	POST INSP. CONTACTS: None	JOINT INSP. AGENCY: None	
WEATHER: Clear	INSPECTOR'S SIGNATURE:

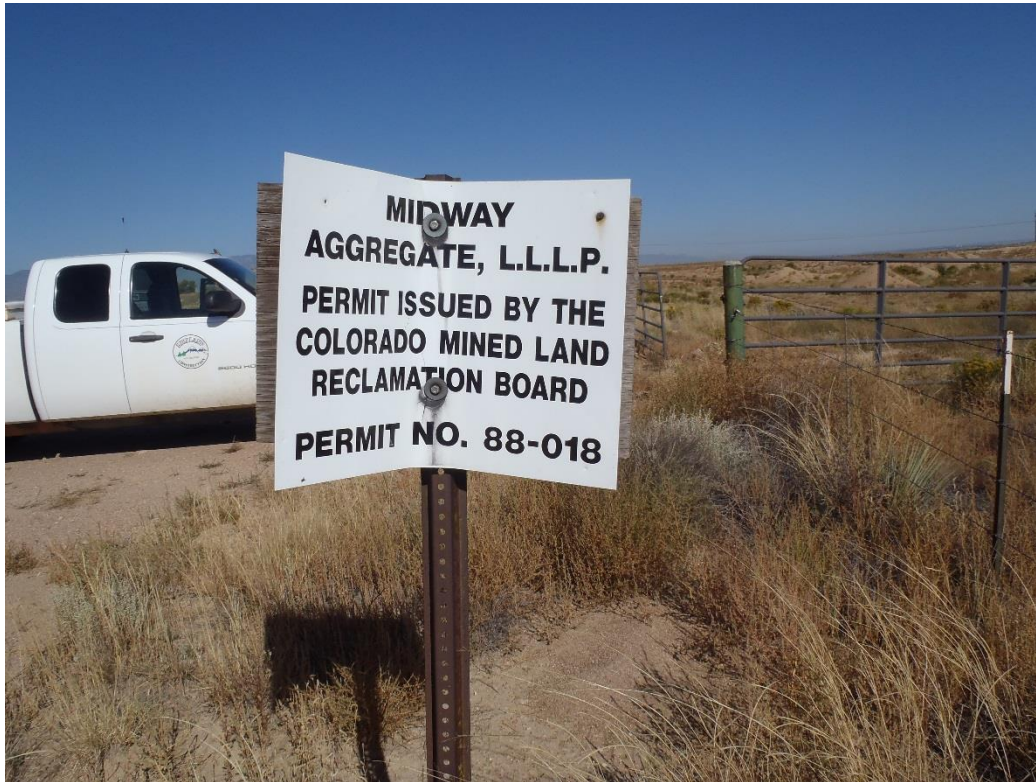
Photo 1. Permit identification sign.

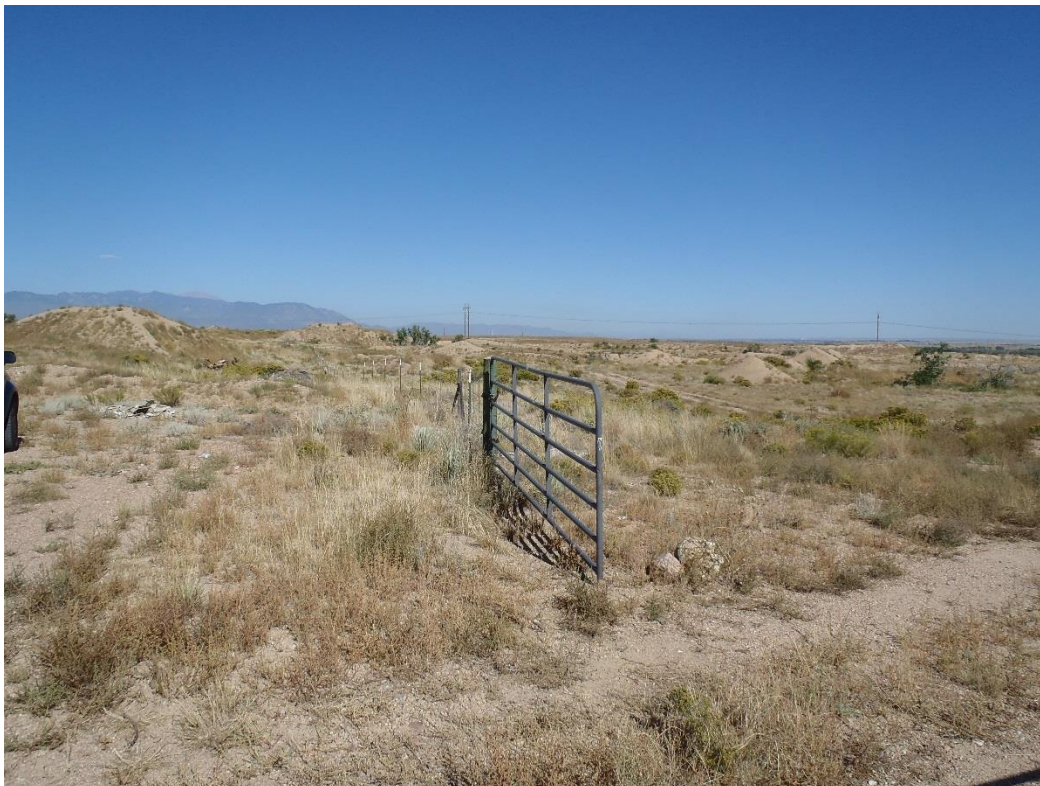
Photo 2. Typical boundary fence (south side looking NW).

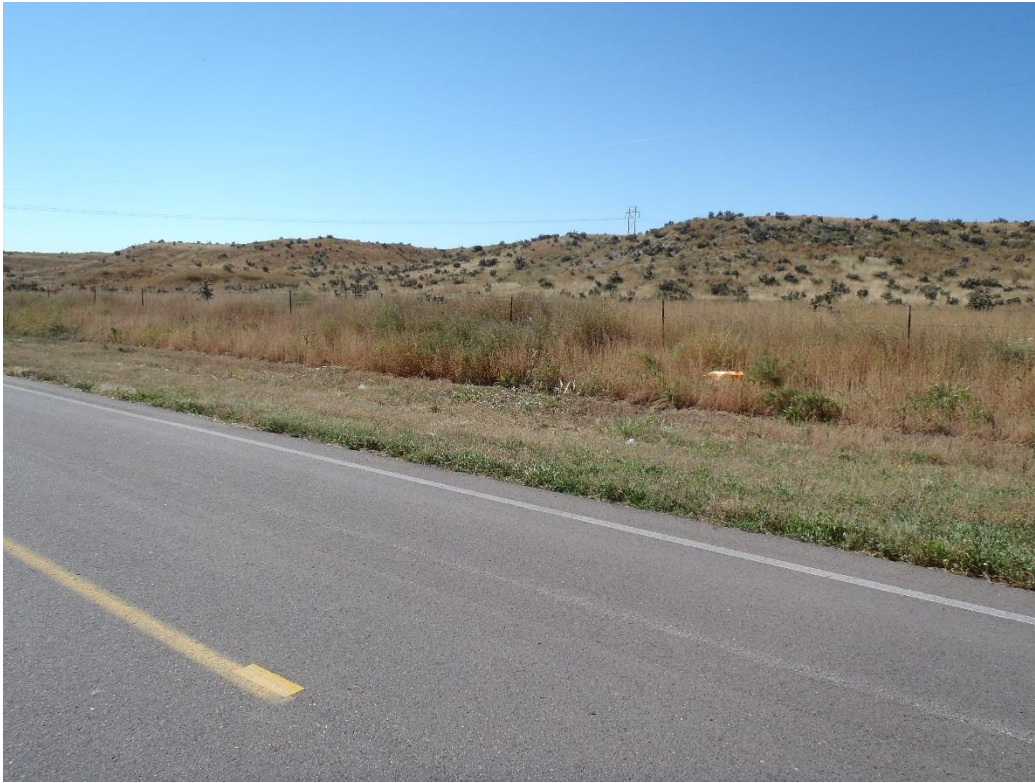
Photo 3. Typical boundary fence (east side looking SW).

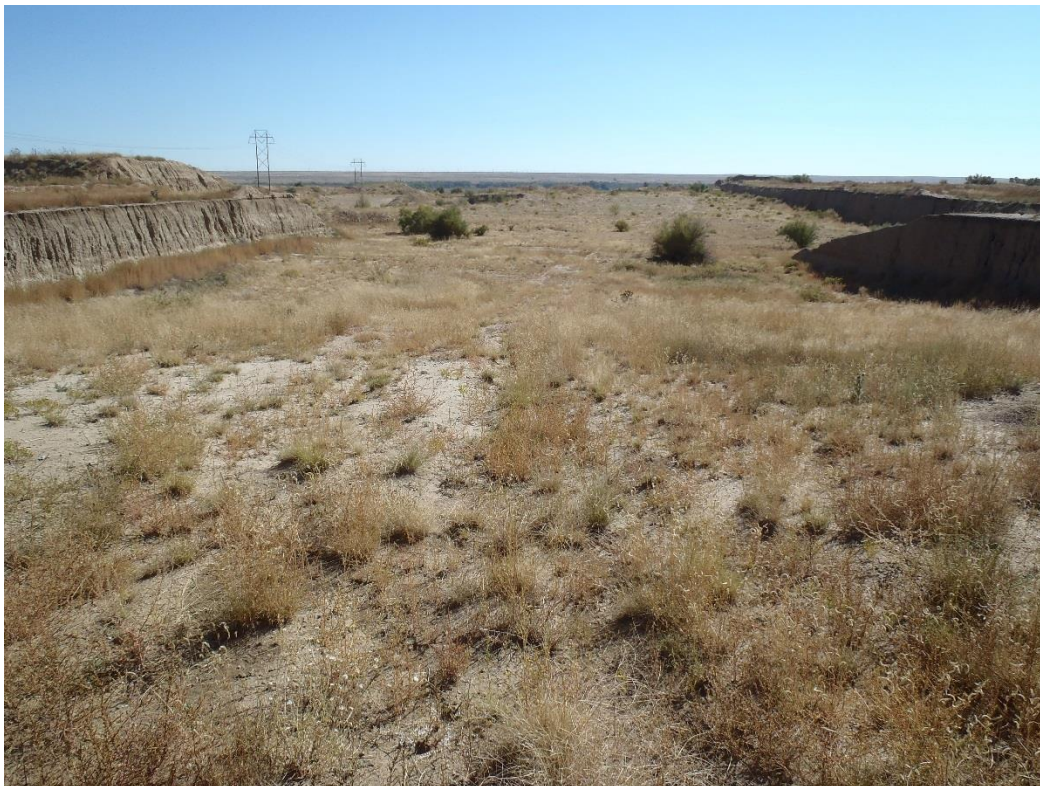
Pit & Permit Area: The operation consists of a large open pit with near vertical highwalls on the west end approximately 10 feet high (see **Photo 4**) and older, somewhat flatter highwalls approximately 15 feet high in the north part of the pit (see **Photo 5**).

The approved reclamation plan calls for highwalls to be no steeper than 4H:1V upon final reclamation. Based on the 2011 Google Earth image and highwalls observed on site, the Division estimates approximately 3,000 feet of highwall that requires flattening to 4H:1V. A review of Google Earth images suggest these highwalls were likely not present in 1999, but were clearly visible in November of 2003 (see **Figures 4a** and **4b**).

Photo 4. Near vertical highwalls on the west end (looking east).

- ii. A revised Exhibit D Mine Plan that addresses the observed highwall mining practice (steeper than the final 4H:1V slopes) and inclusion of the observed ponds so appropriate reclamation costs can be determined;

- iii. A revised Exhibit E Reclamation Plan reaffirming the intent to flatten highwalls to no steeper than 4H:1V, and backfilling of the observed ponds and updating the seed mix to include at least the four previously mentioned species (Western Wheatgrass, Russian Wildrye, Little Bluestem and Sideoats Grama) and their respective seed rates;

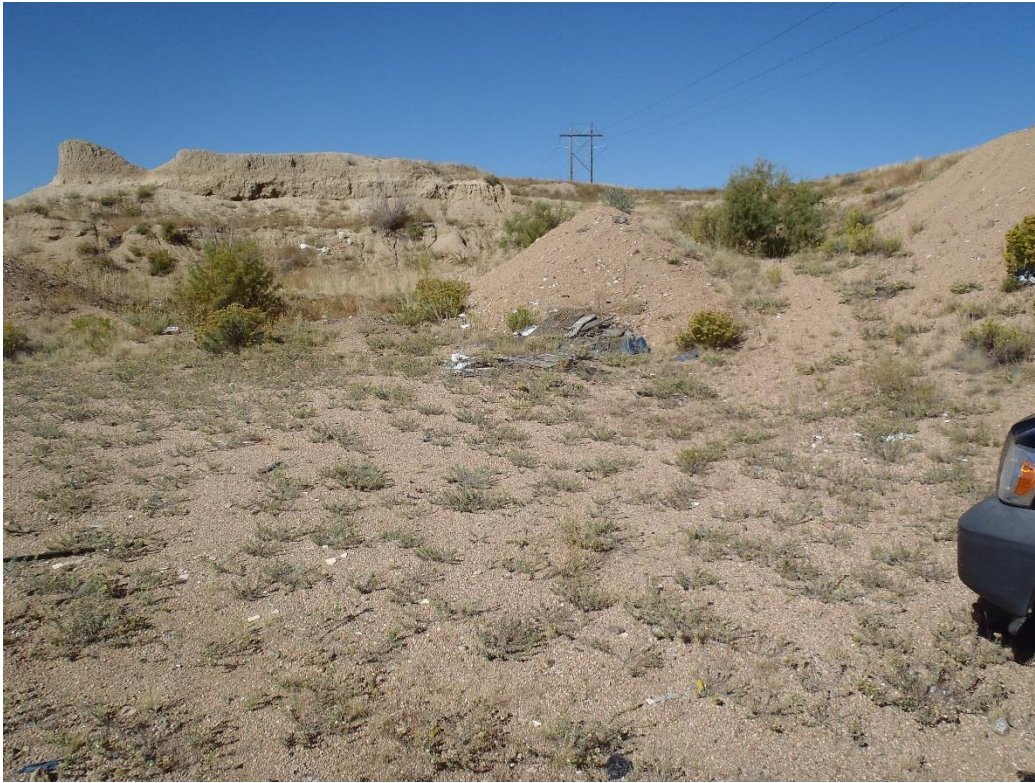
Photo 5. Flatter highwalls in the north part of the pit (looking NW) .

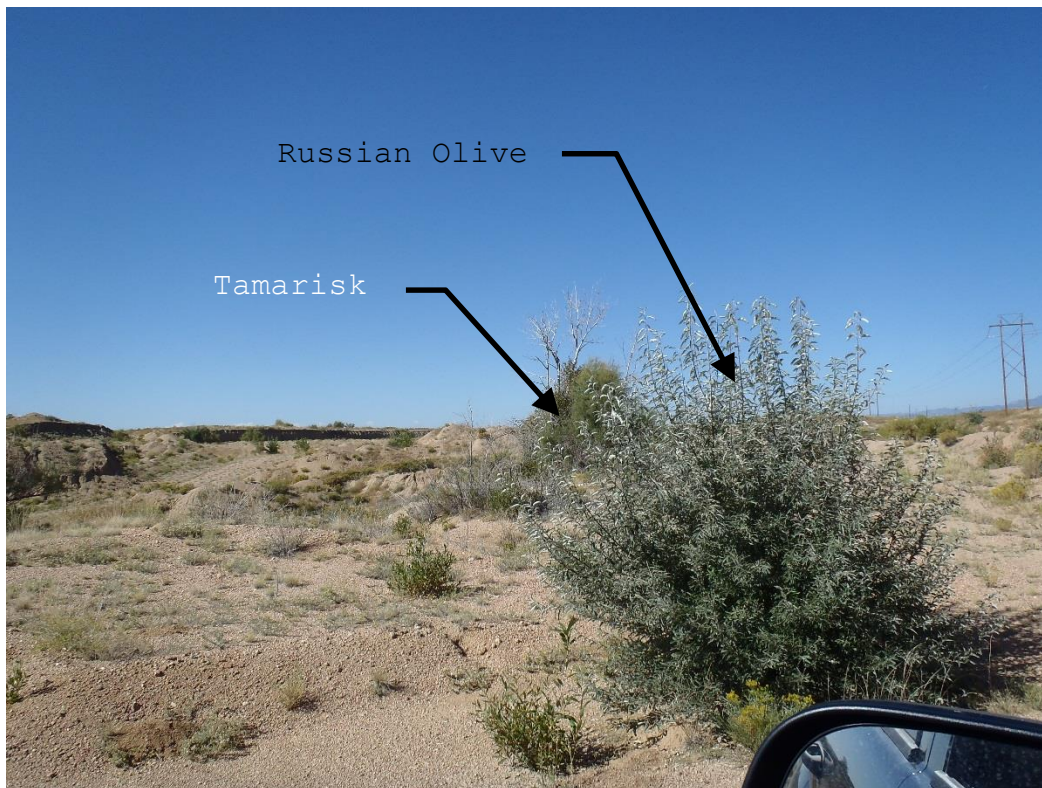
Reclamation: No reclamation has been performed to date (referencing the 2014 annual report). However, some areas (notably the wide west ramp) has revegetated naturally. Some tamarisk and Russian olive were observed on the pit floor (see **Photo 6**). These noxious weeds should be controlled before they are prevalent enough to be cited as a problem.

Photo 6. Tamarisk and Russian olive observed on the pit floor (looking NW).

2. The Division observed some tamarisk and Russian olive on the pit floor. These noxious weeds should be controlled before they are prevalent enough to be cited as a problem.

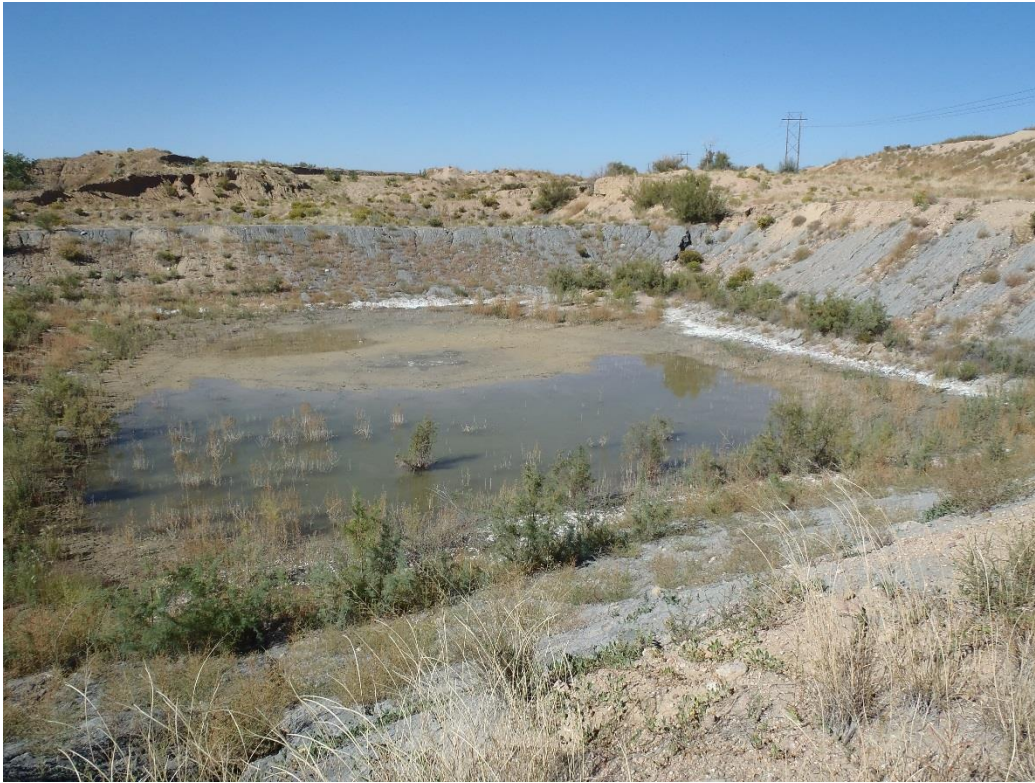
No exposed groundwater was observed during the inspection. Three wash ponds were observed on the east end of the site (see **Figure 3** and **Photo 7**). A review of Google Earth images suggest the ponds were constructed in 2006 (see **Figures 4c** and **4d**).

Photo 7. One of three wash ponds in east pit floor (looking NW).

- iv. A revised Exhibit F Reclamation Plan Map drawn at an acceptable scale (see Rule 6.2.1(2)(e) that reflects proposed final contours of the existing disturbed area and backfilling the existing ponds;
