COLORADO DIVISION OF RECLAMATION, MINING AND SAFETY
MINERALS PROGRAM INSPECTION REPORT
PHONE: (303) 866-3567

MINE NAME: Kittimac Tailings Repository	MINE/PROSPECTING ID#: P-2011-015	MINERAL: Unknown commodity	COUNTY: San Juan
INSPECTION TYPE: Monitoring	INSPECTOR(S): Lucas J. West	INSP. DATE: September 10, 2015	INSP. TIME: 10:45
OPERATOR: Colorado Goldfields Inc.	OPERATOR REPRESENTATIVE: None	TYPE OF OPERATION: MP - Mineral Prospecting

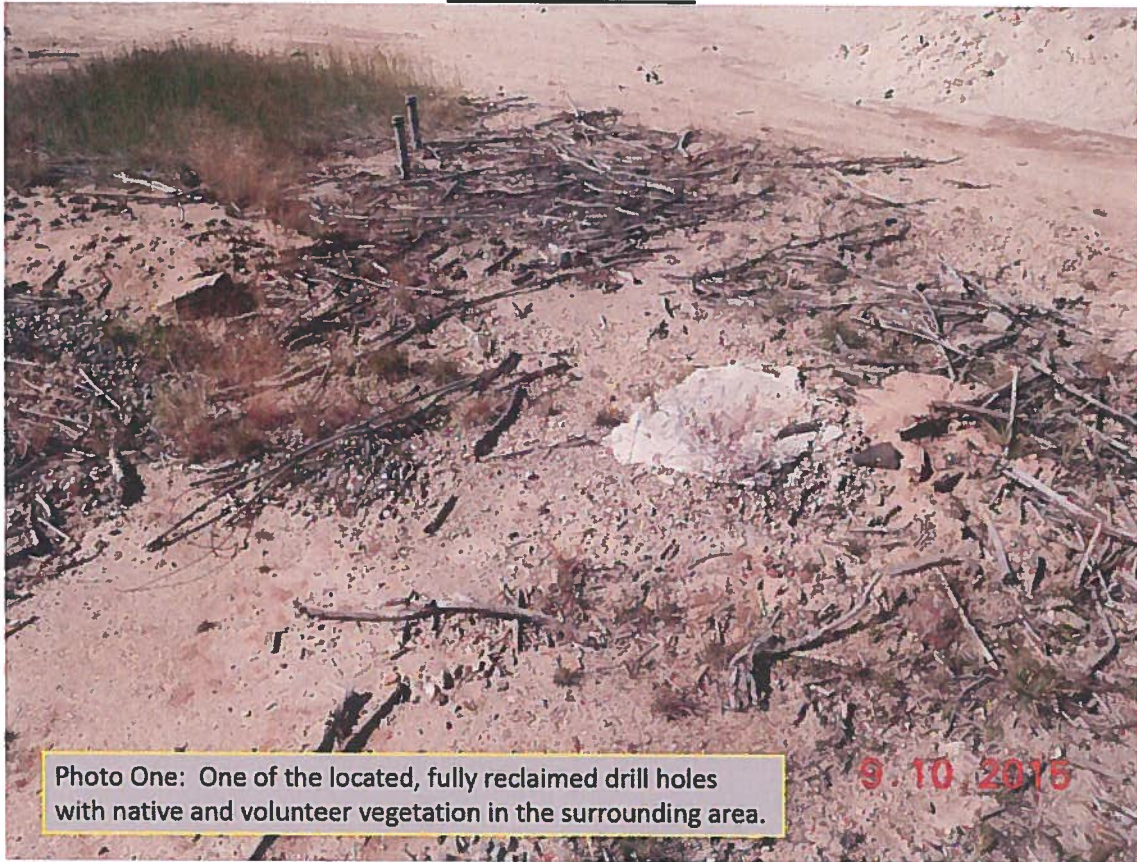
The site was not active at the time of the inspection. This operation consisted of drilling several auger holes into a pre law tailings dump. The site has been fully reclaimed, at the time of the inspection only three drill holes were located. The drill holes observed were backfilled with gravel and plugged with concrete upon completion as seen in Photo One. According to records held by the Division each drill hole was reclaimed prior to the commencement of drilling at the next sequential hole. No casings or drill cuttings were observed on site. All disturbances are fully reclaimed at this time.

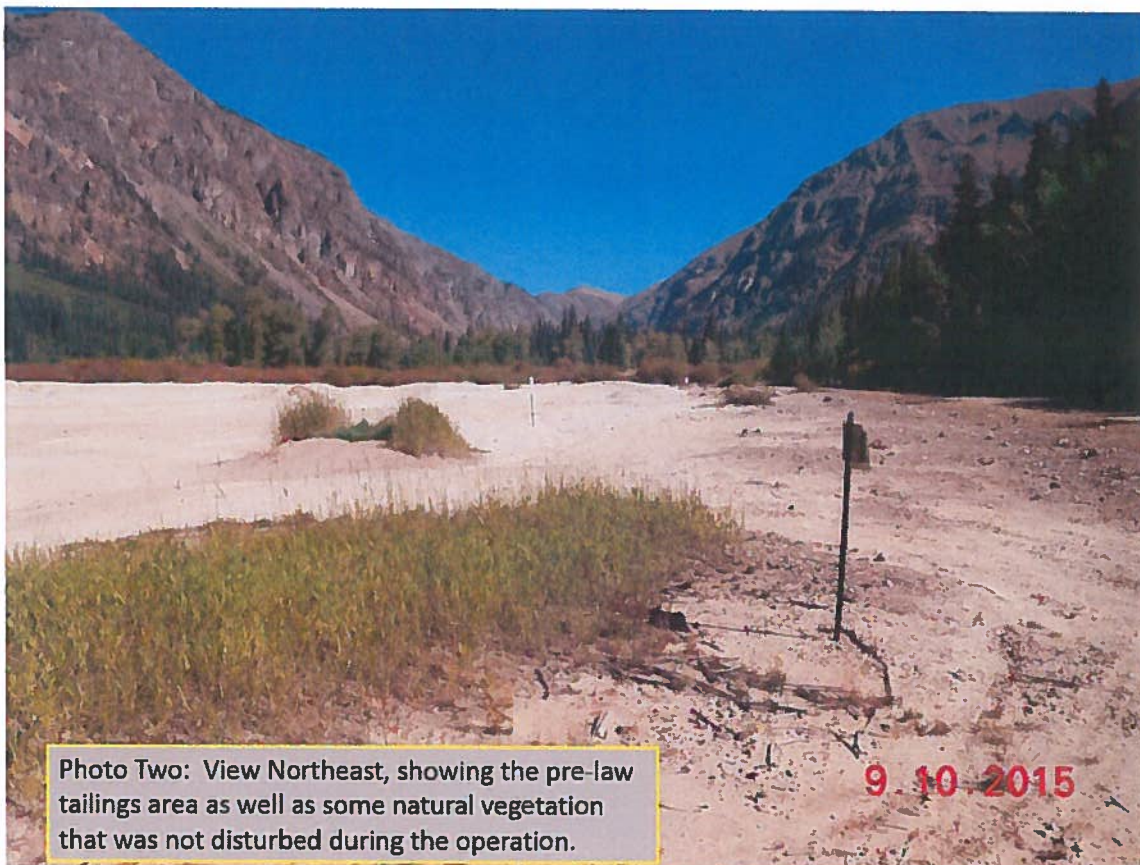
The sites showed little vegetation as seen in Photo Two. Due to the site being located in a pre-law tailings dump, revegetation was never a part of the approved reclamation plan. Some native bunch grasses and willow brush is located on site but was not disturbed by the operation. No noxious weeds were observed on site and the overall footprint of the site was in good condition and free from trash and debris.
